# PROPOSED WIND FARM TOWERS CENTRAL HIGHLANDS TASMANIA

# RECONNAISSANCE LANDSLIDE RISK ASSESSMENT

Cromer, W. C. (2022). Reconnaissance landslide risk assessment, proposed wind farm towers, Central Highlands, Tasmania. Unpublished report for Epuron by William C. Cromer Pty. Ltd., 6 July 2022.

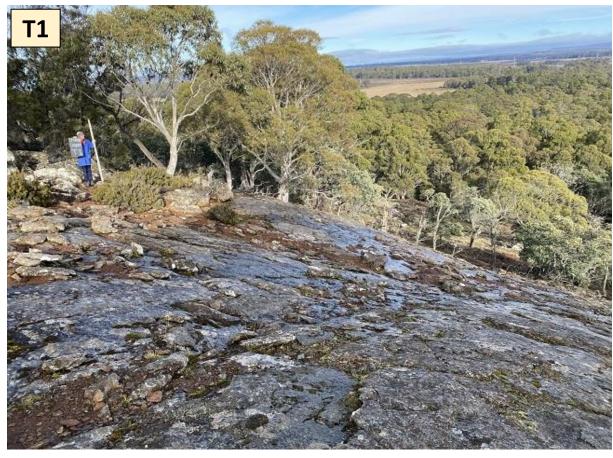
Plate T1-3 (above). Detail of polygonal jointing near T1. Plate T1-4 (below). View southwest from near T1, over a large exfoliated outcrop of high strength dolerite. St. Patricks Plains are in the background.

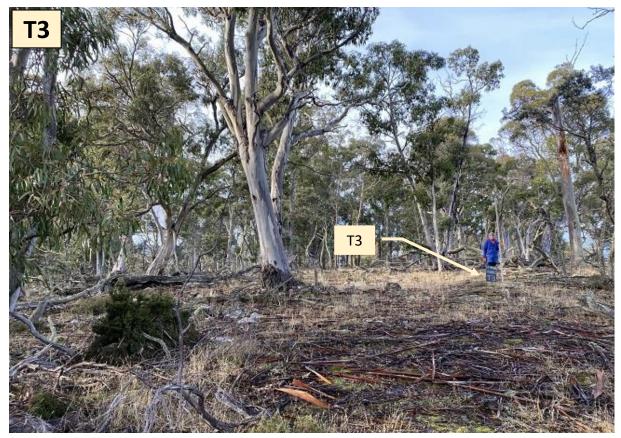
Plate T3-1 (above). View north near proposed tower T3, on the almost flat crest of a broad spur trending NNW - SSE; the ground slopes gently in these directions at angles in the  $0-5^{\circ}$  range. Slopes steepen to up to  $30^{\circ}$  and more along the sides of the ridge. The staff is 3m high.

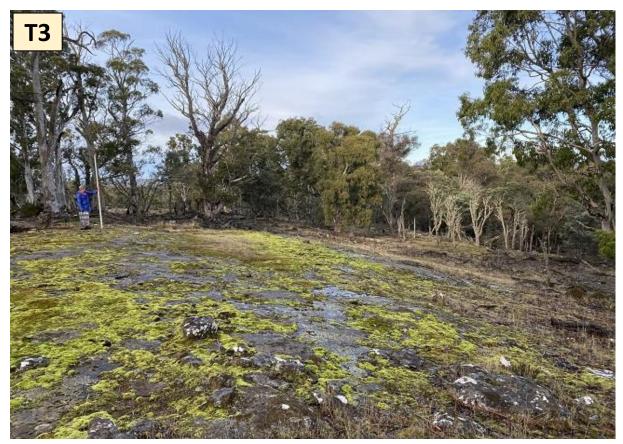
Plate T3-2 (below). View north towards T3. Dolerite cobbles and boulders float litters the ground, and subcrops of bedrock are common.

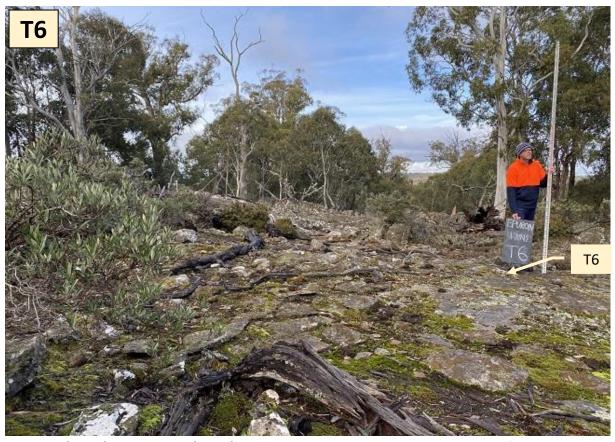
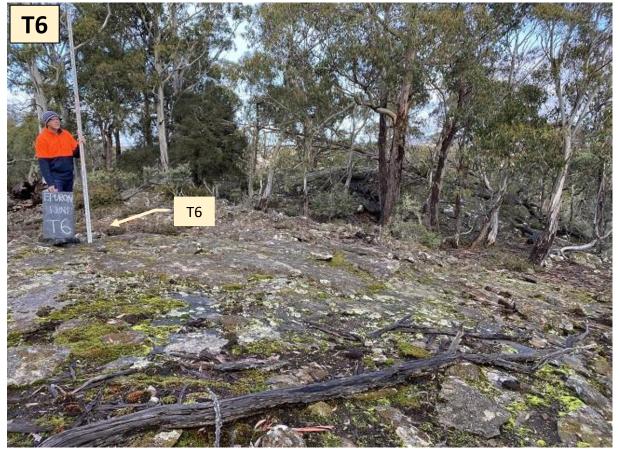
Plate T6-1 (above) and Plate T6-2 (below). View south to T6. Dolerite cobbles and boulders float litters the ground, and outcrops of exfoliated high-strength bedrock are common. The staff is 3m high.

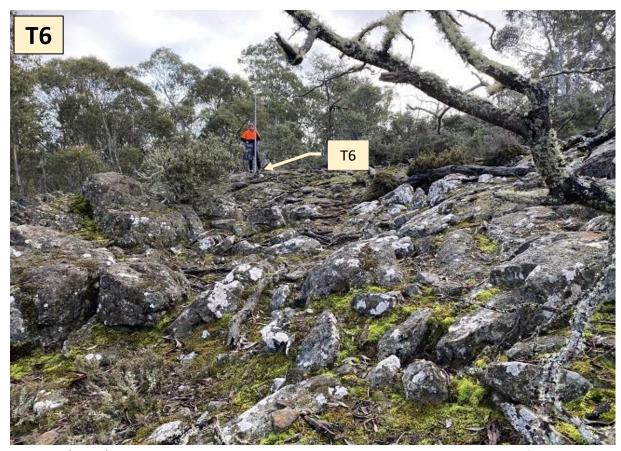
Plate T6-3 (above). View north and slightly upslope towards T6. Dolerite cobbles and boulders float litters the ground, and outcrops of exfoliated high-strength bedrock are common. The staff is 3m high. Plate T6-4 (below). Exfoliated, high-strength Jurassic dolerite (curved joints parallel to land surface) with subvertical polygonal joints (red arrows). These polygons are the eroded tops of subvertical dolerite columns. The jointing may extend for considerable depths into the bedrock., and columns may be cut by subhorizontal joints.

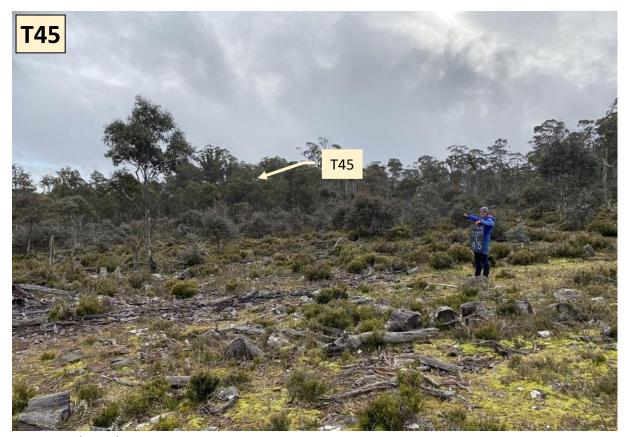
Plate T45-1 (above). View north northwest and slightly upslope towards T45 about 120m away. Dolerite cobbles and boulders litter the ground.

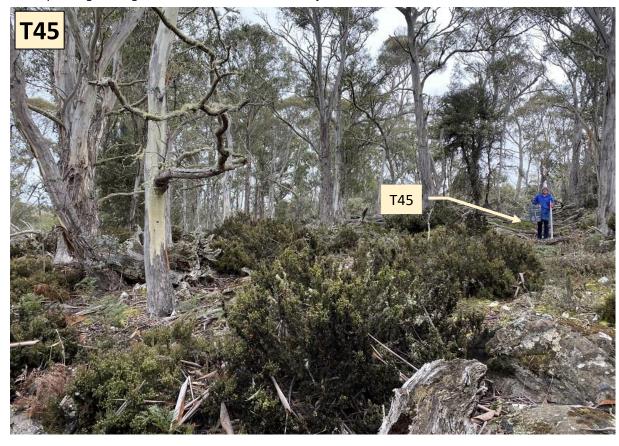
Plate T45-2 (below). View west northwest and slightly upslope. T45 is characterised by numerous subcrops and outcrops of high-strength dolerite. The main subvertical joint directions are north-south.

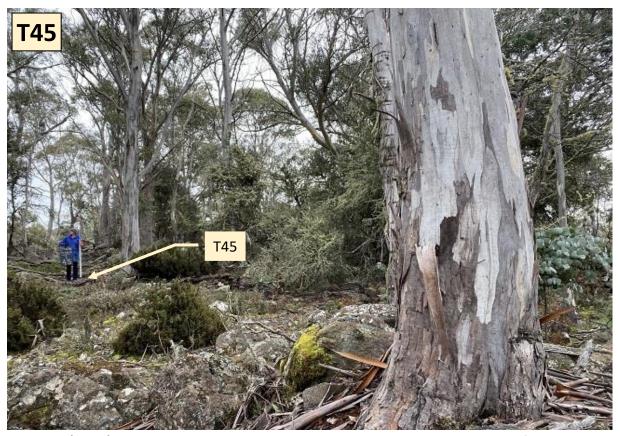
Plate T45-3 (above). View north northwest and slightly upslope. Dolerite cobbles and boulders float litters the ground.

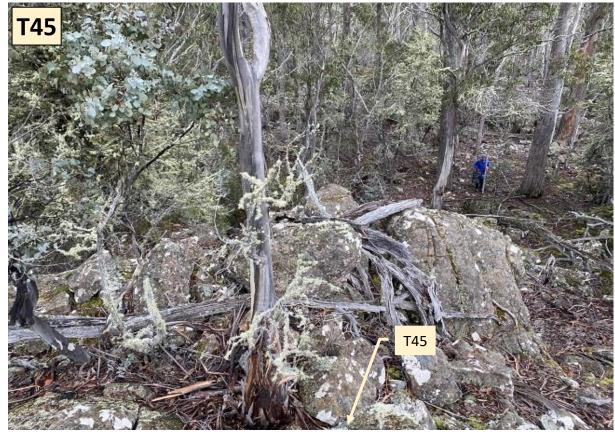
Plate T45-4 (below). View north and steeply downslope. Site T45 is behind the camera. The main subvertical joint directions are north-south.

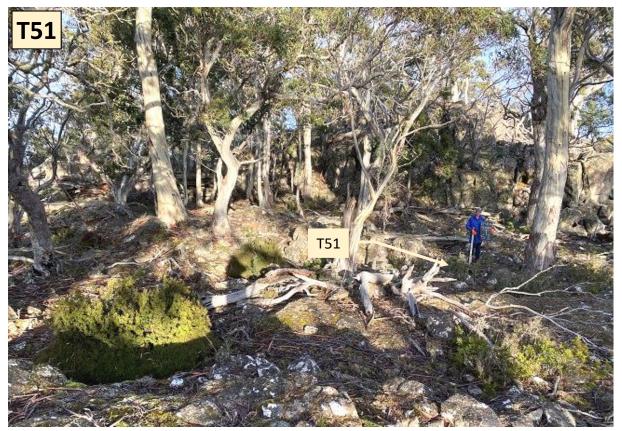
Plate T51-1 (above). View south towards T51, a slightly lower area between two raised dolerite outcrops [a subdued one at camera (see Plates T51-3 and T51-4); the second, higher one in background; see below]. Plate T51-2 (below). View south (site T51 is behind the camera). This outcrop of high strength dolerite shows prominent subvertical north-south jointing. The blocks have slid west (to right) and slightly downslope (yellow arrow), with some topples (red arrows). The staff is 5m high.

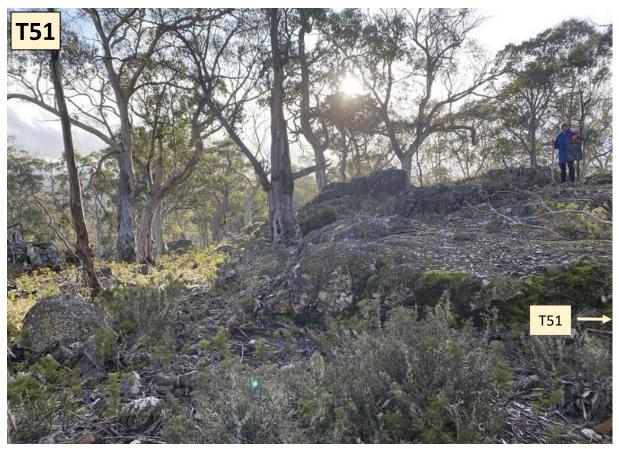
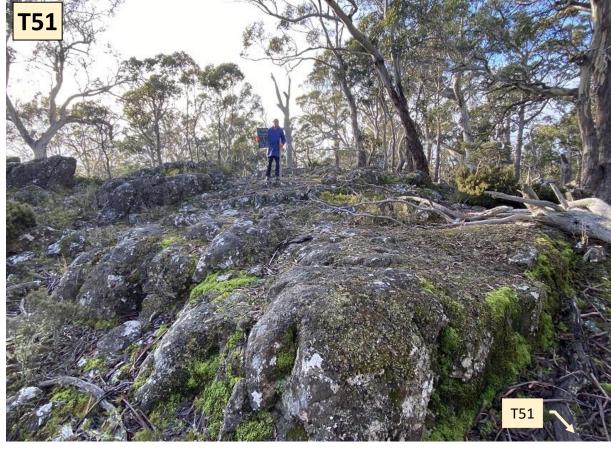
Plate T51-3 (above) and T51-4 (below). Views northeast near T51 (at right, off camera), towards a slightly elevated outcrop of high-strength dolerite. Subvertical joints trend north-south.

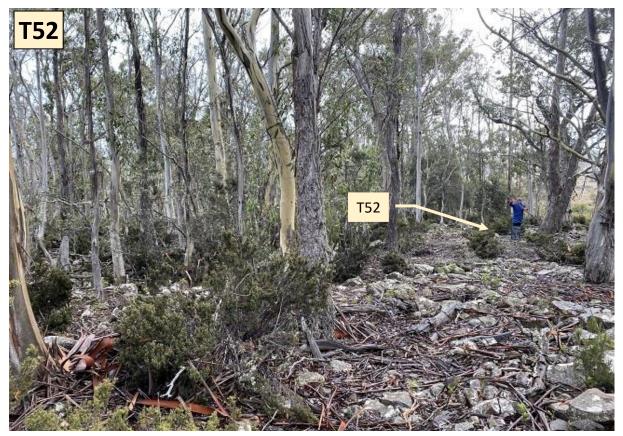
Plate T52-1 (above). View southeast towards T52. A float of approx. 80% cover of dolerite cobbles and boulders on gently rising ground.

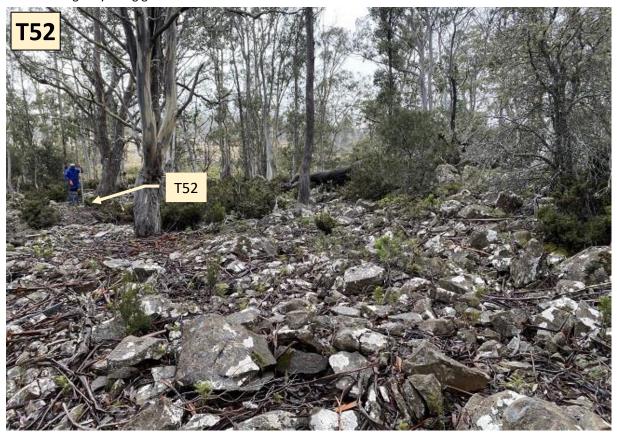
Plate T52-2 (below). View east towards T52. A float of approx. 80% – 90% cover of dolerite cobbles and boulders on gently rising ground.

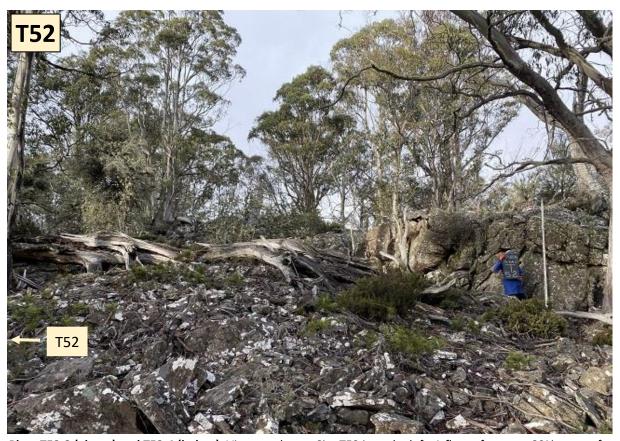
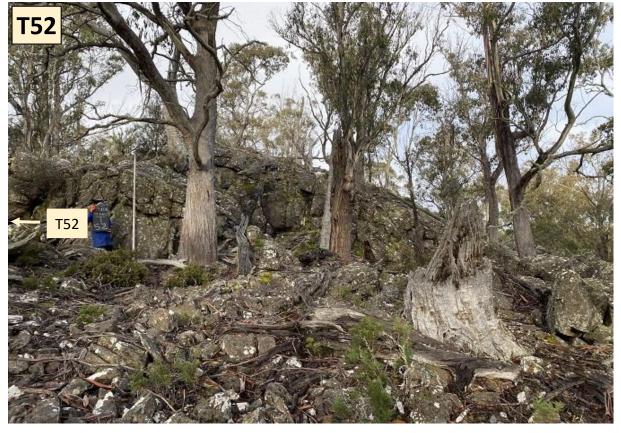
Plate T52-3 (above) and T52-4 (below). View southeast. Site T52 is to the left. A float of approx. 80% cover of dolerite cobbles and boulders on gently rising ground. The outcrop of high strength dolerite with subvertical north-south jointing at right (above) and centre (below) falls away steeply at the rear in 10- - 15m high cliff sections. The staff is 3m high.

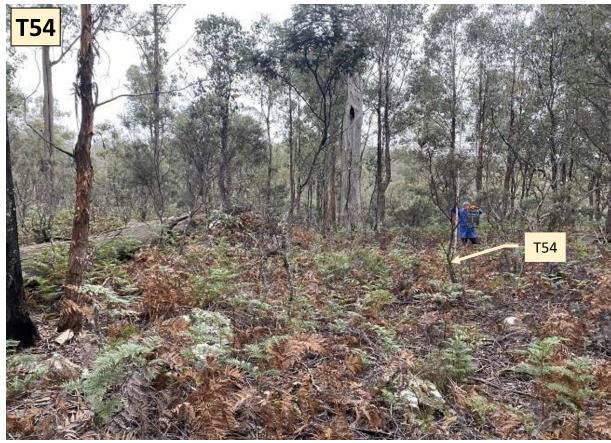
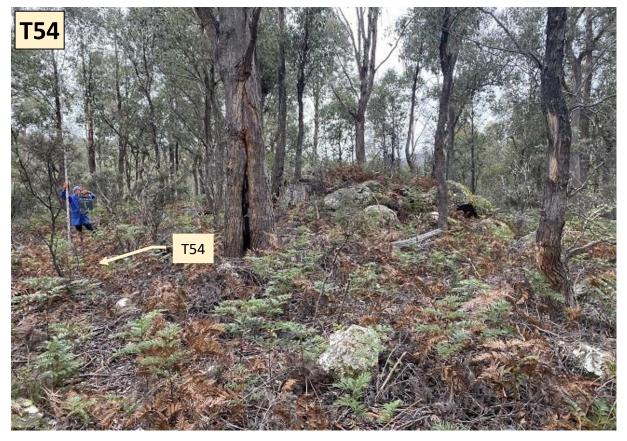
Plate T54-1 (above) and T54-2 (below). Views east towards T54. Gentle slopes with a sparse float of 10-20%surface cobbles and boulders to 1m. The boulders at right centre in the photo below are subcrop, well-graded in size to about 1.5m.

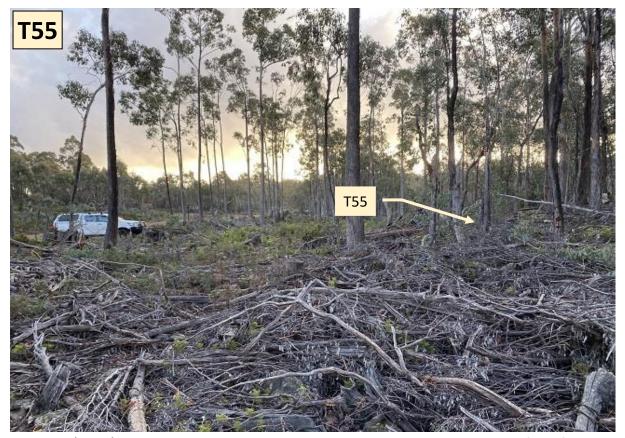
Plate T55-1 (above). View west northwest towards T55, on gently sloping ground with a sparse float of dolerite cobbles and boulders.

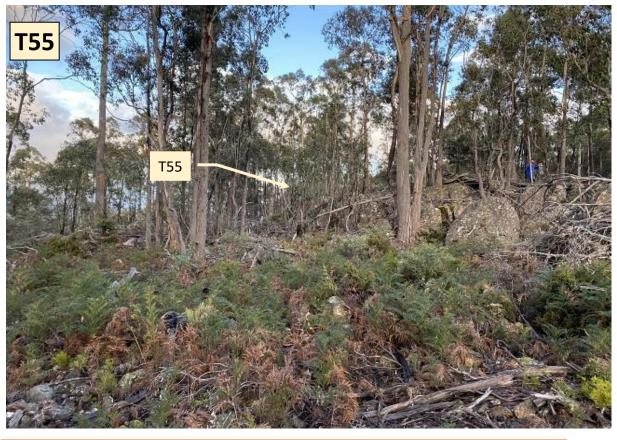
Plate T55-2 (below). View southwest towards T55. The higher ground at right includes subcrops and outcrops of high strength dolerite.

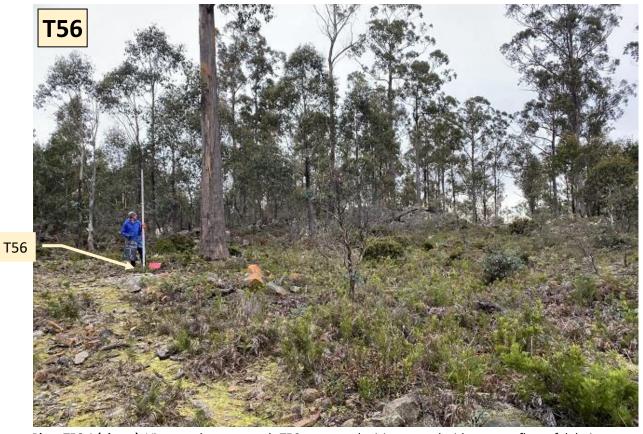
Plate T56-1 (above). View southeast towards T56, over gently rising ground with a sparse float of dolerite cobbles and boulders.

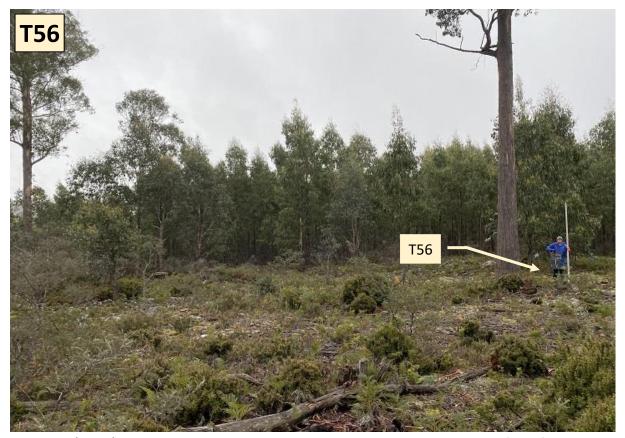
Plate T56-2 (below). View southwest towards T56 over gently falling ground with a float of dolerite cobbles and boulders.

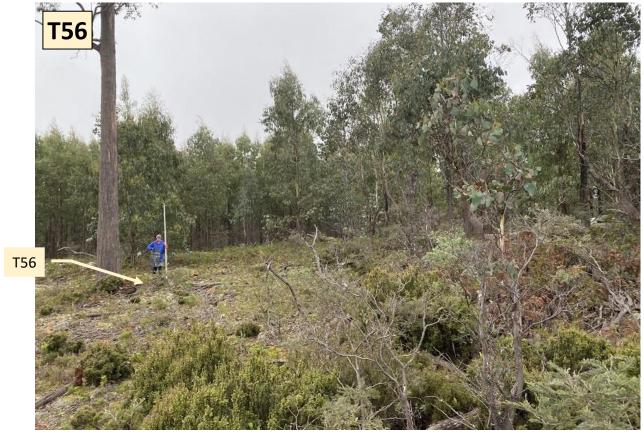
Plate T56-3 (above). View southeast towards T56, across almost level ground with a sparse float of dolerite cobbles and boulders.

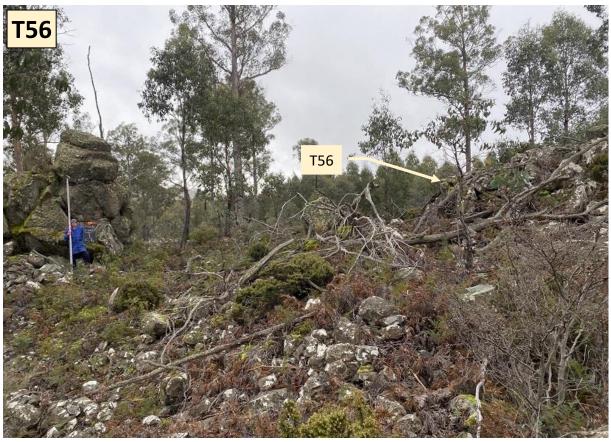
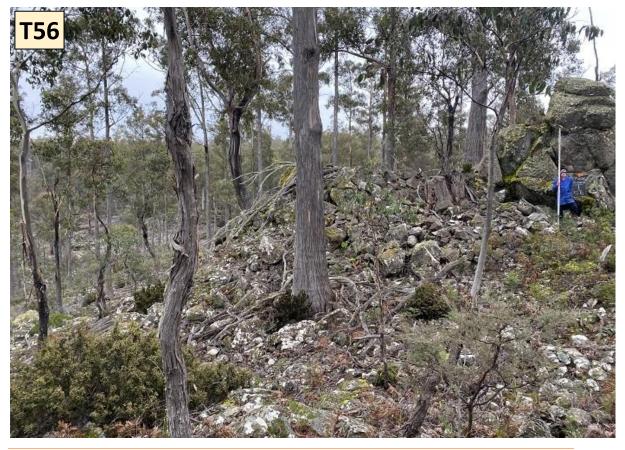
Plate T56-5 (above) and Plate T56-6 (below) View northwest (above) and west northwest near T56. Several knolls of high strength subcrops and outcrops of dolerite with associated float of fallen cobbles and boulders occur. The ground drops sharply to the east.

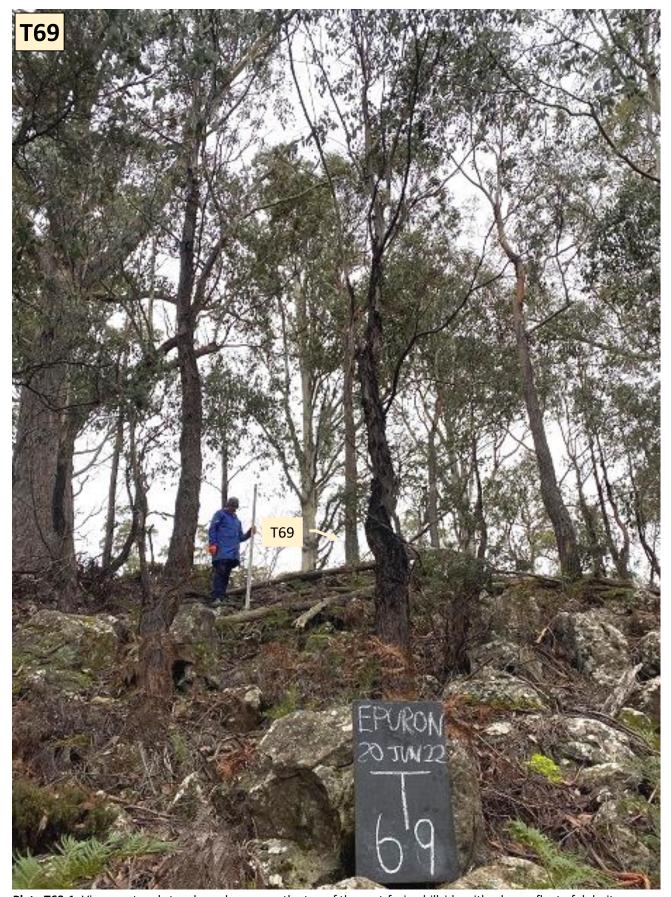
Plate T69-1. View west and steeply upslope, near the top of the east-facing hillside with a heavy float of dolerite cobbles and boulders, and isolated outcrops of high strength rock. T69 is located about 50m west.

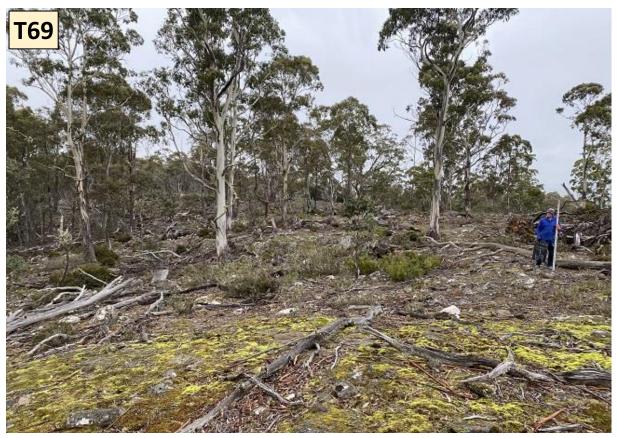
Plate T69-2 (above). View north towards T69, across gently rising ground with a float of dolerite cobbles and boulders.

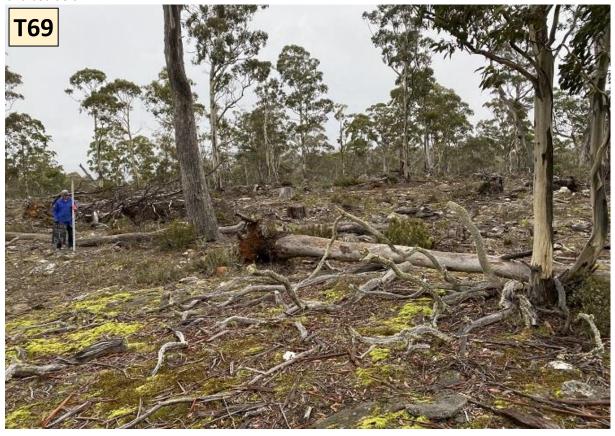
Plate T69-3 (below). View west towards T69, across almost level ground with a sparse float of dolerite cobbles and boulders.

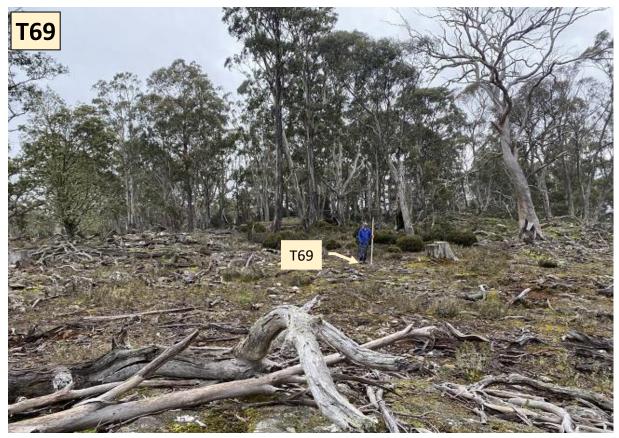
Plate T69-4 (above). View northeast towards T69, across gently rising ground with a float of dolerite cobbles and boulders.

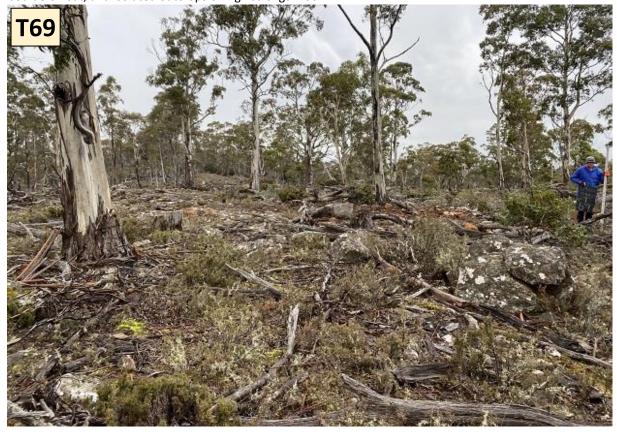
Plate T69-5 (below). View south southeast towards T69, across uneven ground with dolerite cobbles and boulders float, and isolated outcrops of high strength rock.
