APPENDIX 2 - DRAINAGE AND CREEK CROSSING STRUCTURES

Note: Road names are based on Google Maps

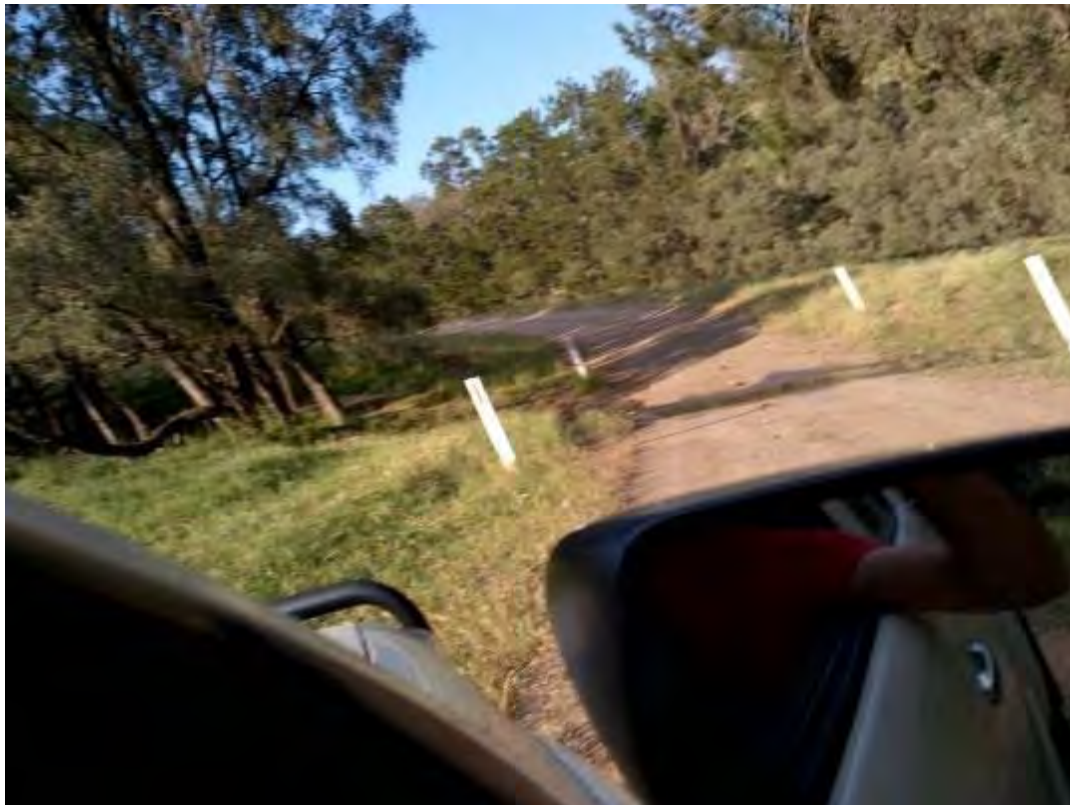
S001 – View to North

S001 – Pandora Rd – 3000m North of Coolah Creek Intersection

4000mm Causeway

Survey recommended to verify compliance with vertical geometry requirements.

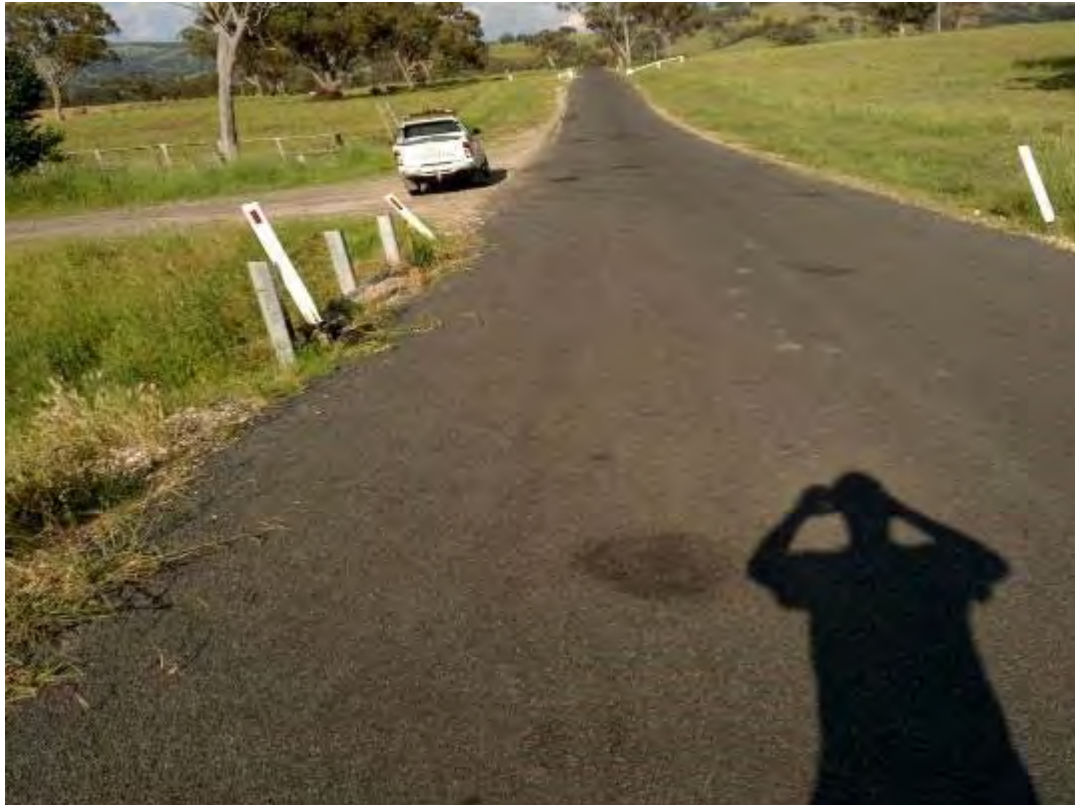
S002 - View to North

S002 – Coolah Creek Rd – 1000m West of Pandora Rd
4-750mm Pipe Culvert
Fair and Serviceable Condition, Good Internal Condition

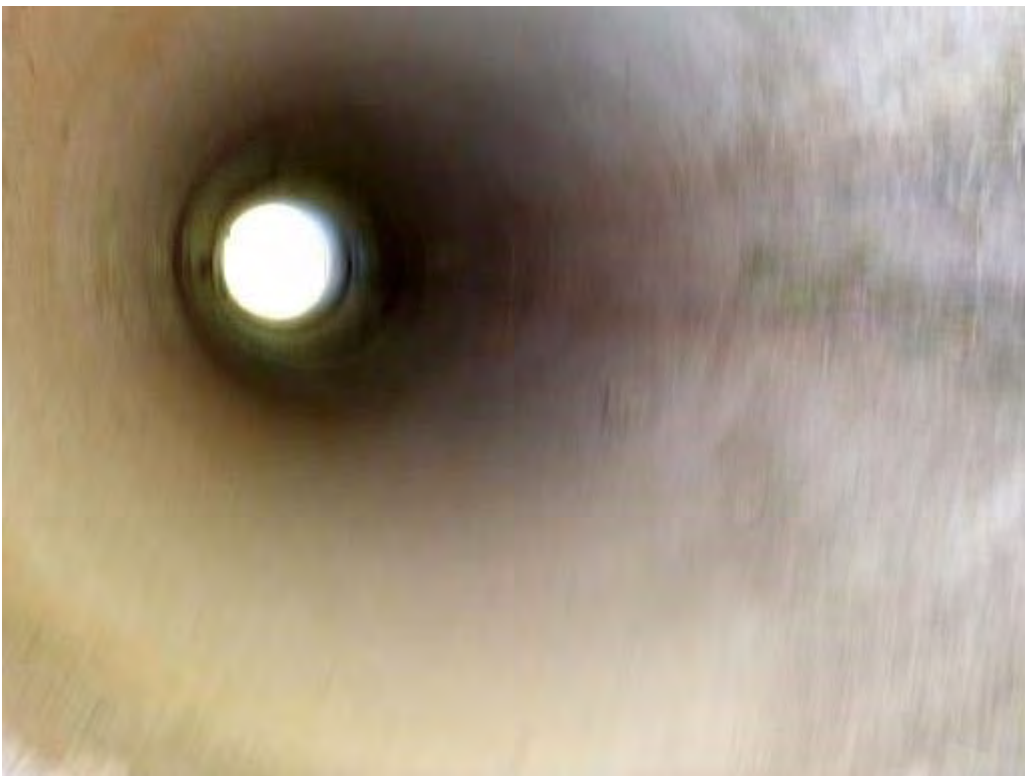
S002 – Internal View Good Condition

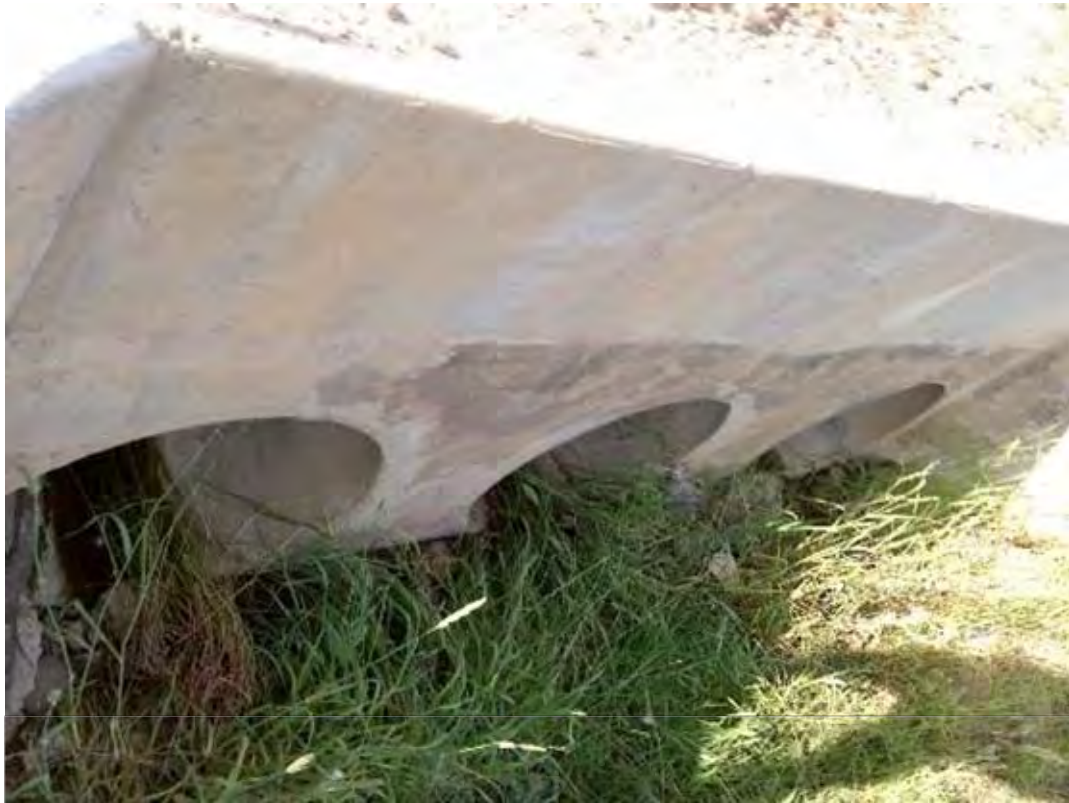
3-900mm Pipe Culvert
Good Condition and Serviceable

S003 – 3 - 900mm Pipe Culvert

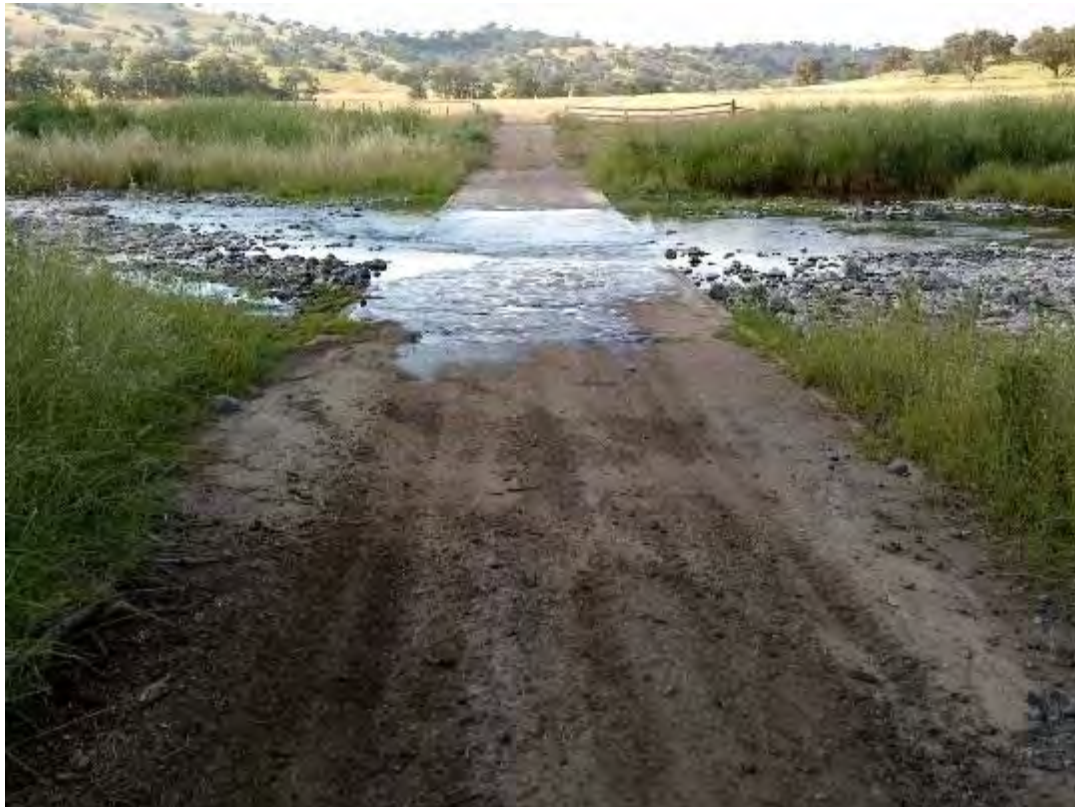
S004 – View to North

S004 – Oakdale Rd - 300m North of Coolah Creek Rd
Concrete Causeway, Submerged and Flood Prone.
Poor Condition and Serviceable. Upgrade likely required.
Surface on Causeway is slippery due to moss

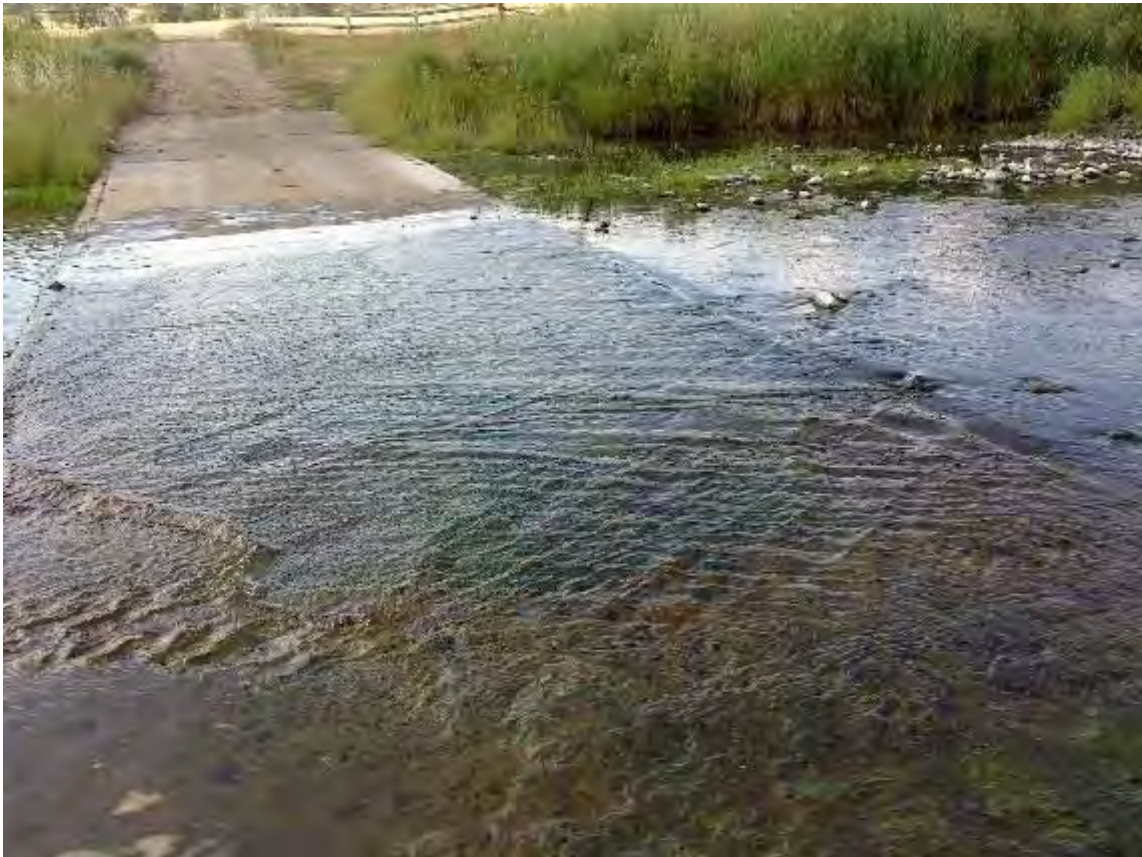
S004 – Top View of Causeway, Slippery Mossy Surface as Shown

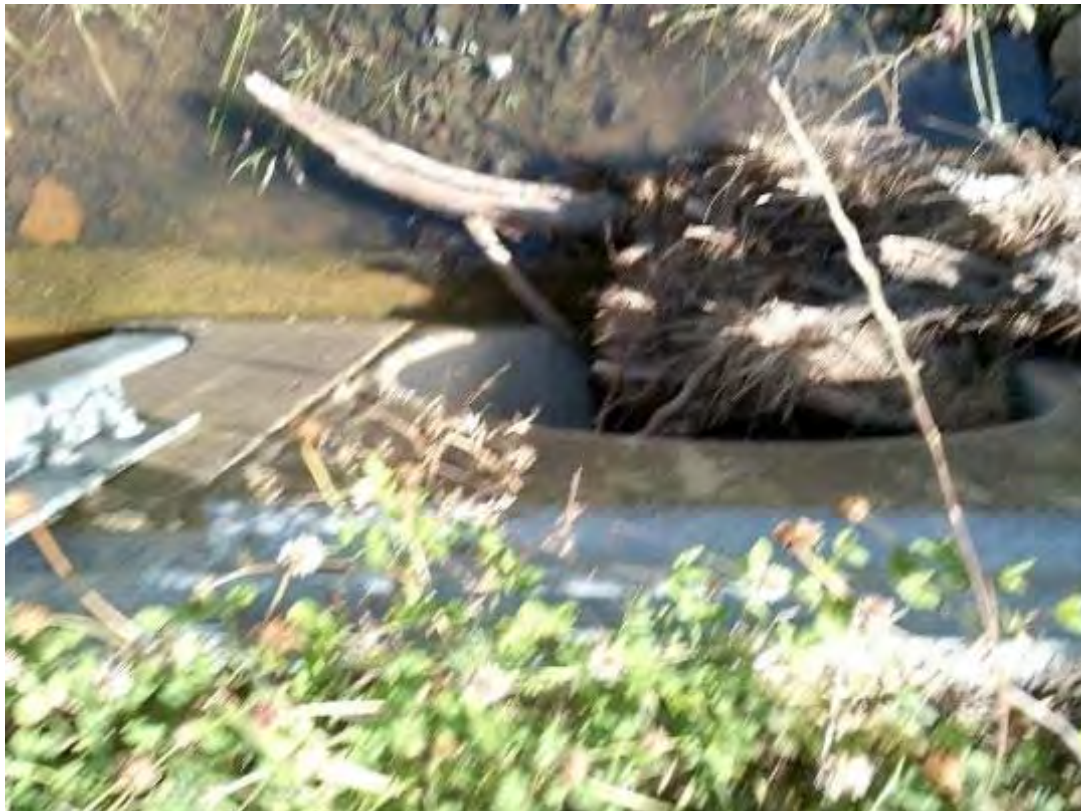
Concrete causeway with bitumen seal - 3-1200mm Pipe Culvert,
Entrance to culvert is blocked,
Further inspection of internal condition is required
Fair condition and Serviceable

S005 – Blocked Pipe Culvert

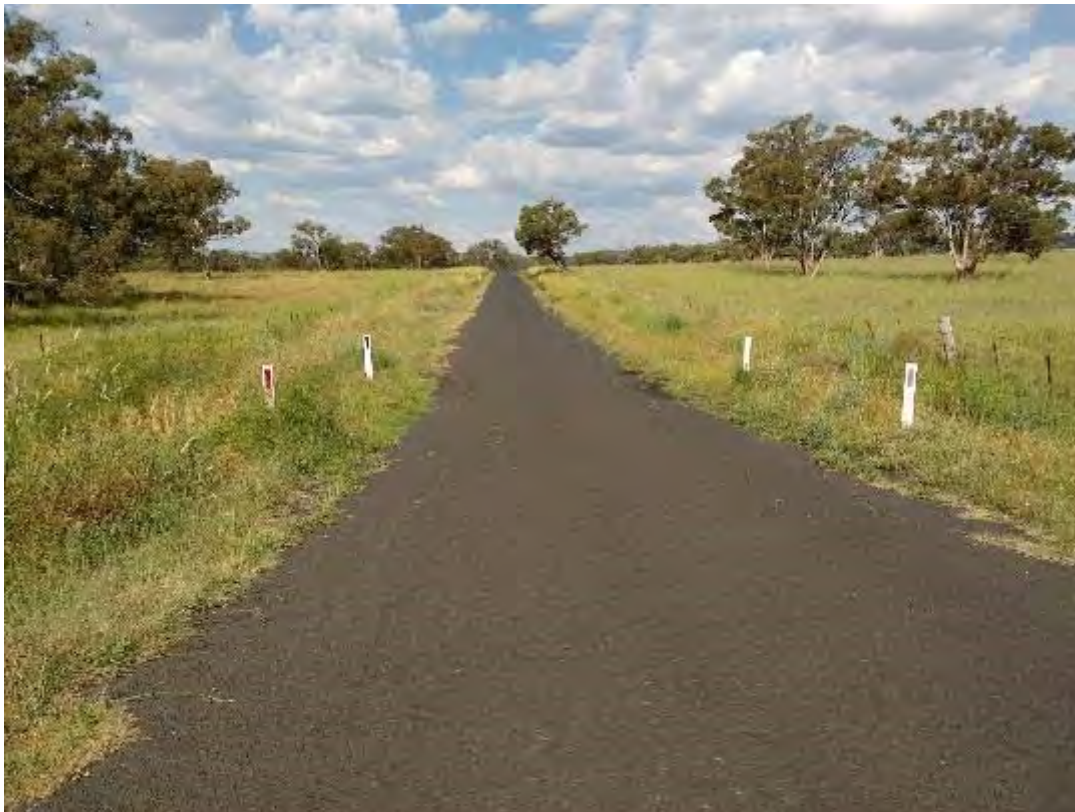
S006 - View to East

S006 – Coolah Creek Rd - 2500m East of Cooks Dr Intersection
1200mm Pipe Culvert
Good condition and Serviceable

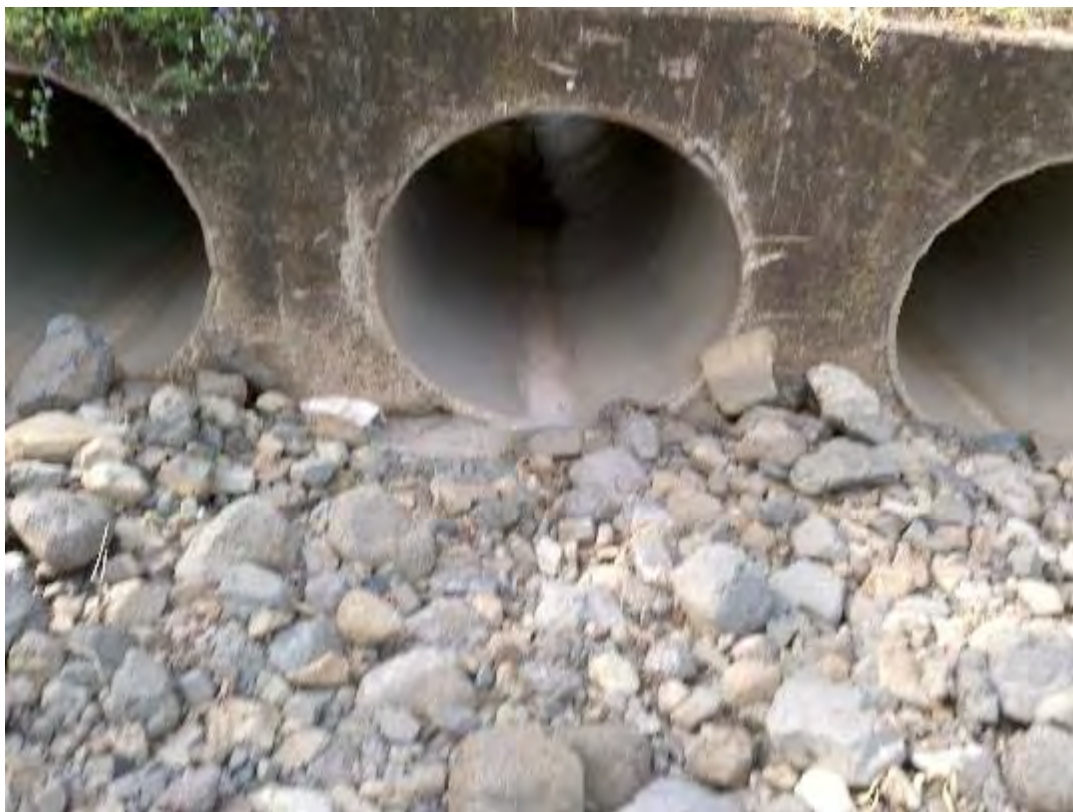
Big invert cracks internally

S007 - 3-1050 Pipe Culvert, Crack shown on bottom side of middle Culvert

Poor condition and serviceable, upgrade required.

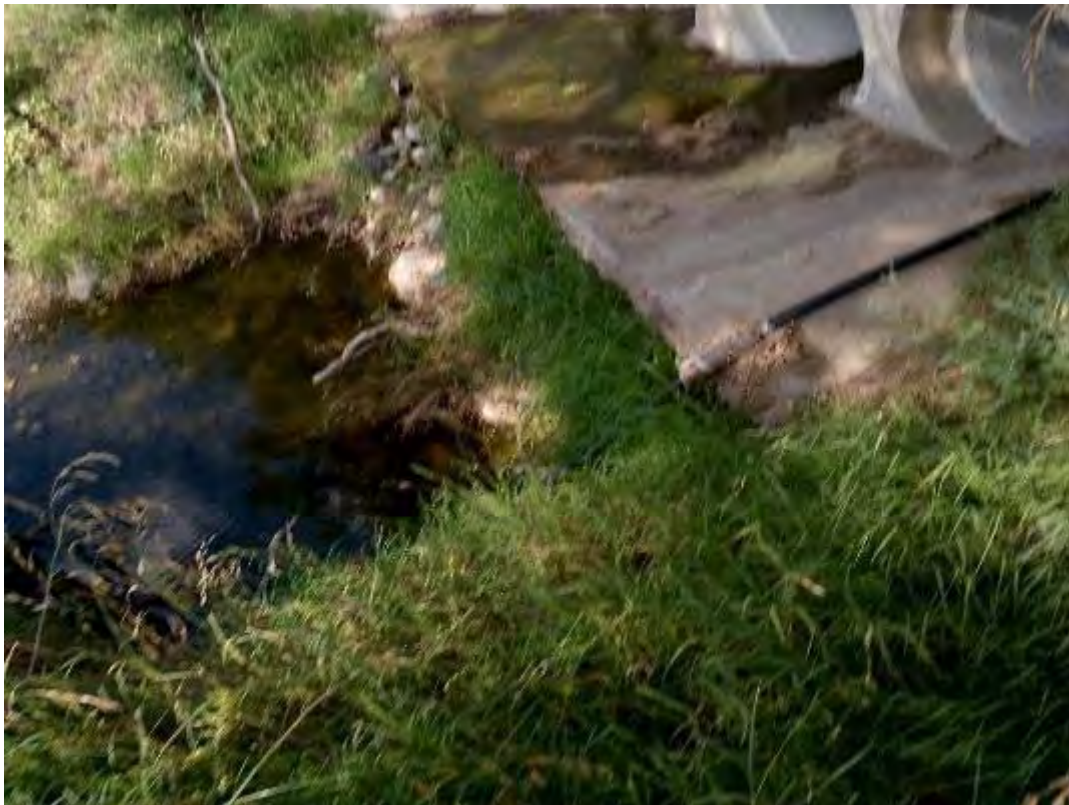
S008 – 3 × 1200mm Pipe Culvert

S008 – Coolah Creek Rd - 600m East of Cooks Dr Intersection
3 -1200mm Pipe Culvert
Fair Condition and serviceable

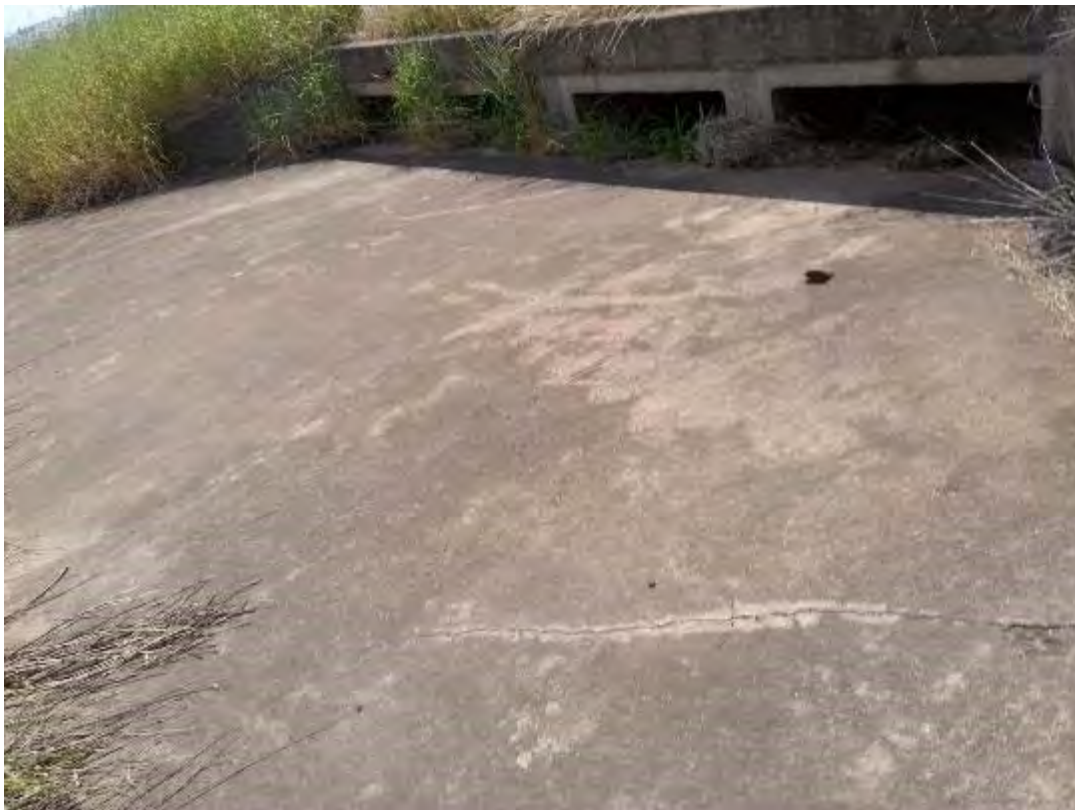
S009 – 4-1200mm Wide-450mm High Reinforced Concrete Box Culvert

4-1200mm Wide-450mm High Reinforced Concrete Box Culvert – Skewed across road alignment.
Good Condition and Serviceable

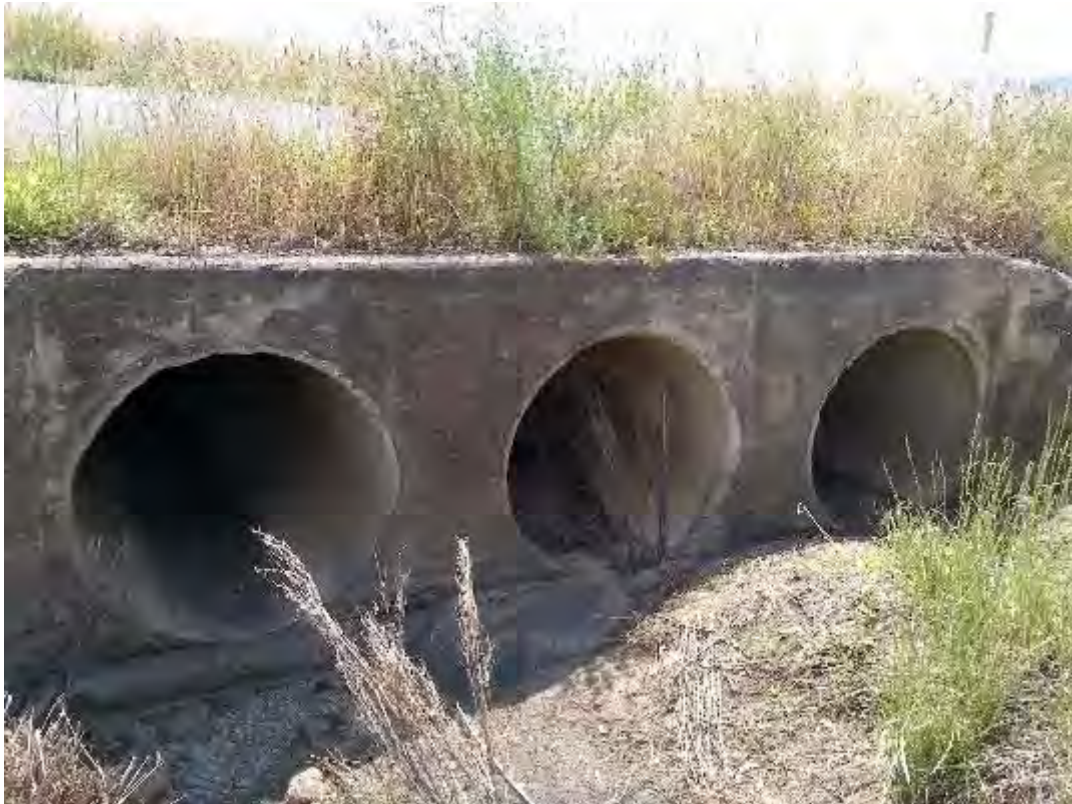
S011 –3-1050 Pipe Culvert

Good Condition and Serviceable

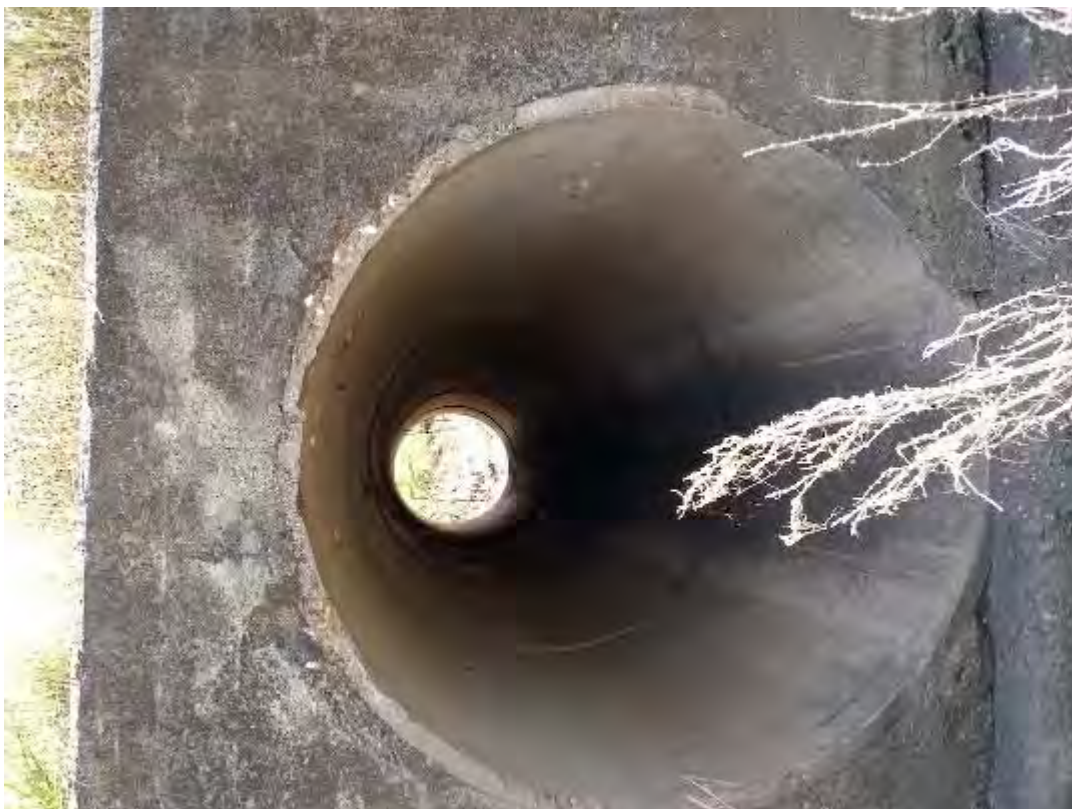
Internal Condition is satisfactory.

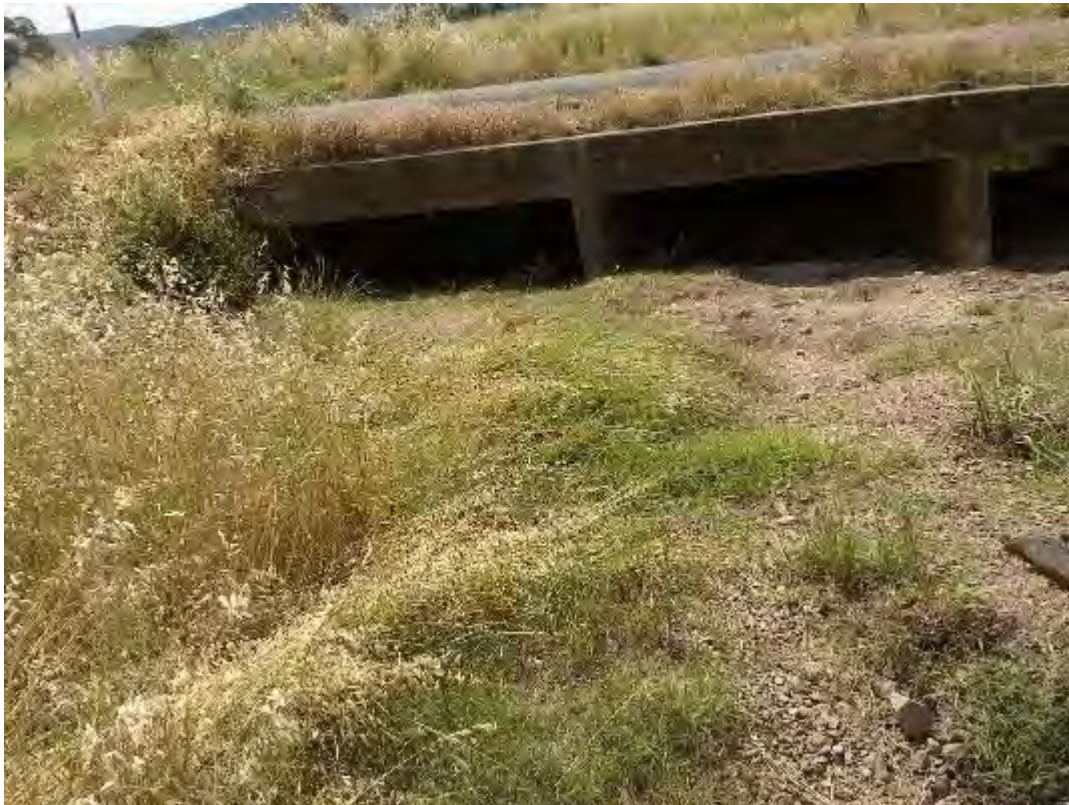
S012 – 3-750mm high-2400mm long reinforced concrete box culvert

7500mm wide Concrete Causeway with bitumen seal,
3-750mm high-2400mm long reinforced concrete box culvert
Fair condition and serviceable

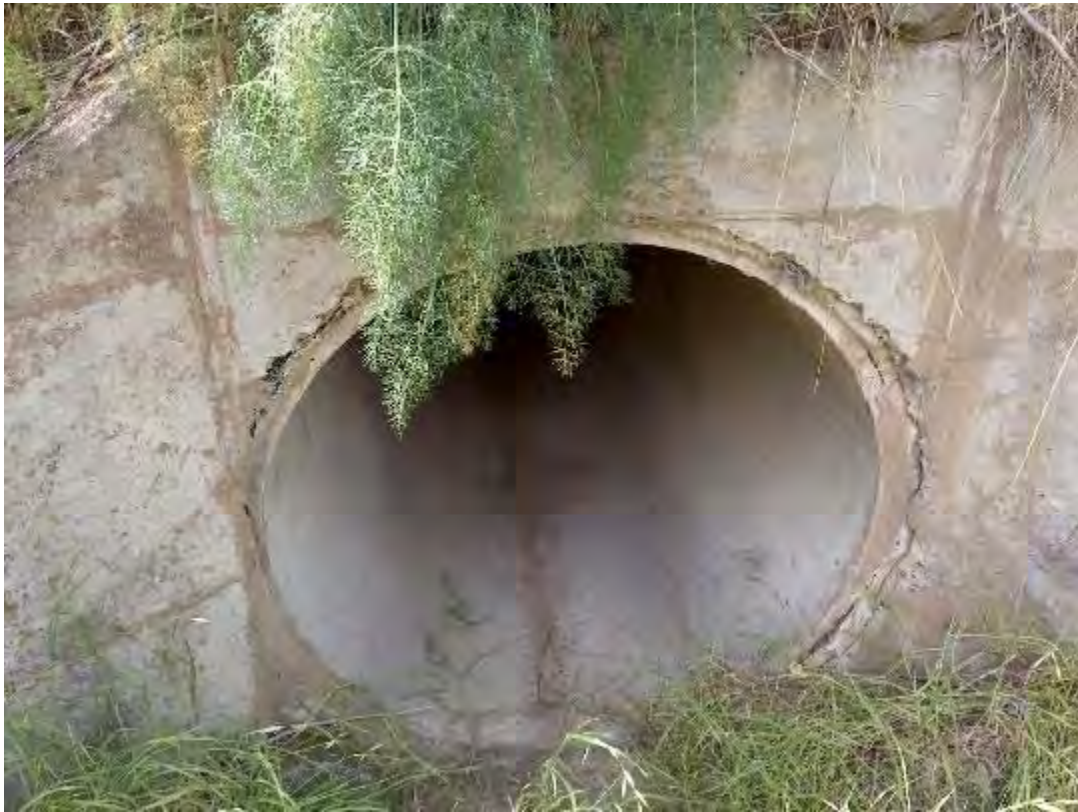
S013 – Single 1200mm Pipe Culvert

S013 - Vinegaroy Rd - 2500m South of Coolah Creek Intersection
1200mm Pipe Culvert
Good Condition and Serviceable

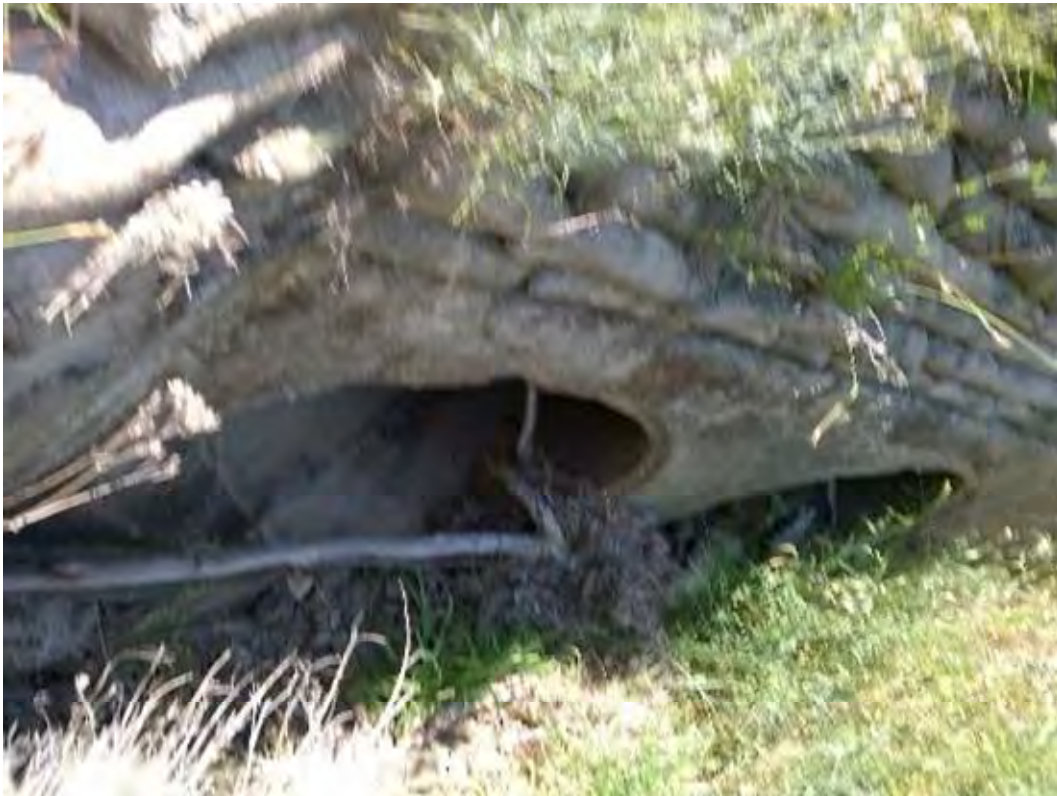
S014 – Dual 1200mm Pipe Culvert

Skewed and not level

Moderate condition and Serviceable

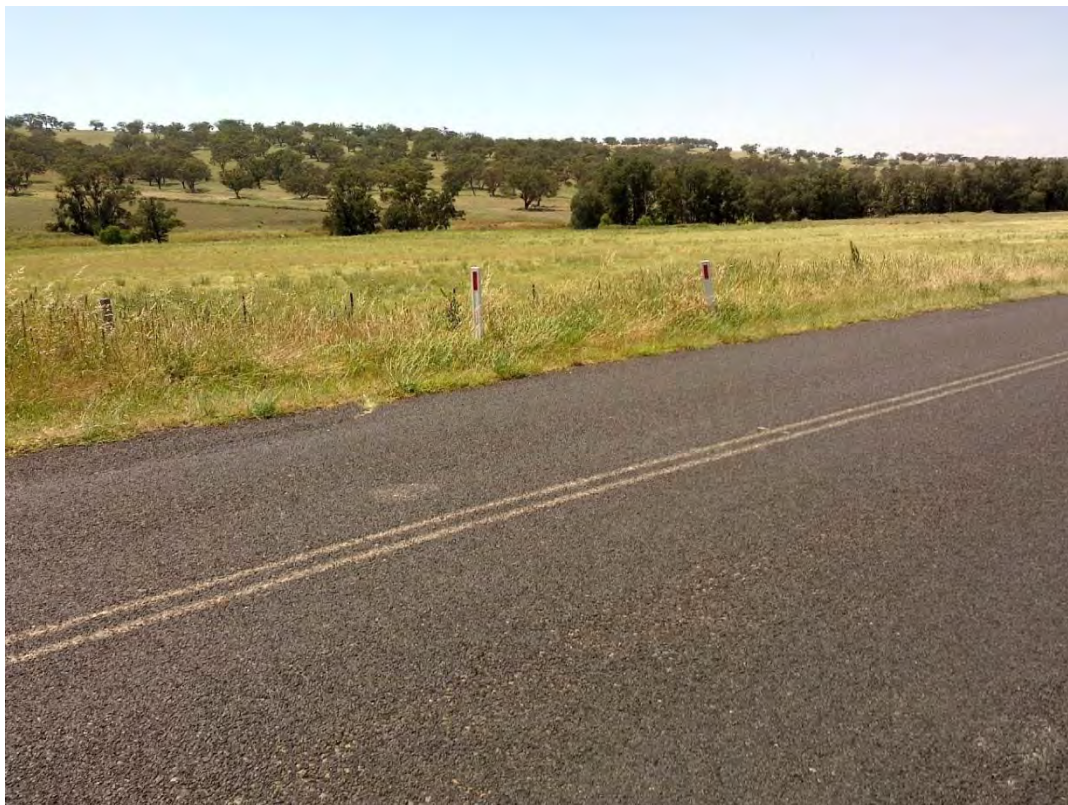
S015 – View to East

S015 - Vinegaroy Rd - 3500m North of Rotherwood Rd intersection
450mm pipe culvert
Fair condition and serviceable

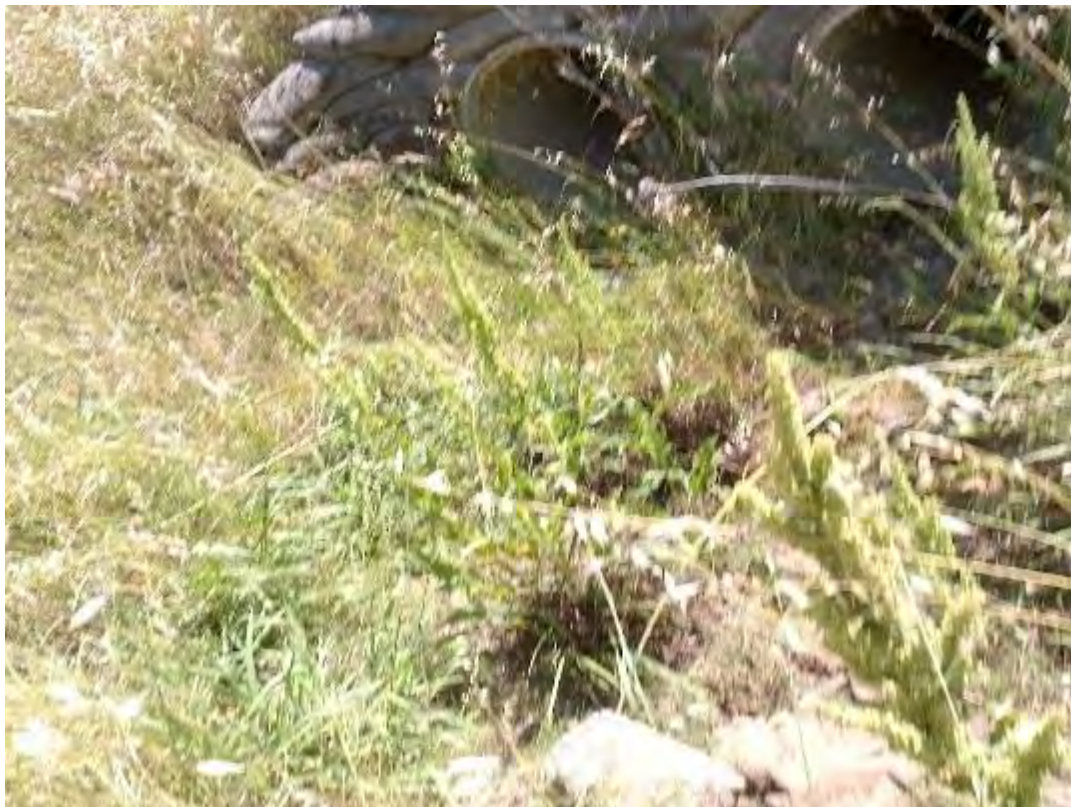
S016 – Dual 900mm Pipe Culvert

Scouring of outlet visible.

Moderate Condition and Serviceable.

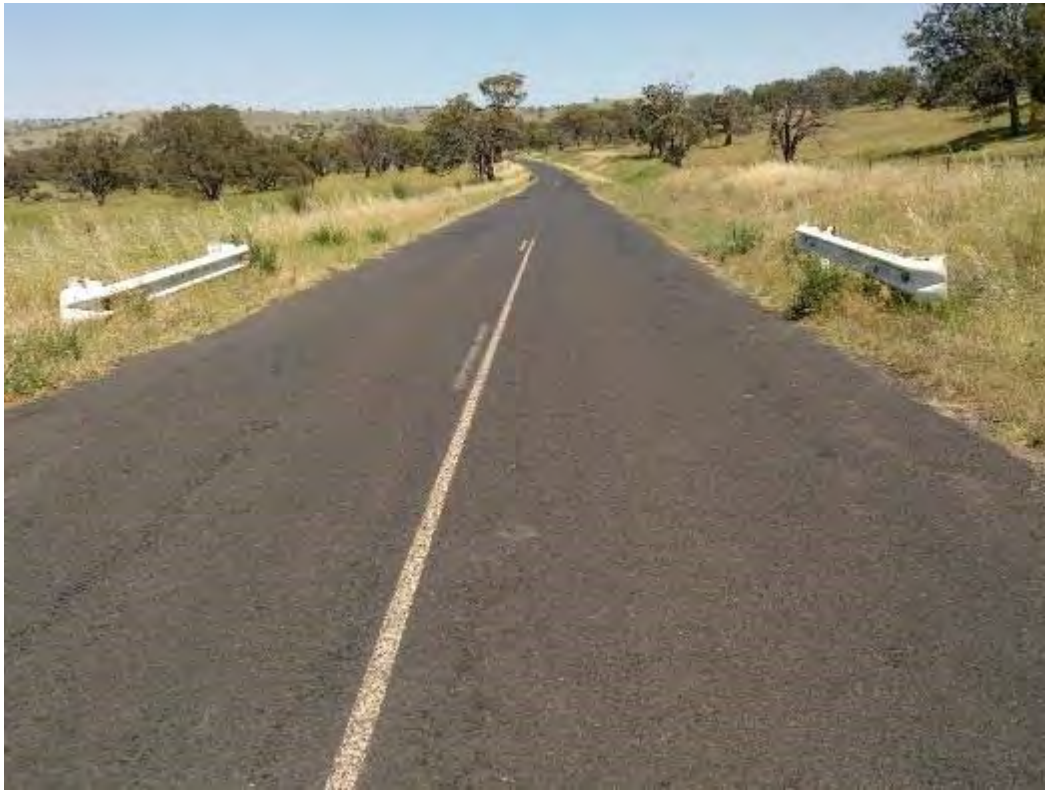
S018 – View to West

Currently blocked, to be reassessed prior to construction.

Moderate condition and serviceable. Maintenance required.

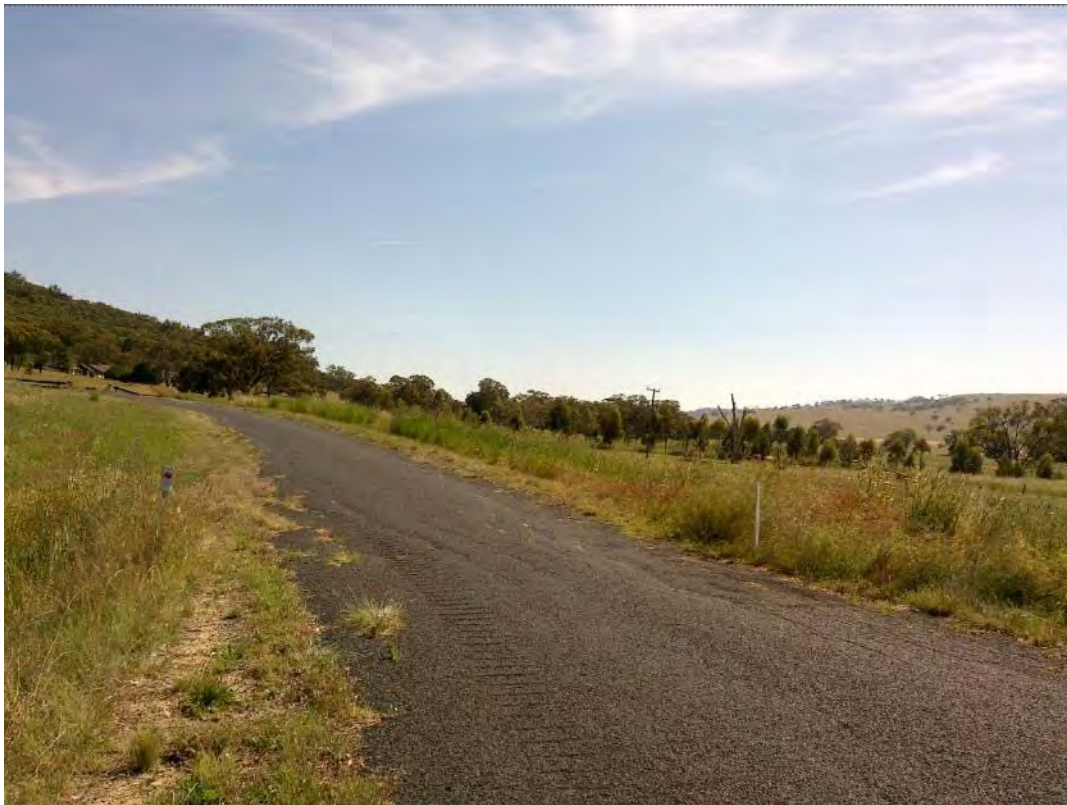
S019 – View to North

S019 – Turee Vale Rd - 2750m North of Vinegaroy Rd
Pipe culvert not accessible. Dimensions and condition unknown.
Maintenance required prior to construction to enable inspection.

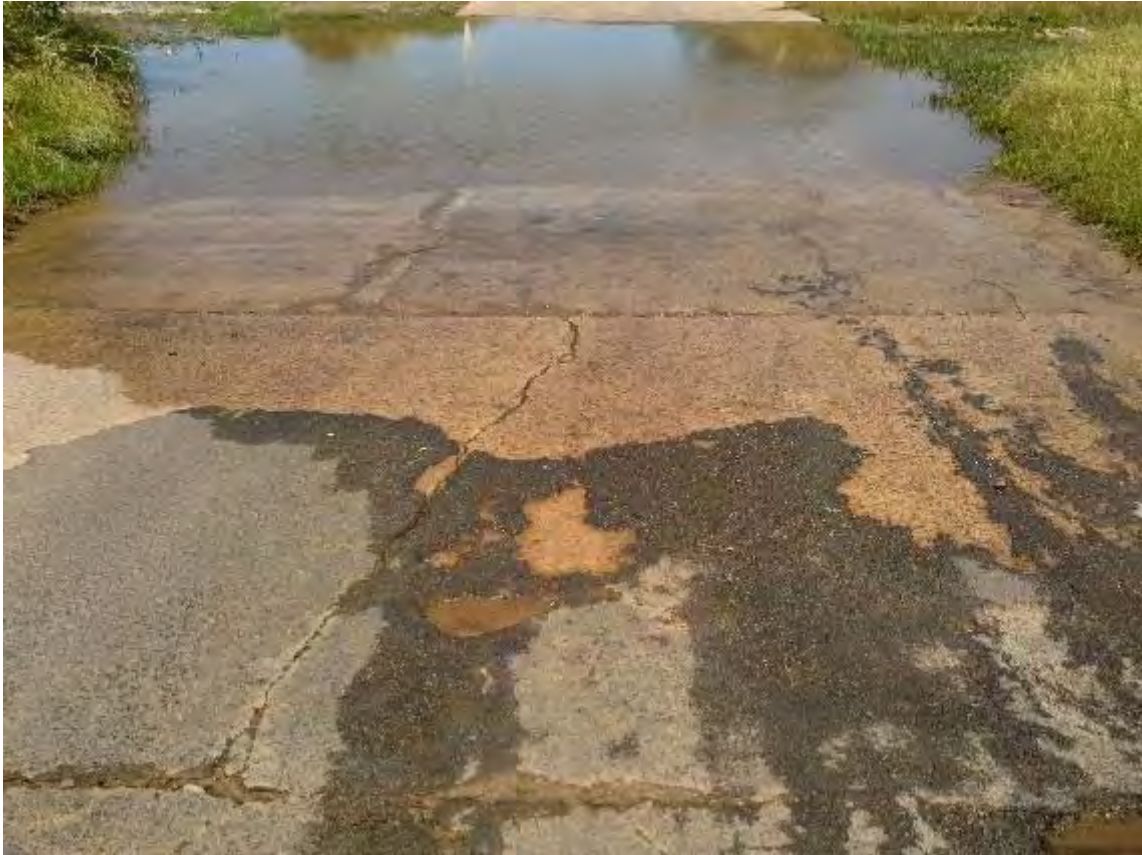
S024 – Causeway

Causeway on Starkey Creek
Submerged and prone to flooding
Poor condition, upgrade required.

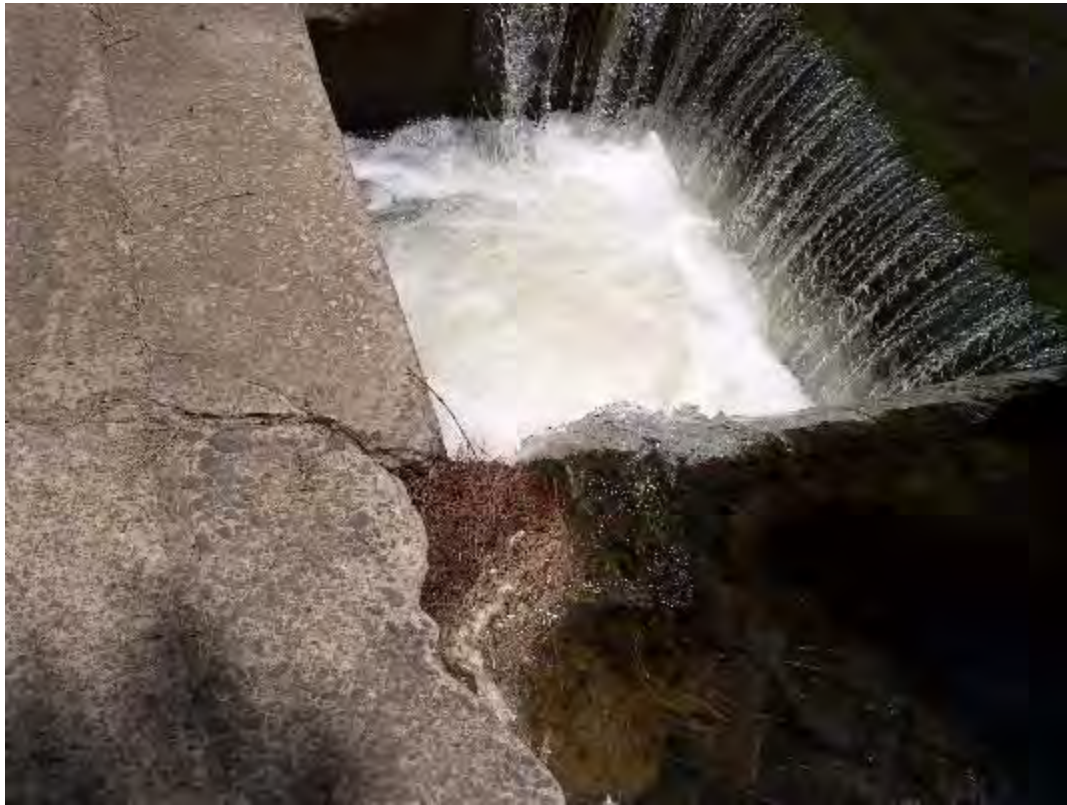
S025 – Invert Culvert

S025 – Rotherwood Road 1000m North of Yarrawonga Intersection
Concrete Causeway 750mm invert culvert
Fair condition and serviceable

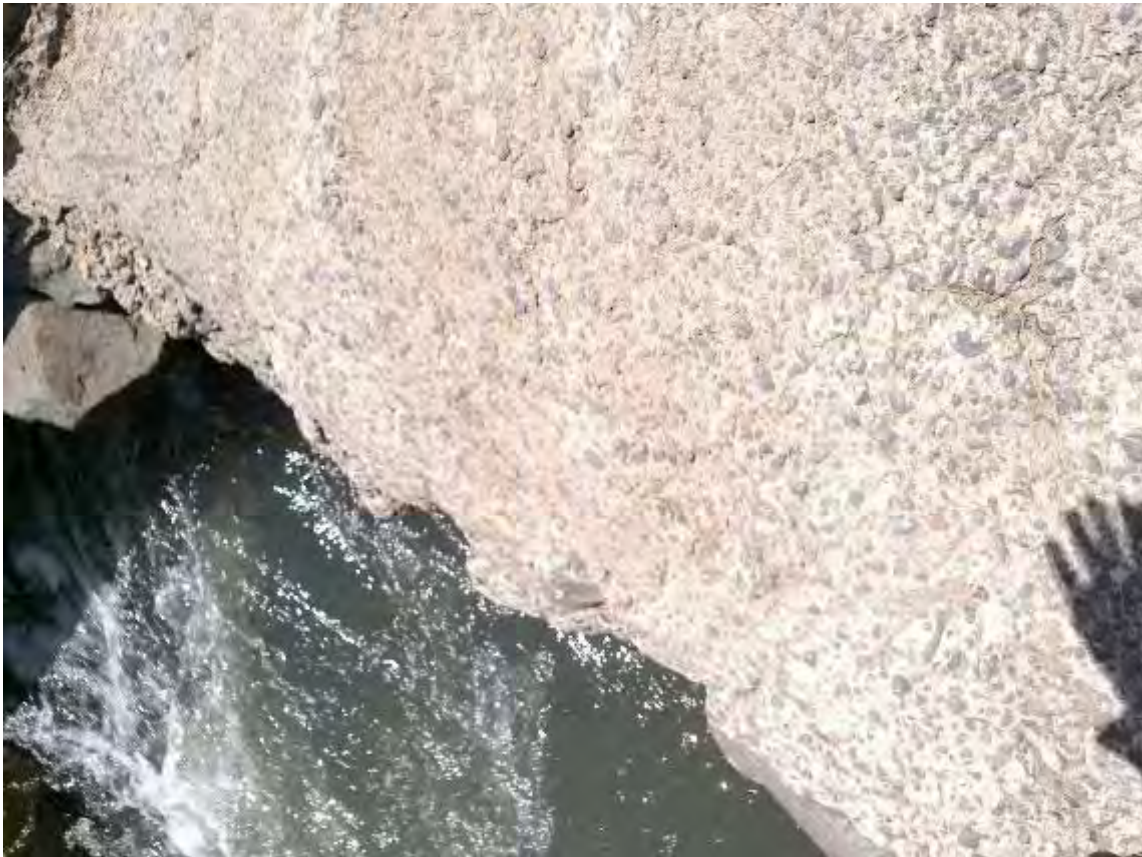
S025 – Edge of culvert is worn.

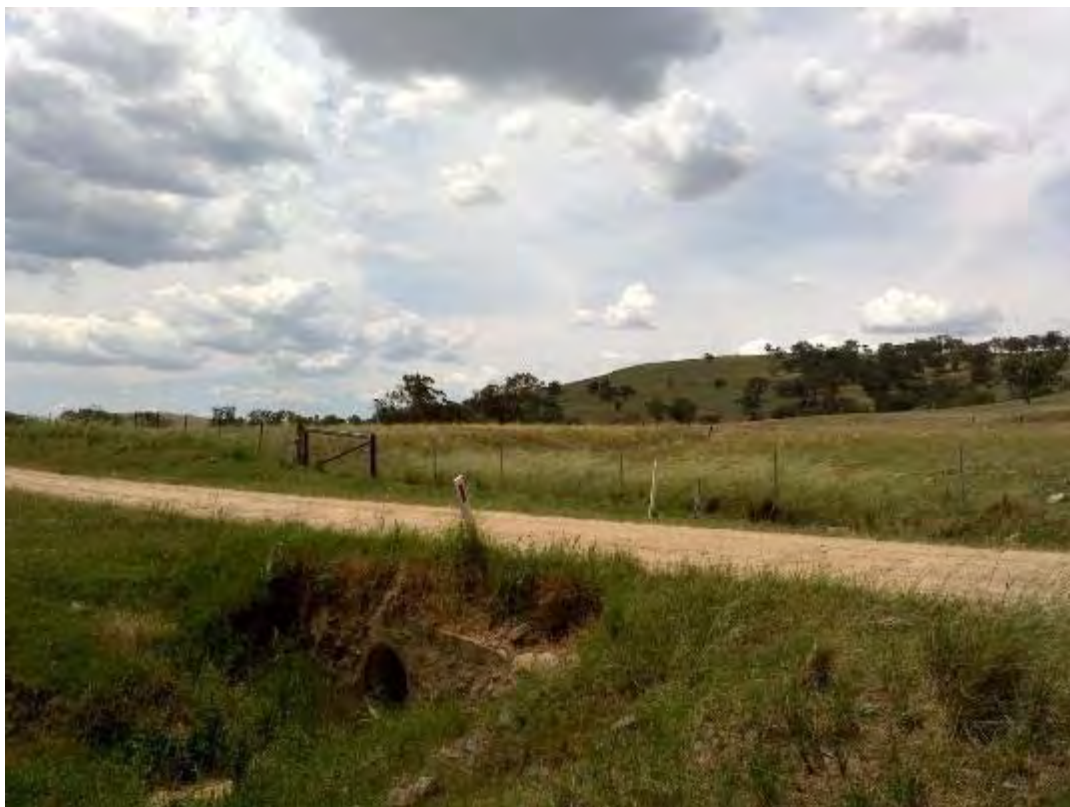
S029 – View from West

S029 – Rotherwood Road 4500m North of Coolah Rd intersection
Causeway, 900mm Pipe Culvert
Moderate Condition and Serviceable

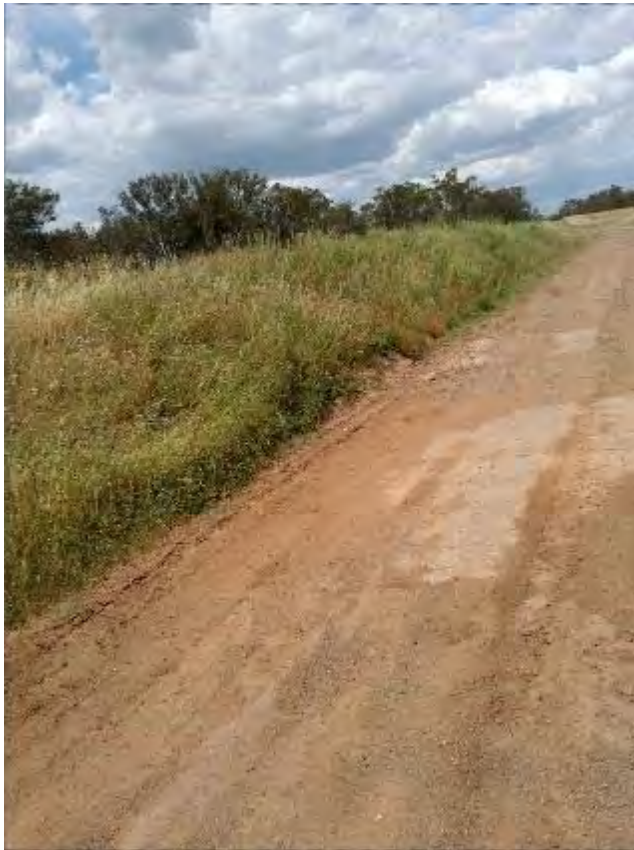
No culvert

S031 – View to East, Steep section of Road

Survey required to verify compliance with vertical geometry requirements of the proposed heavy vehicle configurations.

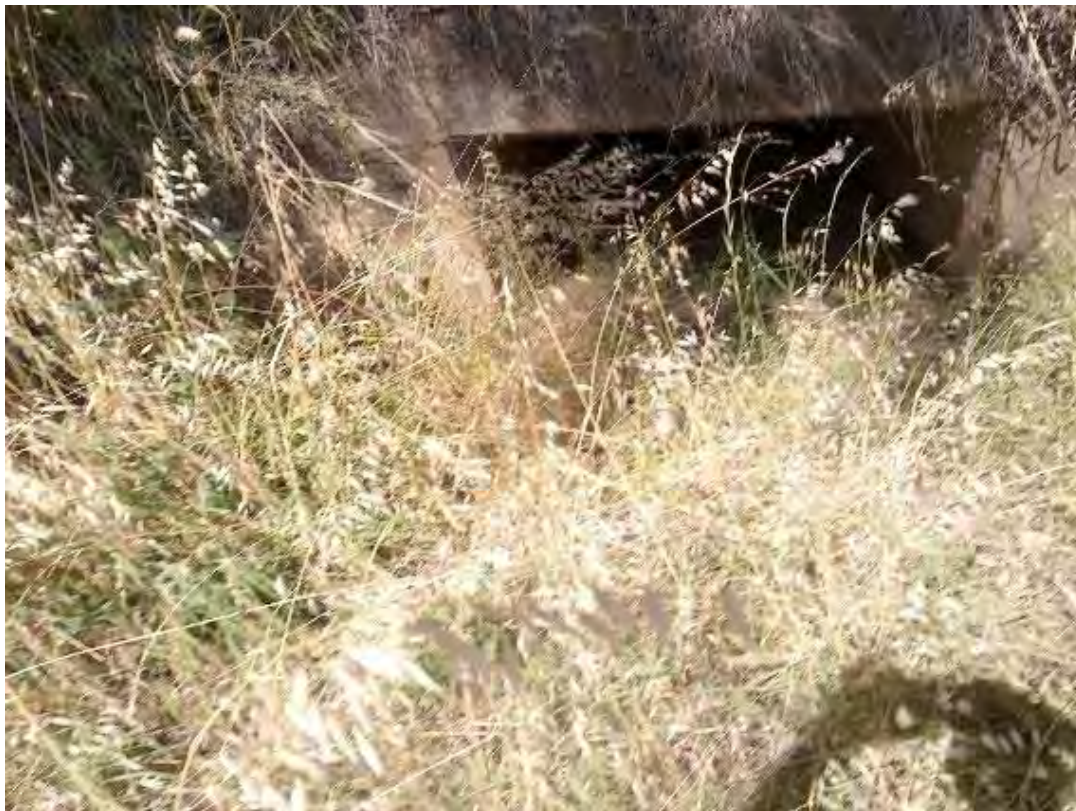
S032 – Box Culvert

S032 – Vinegaroy Road – 750m South of Rotherwood Rd – Vinegaroy Rd Intersection
1200mm - 900mm Reinforced concrete box culvert
Moderate condition and serviceable
