APPENDIX 2 - DRAINAGE AND CREEK CROSSING STRUCTURES

Note: Road names are based on Google Maps

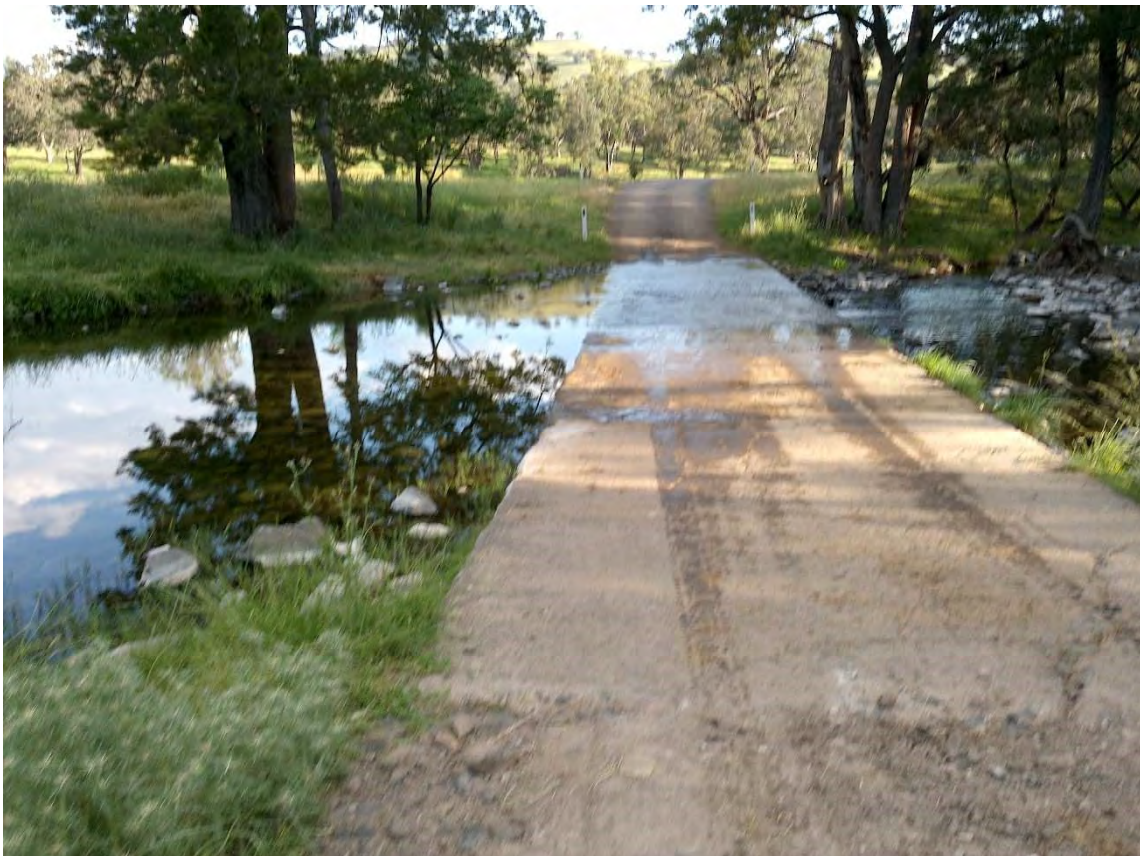
S033 – 4000mm – 20000mm Causeway

Poor condition and serviceable

Upgrade may be required

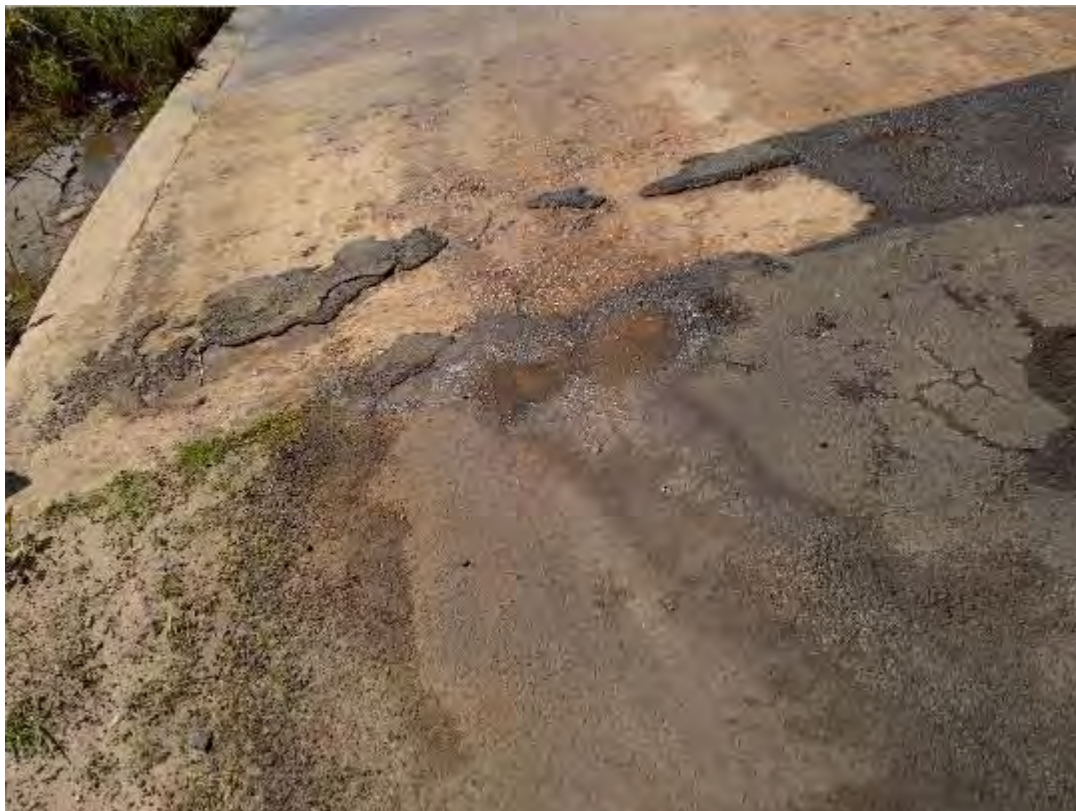
S035 – View of Causeway

Moderate condition and serviceable,

Survey required to verify compliance with vertical geometry requirements of the proposed heavy vehicle configurations.

Upgrade may be required.

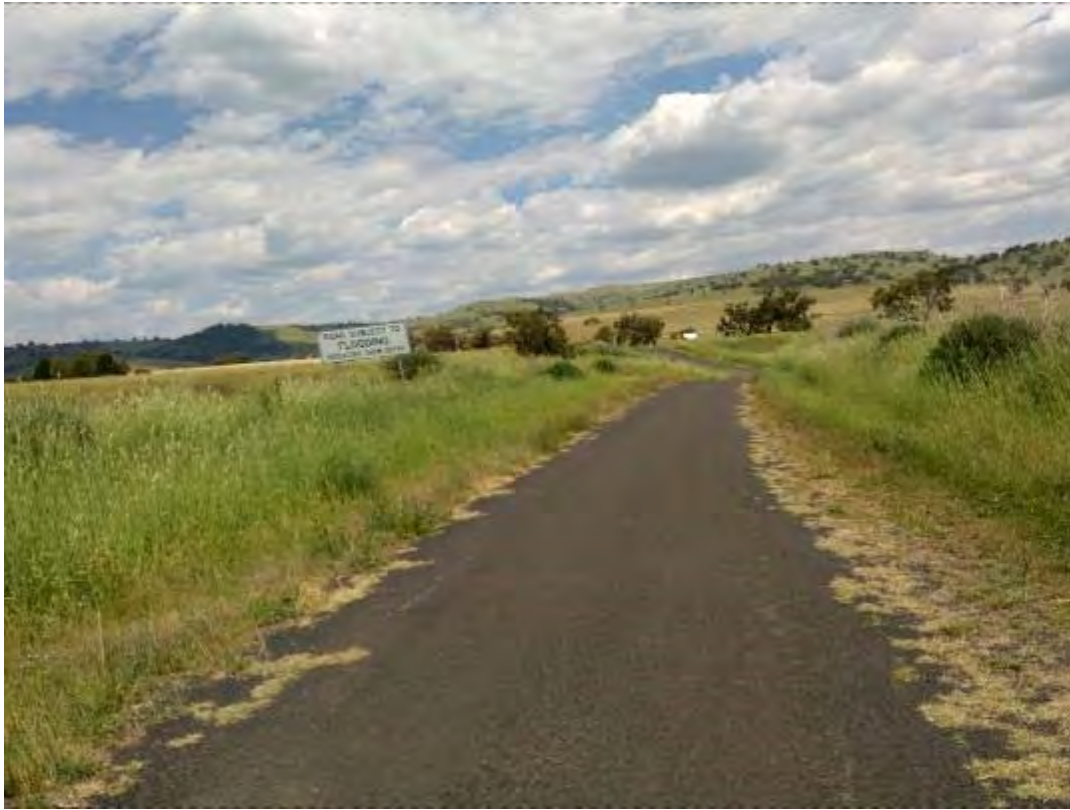
S035 - View to South towards location, 'Road subject to Flooding' sign observed

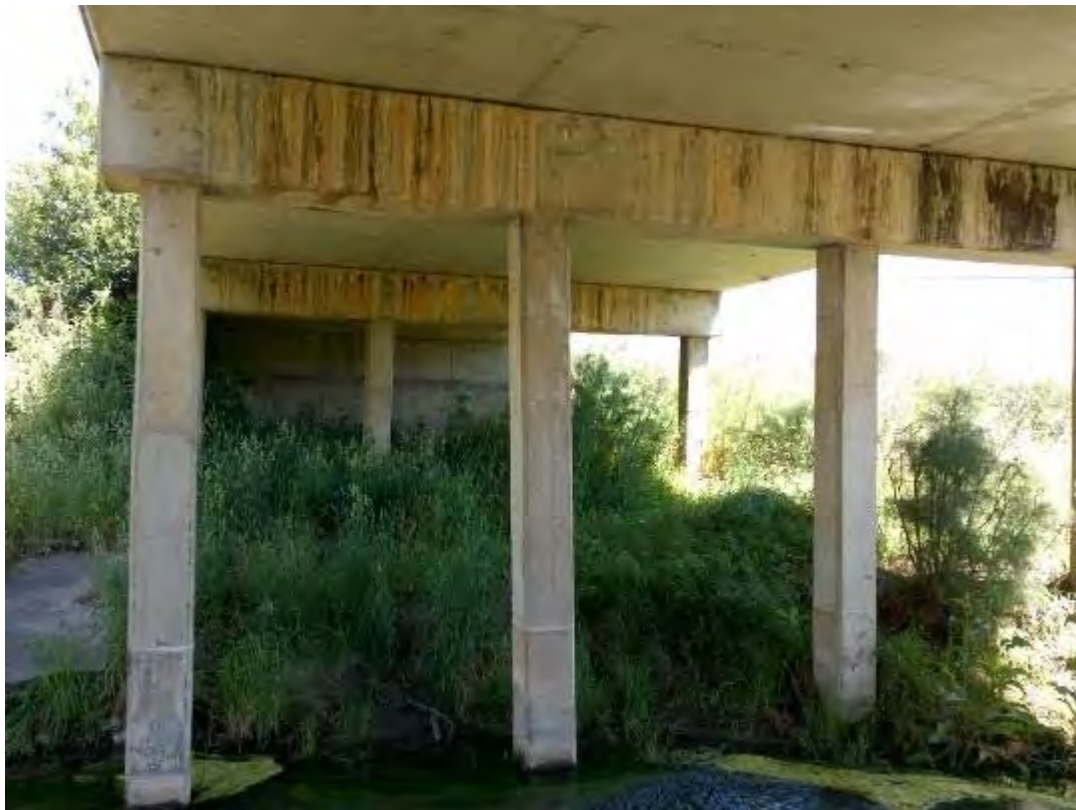
S036 – Soffit View

Bill Foley Bridge – 2750m West of Rotherwood Rd
Reinforced concrete bridge labelled “1965 DMR” on Croppy Creek
4 x 7600mm spans by 7500mm with 4 x 360mm columns/bents
Fair condition and serviceable

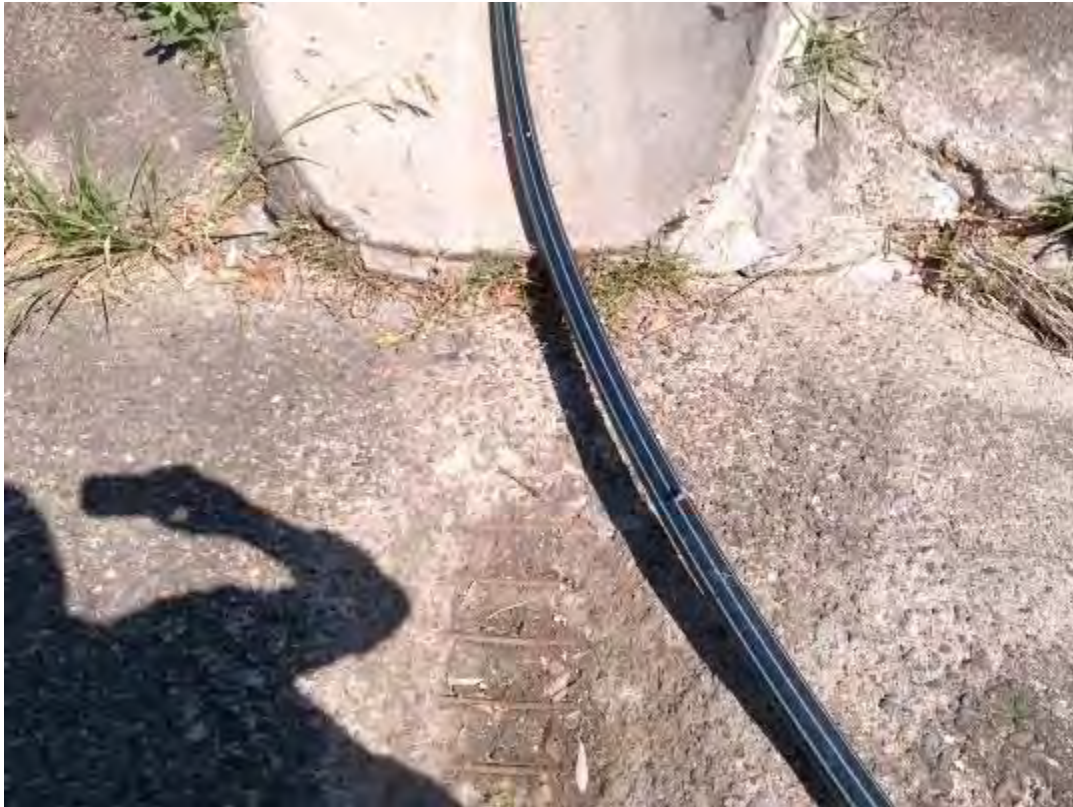
S037 – High flow water has eroded the concrete exposing the reinforcing Steel

Exposed reinforcing steel will require repair.

Survey required to verify compliance with vertical geometry requirements of the proposed heavy vehicle configurations.
