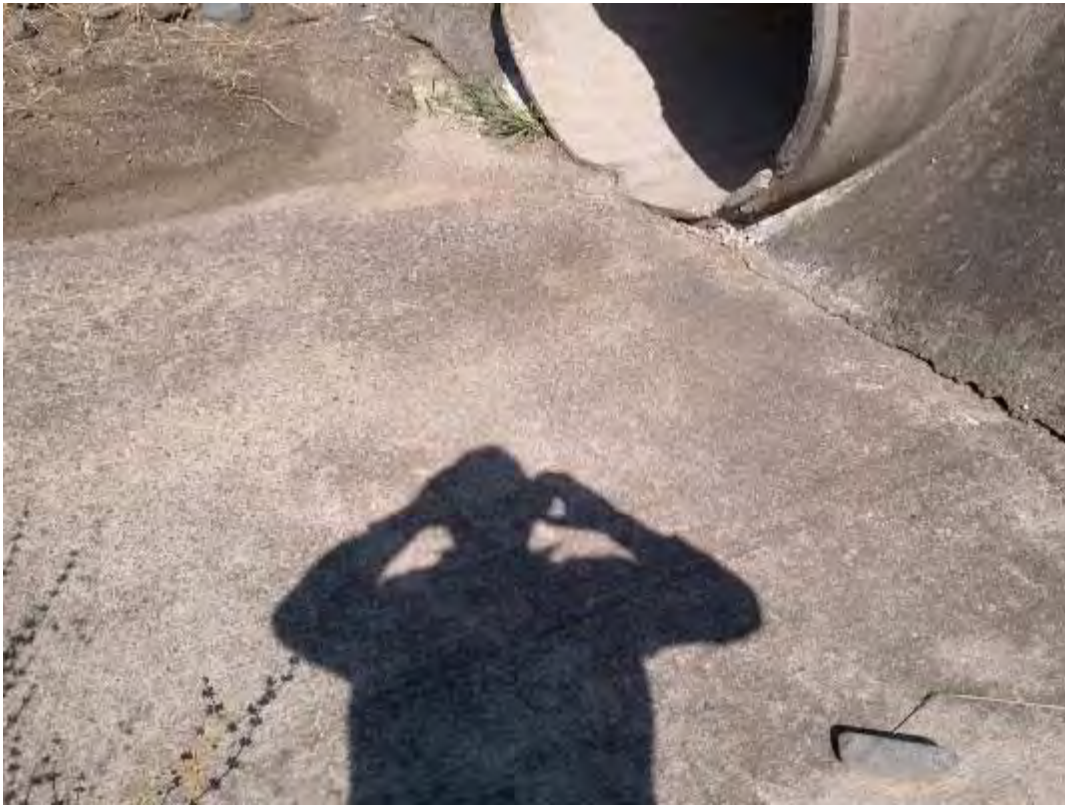
S038 – Turee Vale Road 3000m North of Vinegaroy Intersection
6m by 10m causeway with 1200mm Pipe Culvert
Fair Condition and Serviceable

S038 - 6m-10m CAUSEWAY, View to East

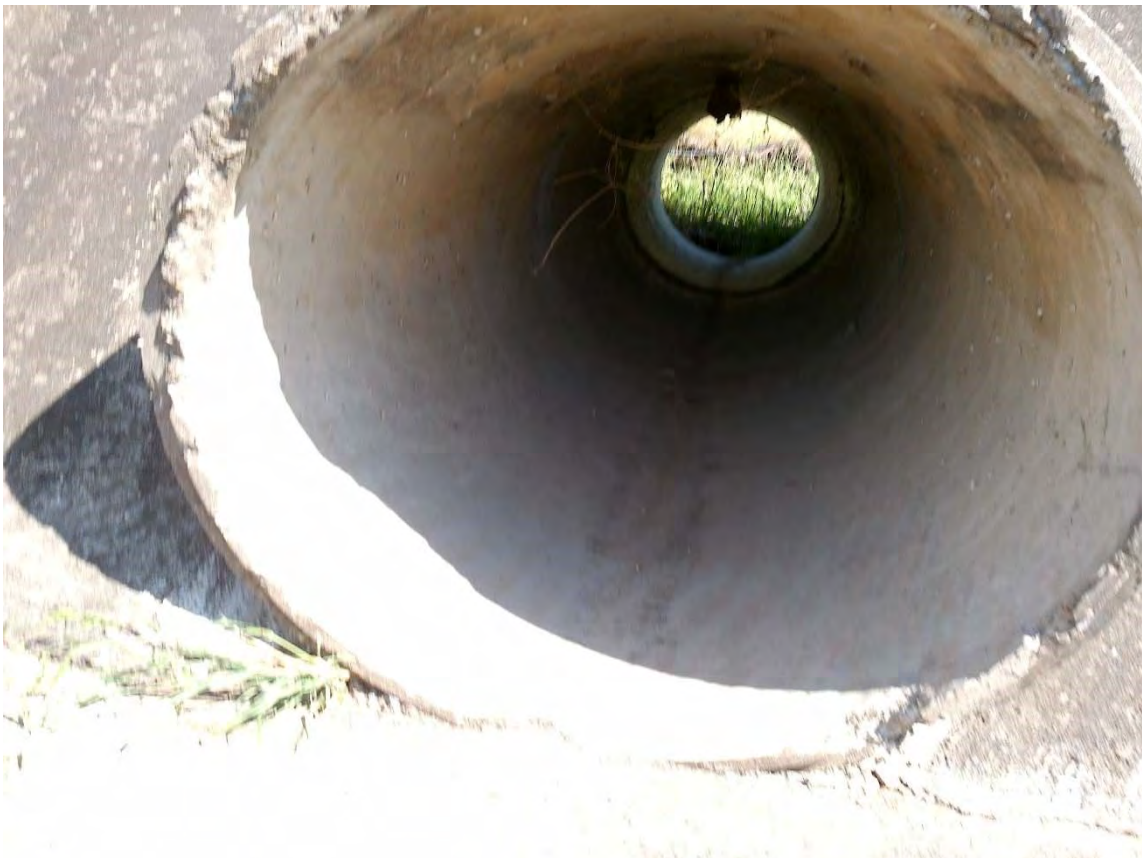
S038 - 1200mm Pipe Culvert

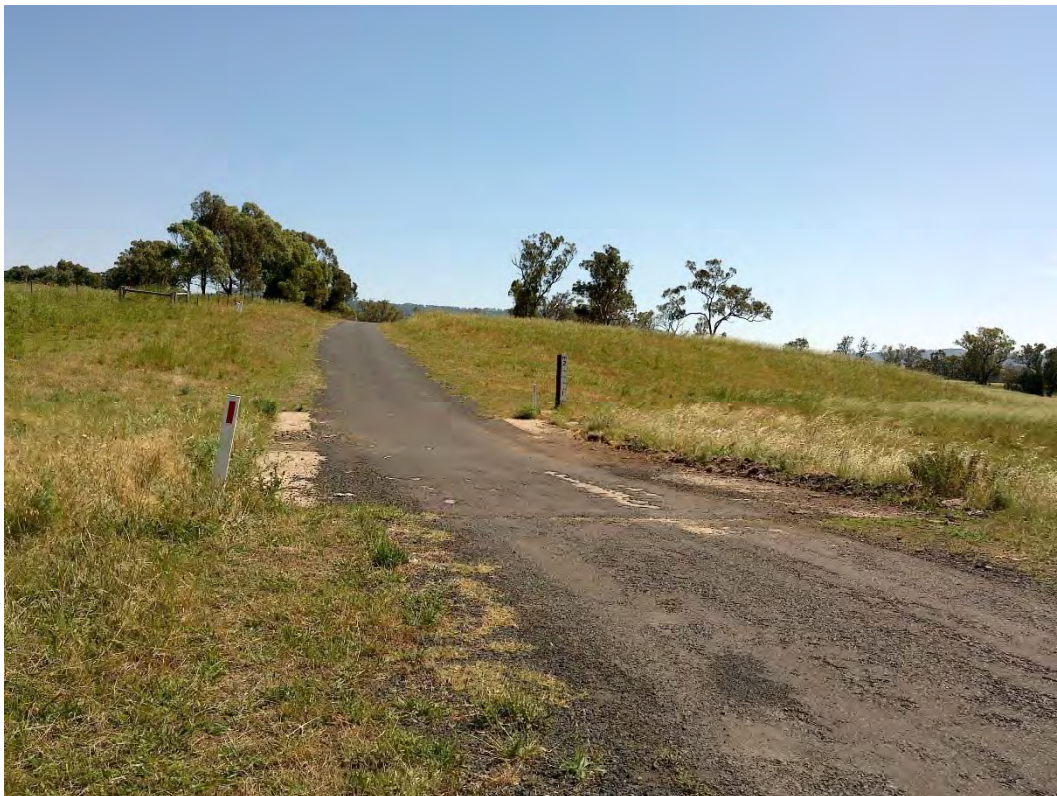
Concrete causeway with bitumen seal, no pipe.

Poor Condition and Serviceable,

S039 - Causeway no pipe

Upgrade may be required.

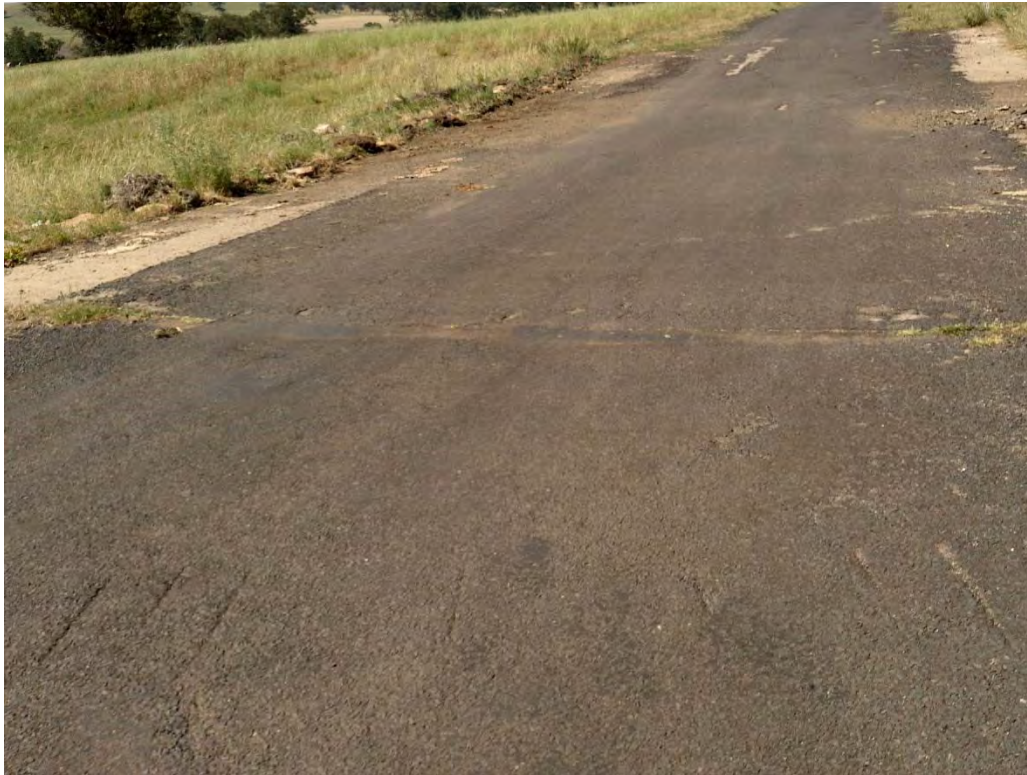
S039 – Moisture on sides of causeway

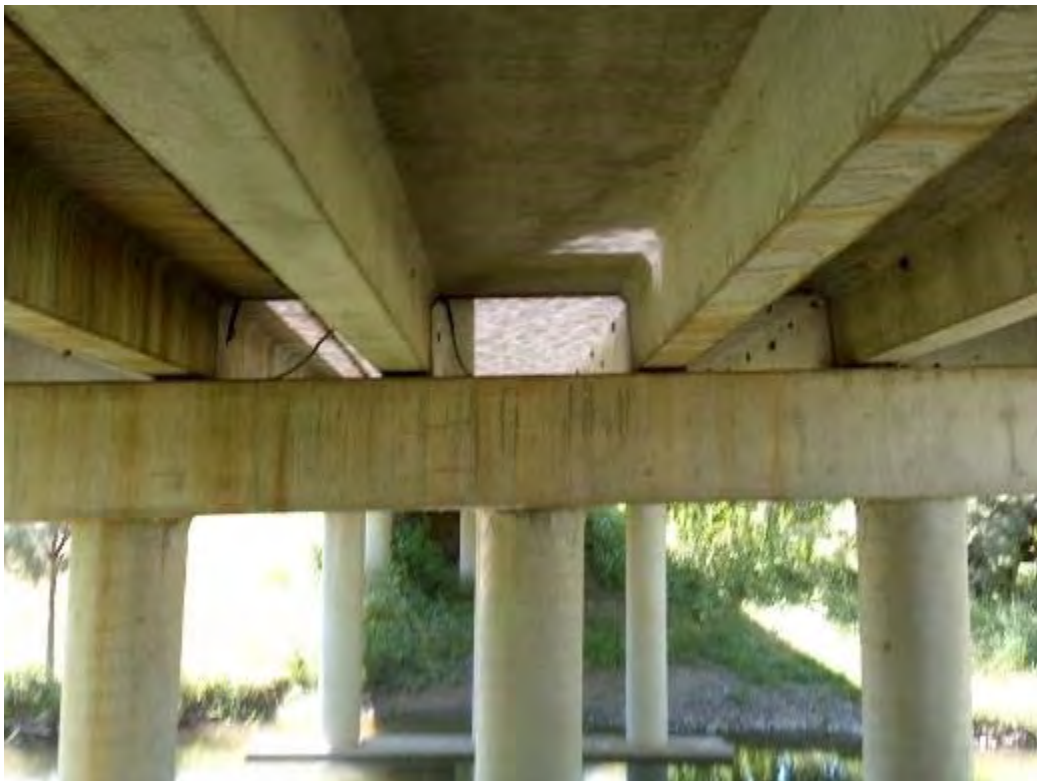
S042 – Soffit View

S042 – Mogadore Bridge – 1000m West of Vinegaroy - Rotherwood Road Intersection
4 x 9000mm by 7500mm spans of Tapered Hume deck, on Turee Creek
Fair condition and serviceable

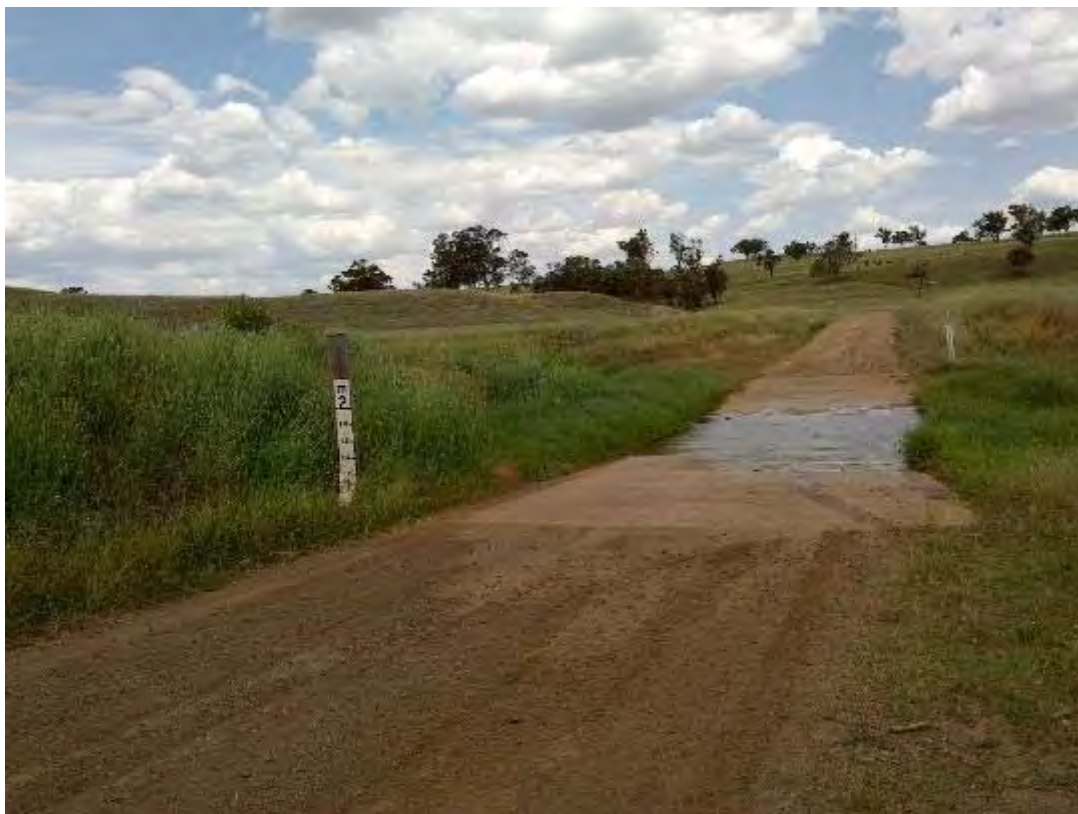
S044- View to South

Prone to flooding, and submerged at time of inspection

Poor condition and partially serviceable

Reconstruction/upgrading may be required.

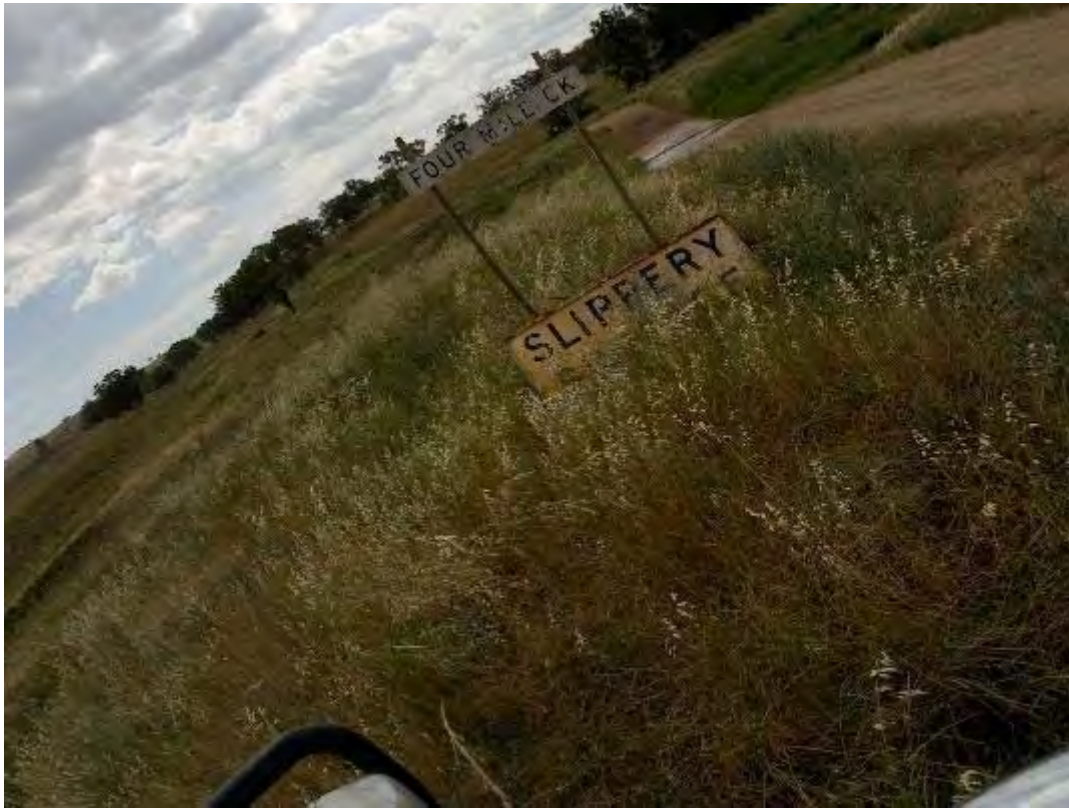
S044- Slippery Surface Caution sign

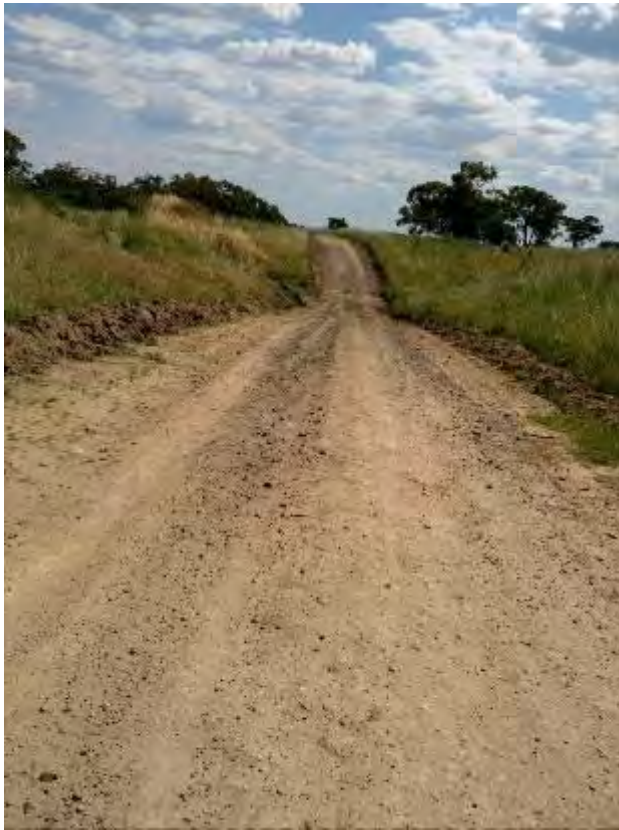
S048- View to South

S048 – Gundare Rd - 2000m East of Cooks Dr- Gundare Rd Intersection Causeway.

New culvert will be required for this location.

Survey required to verify compliance with vertical geometry requirements of the proposed heavy vehicle configurations.

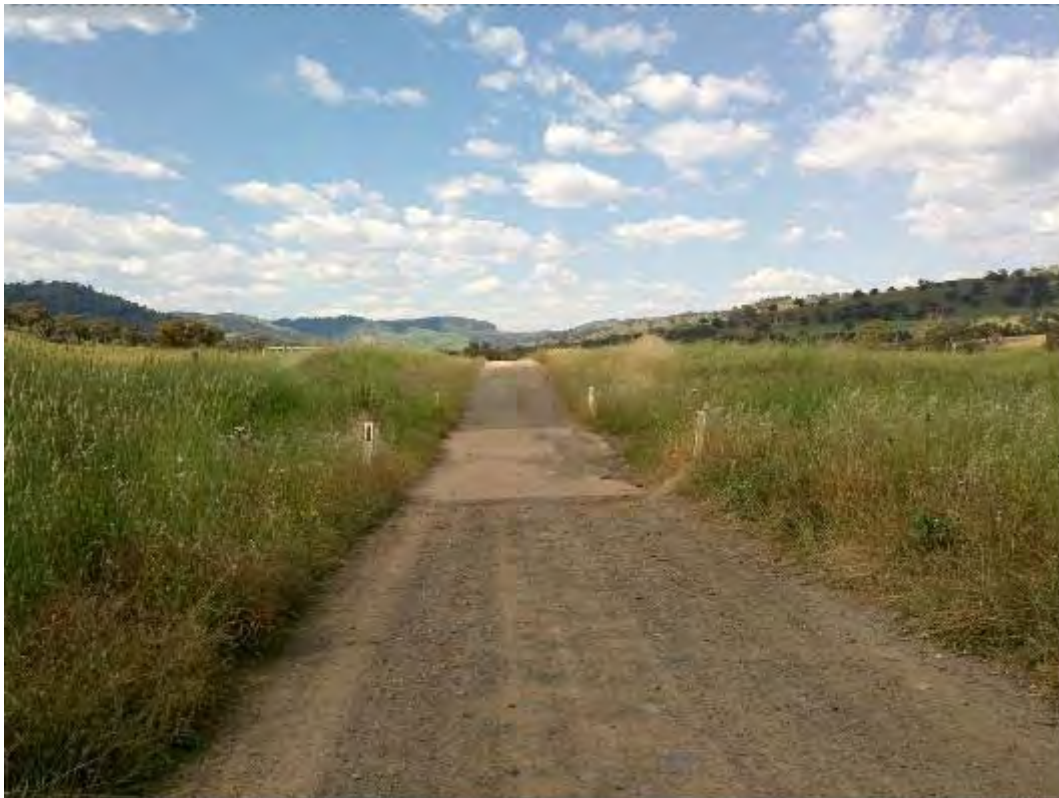
S049 – View to North

S049 – Gundae Rd- 2250m East of Cooks Dr Intersection
Causeway.
New pipe culvert required.

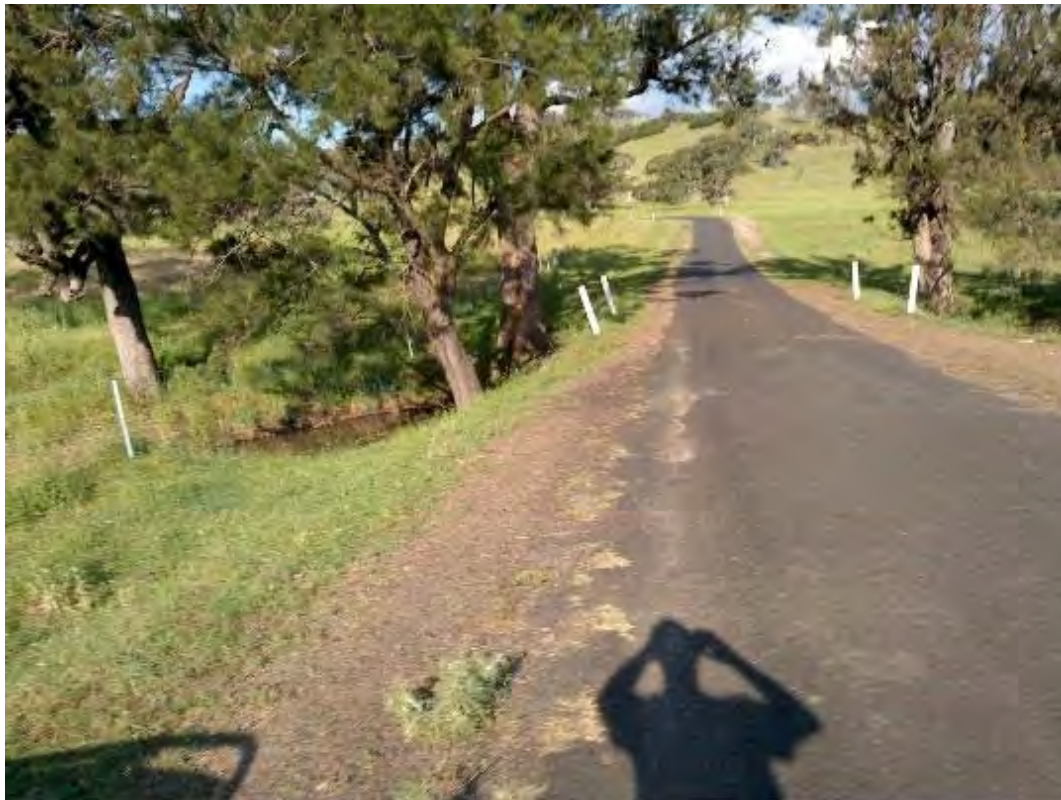
S050 – View to East

S050 - Coolah Creek Rd - 200m South of Forest State Road Rd Intersection 3-1200mm
3 Pipe Culverts
Fair Condition and Serviceable

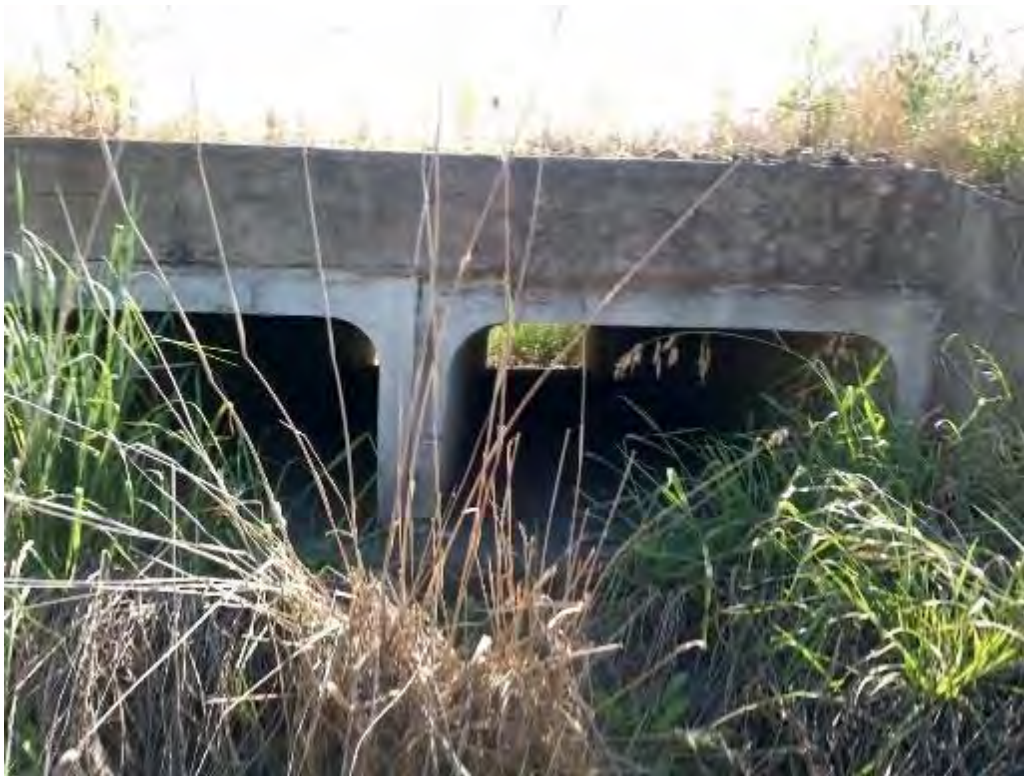
S051 - Box Culvert End View

S051 – Vinegaroy Rd – 2900m South from Rotherwood Rd Intersection
Concrete twin box culvert – 2/1200mm by 600mm
Fair Condition and Serviceable

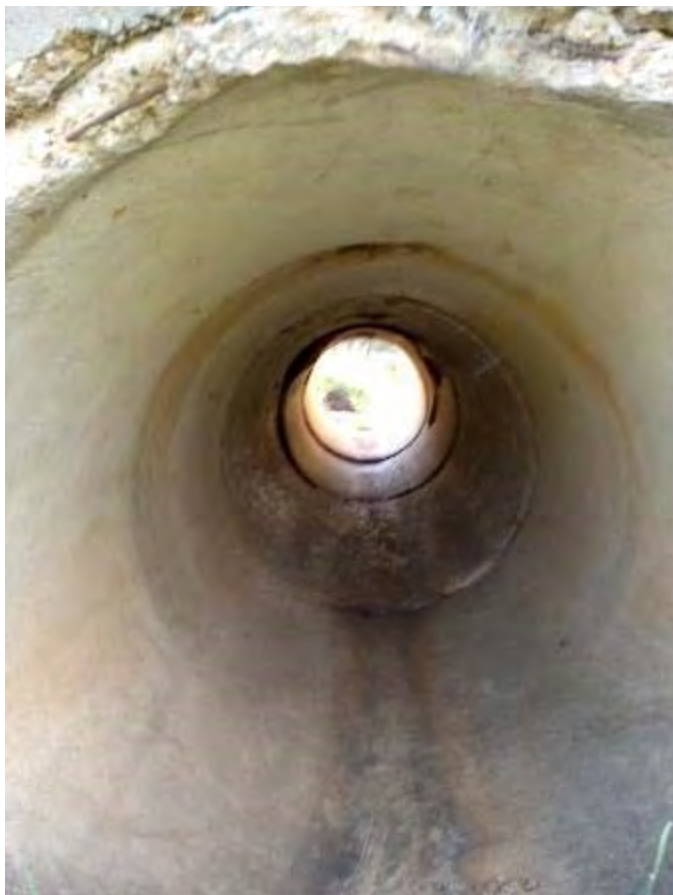
S053 – Internal View

Invert cracking and evidence of a failed joint repair.

Poor Condition and Serviceable

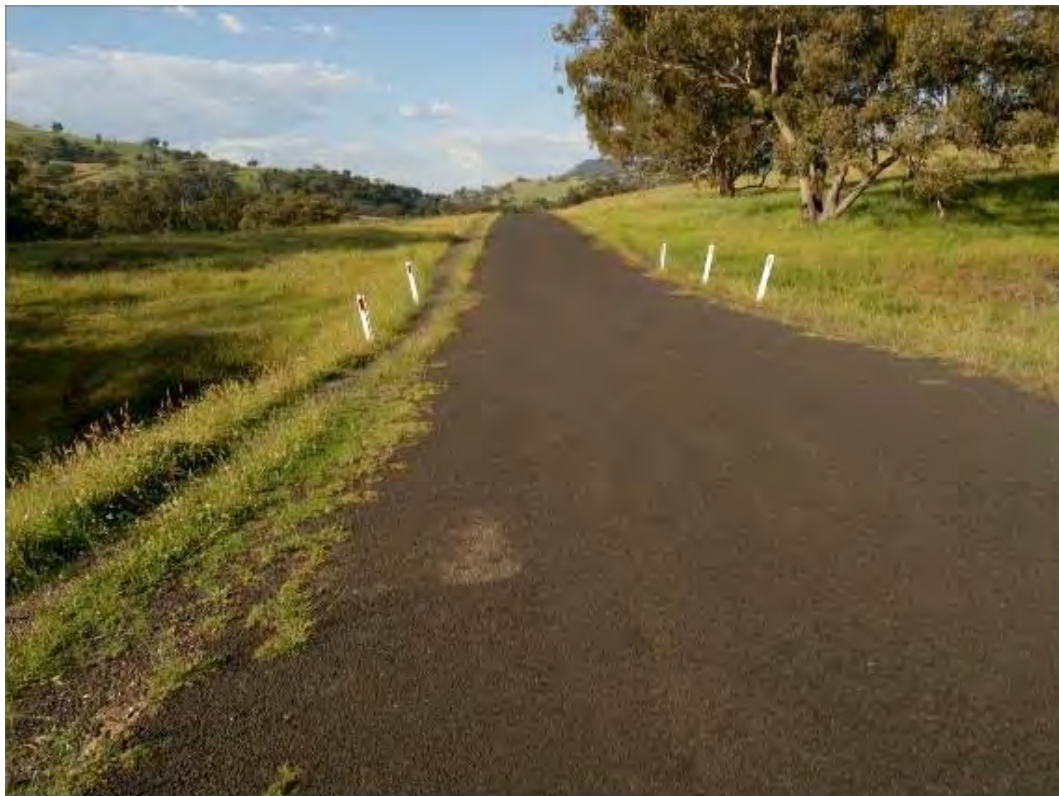
S054 – View to North

S054 - Pandora Rd - 200m North of Coolah Creek Intersection
Dual-1050mm Pipe Culverts
Fair Condition and Serviceable

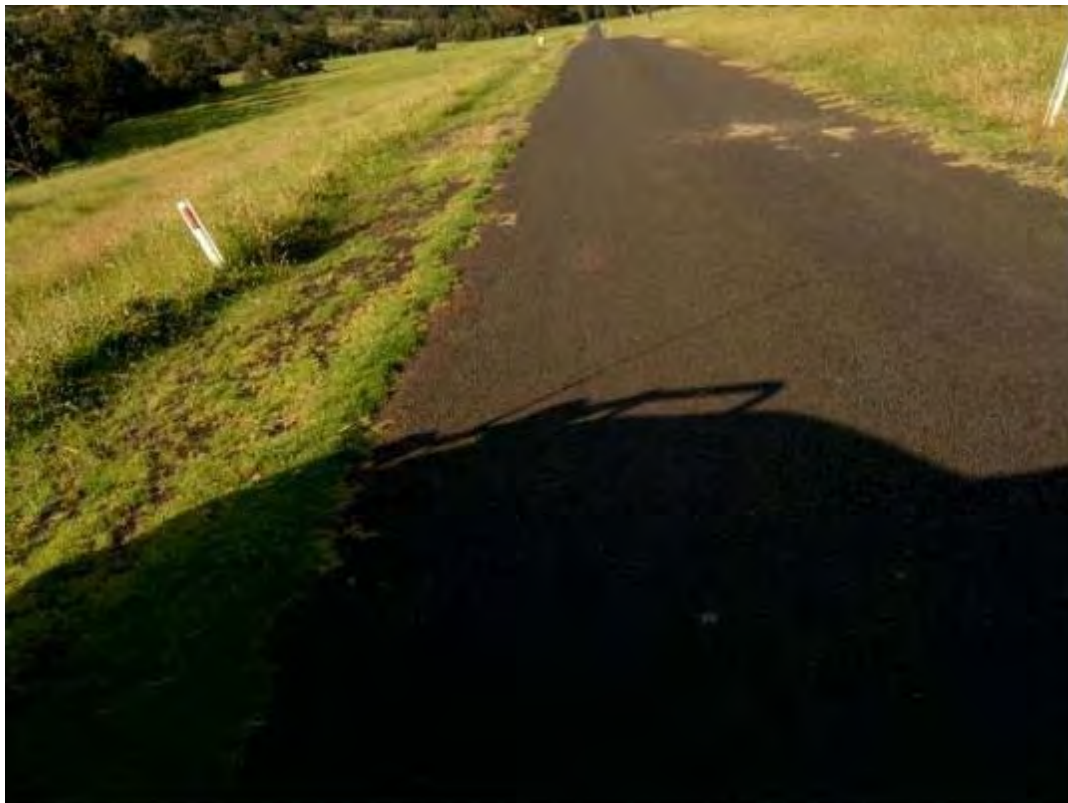
S055 – North of North

S055 – Pandora Rd - 400m North of State Forest Rd Intersection
450mm Pipe Culvert with no headwall
Moderate Condition and Serviceable

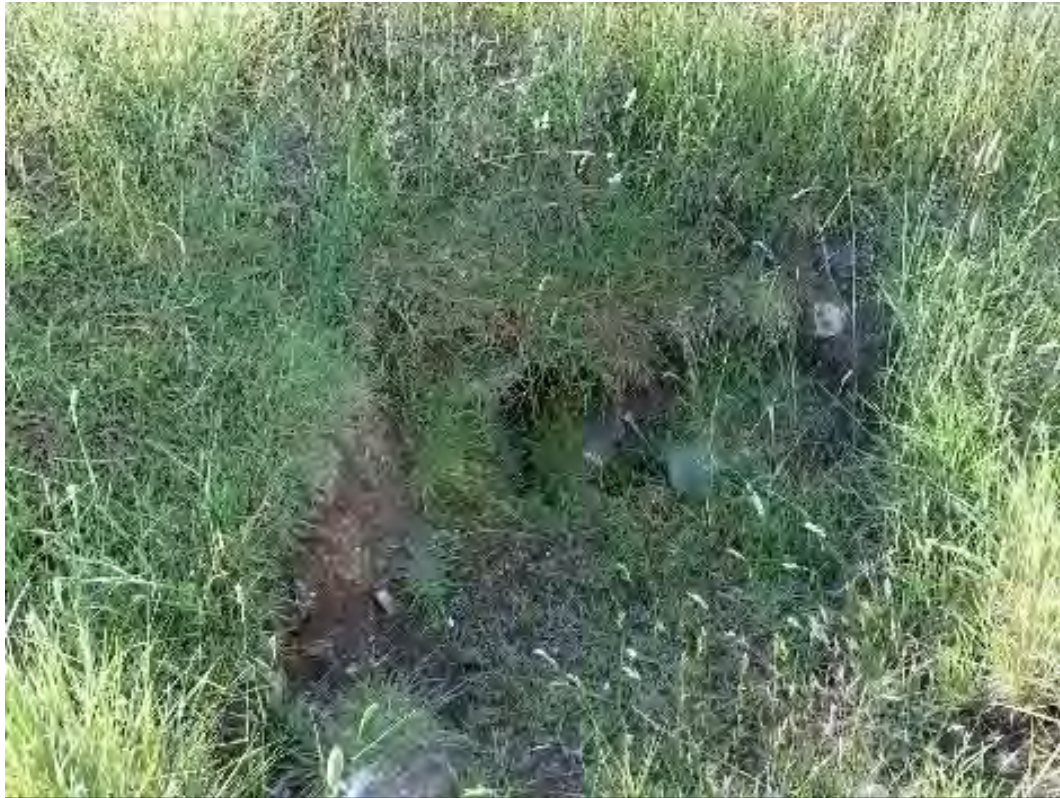
S056 – Pandora Rd- 650m North of State Forest Rd Intersection
375mm Pipe Culvert with no headwall
Moderate Condition and Serviceable

S056 – 375mm Pipe Culvert with no headwall

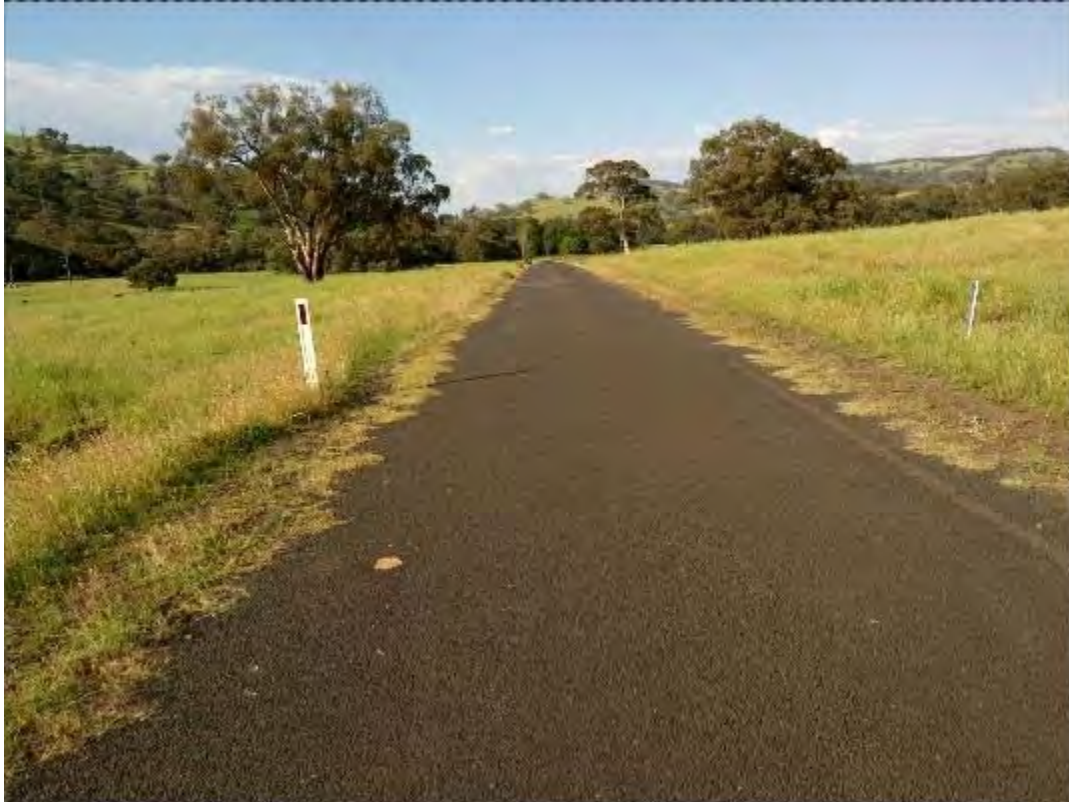
S057 – View to North

**S057 – Pandora Rd- 750m North of State Forest Rd Intersection Concrete Causeway 525mm Pipe Culvert with no headwall
Fair Condition and Serviceable**

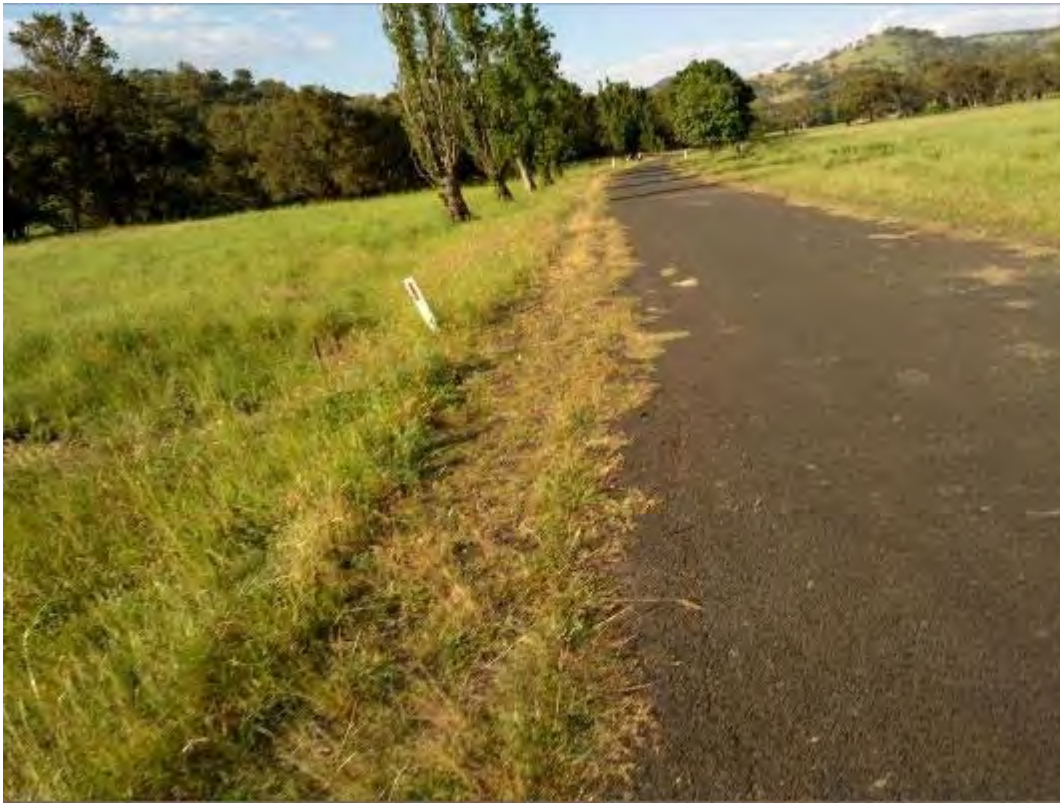
S058 – View to North

S058 – Pandora Rd - 1000m North of State Forest Rd Intersection
375mm Pipe Culvert NO HEADWALL
Unknown Condition

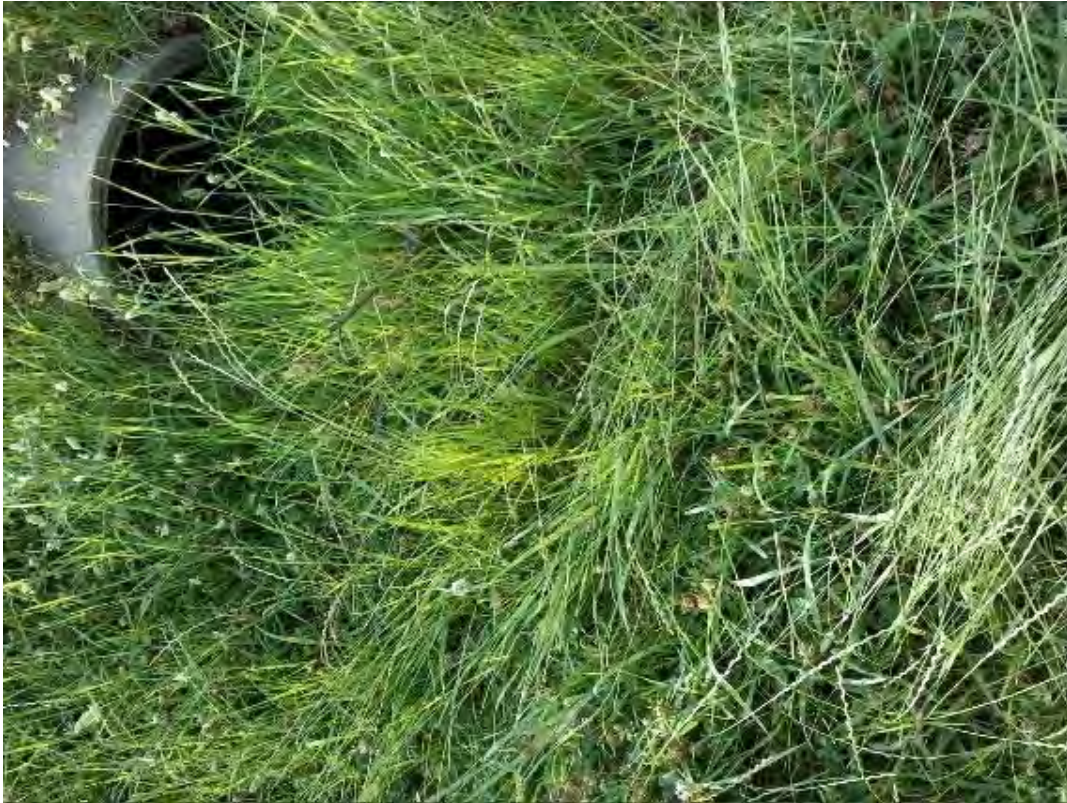
S059 - Pandora Rd - 1300m North of State Forest Rd Intersection
600mm Pipe Culvert no headwall
Moderate Condition and Serviceable

S059 – 600mm Pipe Culvert no headwall

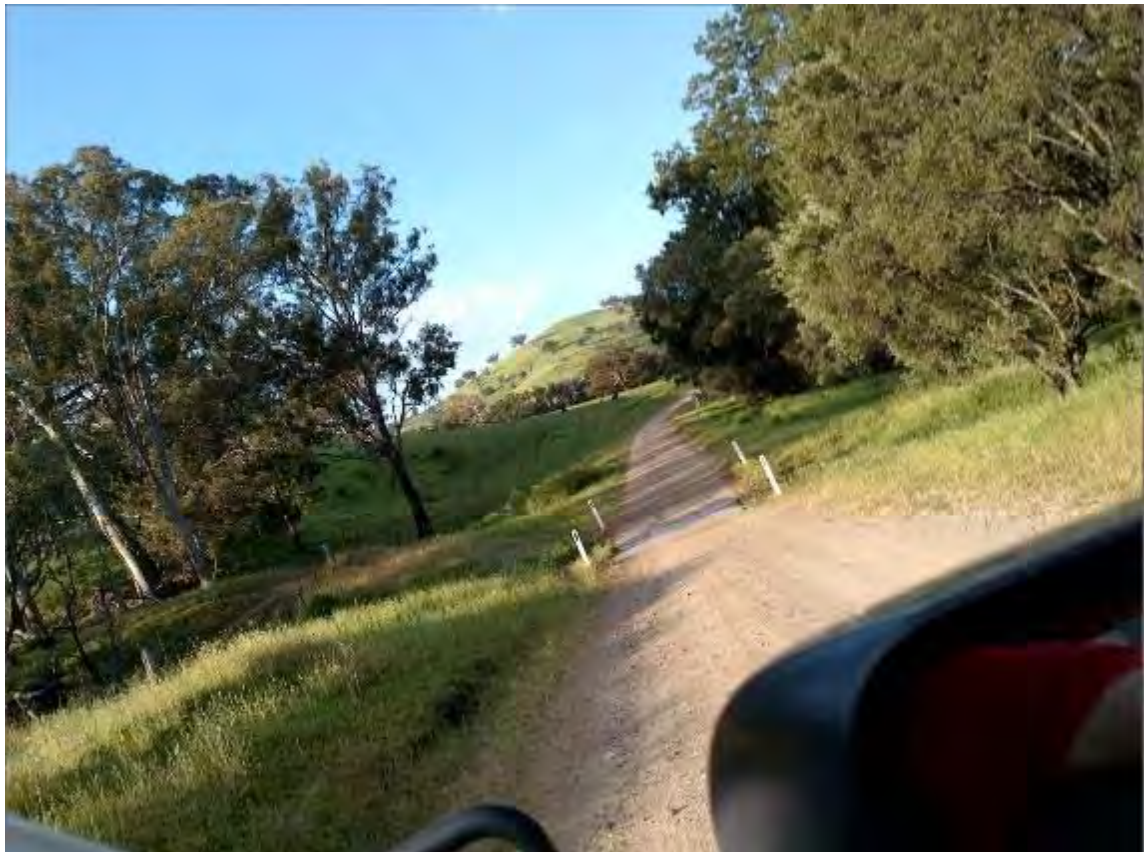
S062 – View to North

4000mm Concrete Causeway

Survey required to verify compliance with vertical geometry requirements of the proposed heavy vehicle configurations

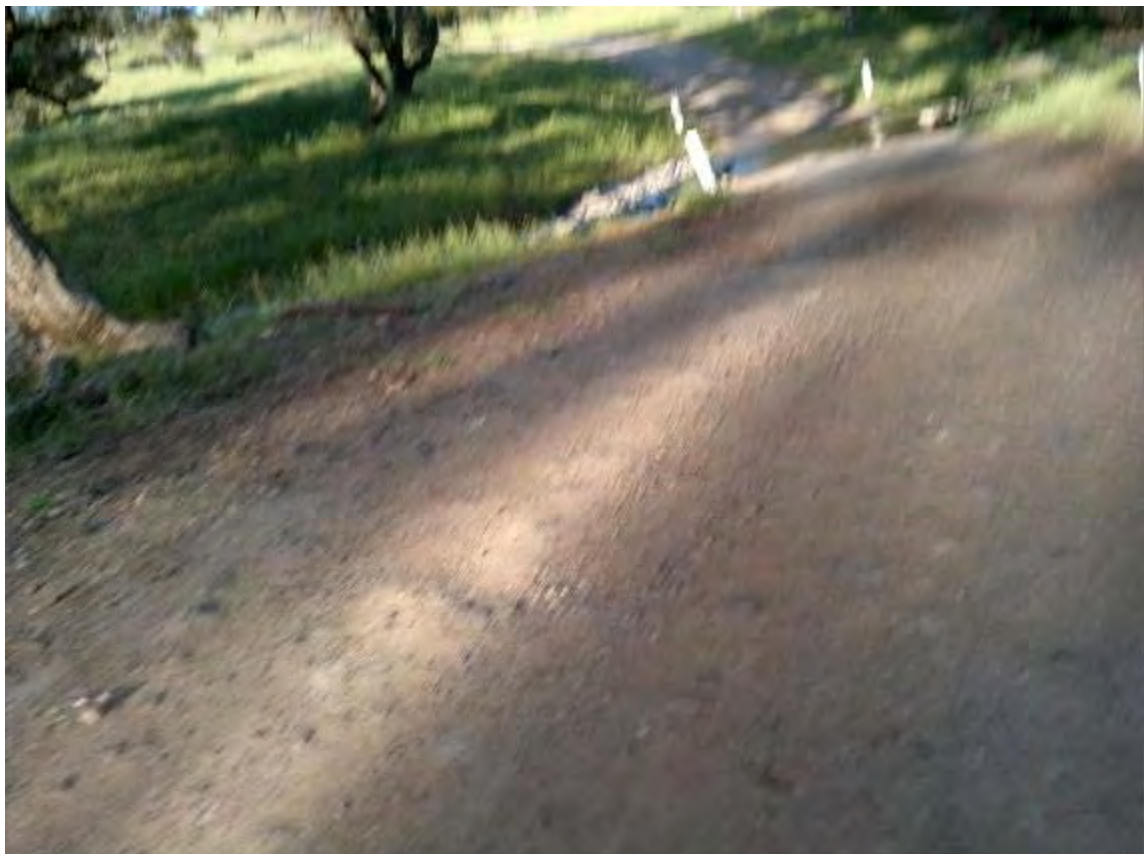
S063 – View to North

Causeway,
Partially submerged at time of inspection
Moderate Condition and Serviceable

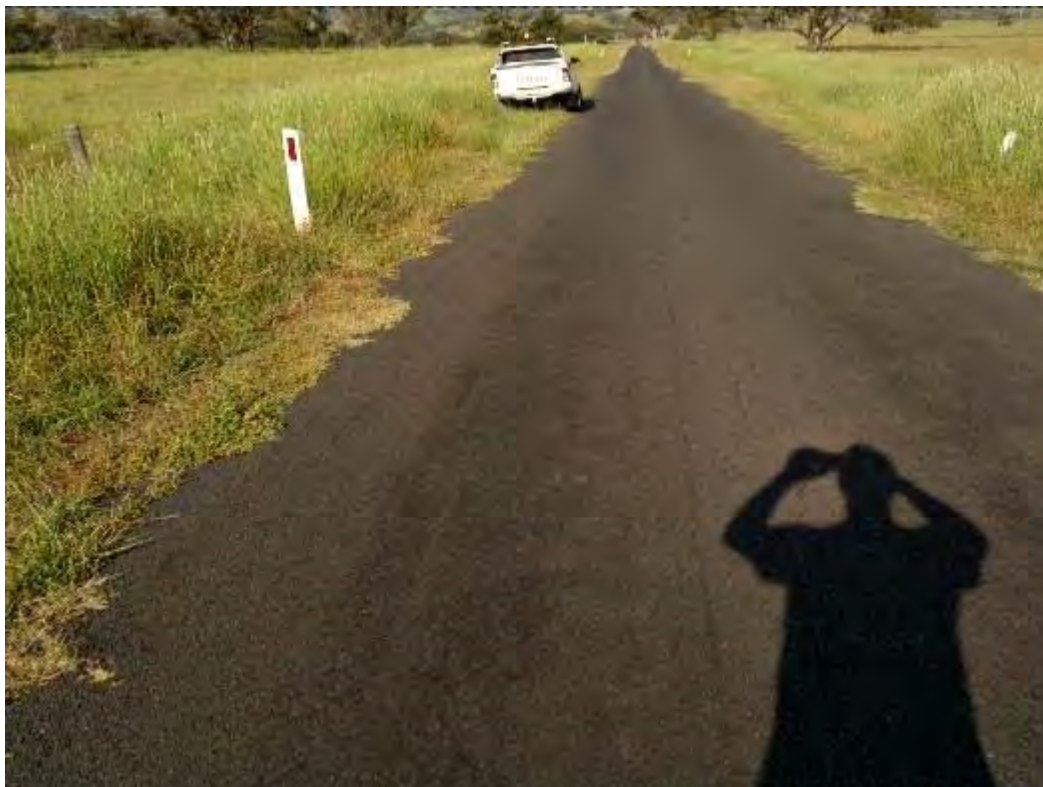
S064 – View to East

S064 – Coolah Creek Road - 1600m West of Pandora-Coolah Creek Road Intersection
Dual Pipe Culvert of approximately 600mm diameter.
Fair Condition and Serviceable

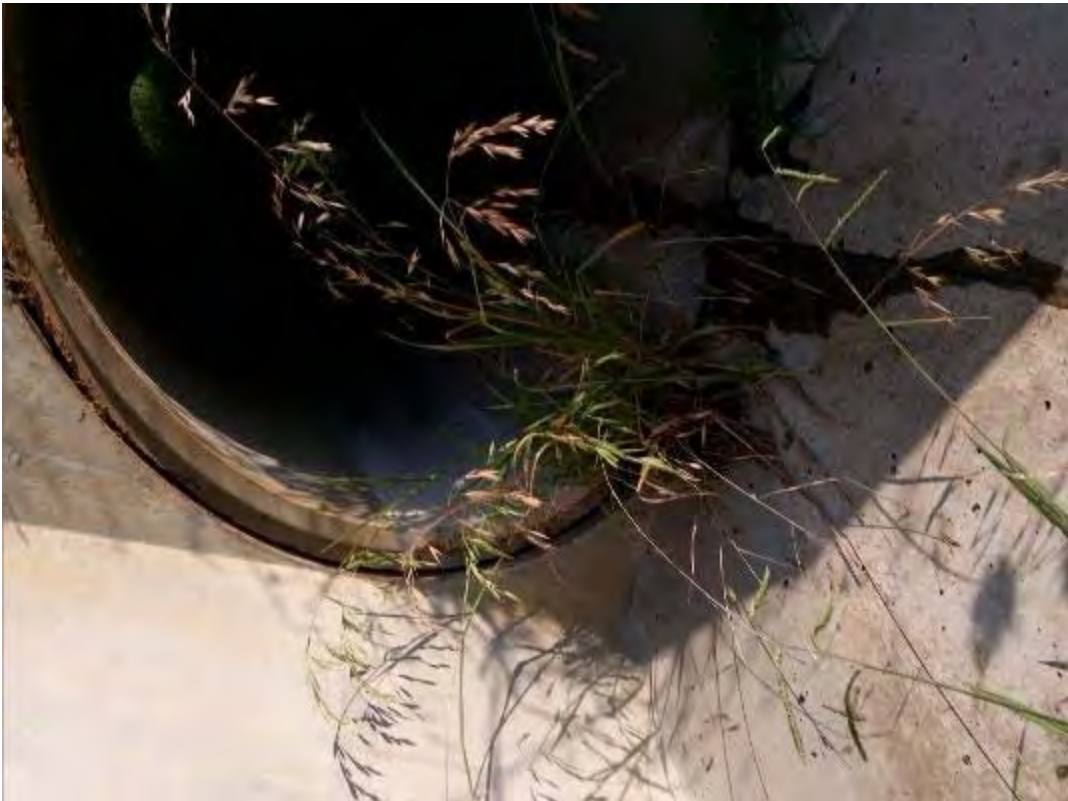
S065 – Internal View

S065 – Coolah Creek Road - 1700m West of Pandora-Coolah Creek Road Intersection
1350mm Pipe Culvert
Moderate Condition and Serviceable

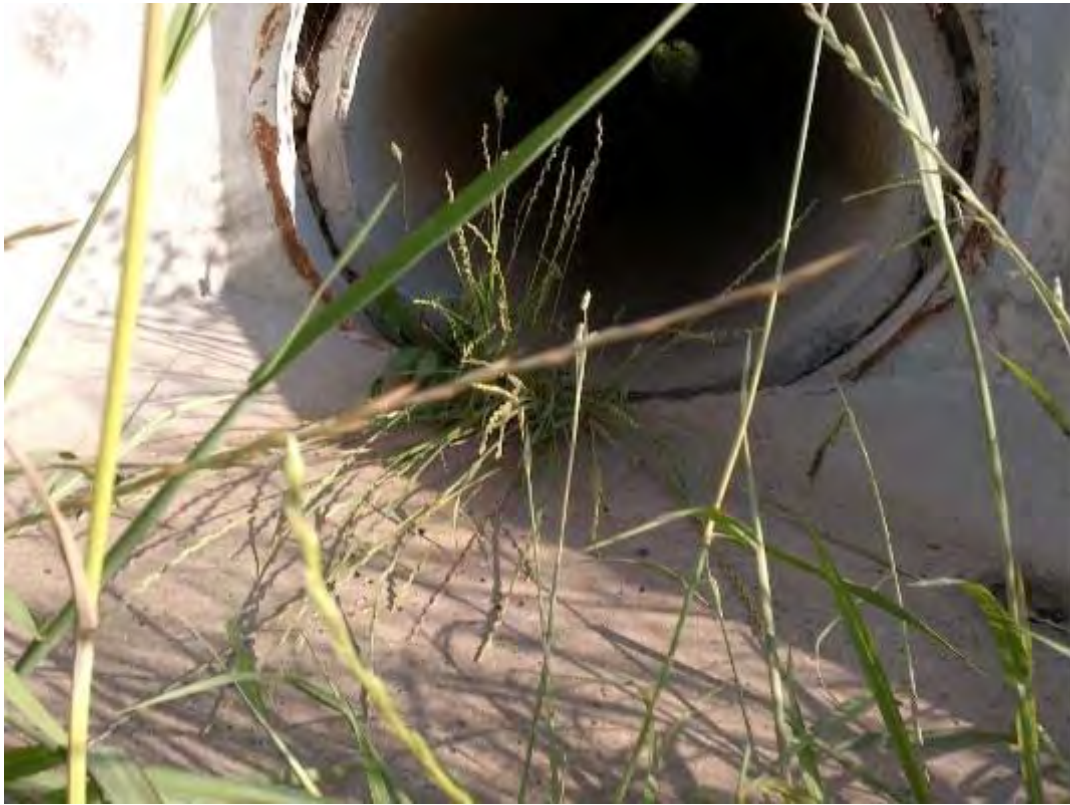
S066 – Internal View

S066 – Coolah Creek Rd – 1600m East of Oakdale Rd Intersection
600mm Pipe Culvert
Moderate Condition and Serviceable

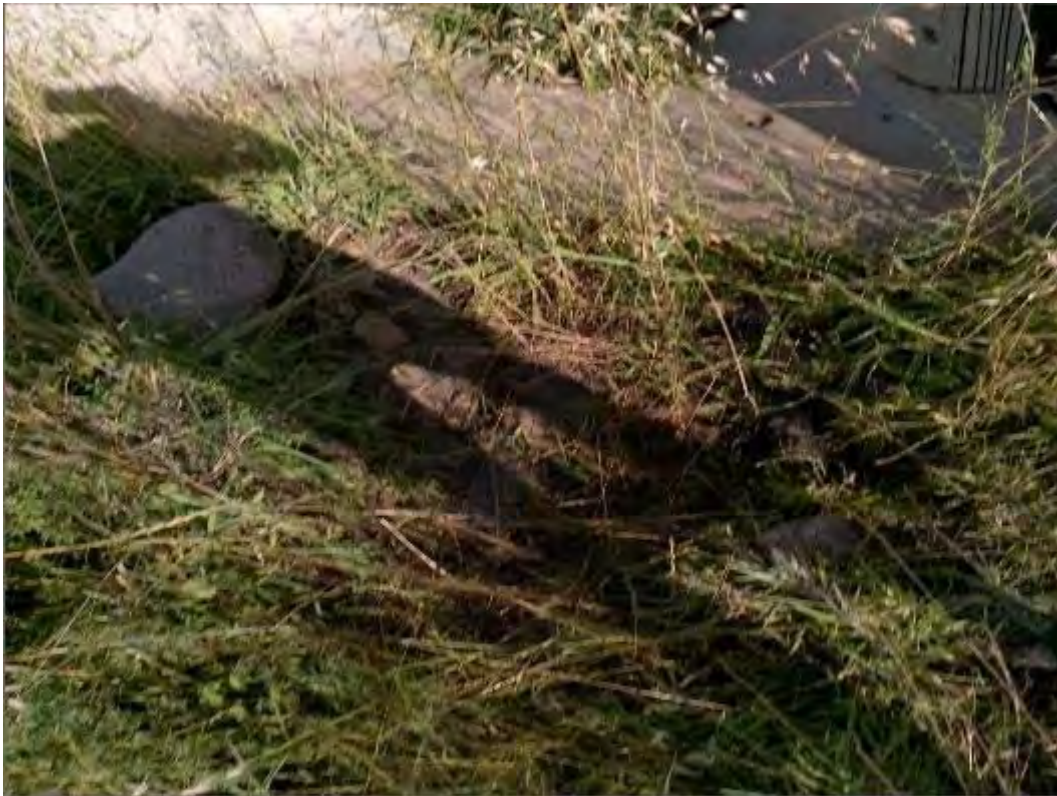
S067 – Coolah Creek Rd – 1500m East of Oakdale Rd Intersection
Concrete Causeway, 600mm Pipe Culvert
Fair Condition and Serviceable

S067 – 600mm Pipe Culvert on top of image

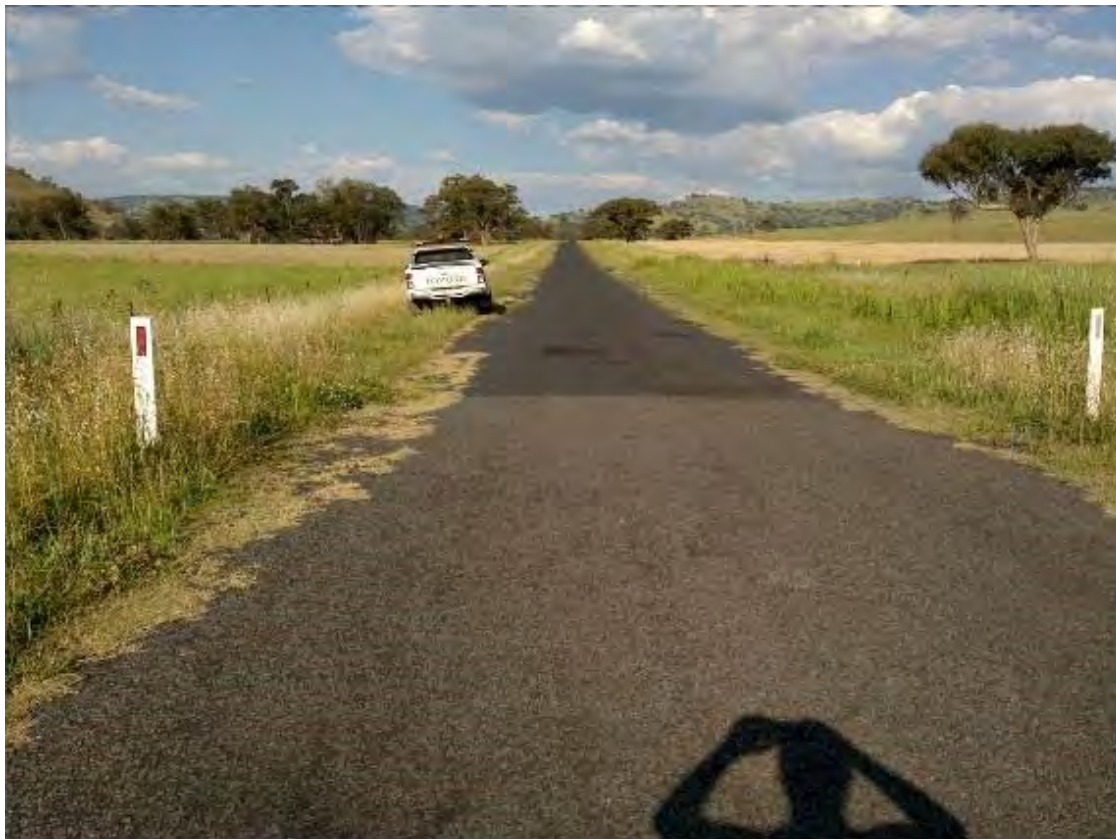
S068 – View to East

S068 – Coolah Creek Rd - 1200m East of Oakdale Rd Intersection
450mm Pipe Culvert
Fair Condition and Serviceable

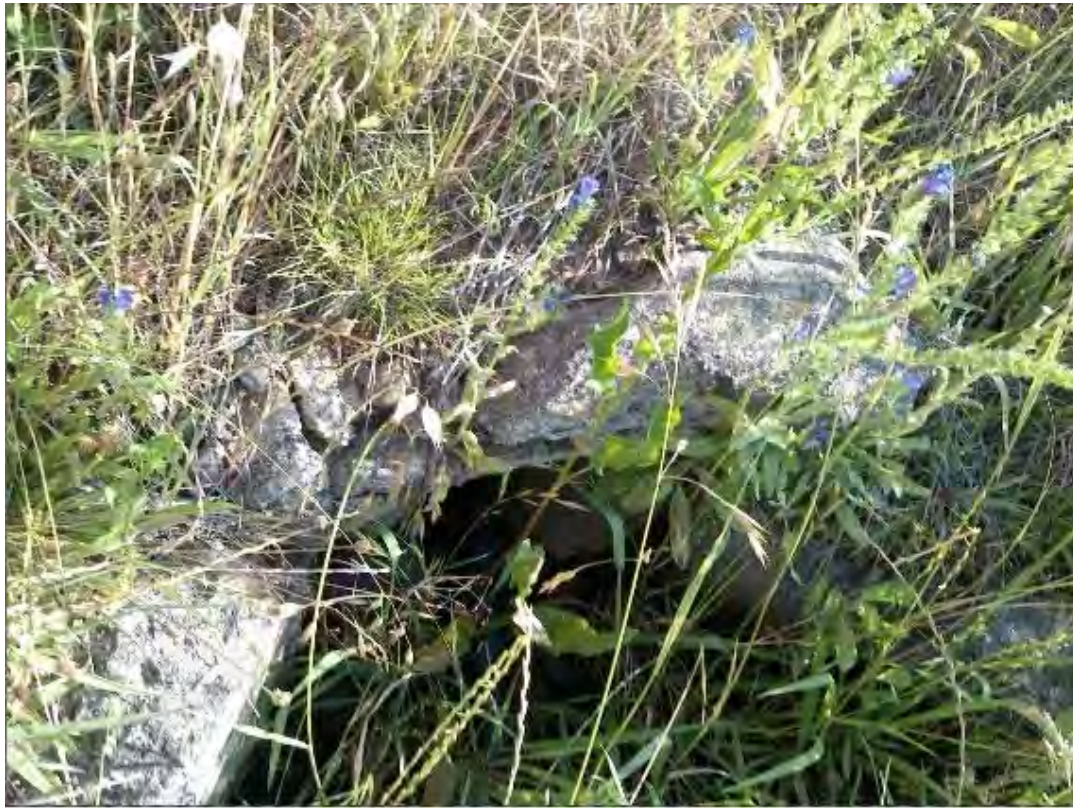
S068 – 450mm Pipe Culvert
