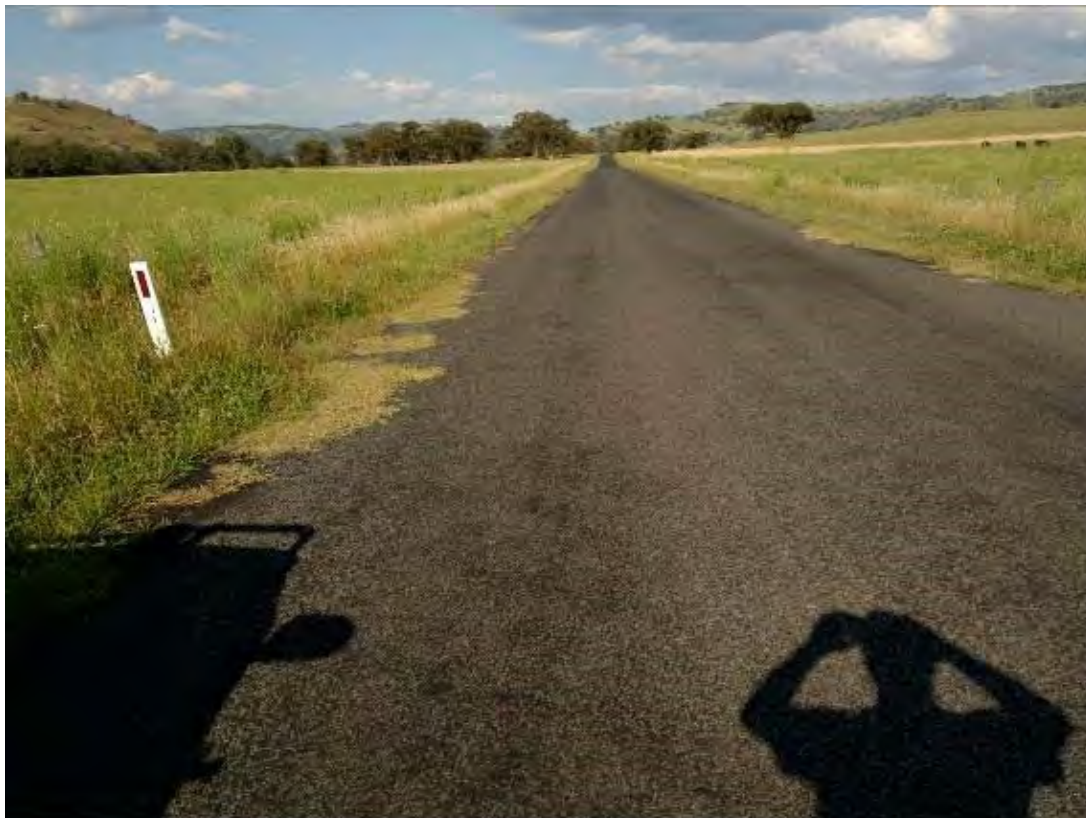
S069 – View to East

S069 – Coolah Creek Rd
Dual 450mm Pipe Culvert
Moderate Condition and Serviceable, May require some maintenance

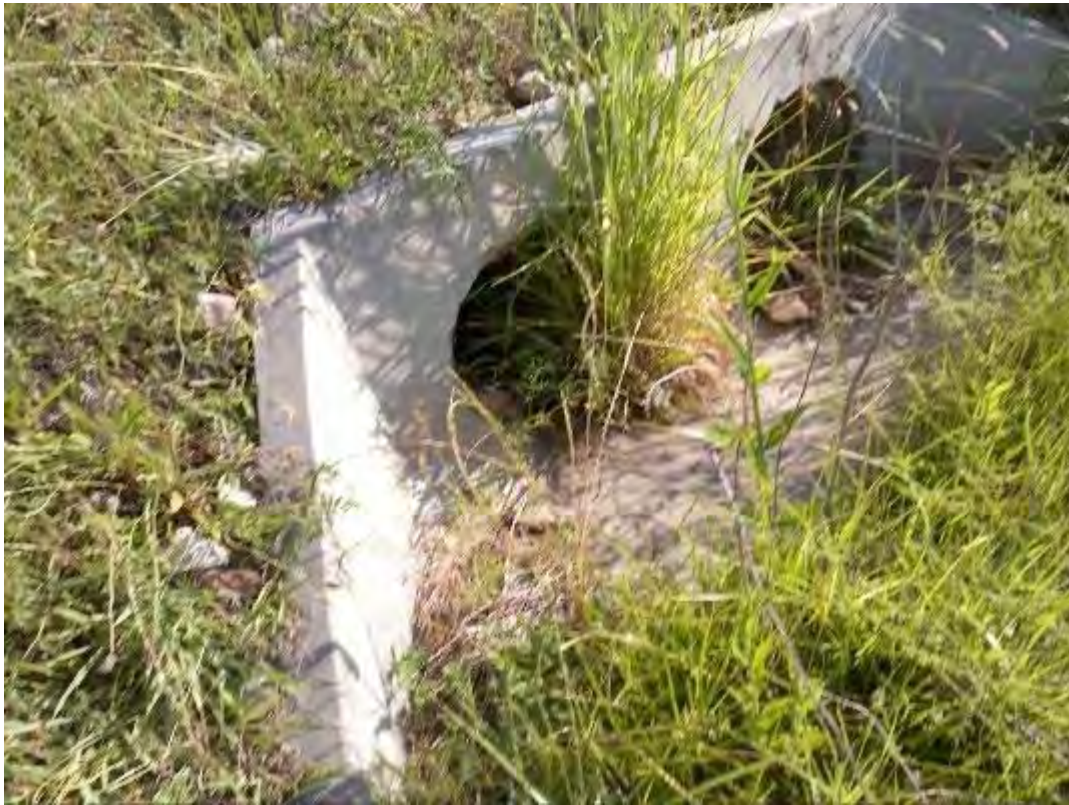
S069 - Dual 450mm Pipe Culvert

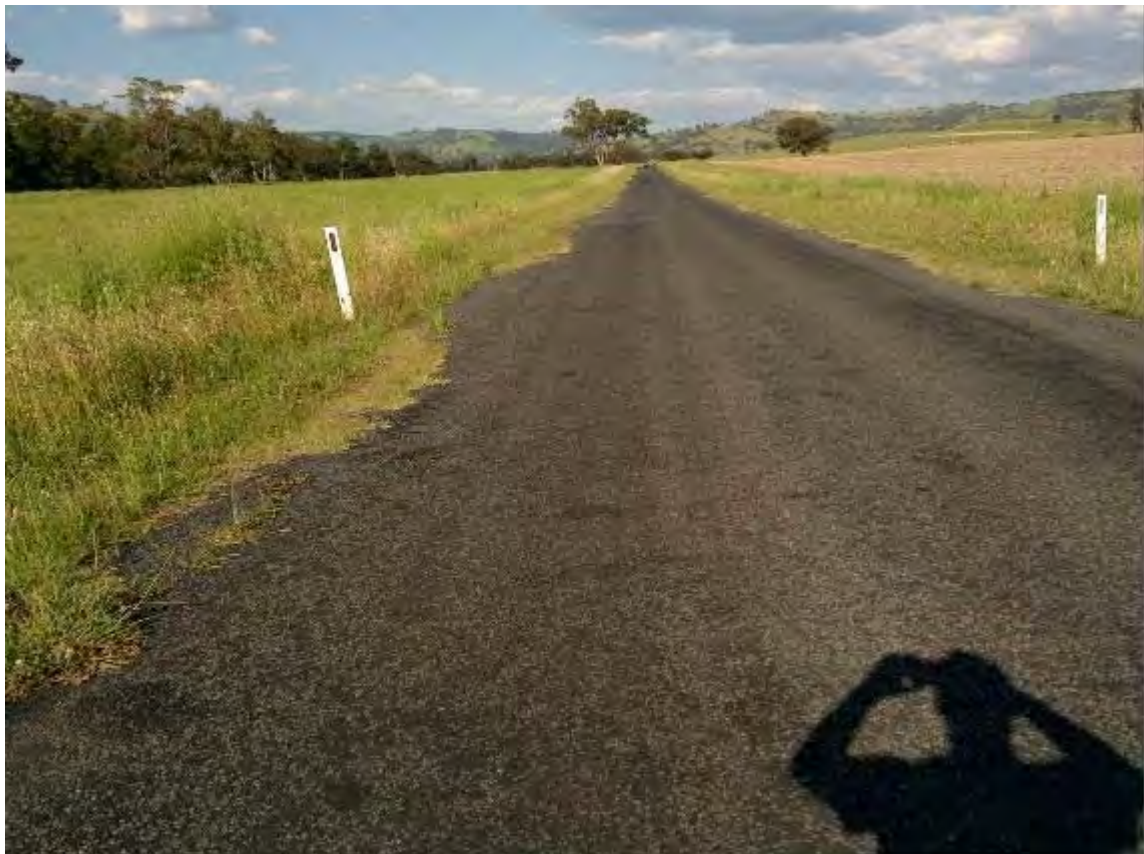
S070 – View to East

S070 – Coolah Creek Rd - 750m East of Oakdale Rd
450mm Pipe Culvert
Fair Condition and Serviceable

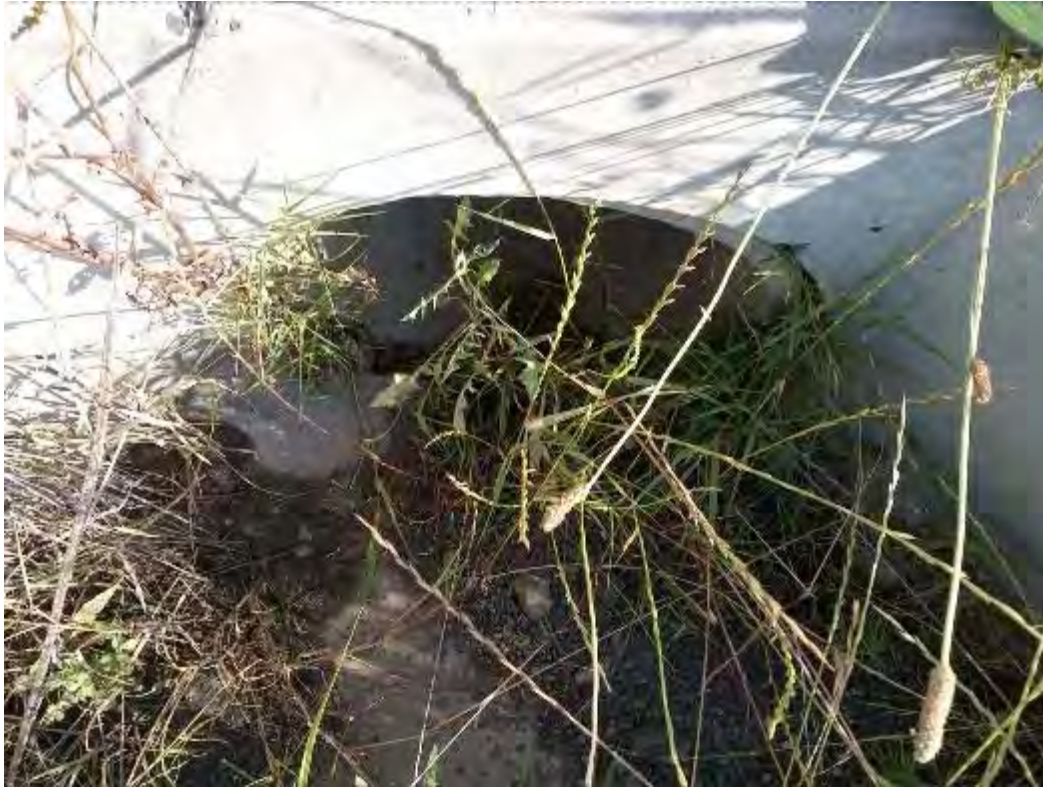
S070 - 450mm Pipe Culvert

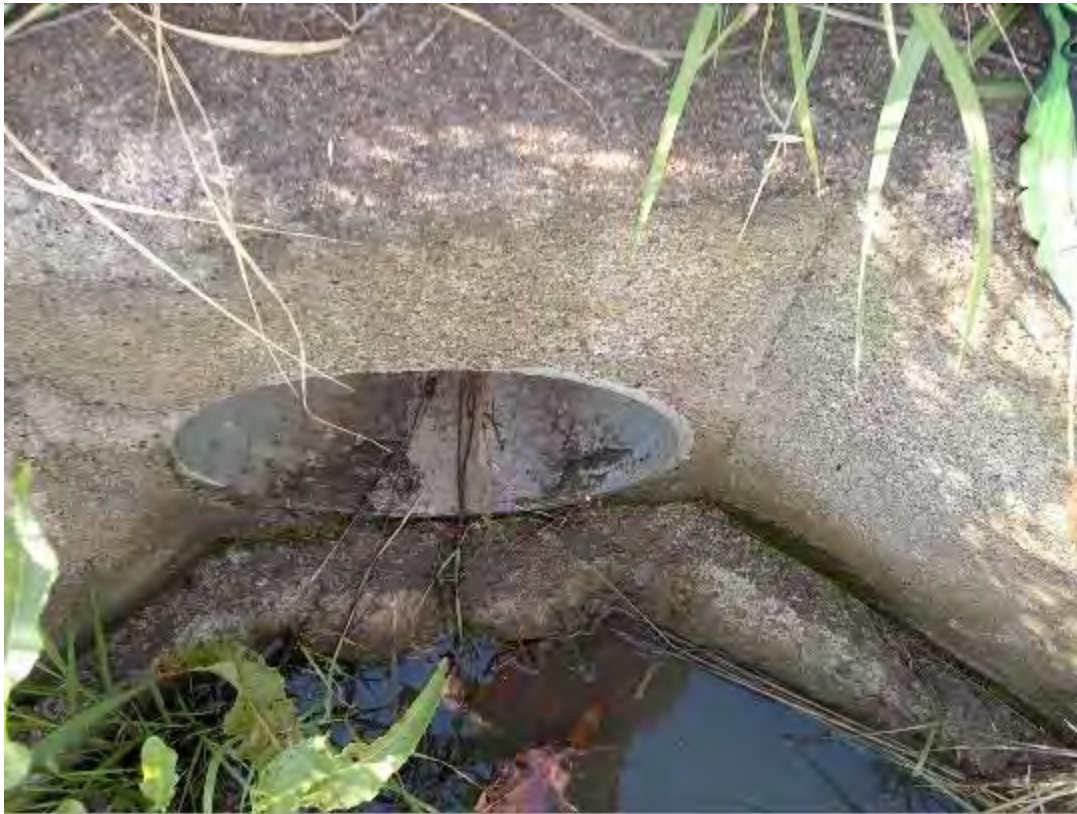
S071 – Coolah Creek Rd - 500m East of Oakdale
450mm Pipe Culvert
Good Condition and Serviceable

S071 - 450mm Pipe Culvert

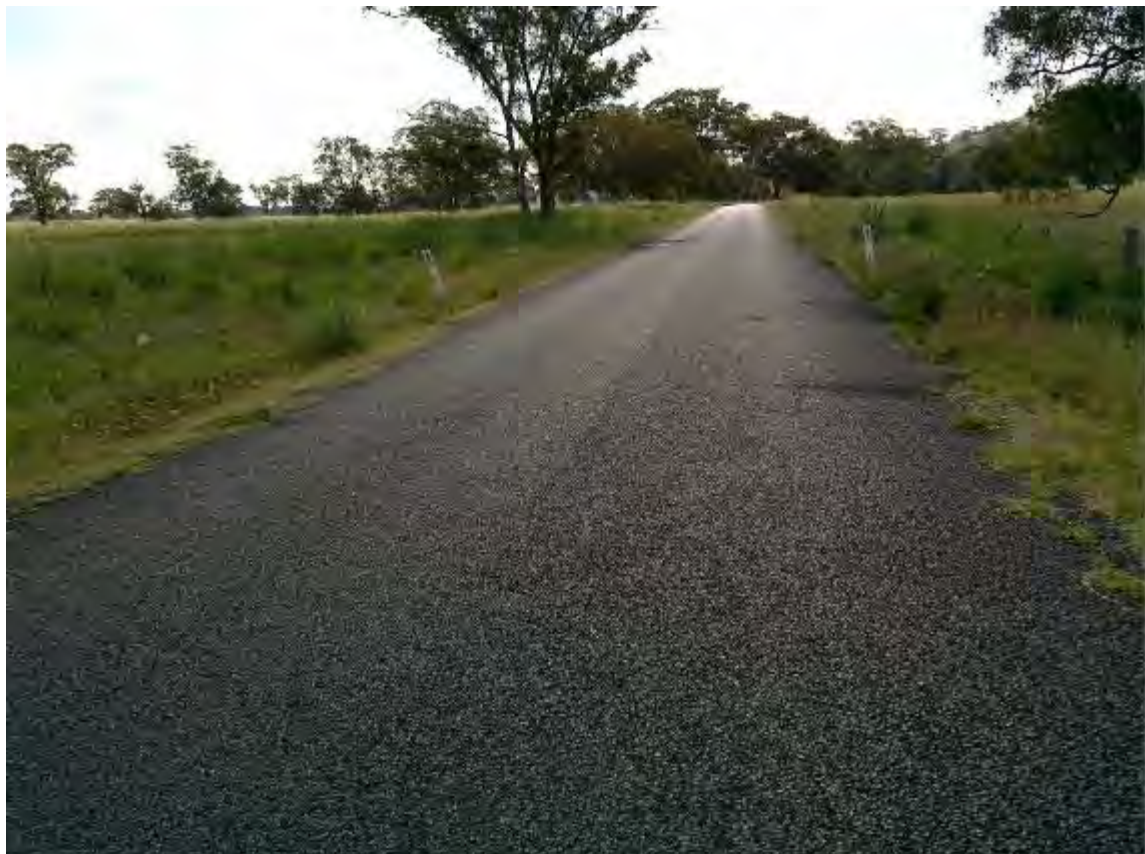
S073 - View to West

S073 – Coolah Creek Rd - 800m West of Oakdale Rd
450mm Pipe Culvert
Fair Condition and Serviceable

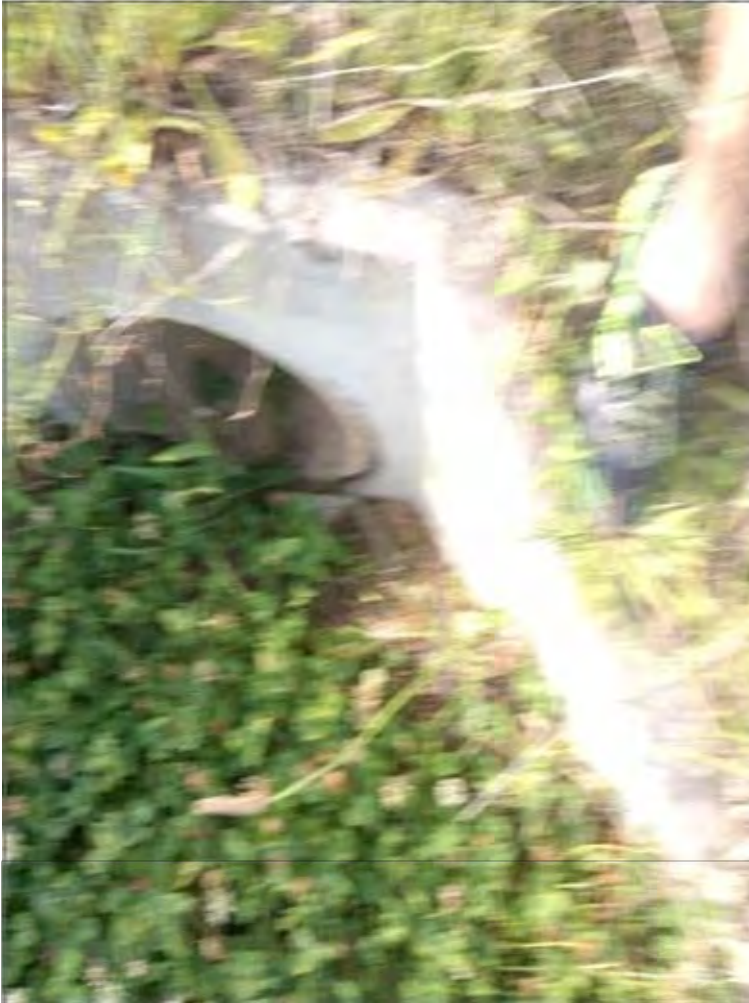
S073 – View of 450mm Pipe Culvert
