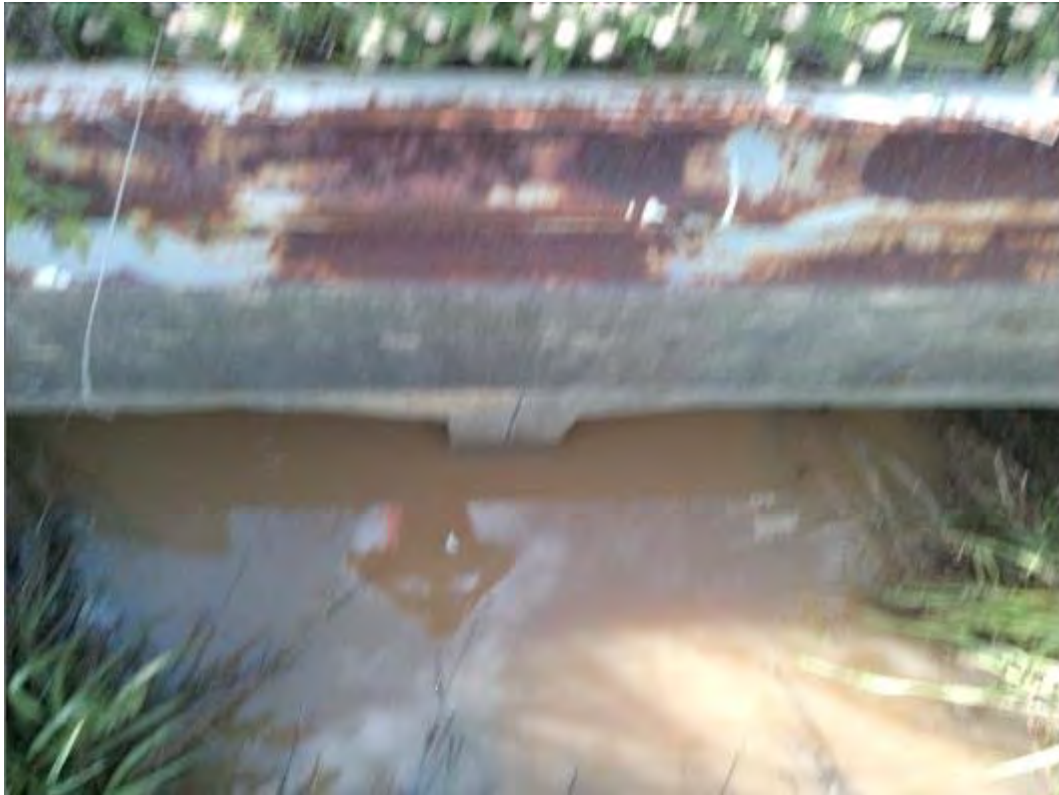
2 of approximately 1500mm Reinforced Concrete Box Culvert

Depth of Box Culvert unknown due to water flow

Fair Condition and Serviceable

S075 – View to East

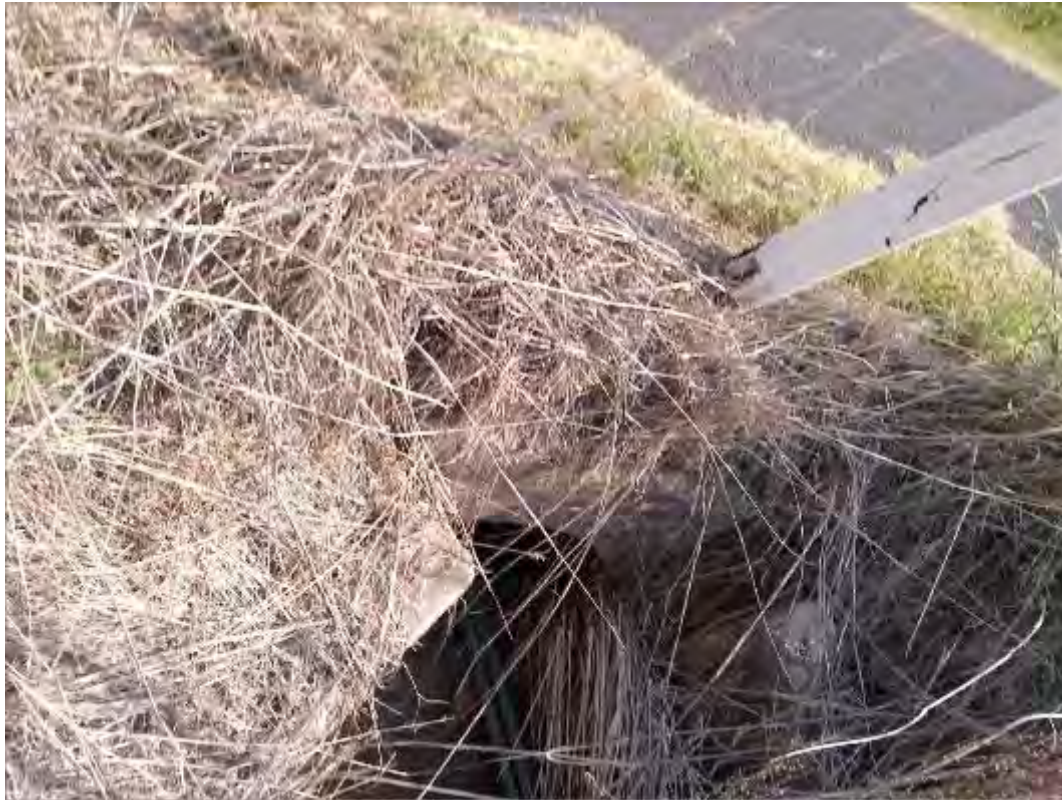
**S076 - Coolah Creek Rd - 2500m West of Oakdale Rd Intersection**  
450mm Pipe Culvert with broken headwall  
Moderate Condition and Serviceable

S076 - 450mm Pipe Culvert with broken headwall

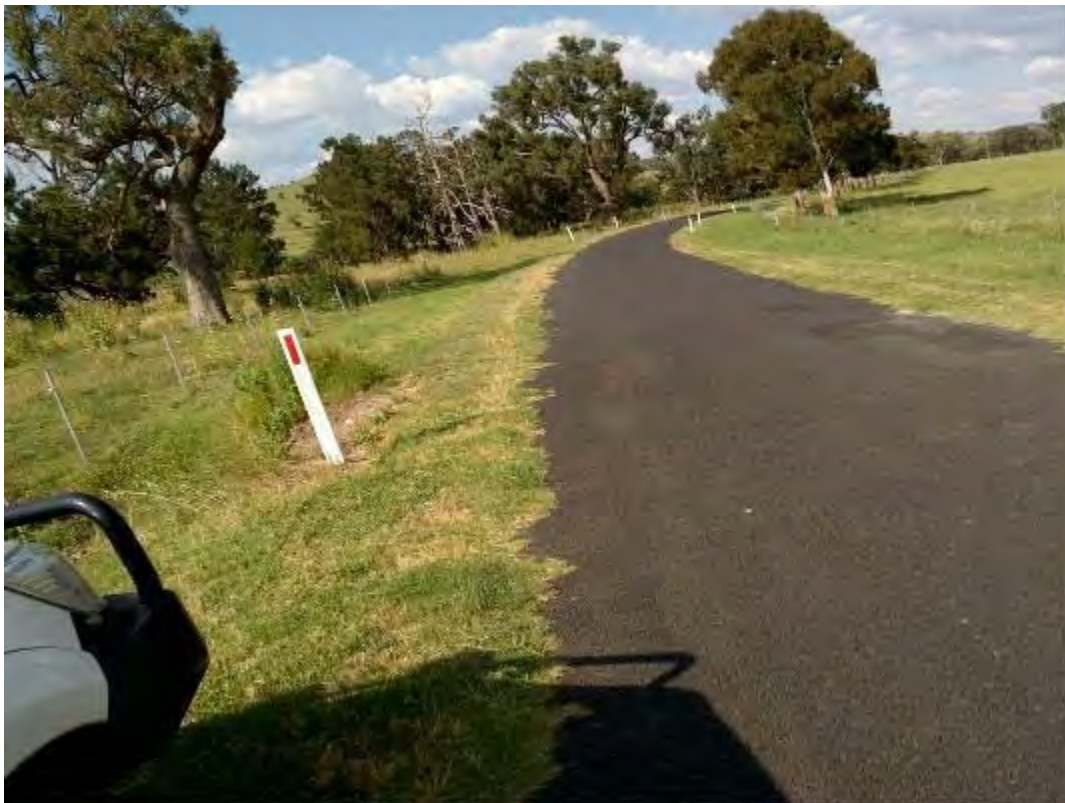
S079 – View to East

**S079 – Coolah Creek Rd – 3000m East of Cooks Dr Intersection**  
525mm Pipe Culvert  
Fair Condition and Serviceable

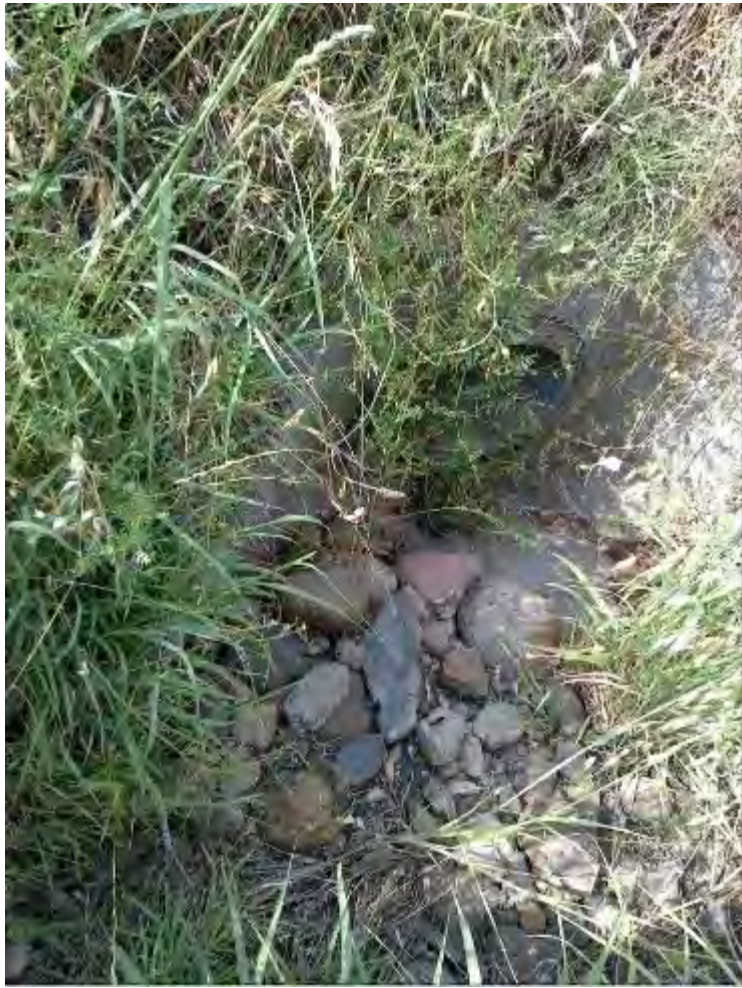
**S080 – Coolah Creek Rd - 2250m East of Coolah Creek Rd - Cooks Dr Intersection**  
450mm Pipe Culvert  
Fair Condition and Serviceable

S080 – 450mm Pipe Culvert

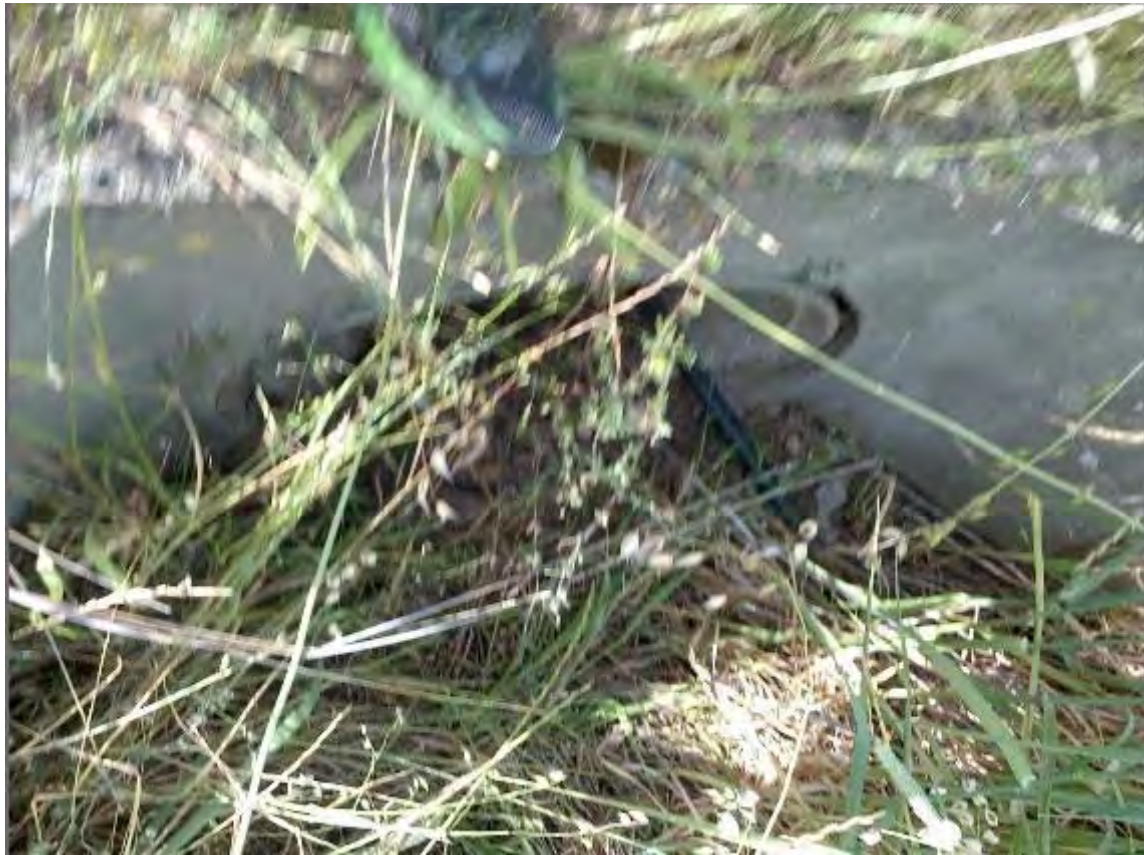
**S081 – Coolah Creek Rd - 1400m East of Coolah Creek Rd - Cooks Dr Intersection**  
600mm Pipe Culvert  
Good Condition and Serviceable, may require some maintenance

S081 - 600mm Pipe Culvert

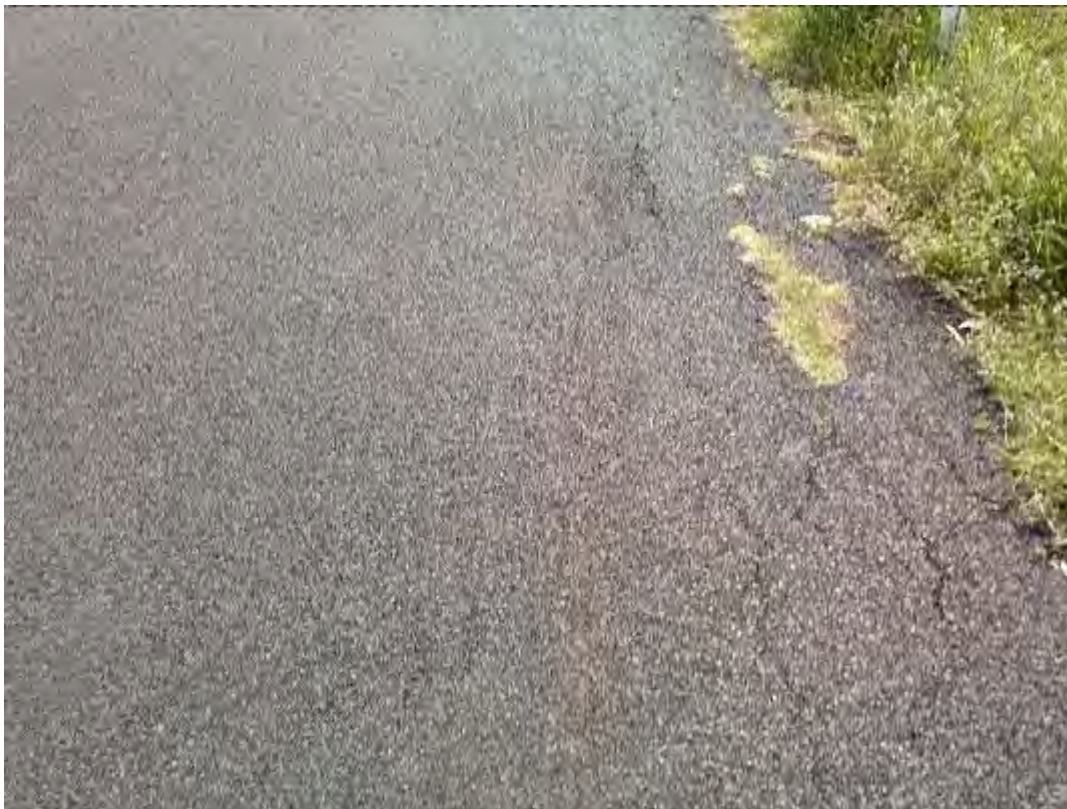
**S082 – View of Causeway, Marker on top right of image**

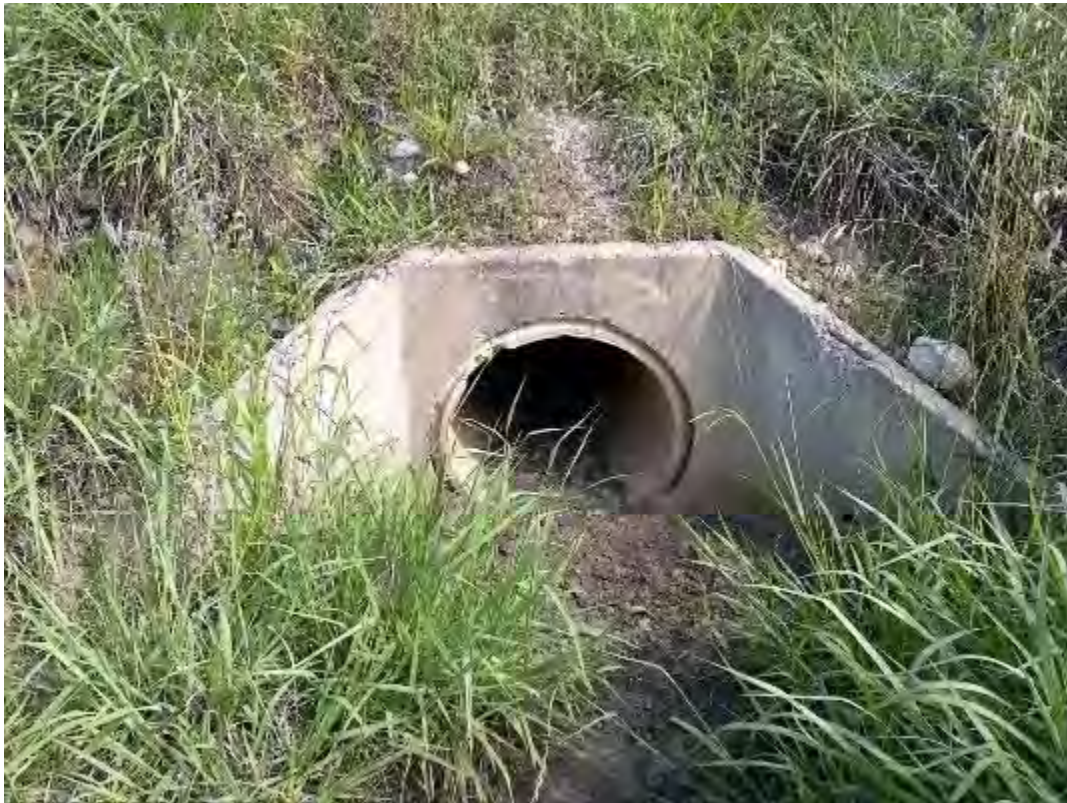
**S082 – Coolah Creek Rd - 1300m East of Coolah Creek Rd - Cooks Dr Intersection**  
600mm Pipe Culvert  
Good Condition and Serviceable

S082 – 600mm Pipe Culvert

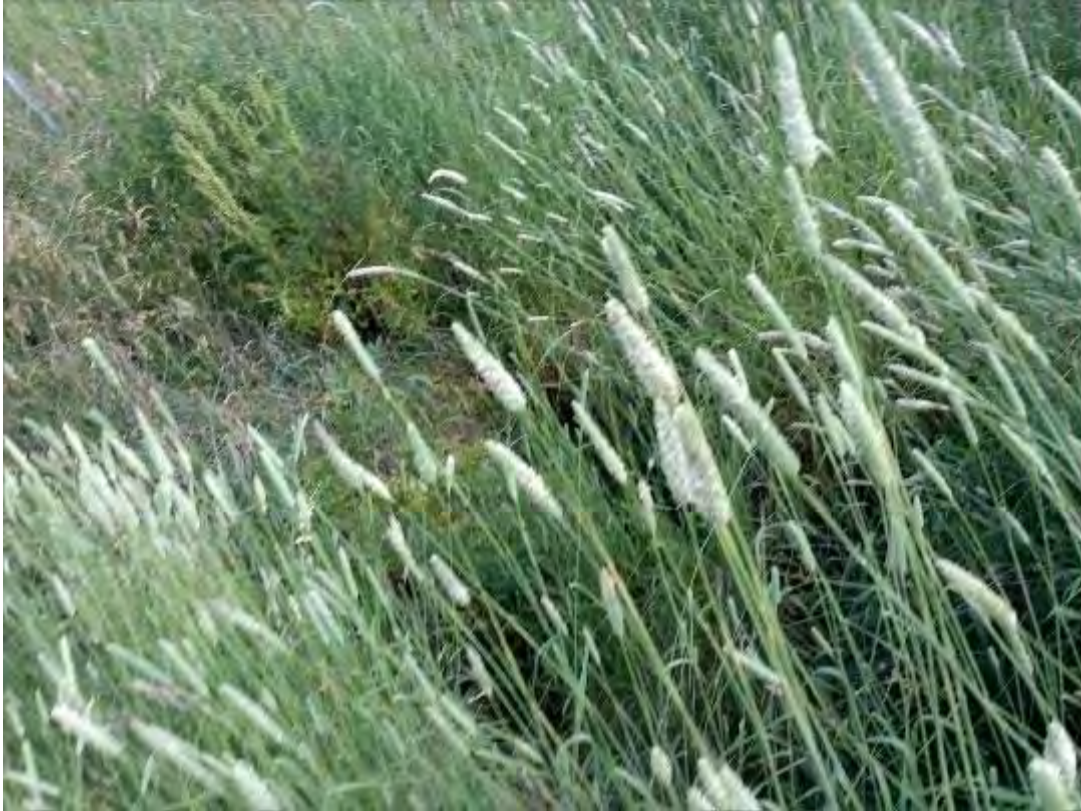
Pipe Culvert of Unknown Dimensions

Unknown Condition

S085 - Pipe Culvert

Maintenance required

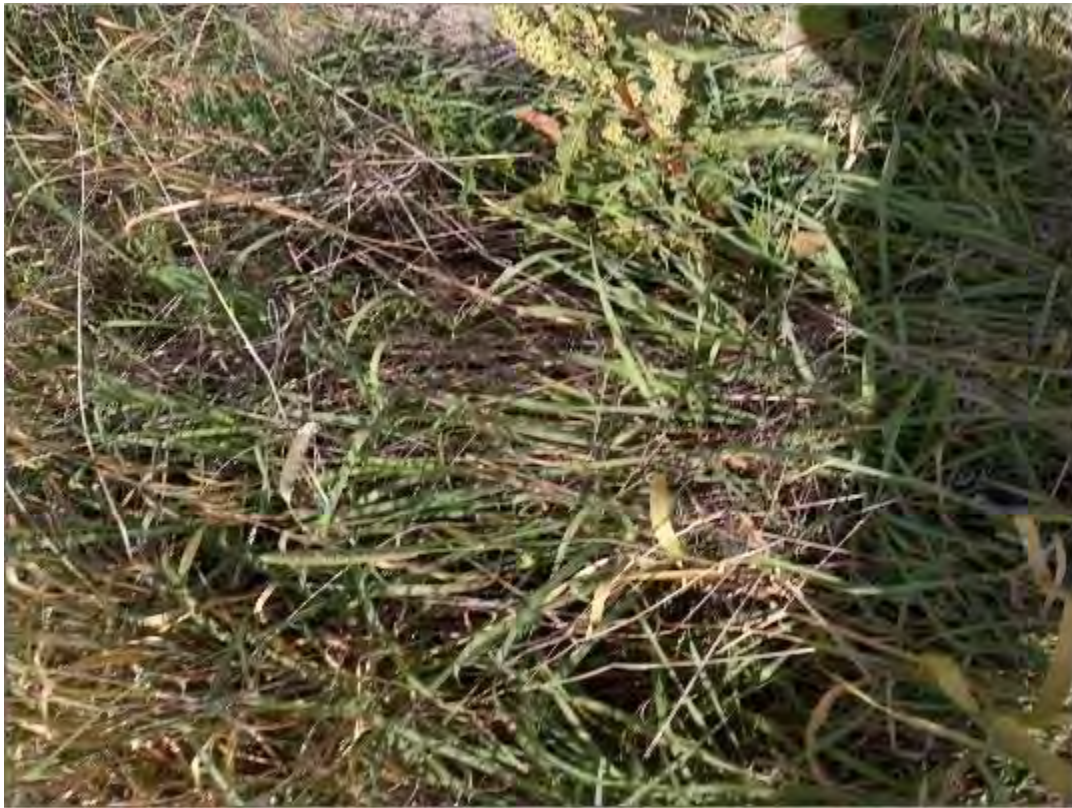
Pipe Culvert

Inaccessible at time of inspection

S087 – View of Hidden Culvert

Maintenance required

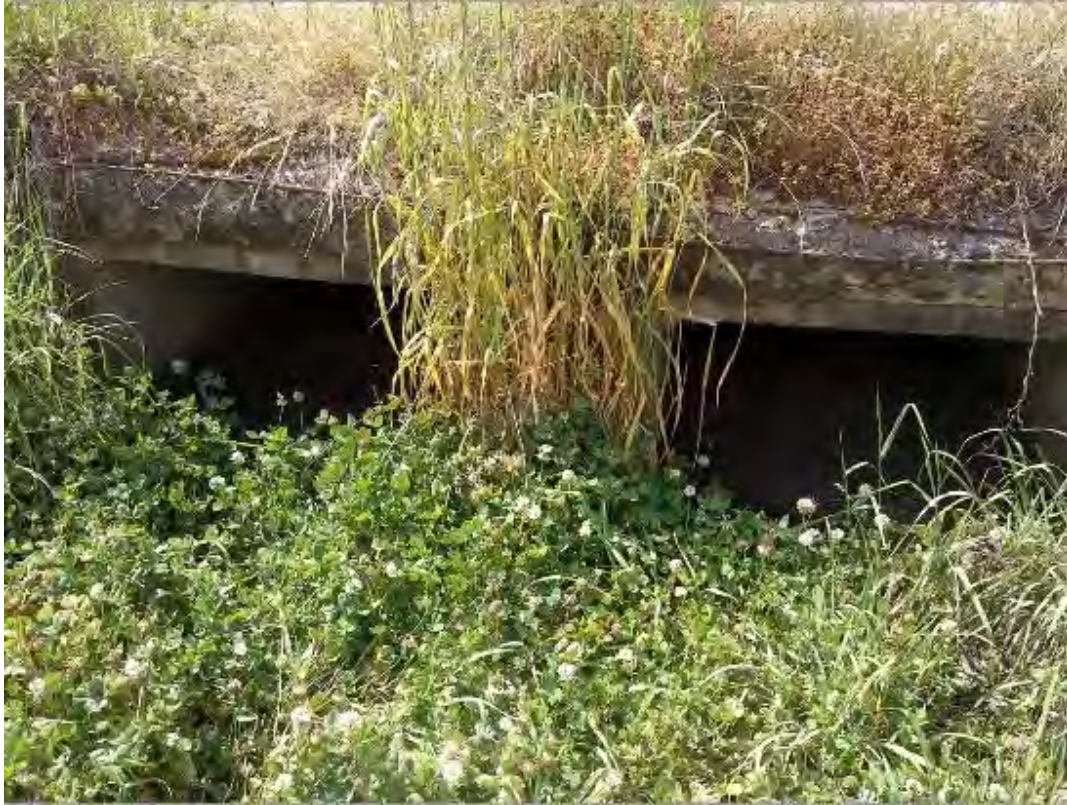
Dual 750mm-1200mm Reinforced Concrete Box Culvert with 3500mm bitumen seal  
Moderate Condition and Serviceable

S089 – 2 of 750mm by 1200mm reinforced concrete box culvert

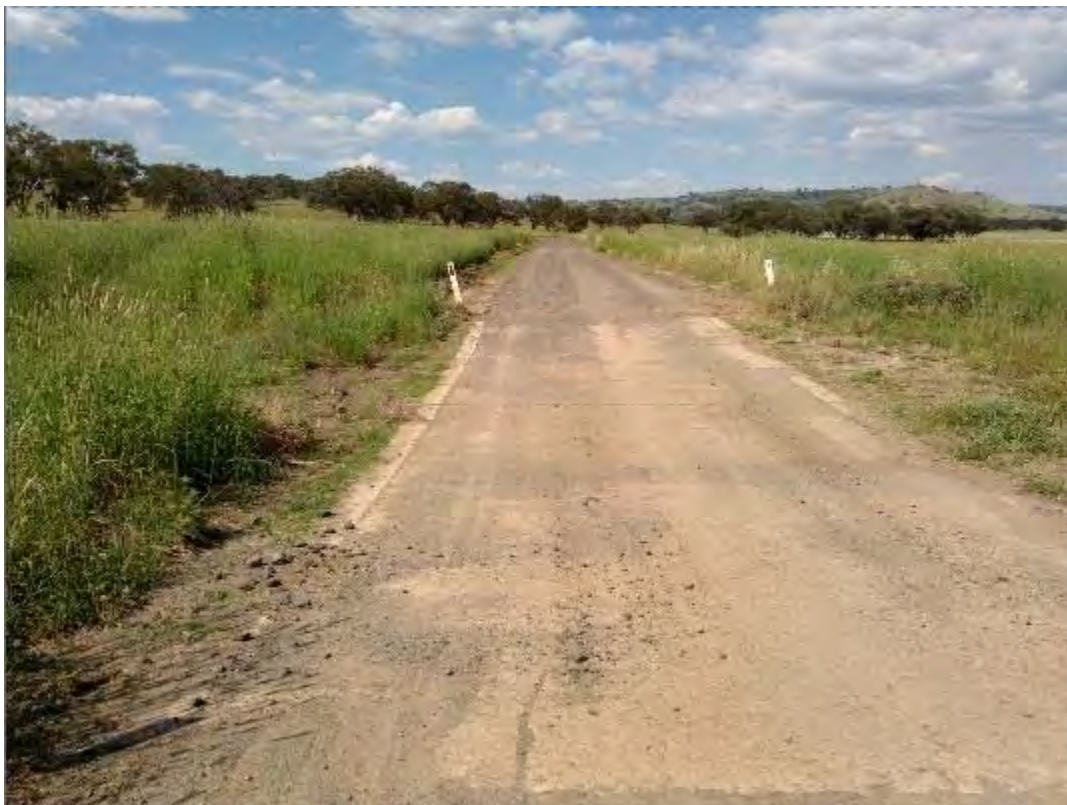
Causeway, Prone to Flooding,  
Fair Condition and Serviceable  
Upgrade may be required

S091 – Causeway, Signs of water damage on either side of road

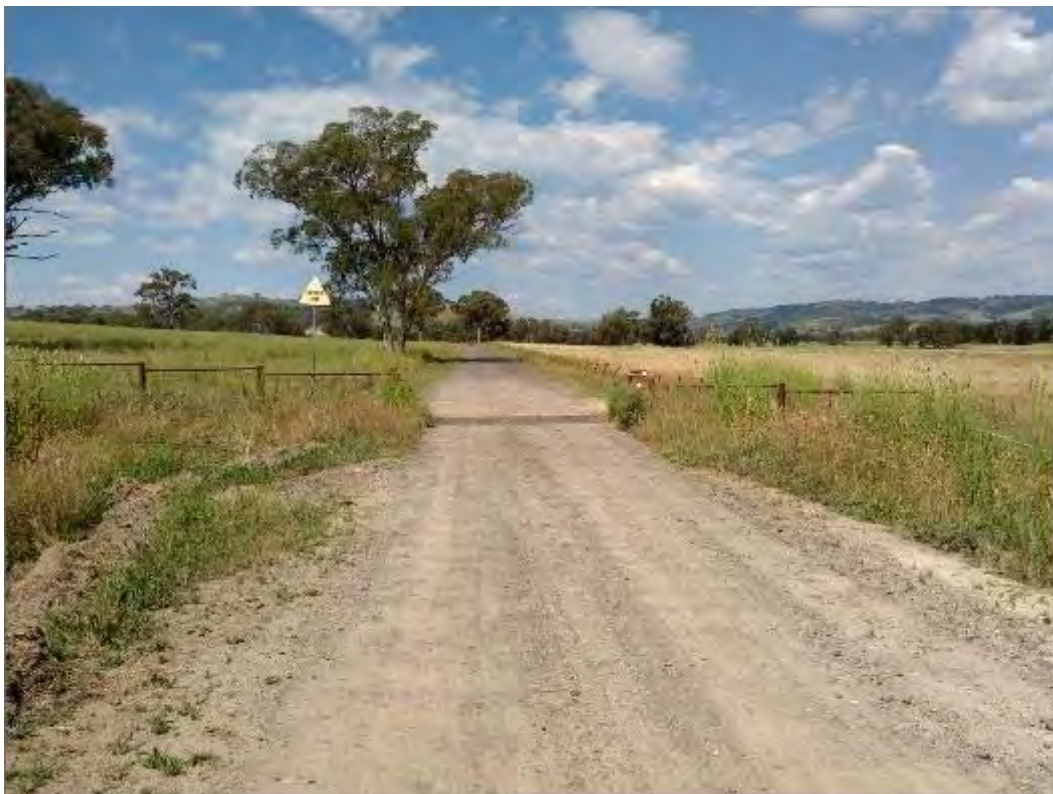
S092 – View to East

**S092 – Gun dare Rd - 1350m East of Cooks Dr Intersection**  
Causeway with pipe culvert approximately 300mm in Diameter  
Moderate Condition and Serviceable

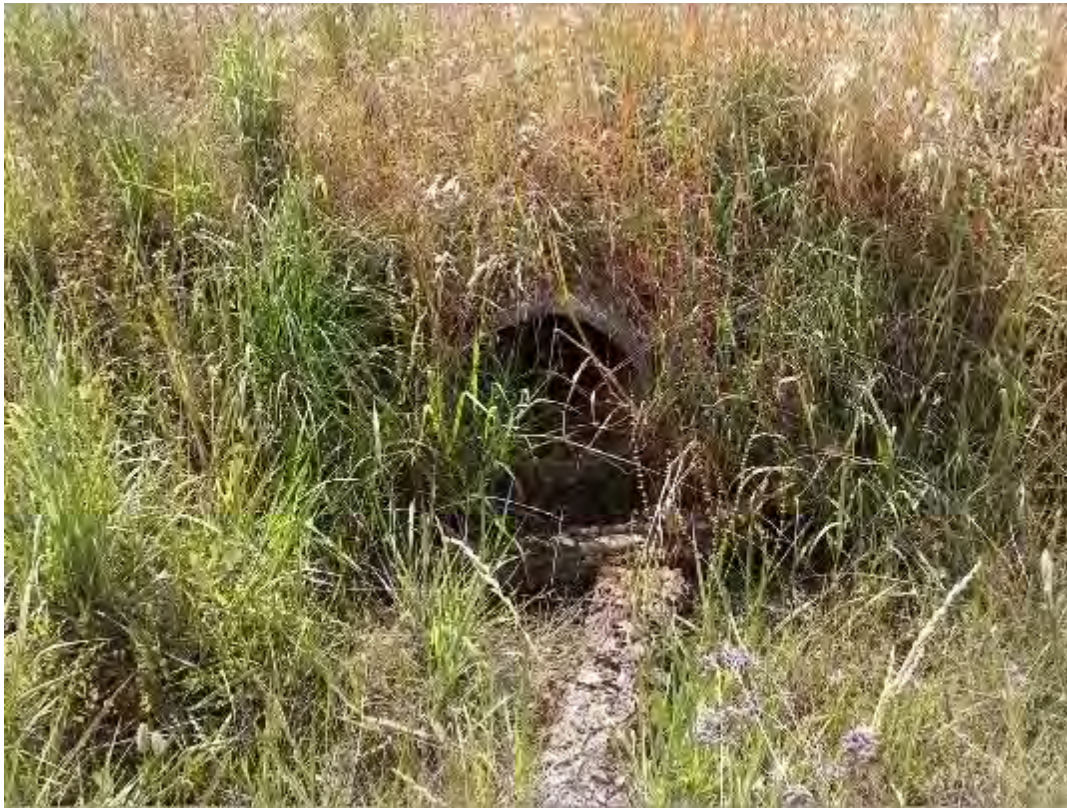
**S103 – Coolah Creek Rd - 1000m North of Vinegory Rd**  
600mm Pipe Culvert,  
Fair Condition and Serviceable

S103 – 600m Pipe Culvert

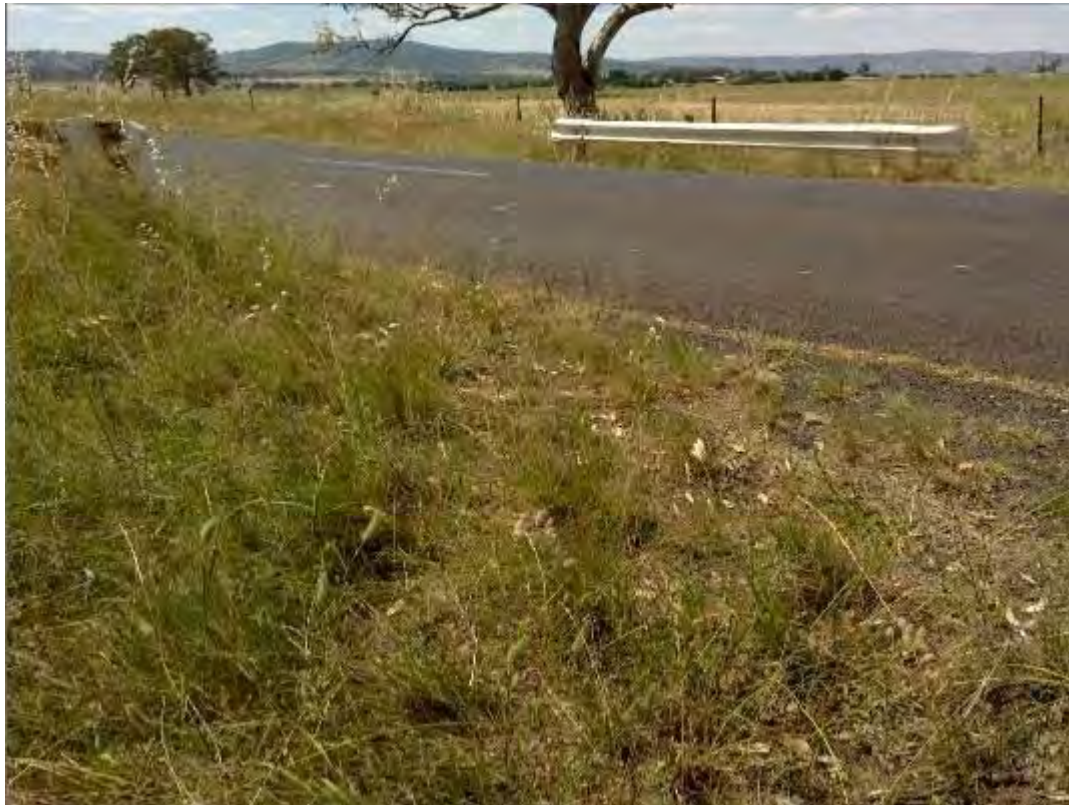
**S105 – View to North**

**S105 – Vinegaroy Rd - 600m South of Coolah Creek Rd Intersection**  
450mm Pipe Culvert  
Moderate Condition and Serviceable

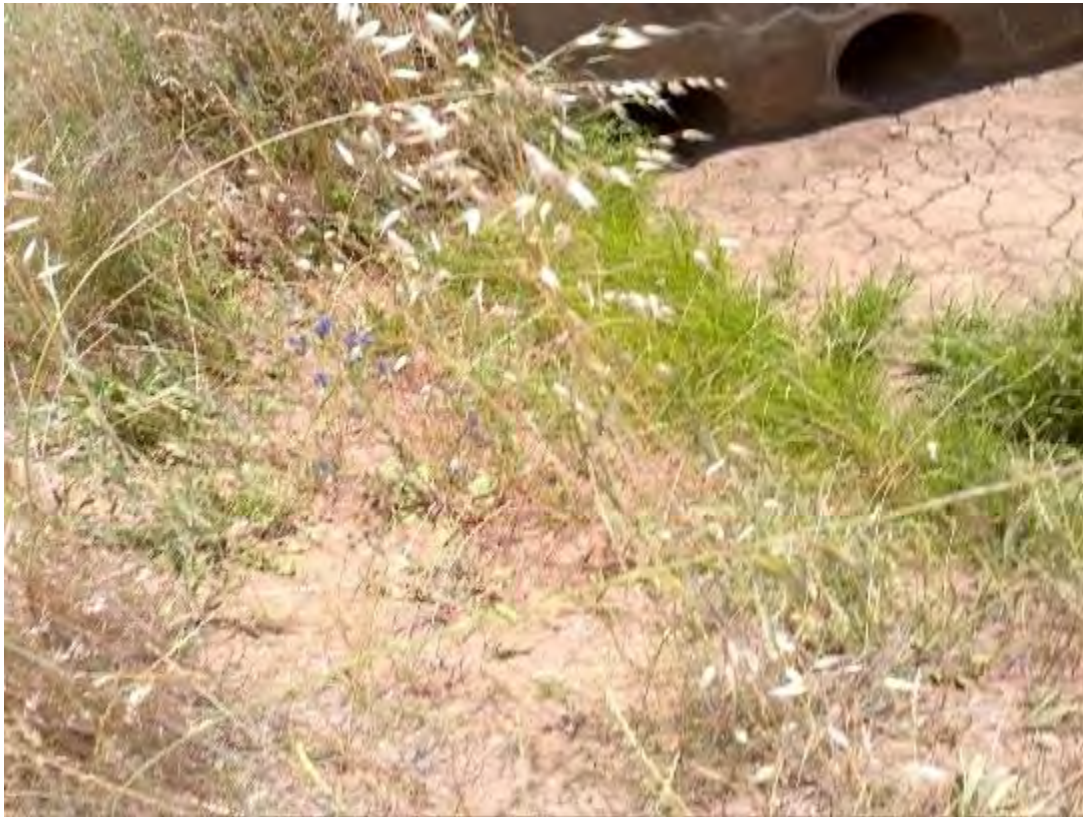
**S106 – Vinegaroy Rd - 700m South of Coolah Creek Rd Intersection**  
3-450mm Pipe Culvert  
Good Condition and Serviceable

S106 - 3-450mm Pipe Culvert

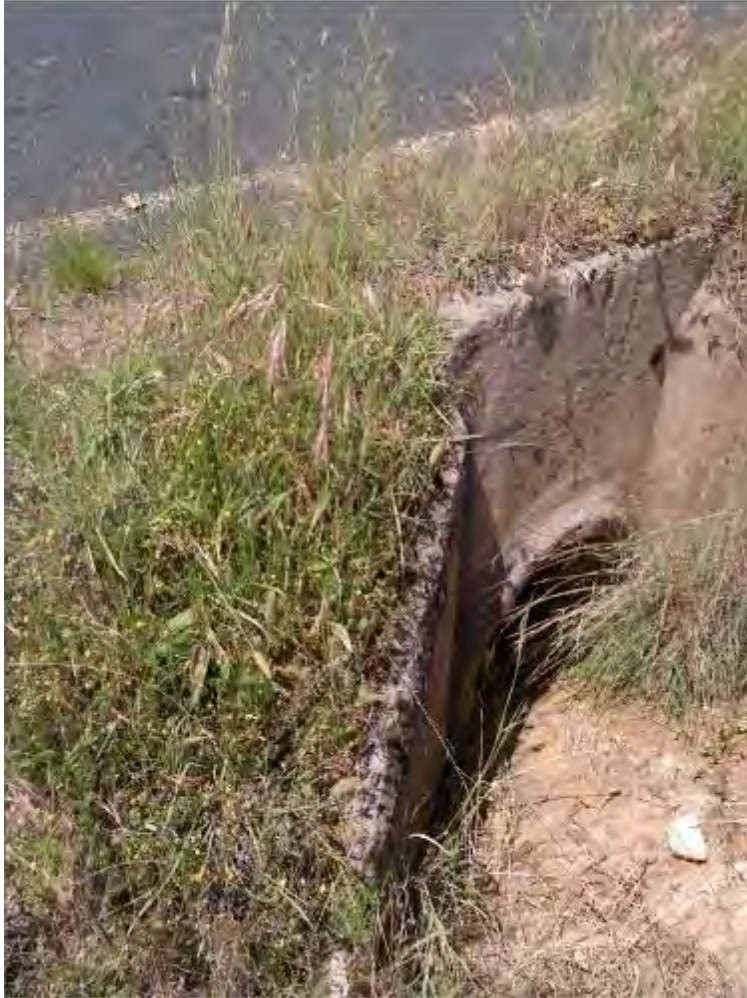
**S107 – Vinegaroy Rd - 900m South of Coolah Creek Rd Intersection**  
600mm Pipe Culvert  
Fair Condition and Serviceable,

S107 – 600mm Pipe Culvert

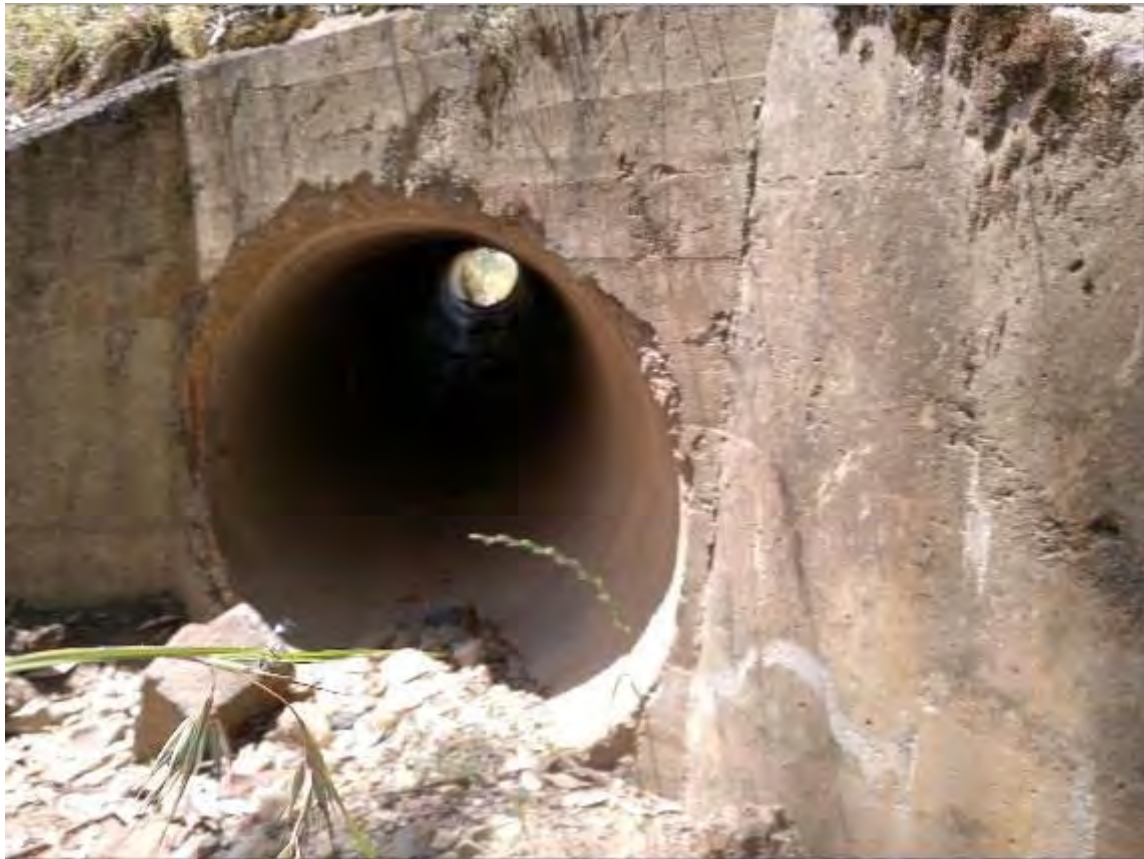
**S108 - Vinegaroy Rd - 2000m South of Coolah Creek Rd Intersection**  
1050mm Pipe Culvert. Skewed across road alignment.  
Fair Condition and Serviceable, Internal condition is also Fair

S108 – Skewed 1050mm Pipe Culvert showing Interior Condition

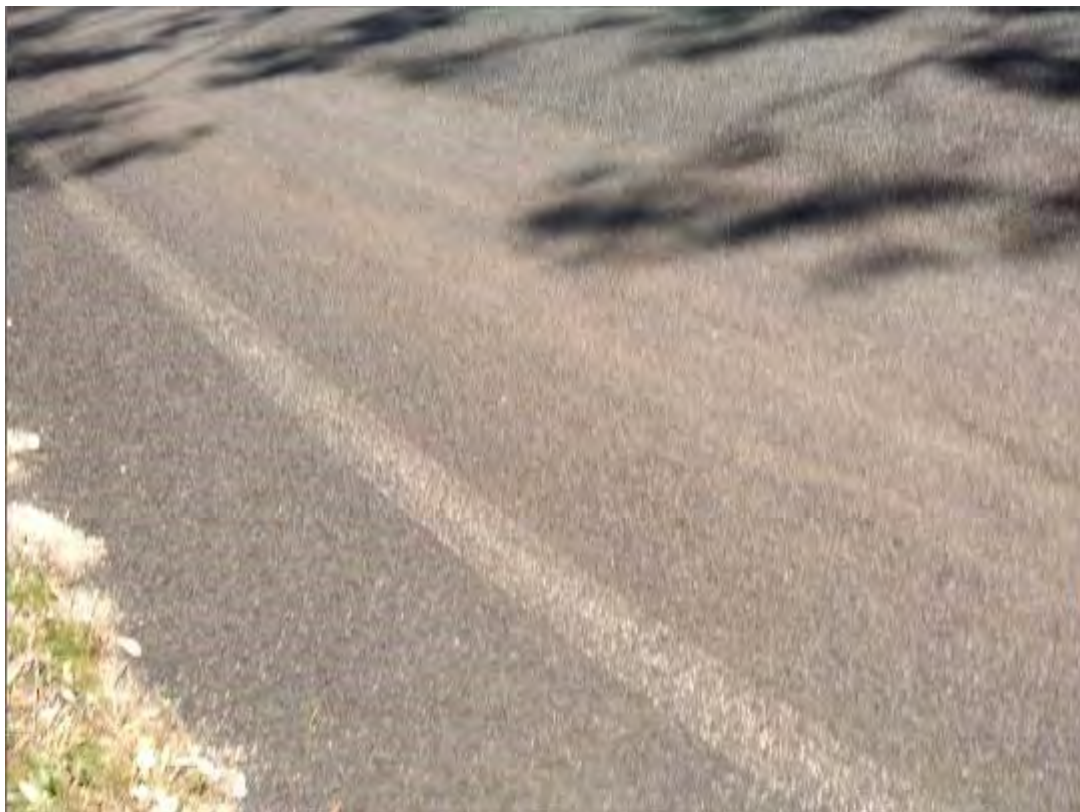
Approximately 450mm Pipe Culvert

Unknown Condition, upgrade may be required

S112 – View of Causeway showing signs of rutting

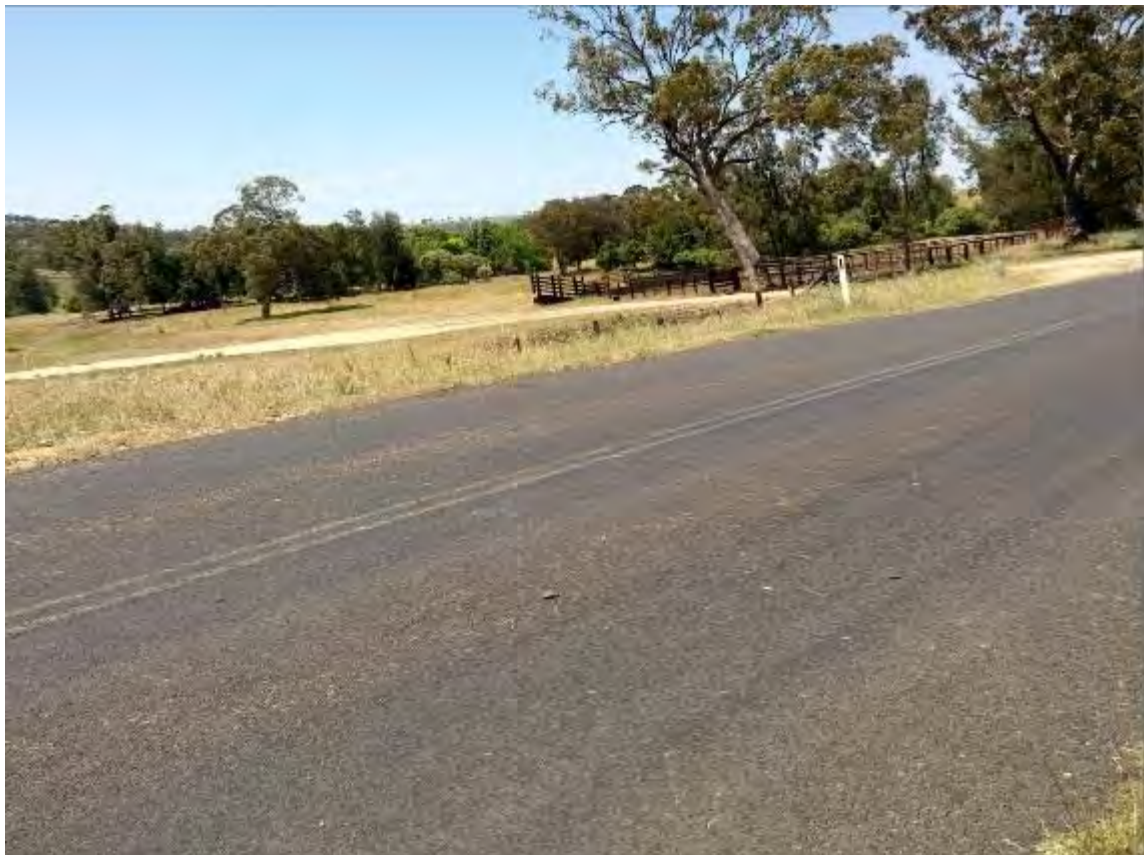
S113 – View to East

**S113 - Vinegaroy Rd - 5000m South from Coolah Town**  
600mm Pipe Culvert  
Unknown Condition

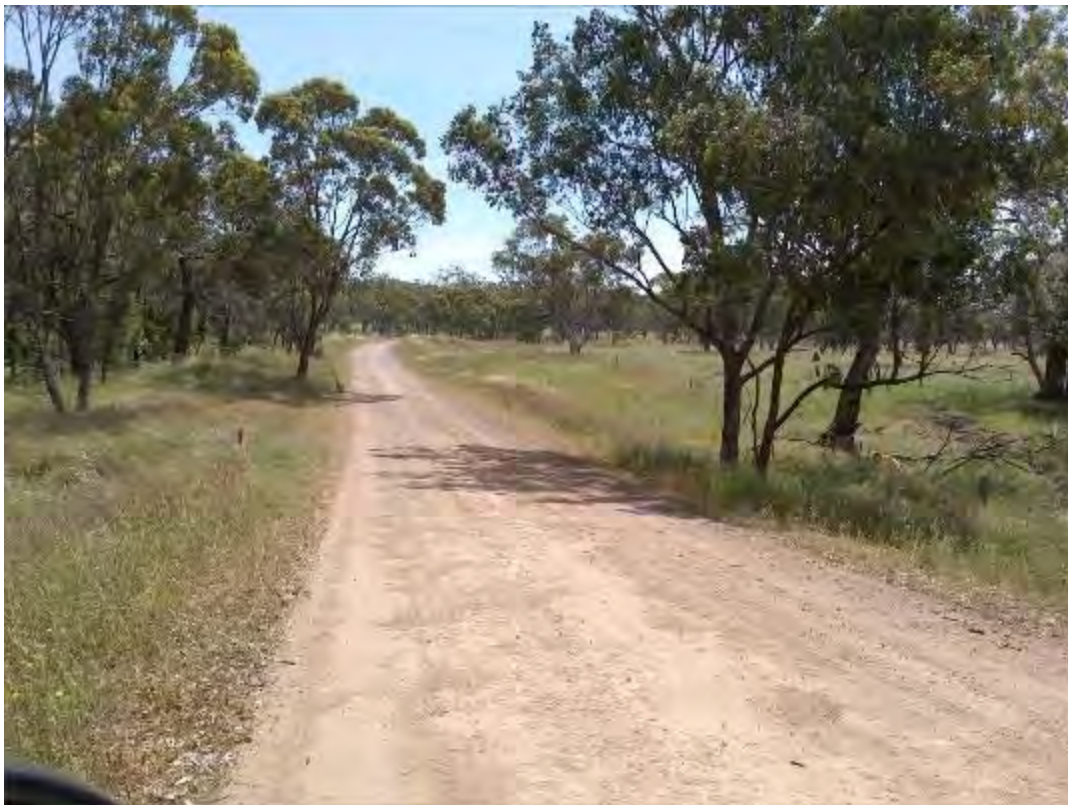
**S115 – View to West**

**S115 – Coolah Rd - 1000m East of Vinegaroy Rd Intersection**  
Pipe Culvert of Unknown Dimensions  
Unknown Condition

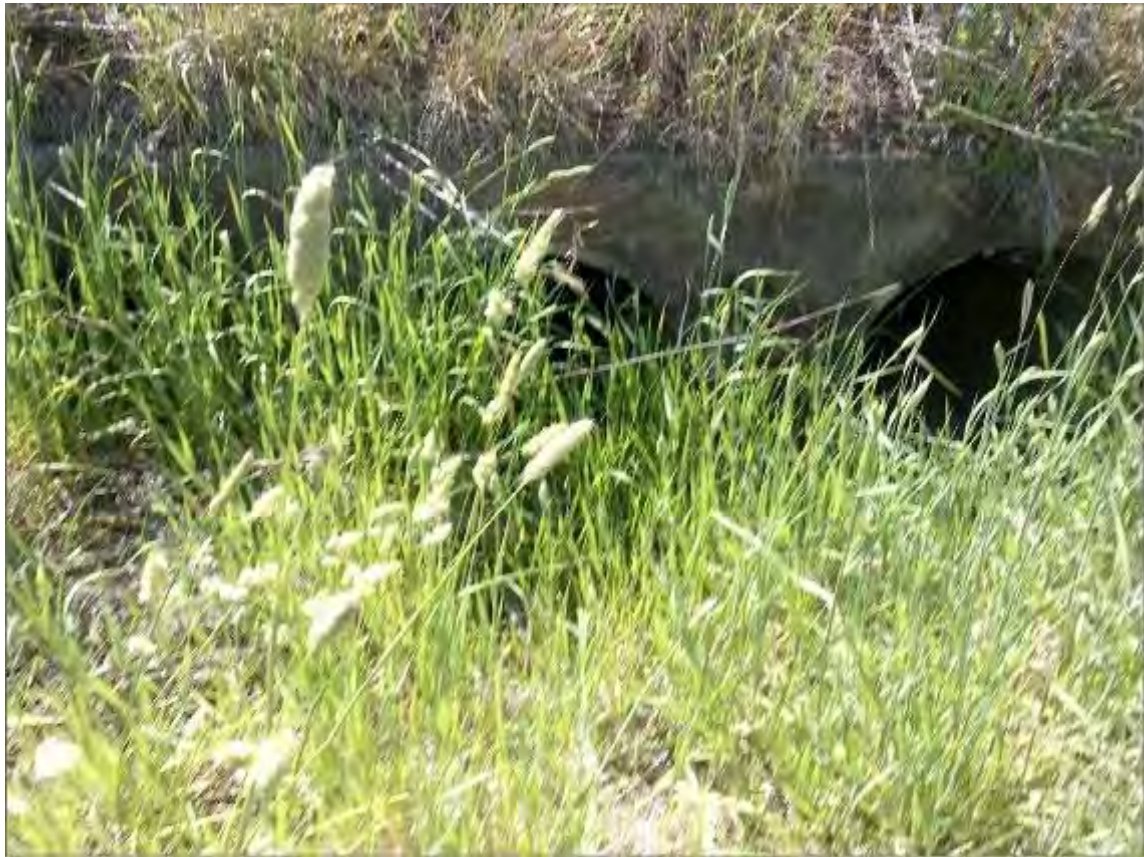
**S116 - Vinegaroy Rd - 3300m North of Rotherwood Rd Intersection**  
3-750mm Pipe Culvert  
Moderate Condition and Serviceable

S116 - 3-750mm Pipe Culvert

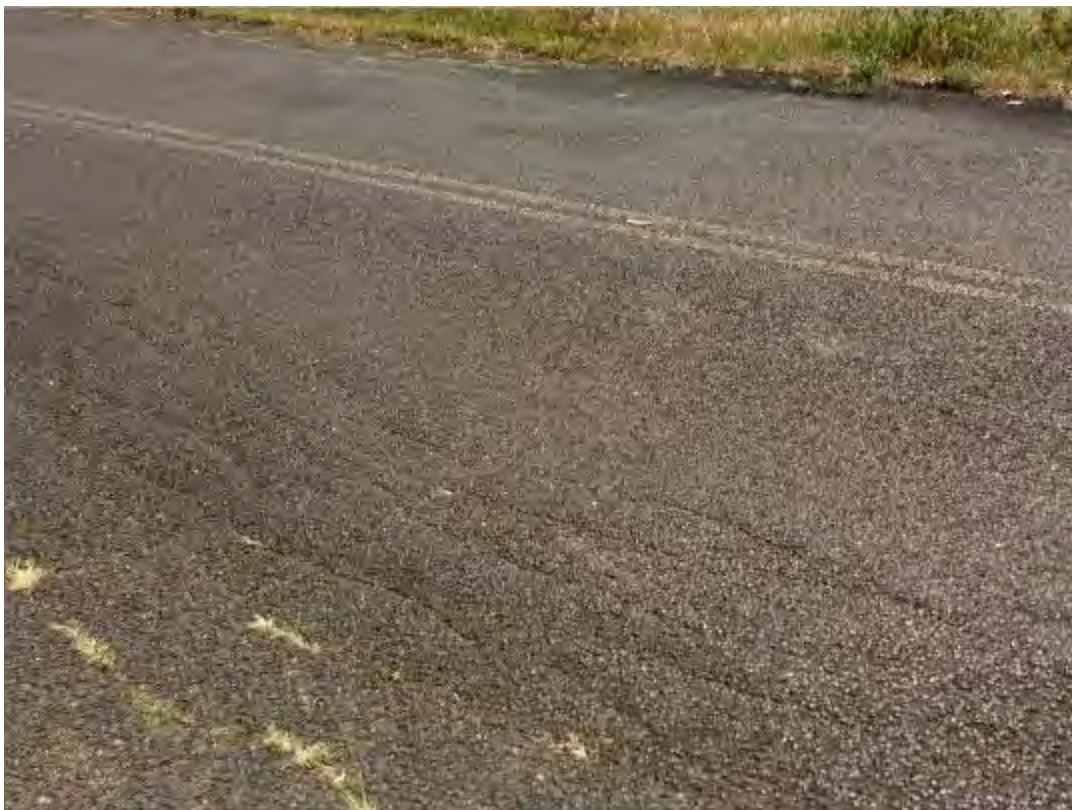
Moderate Condition and Serviceable, upgrade may be required.

S119 – Road showing signs of wear

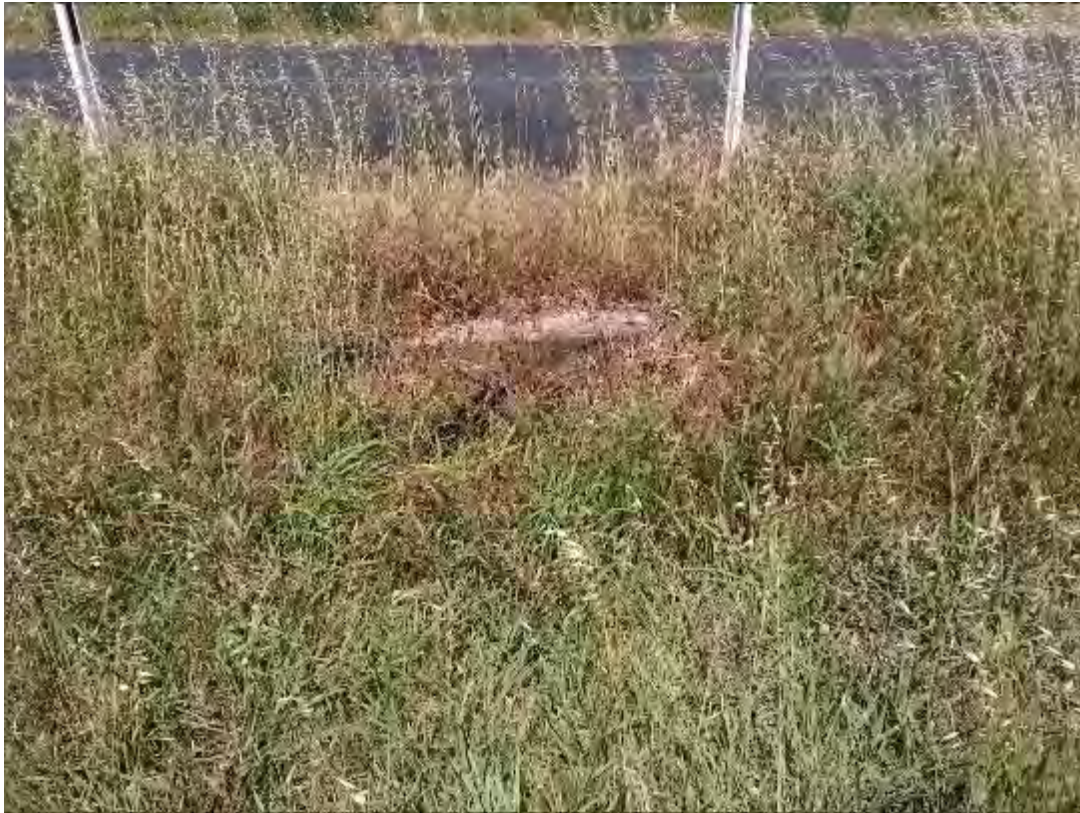
600mm Pipe Culvert

Further inspection of internal condition is required

S119 - 600mm Pipe Culvert

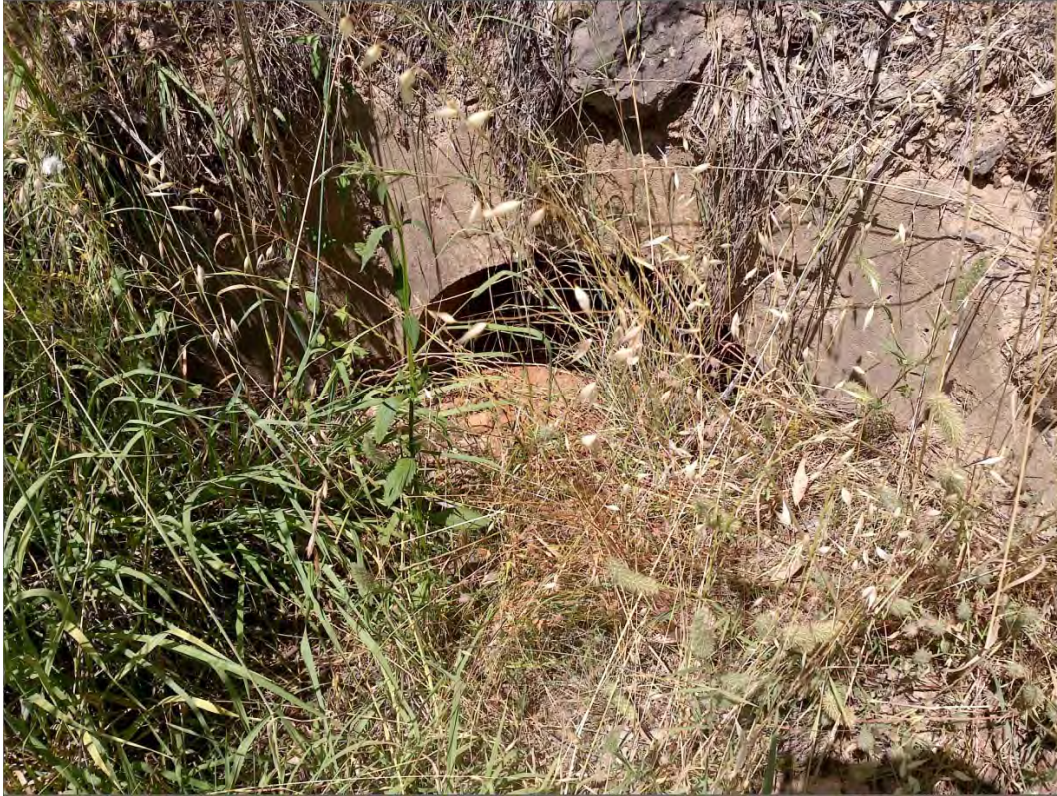
S121 - 600mm Pipe Culvert

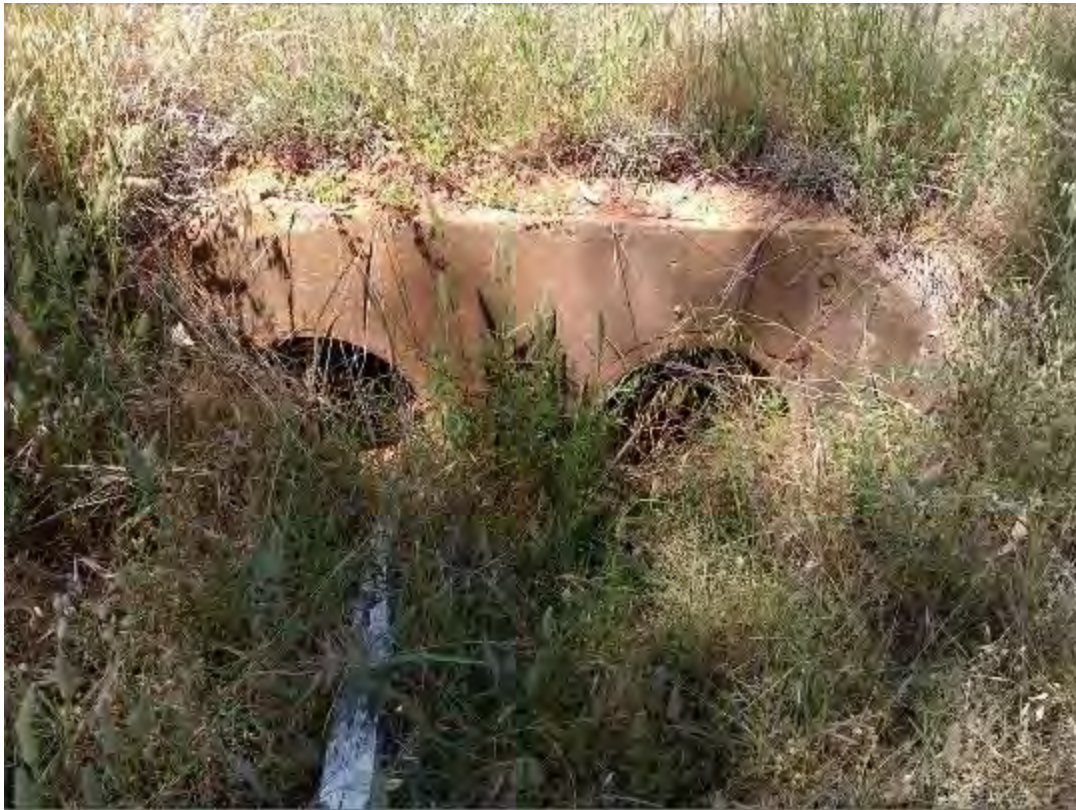
**S122 - Vinegaroy Rd - 1300m North of Rotherwood Intersection**  
Dual 450mm Pipe Culvert  
Fair Condition and Serviceable

S122 – Dual 450mm Pipe Culvert
