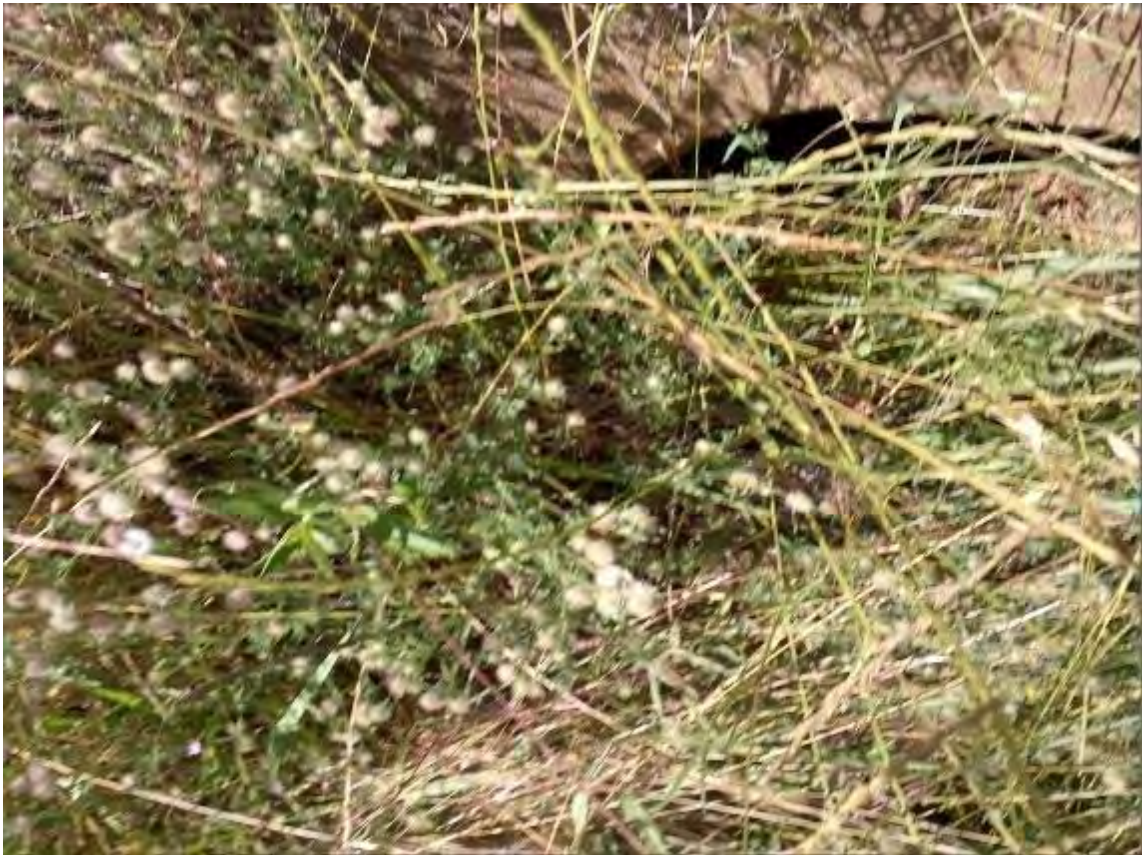
Blocked at time of inspection

Moderate Condition and Serviceable, maintenance required.

S125 –450mm blocked pipe culvert

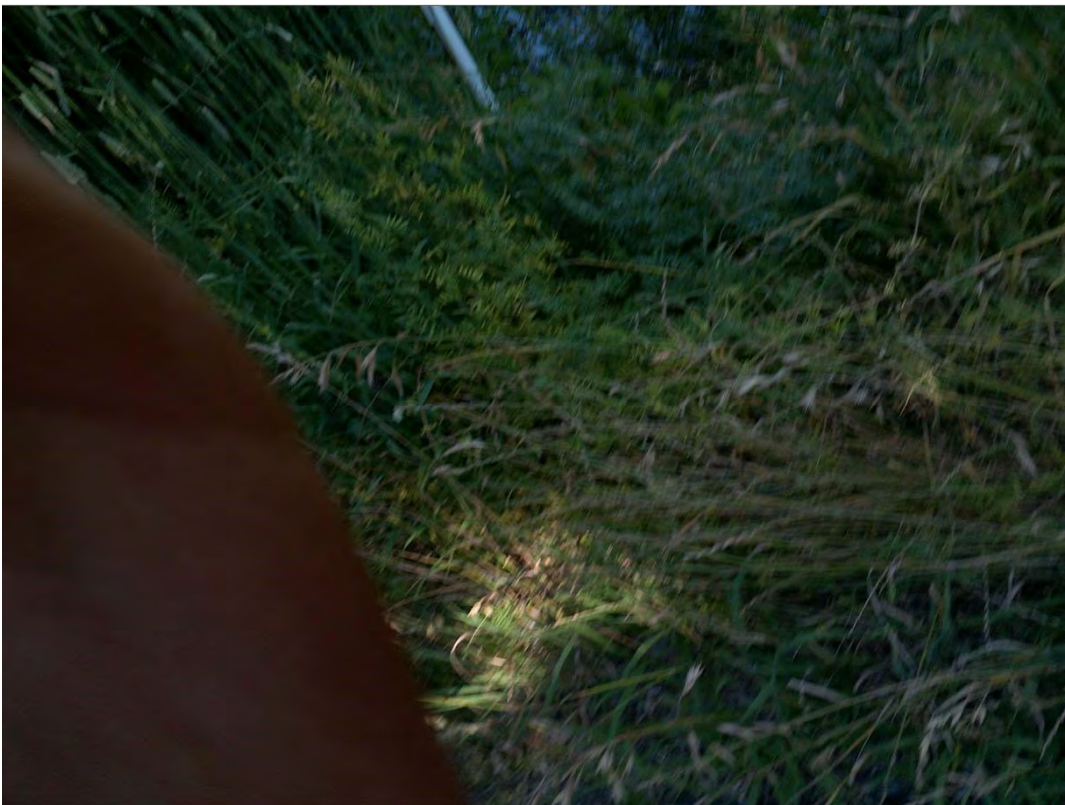
**S126 – Turee Vale Rd - 600m North of Vinegaroy Rd Intersection**  
Culvert of unknown Dimensions  
Unknown Condition

S126 – Hidden Culvert

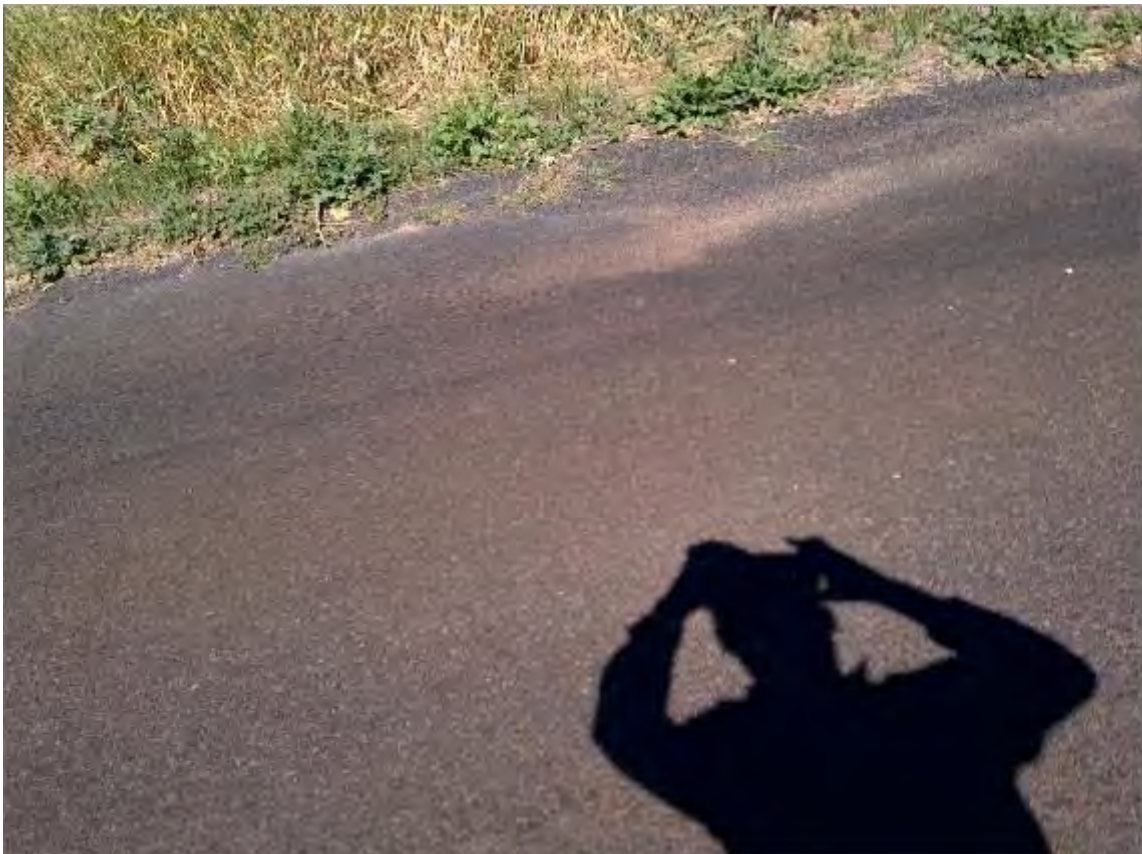
S127 – Pothole on Road Caused by Rutting

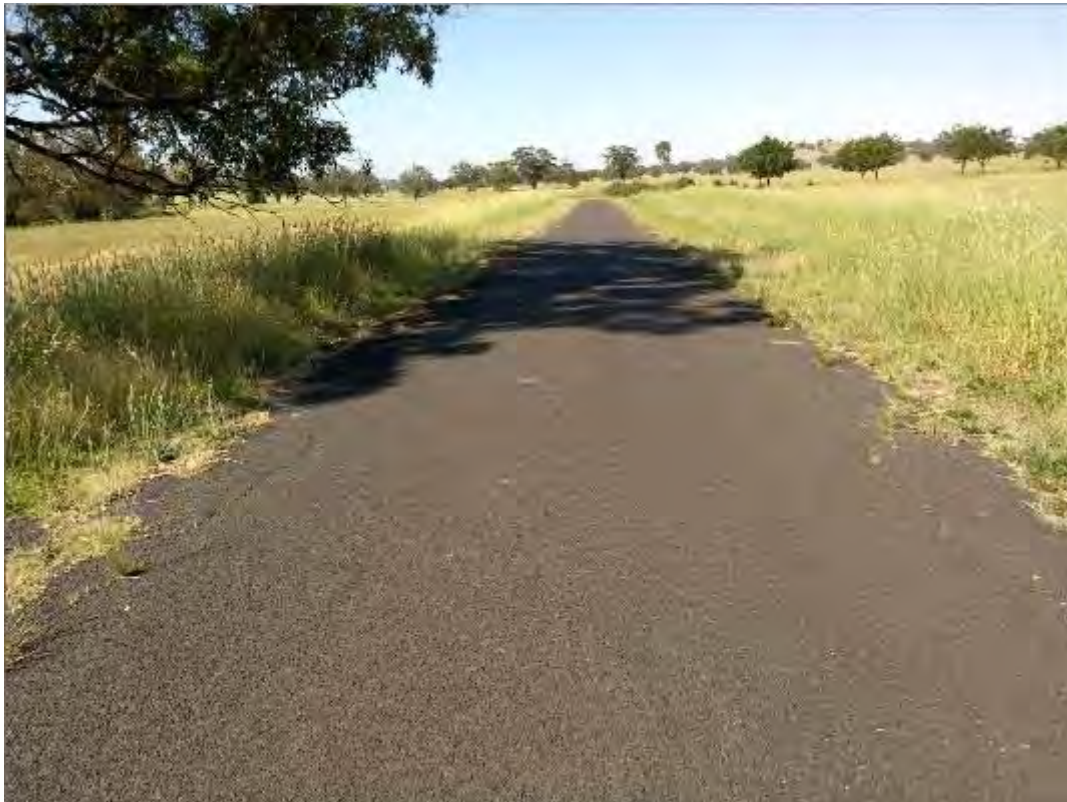
**S128 – View to North**

**S128 – Turee Vale Rd - 1500m North of Vinegaroy Rd Intersection**  
Pipe Culvert of Unknown Dimensions  
Unknown Condition

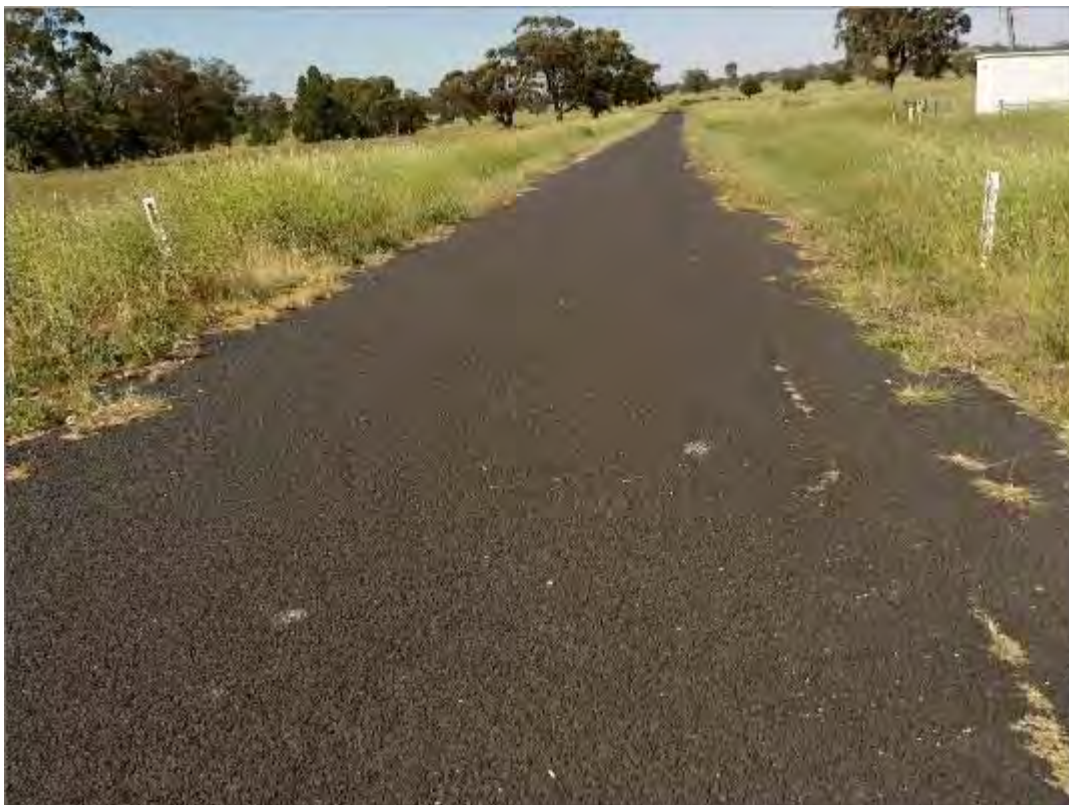
S129 – View to South

**S129 - Turee Vale Rd - 1700m North of Vinegaroy Rd Intersection**  
Pipe Culvert of Unknown Dimensions  
Unknown Condition

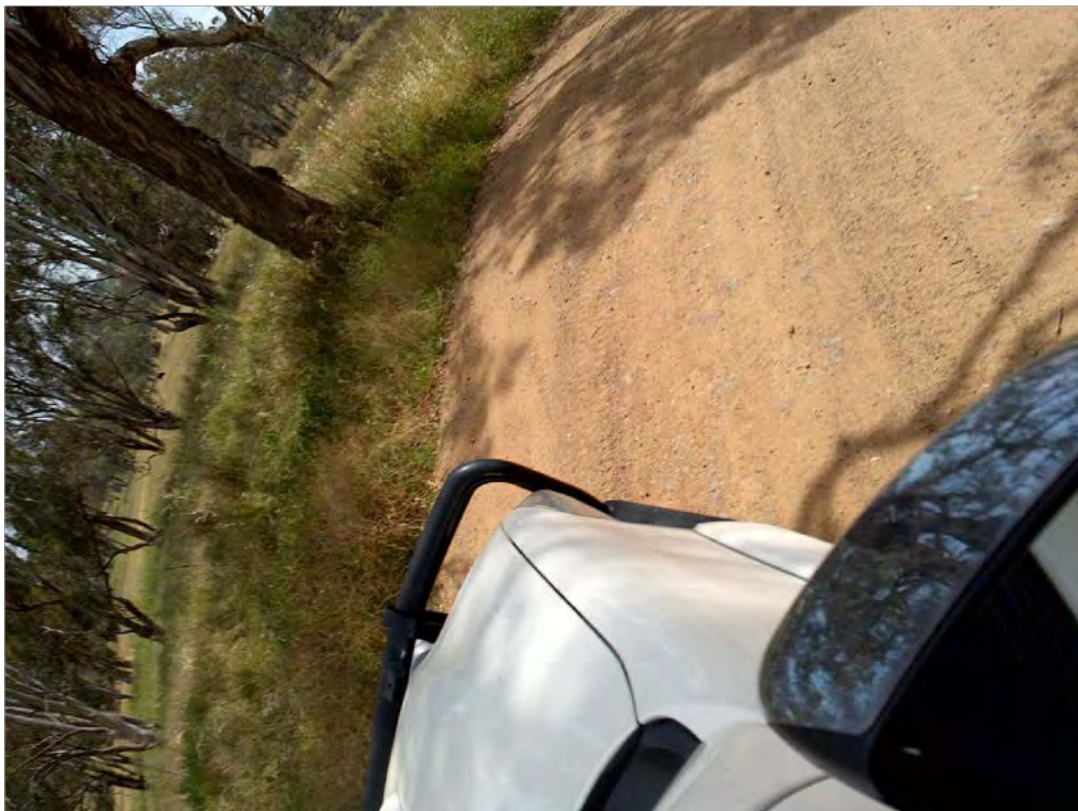
S134 – View to West

Pipe culvert is required at this location as water is evidently washing over the road
