S136 – Turee Vale Rd - 3200m North of Vinegaroy Intersection
450mm Pipe Culvert
Fair Condition and Serviceable

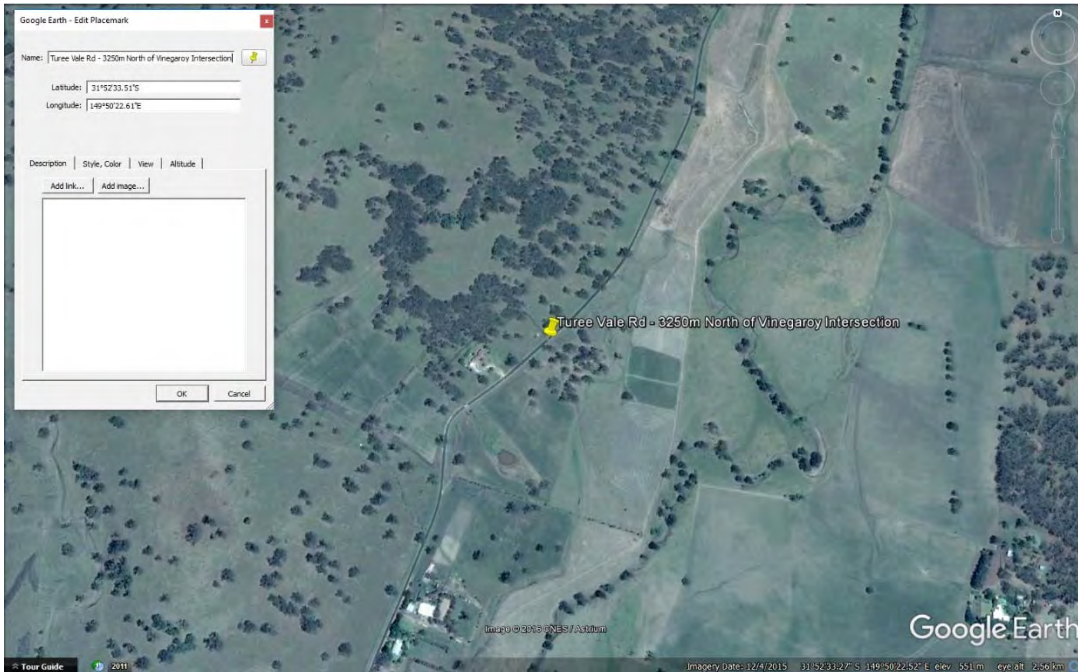
S137 - Turee Vale Rd - 3250m North of Vinegaroy Intersection
Pipe Culvert of Unknown Dimensions
Unknown Condition

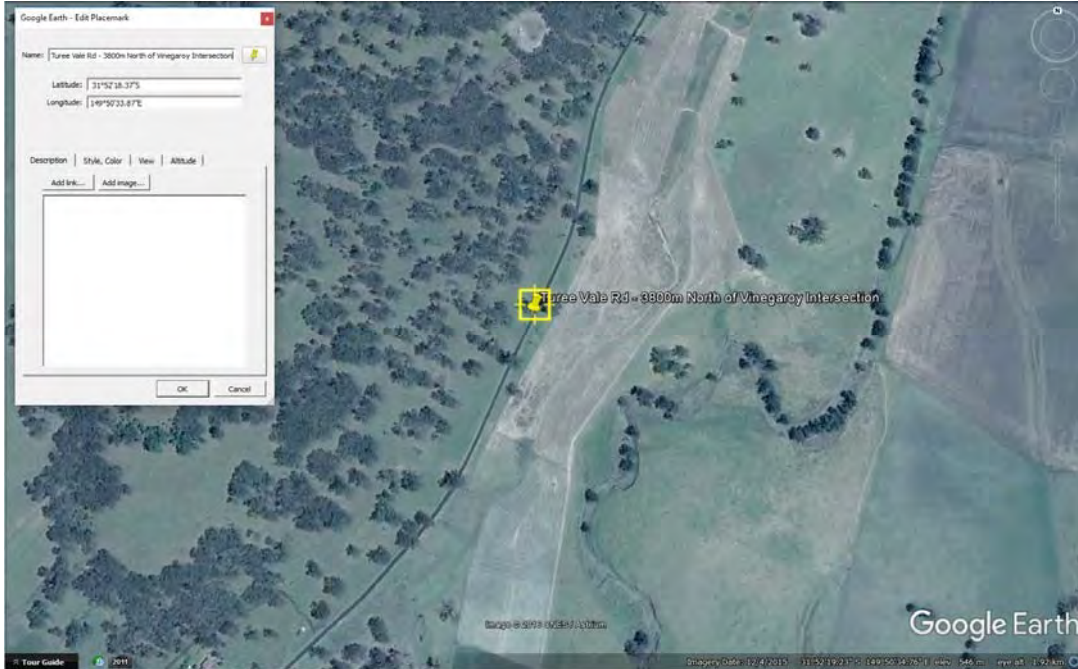
S140 – Turee Vale Rd - 3800m North of Vinegaroy Intersection

375mm Pipe Culvert,

Cracked headwall may not last through life of project

Poor Condition and serviceable

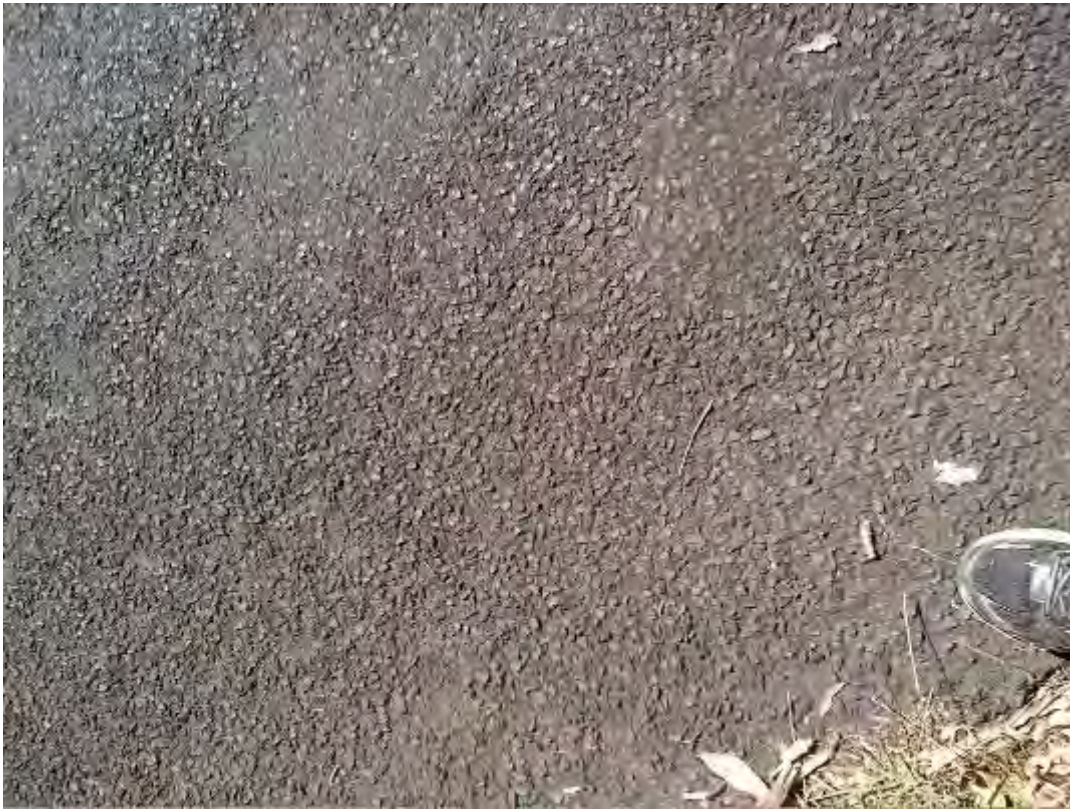
S141 – Turee Vale Rd - 3800m North of Vinegaroy Intersection
1200mm-450mm Reinforced Concrete Box Culvert
Moderate Condition and Serviceable

S141 - Parts of the Surface has been polished

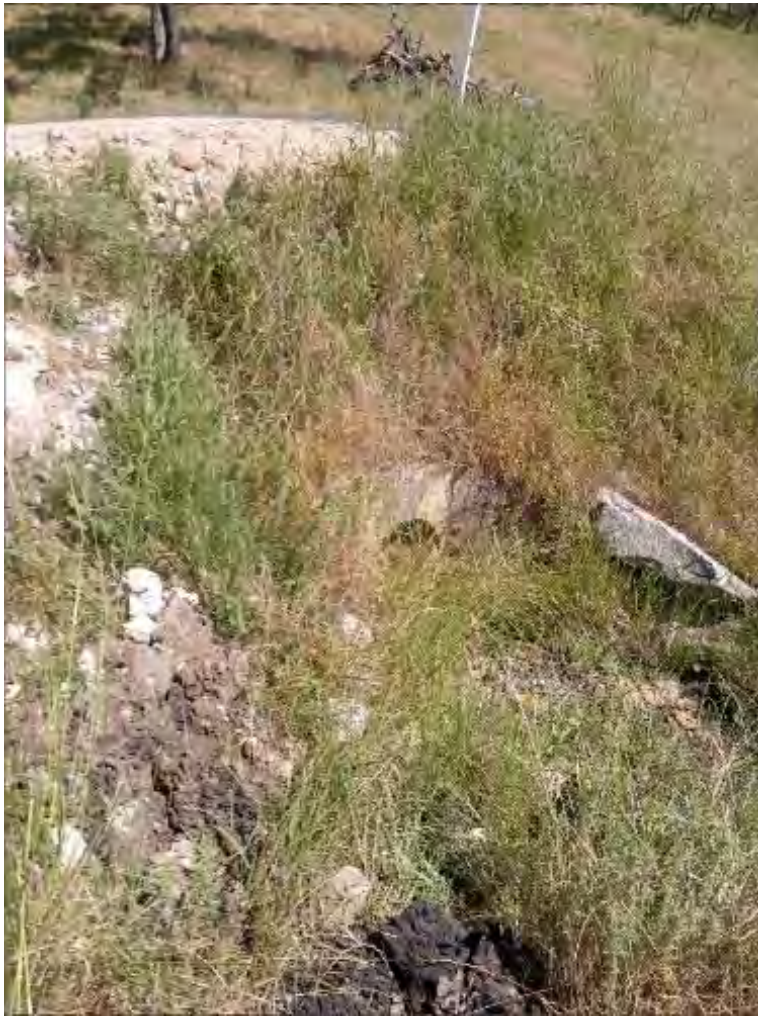
S142 - 450mm Pipe Culvert

S142 – Turee Vale Rd - 4100m North of Vinegaroy Intersection
450mm Pipe Culvert
Fair Condition and Serviceable

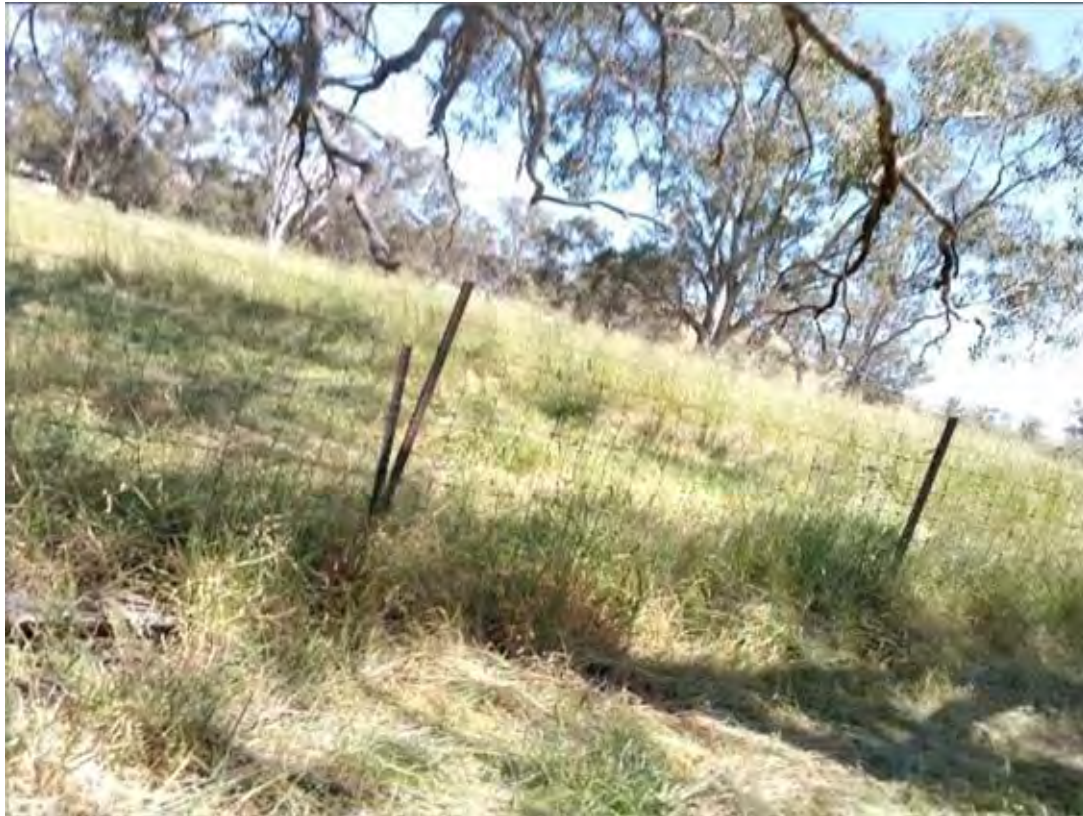
S145a – View towards 525mm Pipe Culvert

Location is of Poor Condition, Will require upgrade otherwise it will further degrade over the course of the project

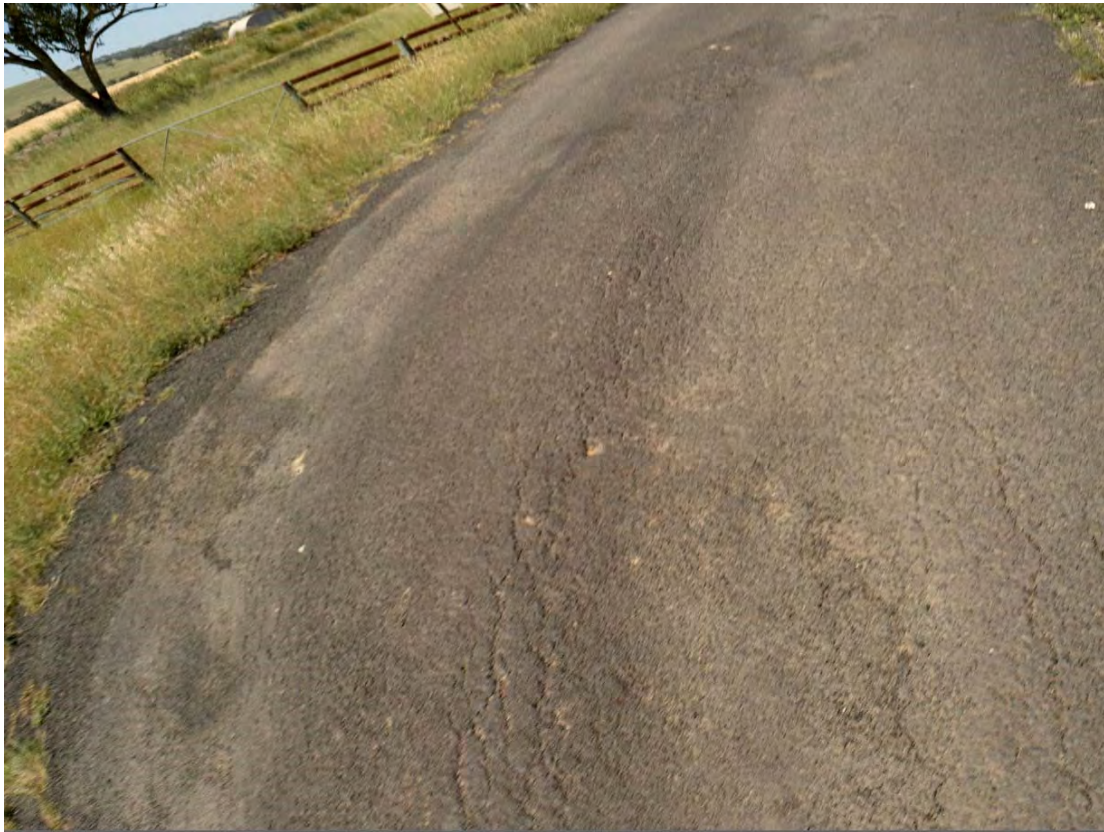
S146 – Road showing Cracking/Ravelling

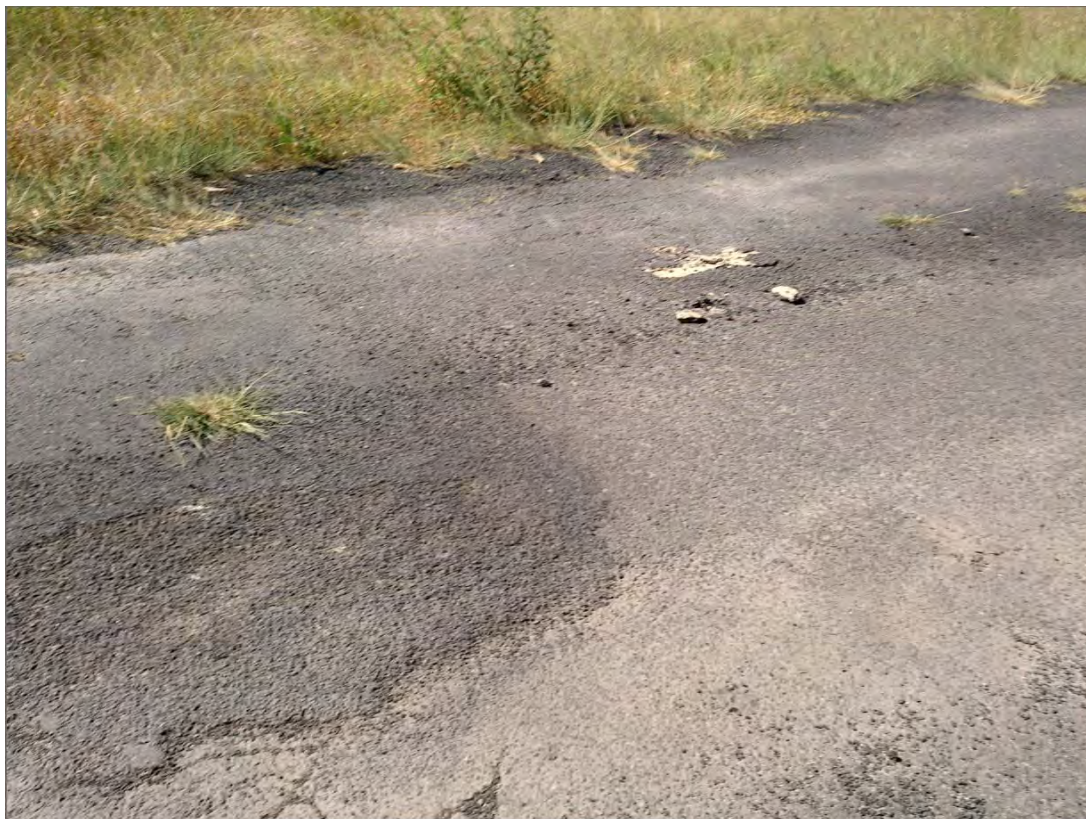
S147 – Road in sub-par condition

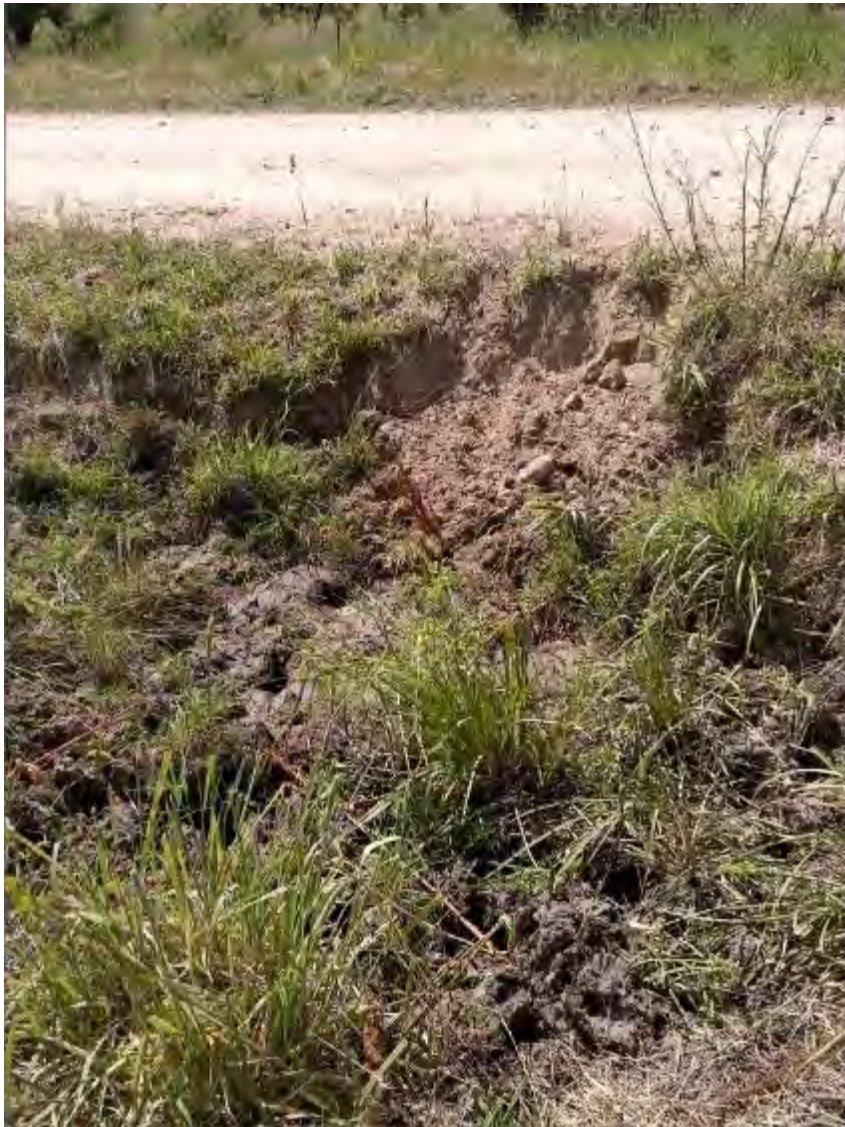
Blocked,

S151 – Blocked Pipe Culvert

Will require Upgrade or maintenance

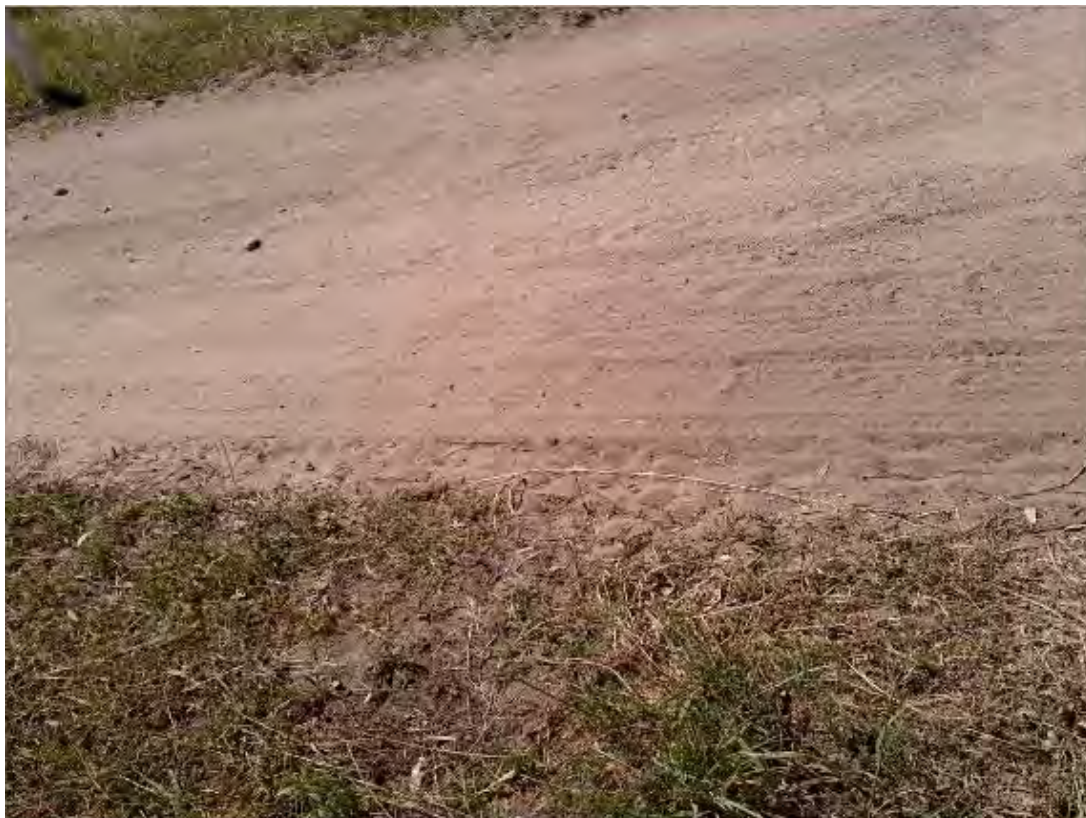
Poor Condition and Serviceable,

S154 – View of Causeway, Water damage shown on close side

Upgrade likely to be required.

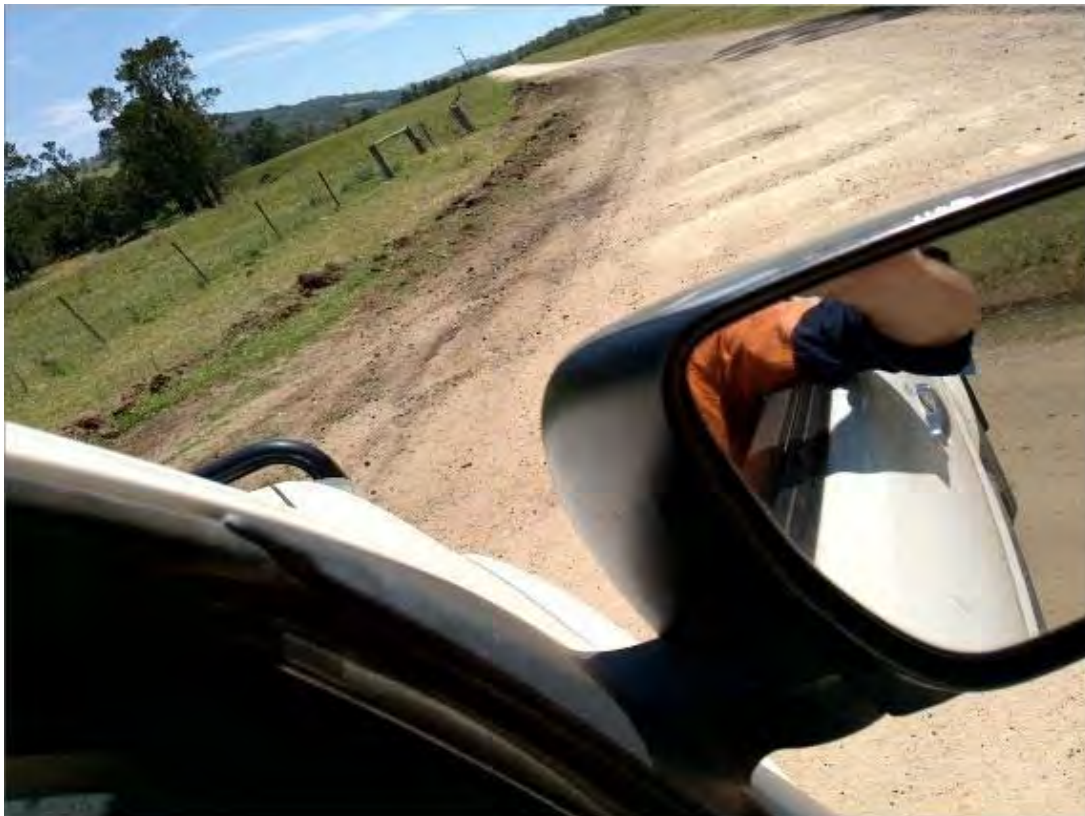
S158 – View to North

S158 - Turee Vale Road - 6450m South of Coolah Creek Rd - State Forest Rd
Causeway, A Culvert will be needed for this location
Poor Condition and Serviceable

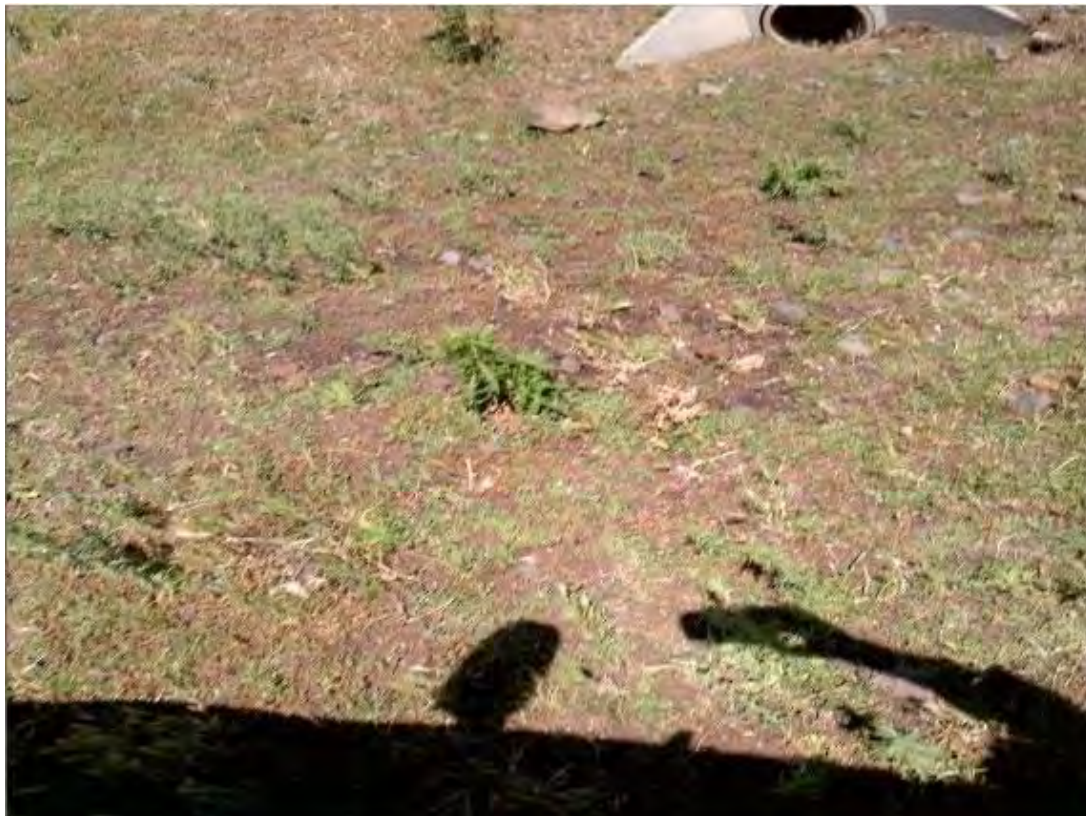
S159 – 450mm Pipe Culvert

S159 – Turee Vale Road - 6450m South of Coolah Creek Rd - State Forest Rd
Causeway, 450mm Pipe Culvert
Excellent Condition and Service

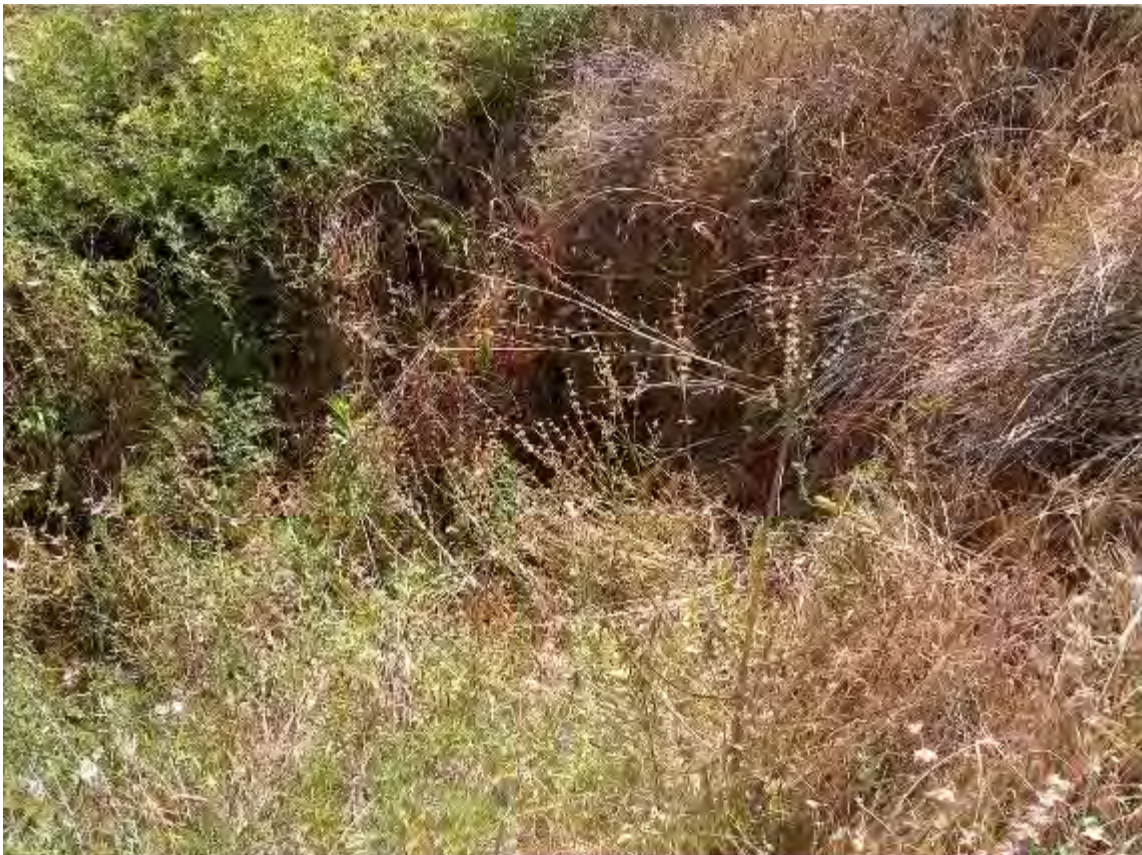
S162- View to Culvert

Culvert inaccessible at time of inspection,

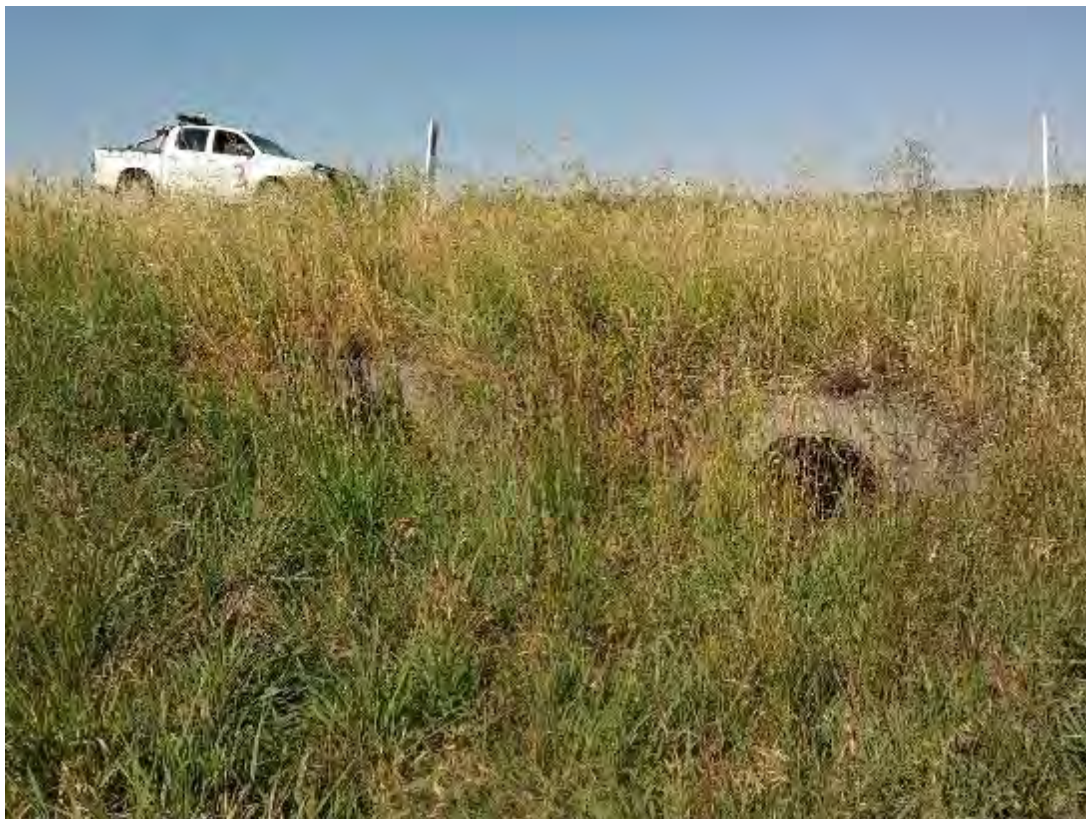
S164 – Dual 600m Pipe Culvert

S164 – Vinegaroy Rd - 4050m North of Coolah Rd Intersection
Dual 600mm Pipe Culvert
Good Condition and Serviceable

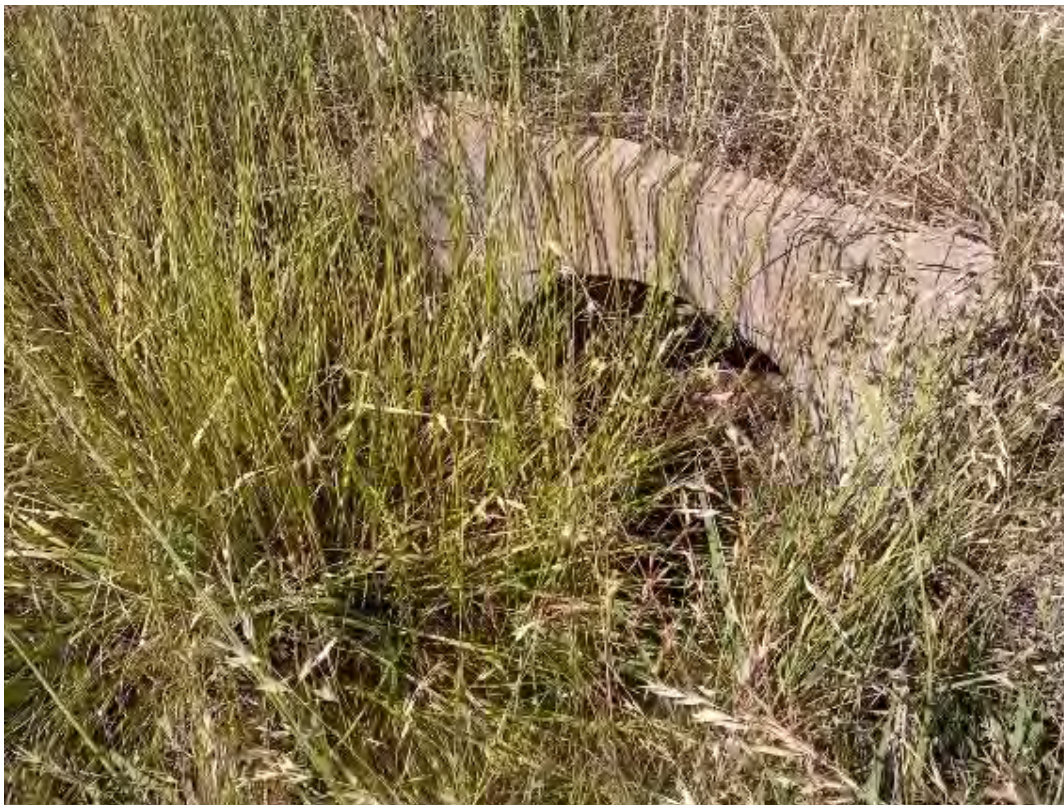
S166 - 750mm Pipe Culvert

S166 – Vinegaroy Rd - 1700m North of Coolah Rd Intersection
750mm Pipe Culvert
Good Condition and Serviceable

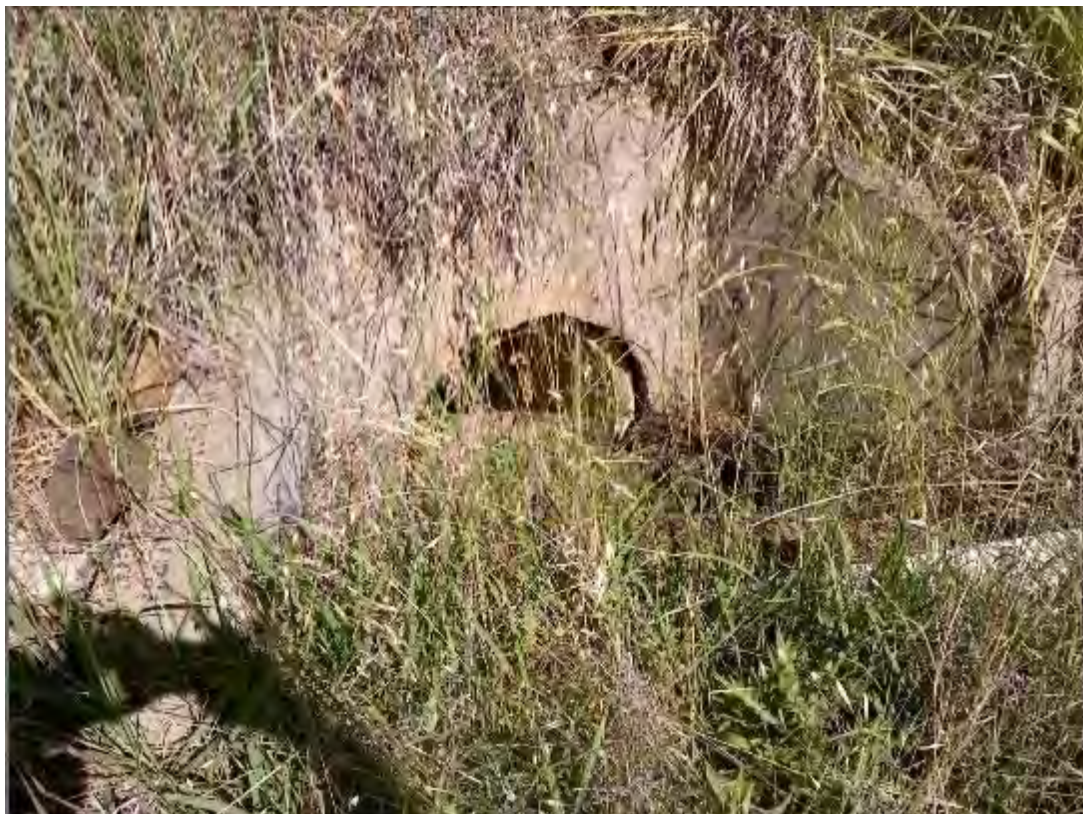
S170 - 600mm Pipe Culvert

S170 – Vinegaroy Rd - 1100m North of Coolah Rd Intersection
600mm Pipe Culvert
Fair Condition and Serviceable

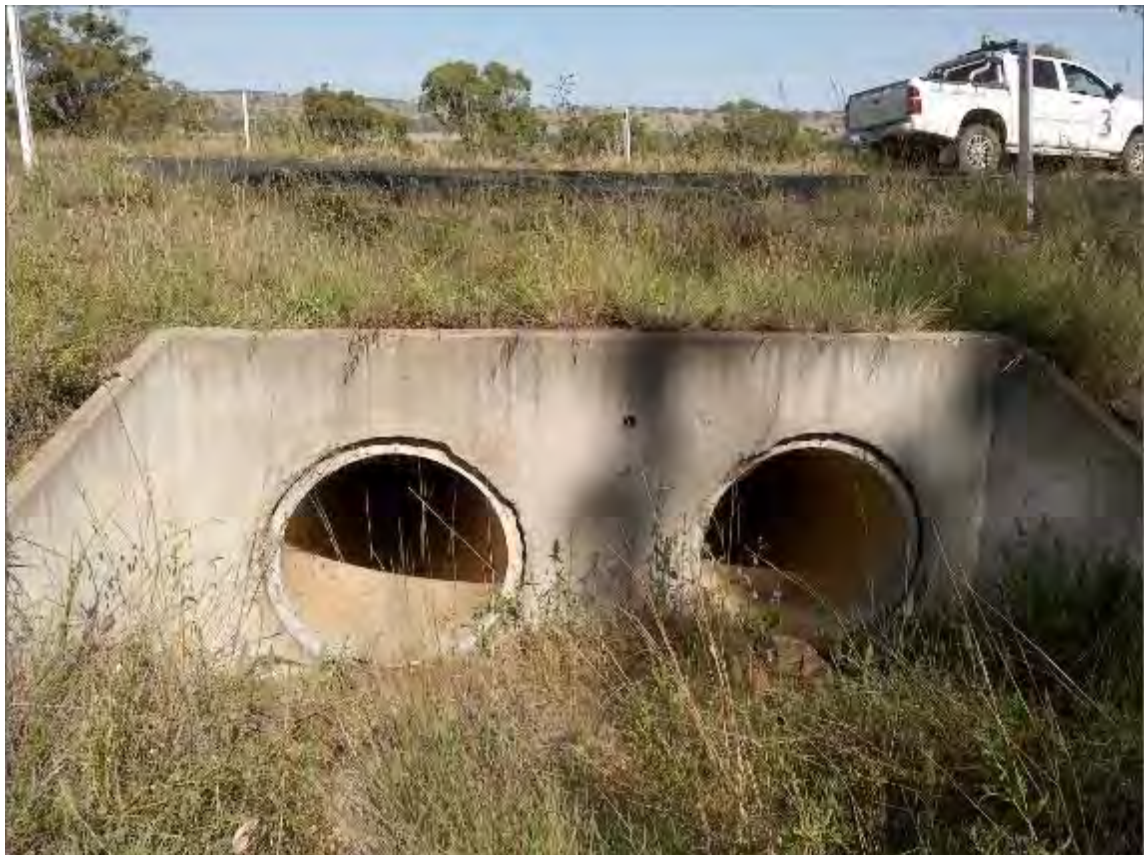
S171 – Dual 750mm Pipe Culvert

S171 – Vinegaroy Rd - 1000m North of Coolah Rd Intersection
Dual 750mm Pipe Culvert
Excellent Condition and Serviceable

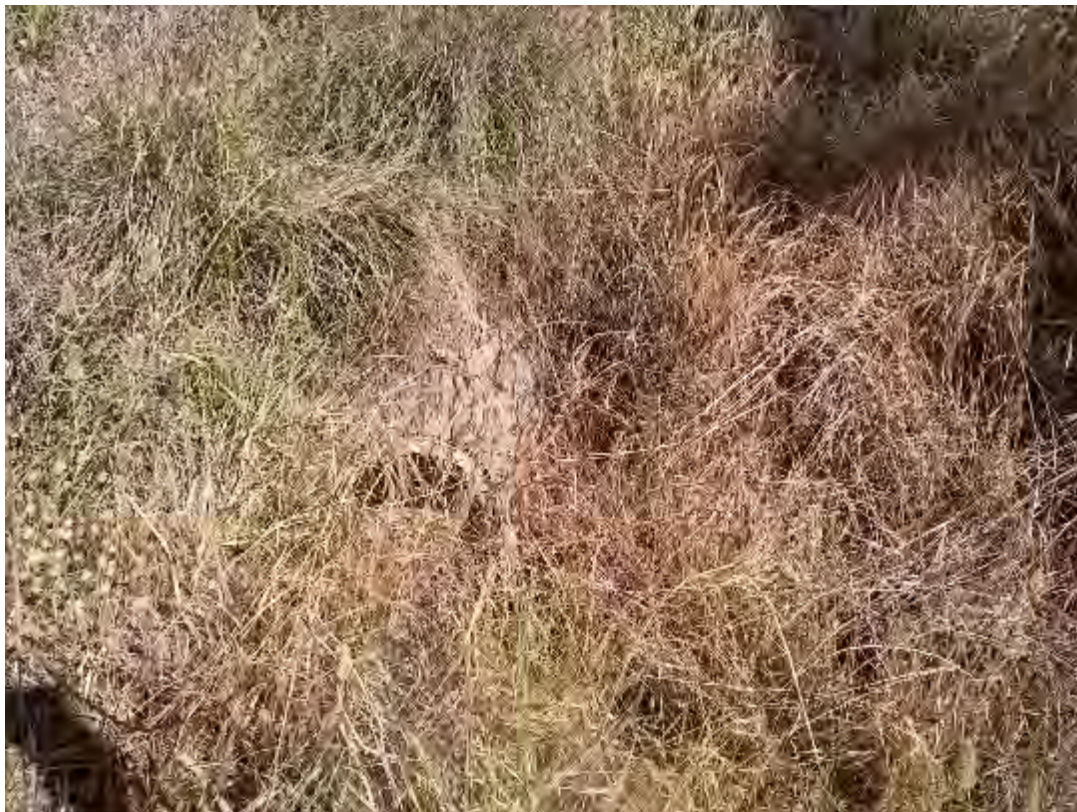
S172 – 600mm Pipe Culvert

S172 – Vinegaroy Rd - 800m North of Coolah Rd Intersection
600mm Pipe Culvert
Fair Condition and Serviceable

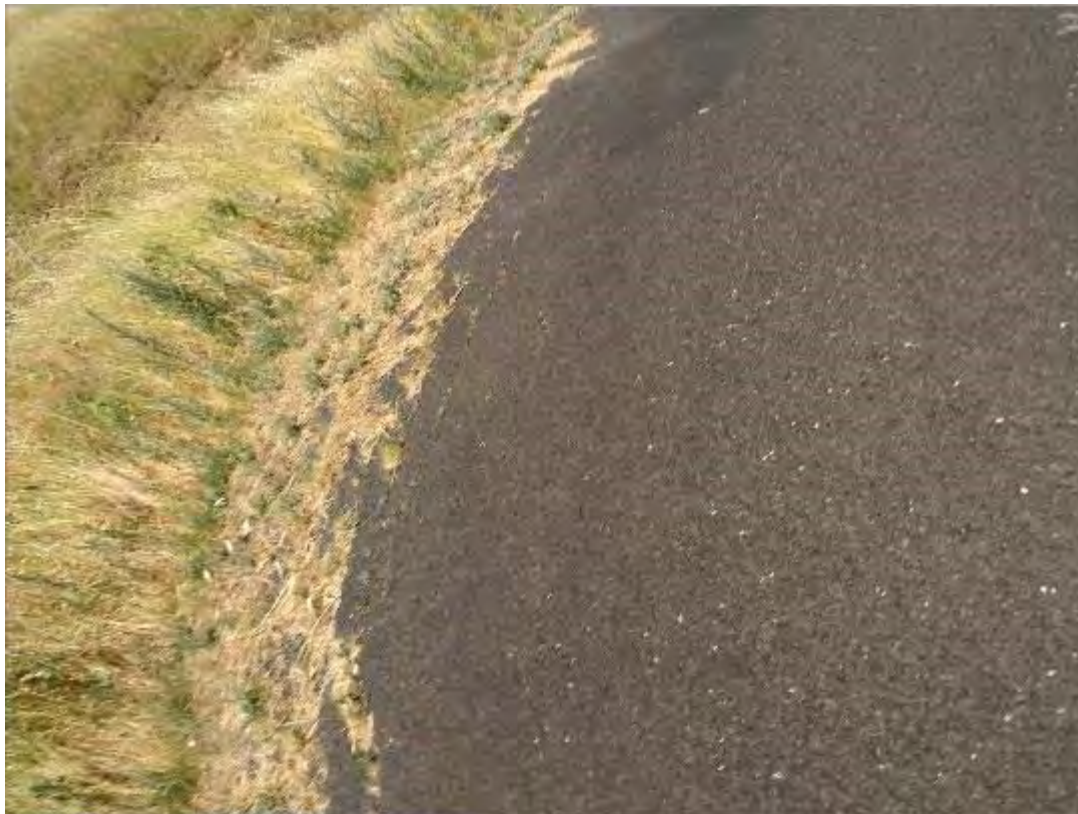
S181 – Water damage on Road

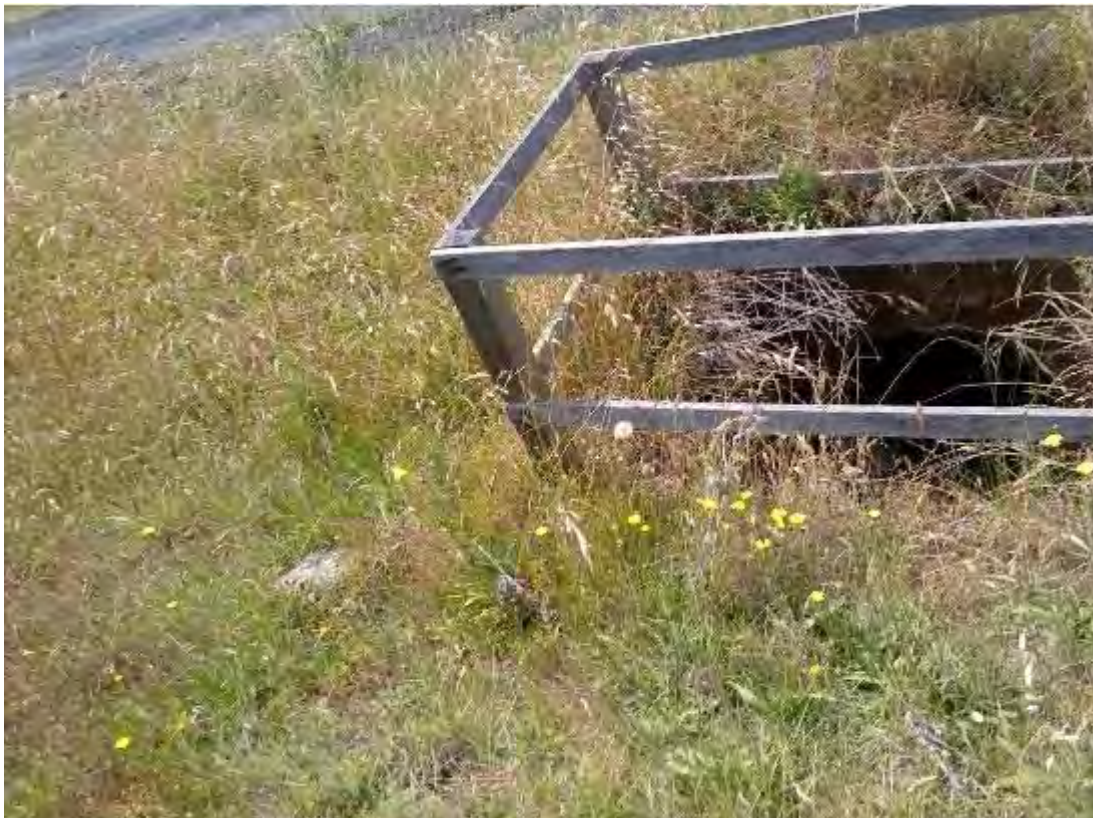
S184 – 750mm Pipe Culvert

S184 – Rotherwood Rd - 2250m East of Vinegaroy Rd Intersection
750mm Pipe Culvert
Fair Condition and Serviceable

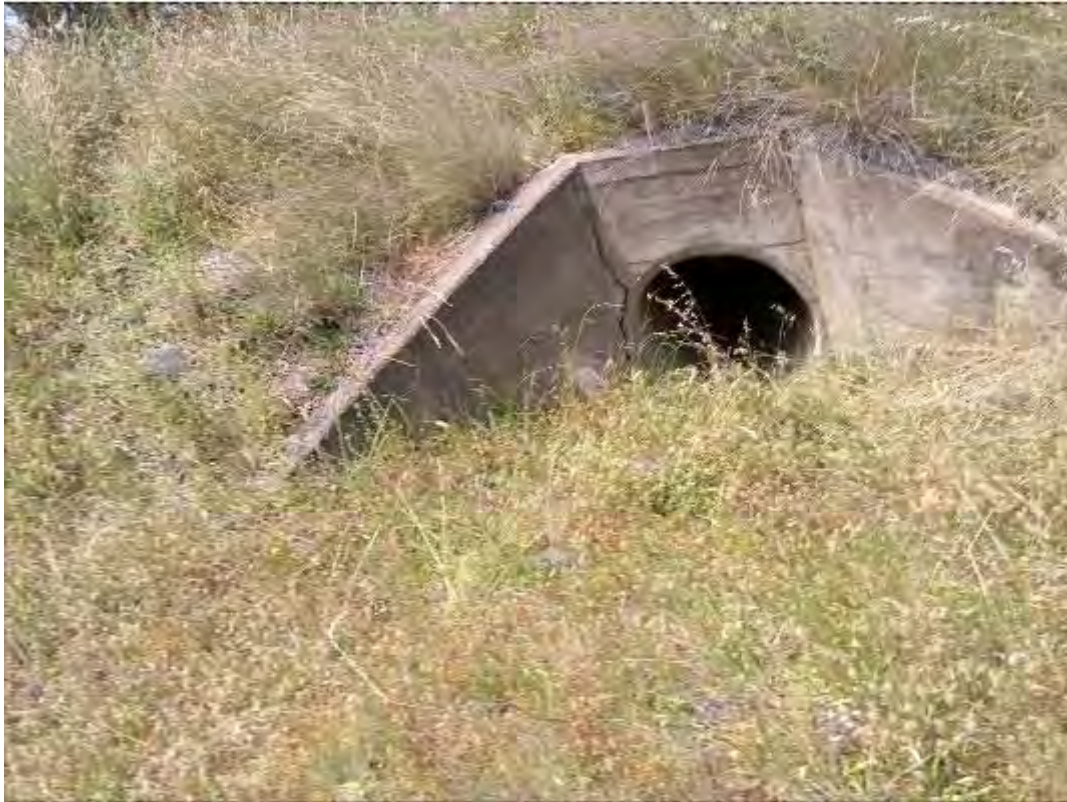
S186 – Rotherwood Rd - 2400m East of Vinegaroy Intersection
750mm Pipe Culvert with cracked headwall
Moderate Condition and Serviceable

S186 - 750mm Pipe Culvert with cracked headwall

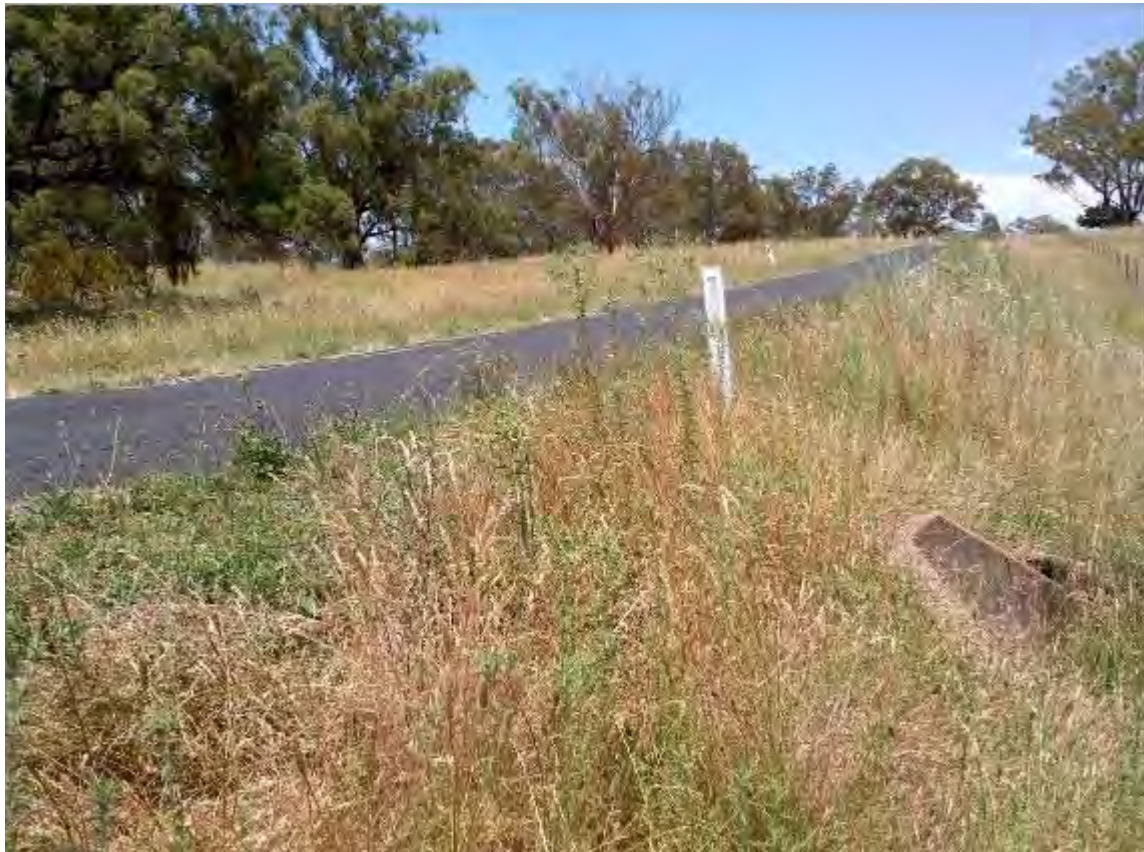
S187 - 750mm Pipe Culvert

S187 - Rotherwood Rd - 2900m East of Vinegory Intersection
Approximately 750mm Pipe Culvert
Fair Condition and Serviceable

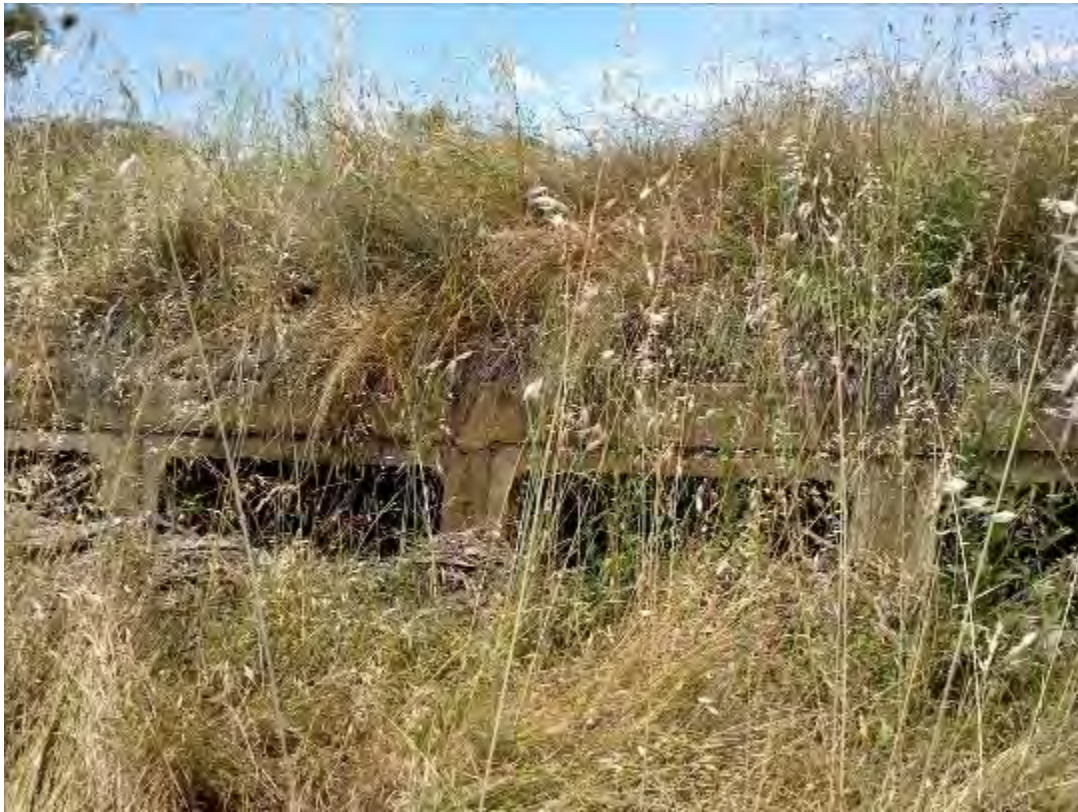
S190 - 4-1200mm-900mm Reinforced Concrete Box Culvert

S190 – Rotherwood Rd - 3700m East of Vinegaroy Intersection
4-1200mm-900mm Reinforced Concrete Box Culvert

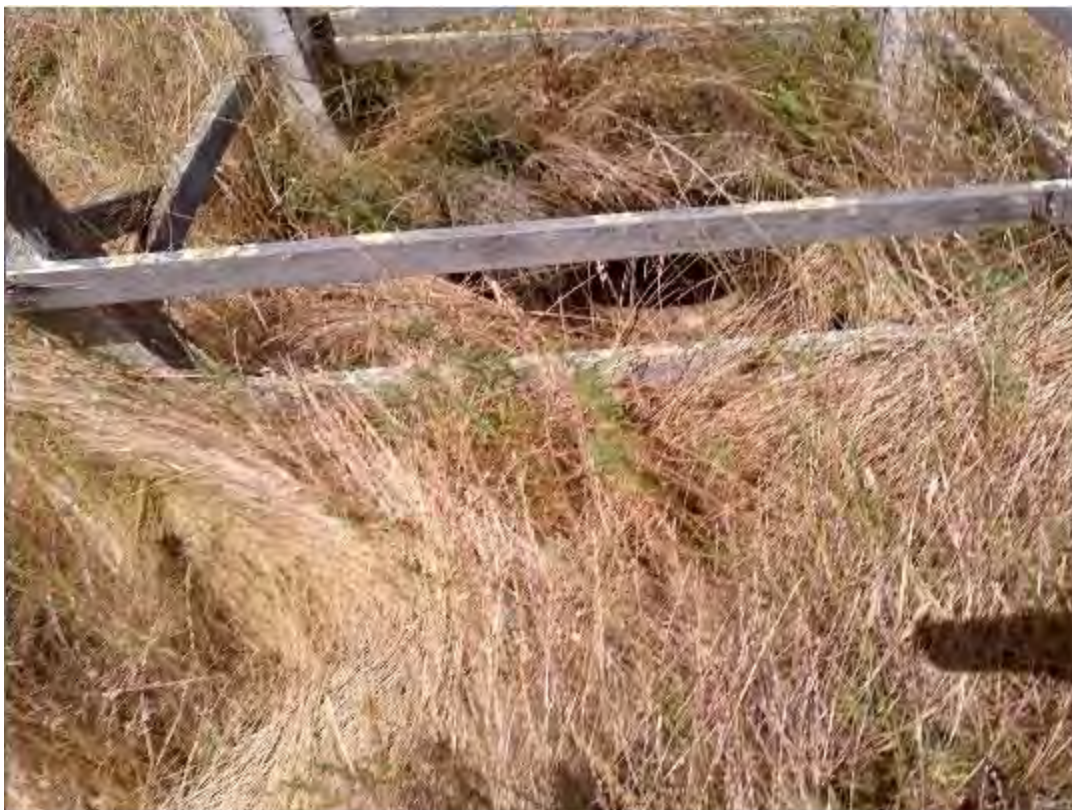
S191 - 450mm Pipe Culvert

S191 – Rotherwood Rd - 3900m East of Vinegaroy Intersection
450mm Pipe Culvert
Fair Condition and Serviceable

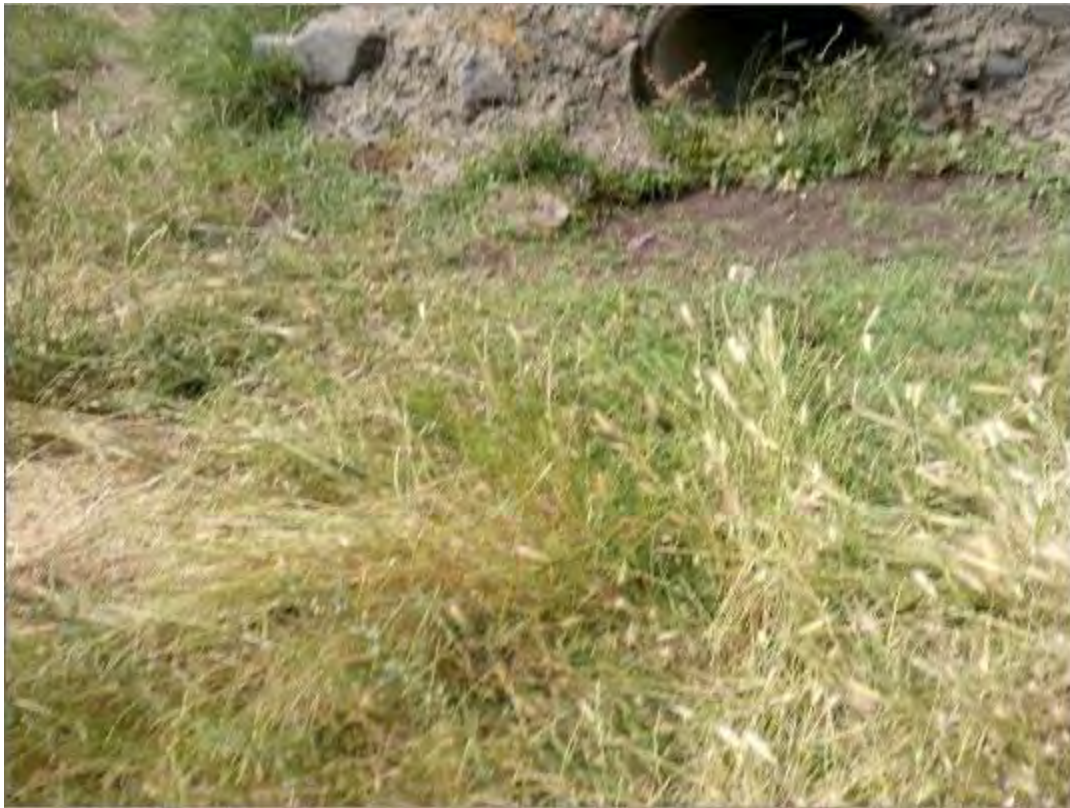
S193a - 675mm Pipe Culvert

S193a – Rotherwood Rd - 3400m West of Yarrowonga Rd
675mm Pipe Culvert
Good Condition and Serviceable

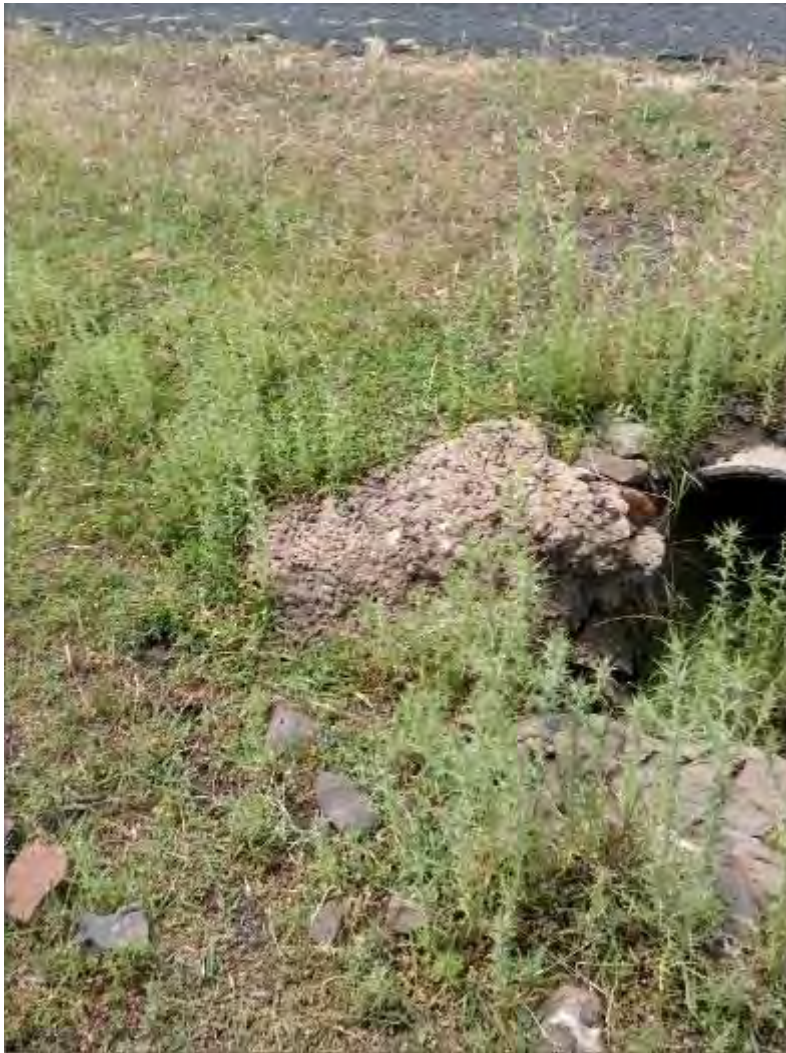
S195 – 600mm Pipe Culvert

S195 – Rotherwood Rd - 2200m West of Yarrawonga Rd
600mm Pipe Culvert
Fair Condition and Serviceable
