3 November, 2015

Our Reference: 0295776 PROJECT MODIFICATION HERITAGE SURVEY\_FINAL.DOCX

RE: HERITAGE SURVEY FOR MODIFICATION AREAS - WHITE  
ROCK WIND FARM

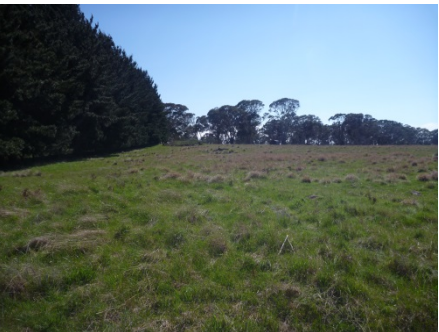
Survey Unit	Landform	Description	Photograph
1	Gentle Slopes	Survey Unit 1 traverses proposed modification to access track from Kelleys Road to turbine 109 along western boundary of property and then to turbines 110 and 111 and towards 112 and 113. Comprises grazing paddocks with disturbance evident through ploughing, collection and stockpiling of basalt boulders, access tracks and farm dams, planting of pine tree shelter belts and various other farming activities. Generally a very poor level of ground surface visibility but some visibility within exposures along fences and access tracks, near farm dams and in areas of soil erosion. Scattered trees are present in some locations.

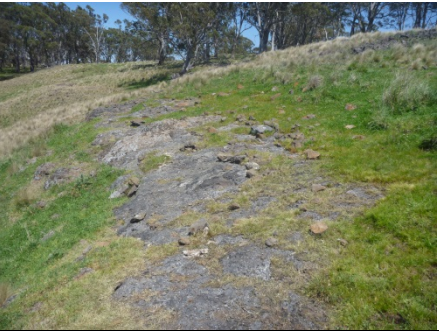
2	Slopes	Survey Unit 2 traverses area adjacent to Kelleys road where construction facilities are proposed and for a modified track route to the north on moderately inclining slopes south of turbine 83. Comprises grazing paddocks with disturbance evidence through ploughing, construction of dams and fences and other farming activities. Some basalt outcropping present on slopes south of turbine 83. Generally a very poor level of ground surface visibility but some visibility within exposures around dams and on access tracks. In some places rock outcrops have no soil cover.

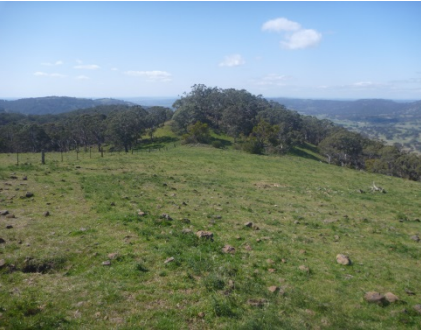
Survey Unit	Landform	Description	Photograph
3	Slopes	<p>Survey Unit 3 traverses existing vehicle track within moderately inclining upper and mid slope landforms at turbine between turbines 76 and 79. Some ground surface visibility is available along an existing vehicle access track and within proximity to fence lines in areas of soil erosion. Disturbance was observed from farming activities such as clearance of woodland vegetation and the development of vehicle tracks and fences.</p>

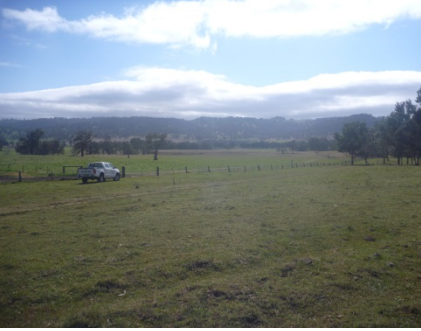
4	Gentle slopes	<p>Survey Unit 4 traverses site options for proposed ancillary facilities and access track options north east of turbine 51 close to the potential site entry points from Ilparran Road. Areas assessed included:</p> <ul style="list-style-type: none"> <li>• A northern access route option (Cameron property) had not previously been surveyed and is outside the current project boundary. A Modification Approval is required for this route to form part of the WRWF Stage 1 project. This survey provides the assessment of that option</li> <li>• Two options for a Construction Compound were surveyed on the Dulhunty property <ul style="list-style-type: none"> <li>• One between a farm dam and shed near property entrance</li> <li>• Second further to the west</li> </ul> </li> <li>• a single laydown area was surveyed on the Dulhunty property.</li> </ul> <p>The landform is comprised of gentle slopes within a wider rolling hills landscape. Some scattered trees are present around the proposed facility location. Disturbance was observed due to land clearance, the installation of fences, stockyards, farm dams, sheds, contour drains and vehicle access tracks as well as other farming activities. Some ground surface visibility was present along the existing vehicle access track and in watercourses and a farm dam.</p> <p>One stone artefact (ERM WR01) was identified adjacent to the track on Cameron Property. No other artefacts or areas of archaeological sensitivity were identified.</p> <p>A map of the assessed area for Survey Unit 4 is included in <i>Figure 1</i> following this table.</p>

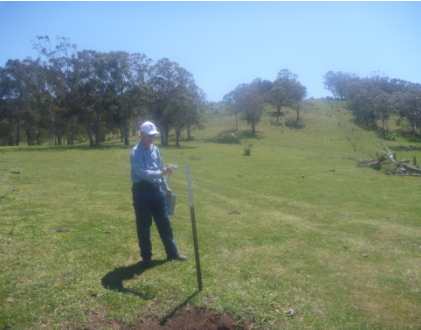
Survey Unit	Landform	Description	Photograph
5	Slopes	Survey Unit 5 traverses proposed access tracks around turbines 28 to 29 and from turbine 28 to 30. This Survey Unit traverses upper, middle and lower slopes within a wider rolling hills landscape. Some scattered trees are present. The area has been disturbed by land clearance, access tracks, ploughing and other farming activities. Some areas of erosion of an existing farm access track were evident on steep slope between T28 and T30.

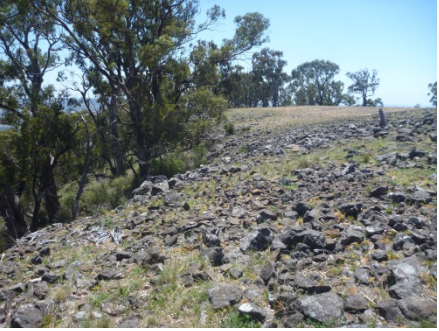
6	Upper Slope	Survey Unit 6 traverses area around turbine 19 comprised of a bench area on an upper slope landform. Extensive basalt outcropping was observed in this area. Ground surface visibility was generally poor away from areas of rock outcrop. Disturbance in this area was observed including land clearance and other farming activities.

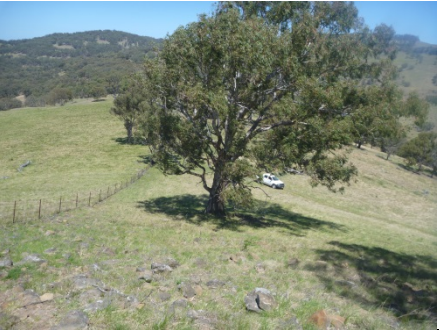
7	Slope	Survey Unit 7 traverses moderately inclining slope (proposed landowner access track) at turbine 9. It represents the farmer's preferred access route between Turbine s 9 and 10. Ground surface visibility was generally poor. Disturbance in this area was observed including land clearance and other farming activities.

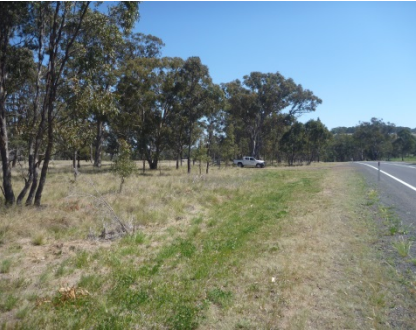
Survey Unit	Landform	Description	Photograph
8	Gentle Slopes	<p data-bbox="483 300 1491 400">Survey Unit 8 traverses gentle slopes south of Gwydir Highway – the proposed location of facilities and the proposed site entrance at the Gwydir Highway. Locations surveyed included:</p> <ul data-bbox="577 424 1491 600" style="list-style-type: none"> <li data-bbox="577 424 1099 448">• a modified O&amp;M Facilities Building location</li> <li data-bbox="577 461 1429 485">• Areas adjacent access track for Gwydir Highway to northern site office area</li> <li data-bbox="577 497 1491 600">• Roadside area of Gwydir Highway in the vicinity of the Site Entrance and particularly to the east where some road upgrades to provide a turning lane may be undertaken.</li> </ul> <p data-bbox="483 624 1491 764">A creek was identified within proximity to the location of the proposed facilities. Some soil exposures were present along the creek and examined. The area proposed for the site entrance comprises a very highly disturbed road corridor area with very poor ground surface visibility due to dense grass coverage. No areas of archaeological sensitivity were identified.</p>

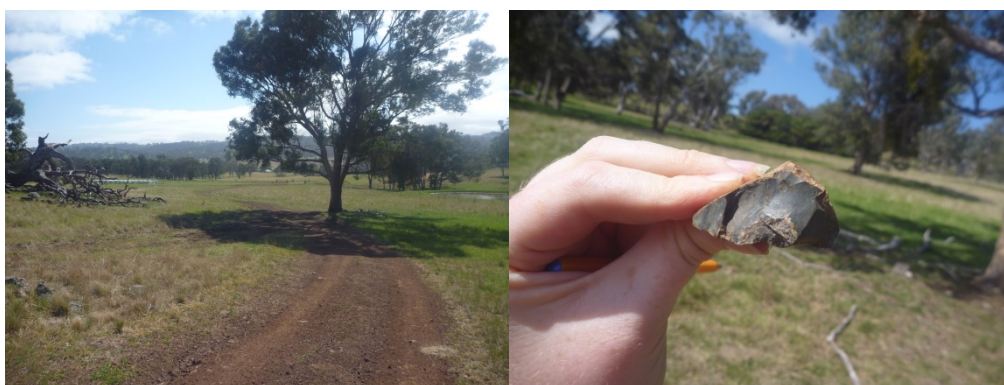
The field survey identified one new Aboriginal heritage site (refer to *Photograph 1* and *Annex B*). No historic heritage sites or areas of archaeological sensitivity were identified. The new site, ERM WR01 is described below with completed site card attached in *Annex C*:

Location (GDA94 MGA Zone 56): Easting 362631 Northing: 6704300

ERM WR01 consists of one grey silcrete core artefact. Three flake scars and overhang removal were present on the artefact. The artefact was identified adjacent to a vehicle access track within an area of soil erosion under a tree. The surrounding area comprises a paddock with dense grass coverage. No other artefacts were found within the area. Soils at this location comprise highly disturbed (ploughed) medium brown loose silt. The area has been disturbed by land clearance and farming activities.

*Photograph 1 View towards ERM WR01 (left) and detail of artefact found at ERM WR01 (right) (ERM 2015).*

- the newly recorded site ERM WR01 should be avoided;
- a fence with a 30m buffer should be established around ERM WR01 during construction works to ensure its protection;

- the landowner should be informed of the location and nature of the newly recorded site, ERM WR01; and
- if the Project Approval is modified in respect of the proposed layout modifications that have been assessed in this report, then the Stage 1 Construction Heritage Management Plan is to be updated to reflect the changes and the additional recorded site ERM WR01.
