**S198 – Rotherwood Rd - 1600m West of Yarrawonga Rd**  
A Culvert is required for this location

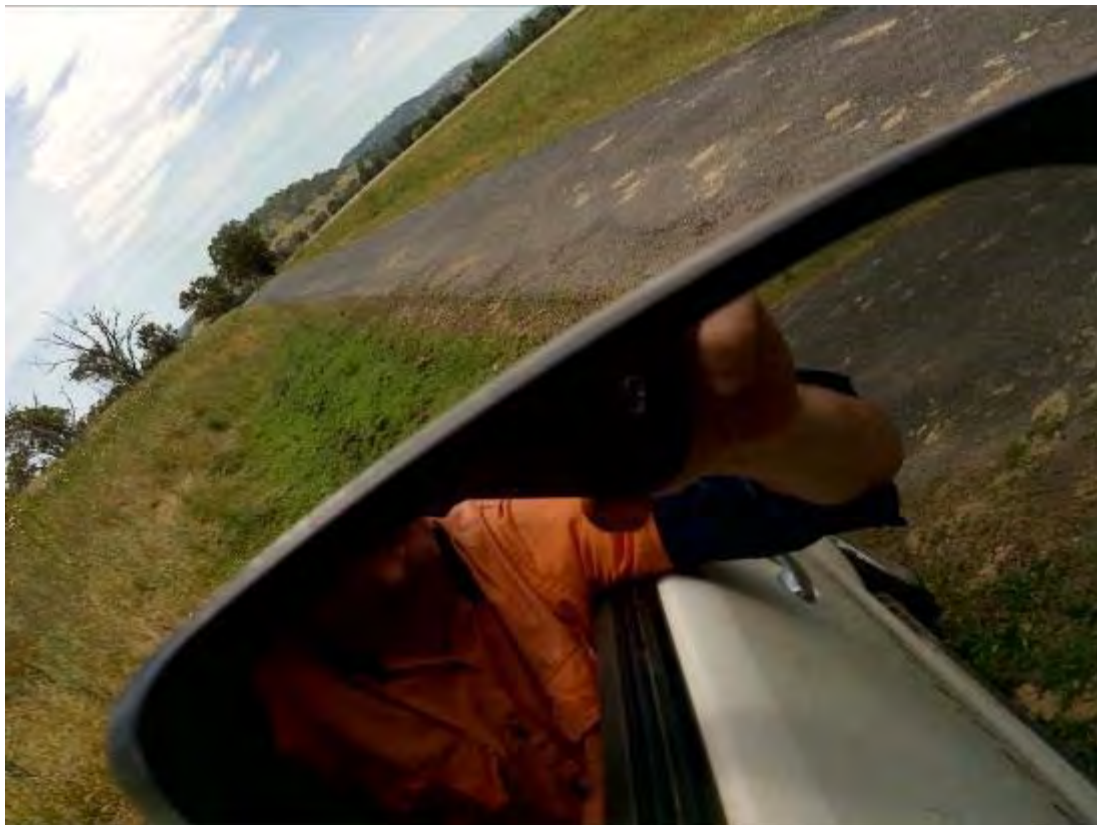
S198 – View to North

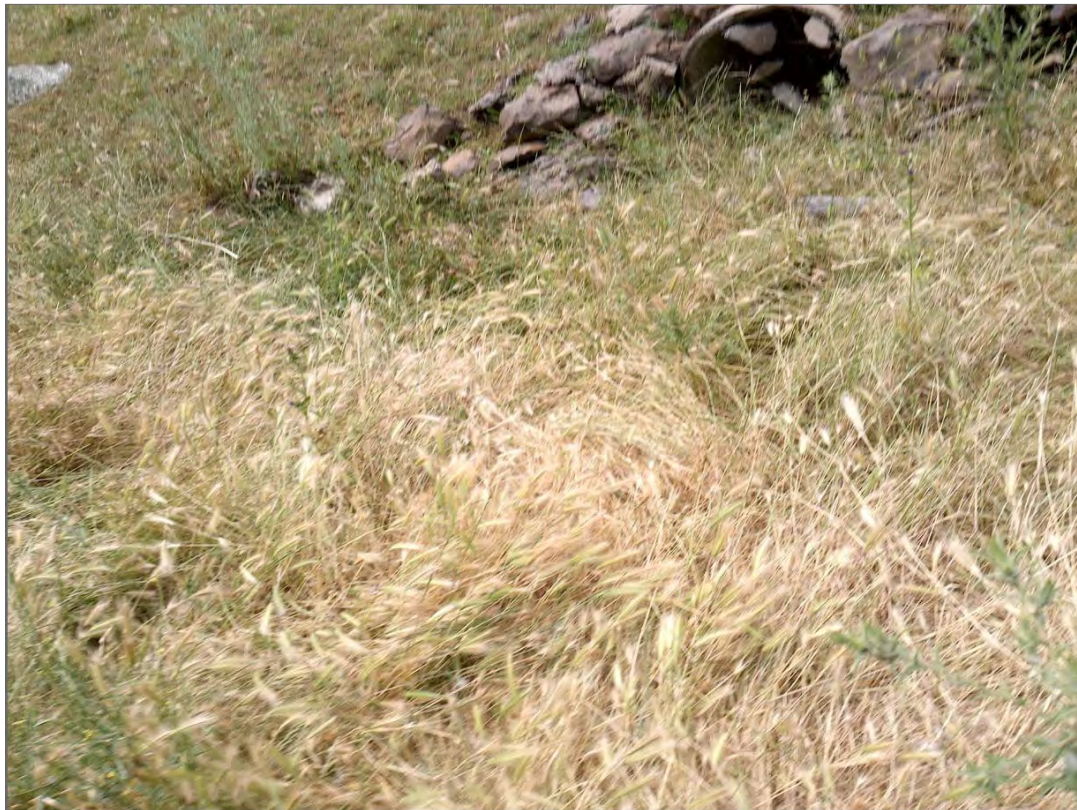
S199 - 600mm Pipe Culvert broken

**S199 – Rotherwood Rd - 1550m West of Yarrawonga Rd**  
Dual – 600mm Pipe Culvert - Broken  
Poor Condition and Serviceable, Upgrade likely required.

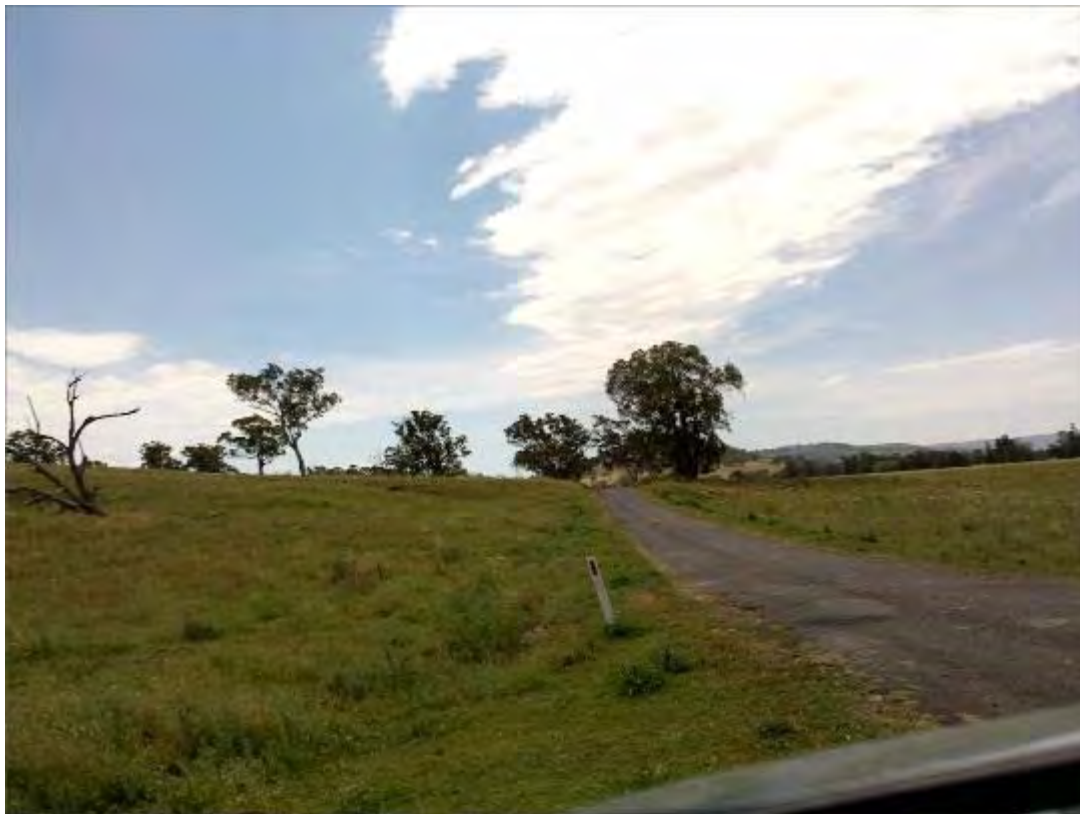
**S200 – Rotherwood Rd - 1550m West of Yarrawonga Rd**  
Dual – 600mm Pipe Culvert,  
Condition Unknown

**S200 – View to North**

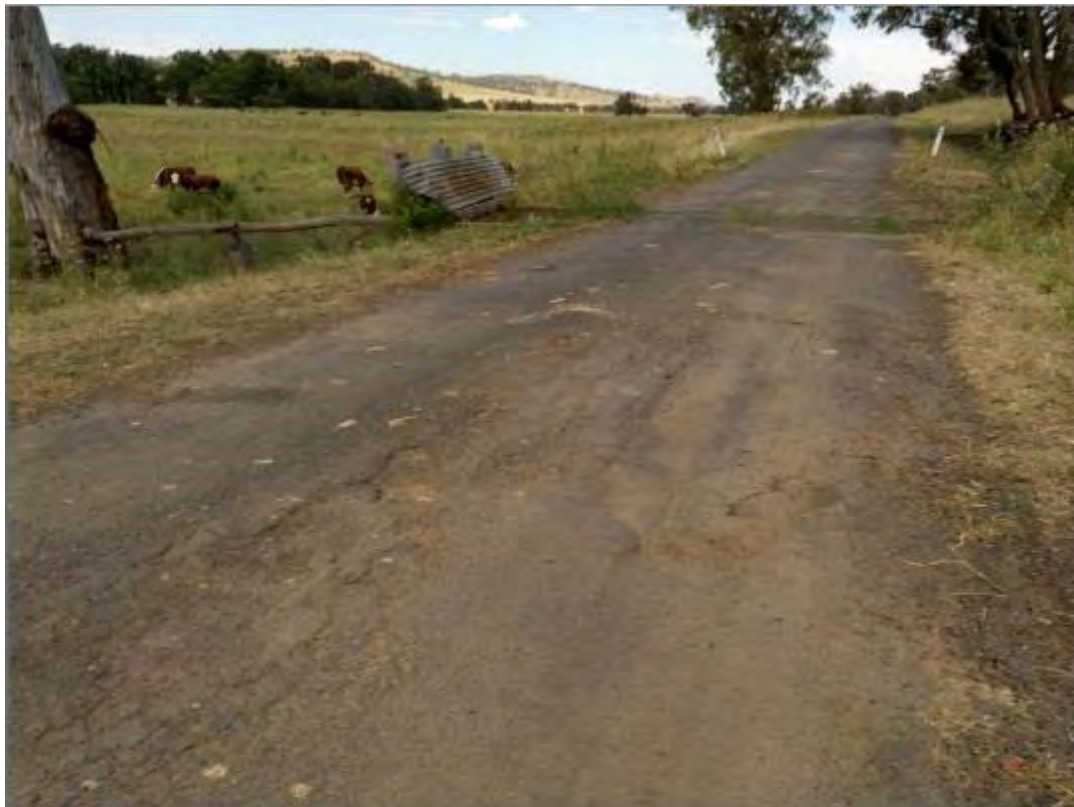
**S201 - Rotherwood Rd - 1450m West of Yarrawonga Rd**  
600mm Pipe Culvert including Grid,  
Poor Condition and Serviceable, may require upgrade

S201 – View to North, Location of Culvert Shown at Top Right of Image

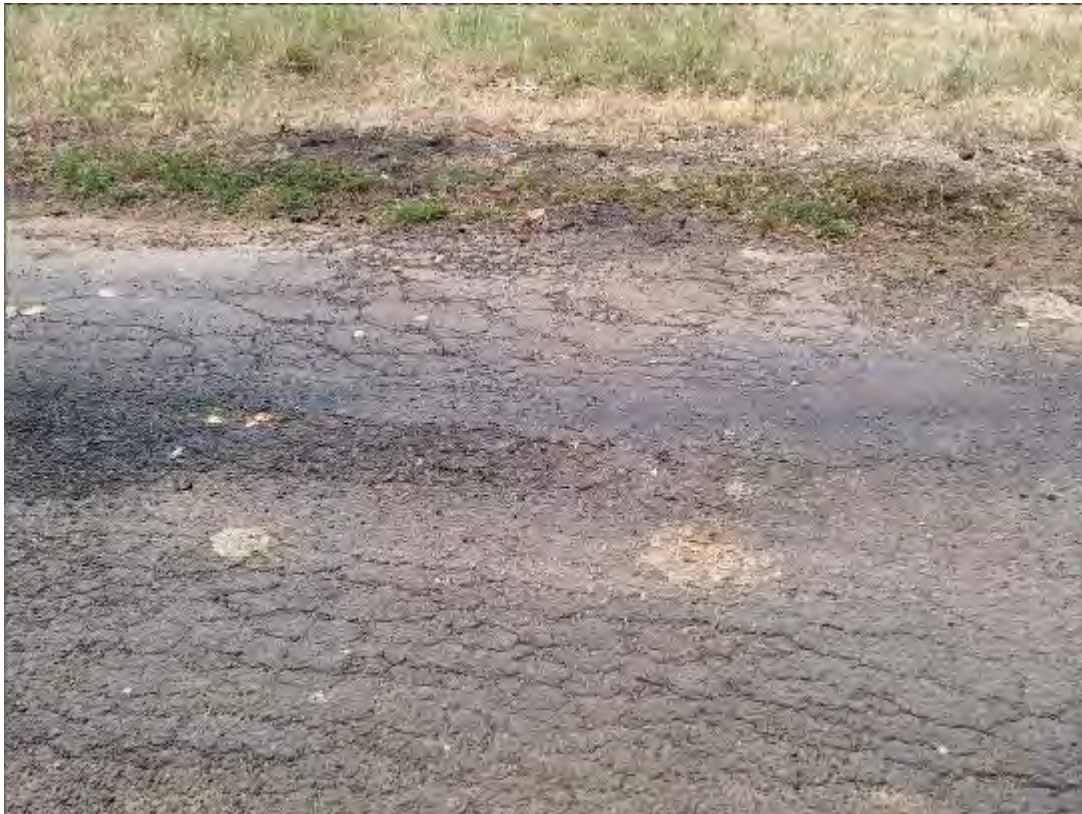
S201 – Road badly damaged at Location, Rutting and Extreme Cracking shown above, also signs of Stripping

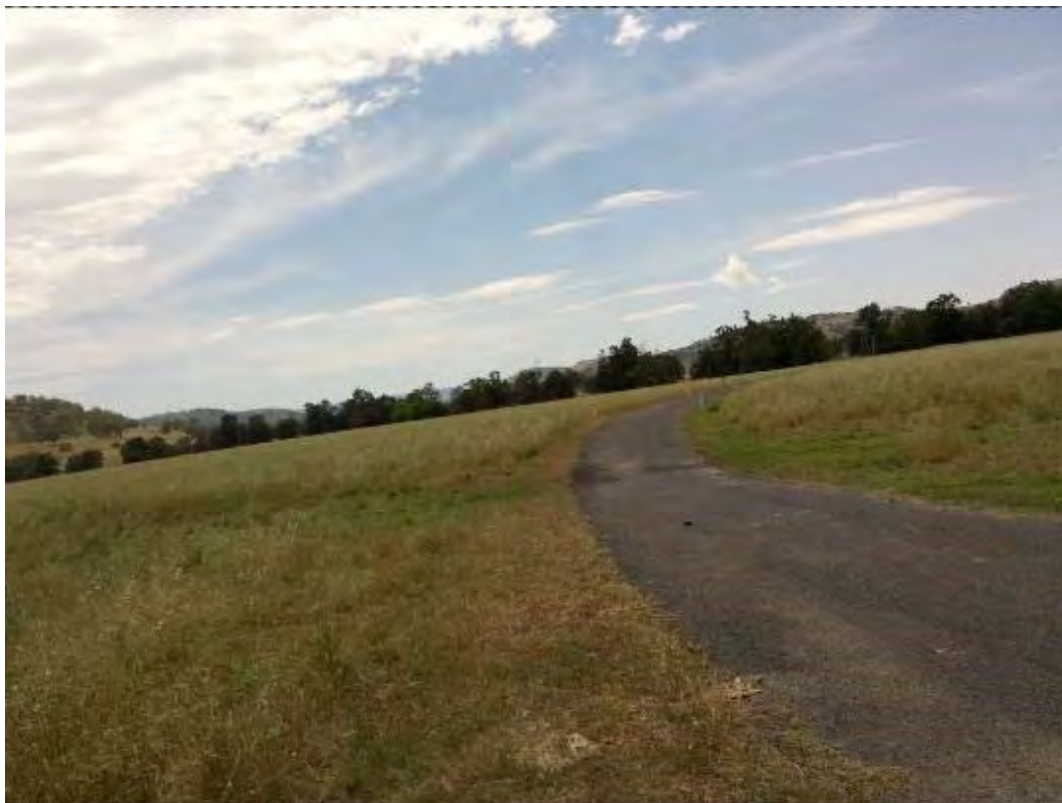
**S202 – Rotherwood Rd - 1450m West of Yarrawonga Rd**  
Bitumen floodway, Upgrade required  
Poor Condition and Serviceable

**S202 – View to East**

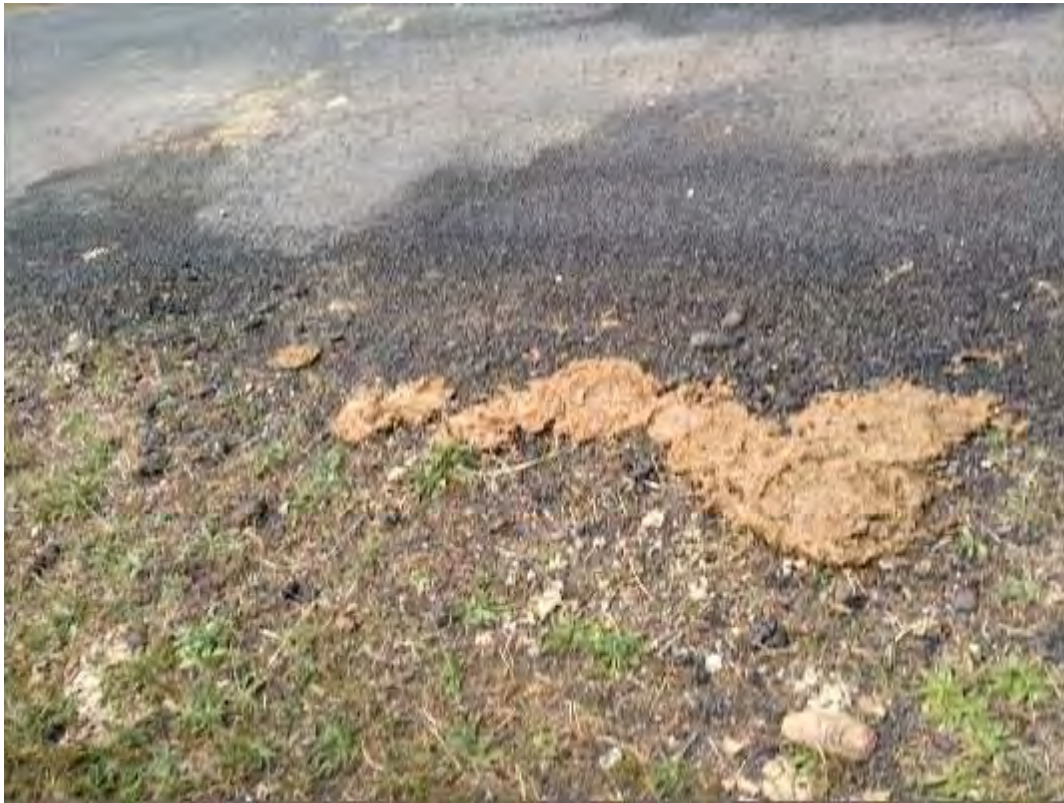
S202 – Evidence of Floodway

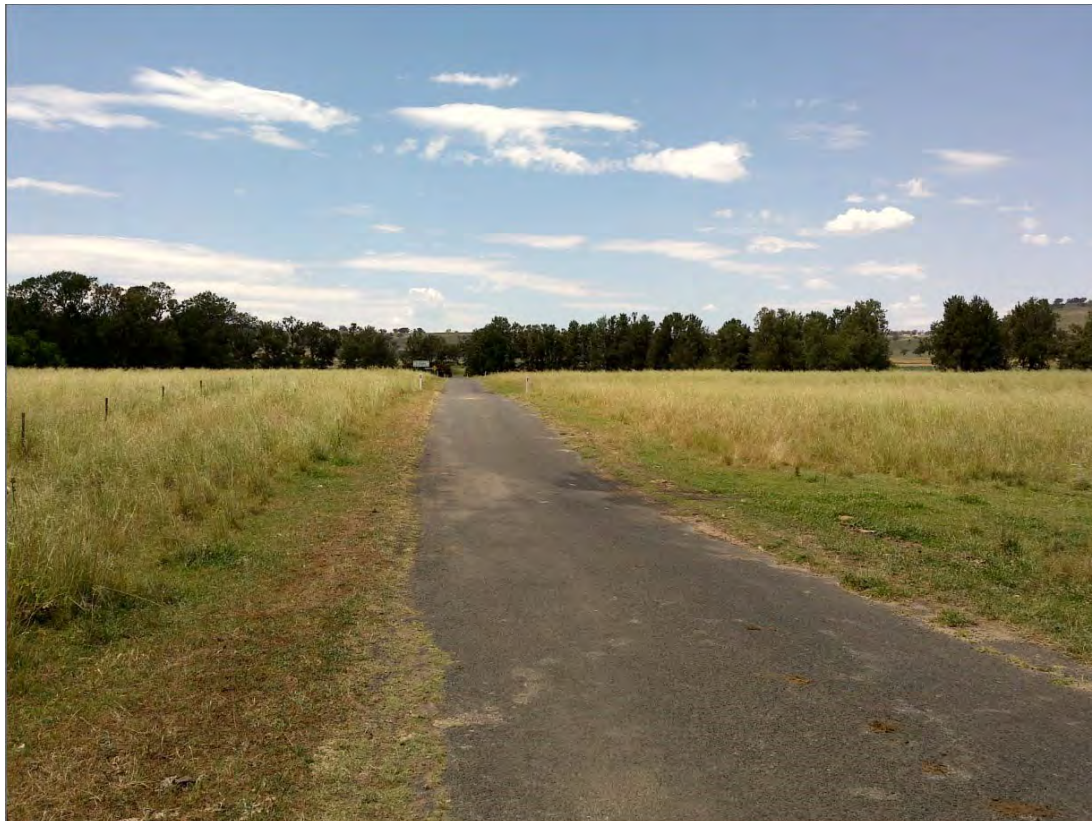
Bitumen floodway  
Road in Poor Condition,  
Upgrade required

**S203 – View to East**

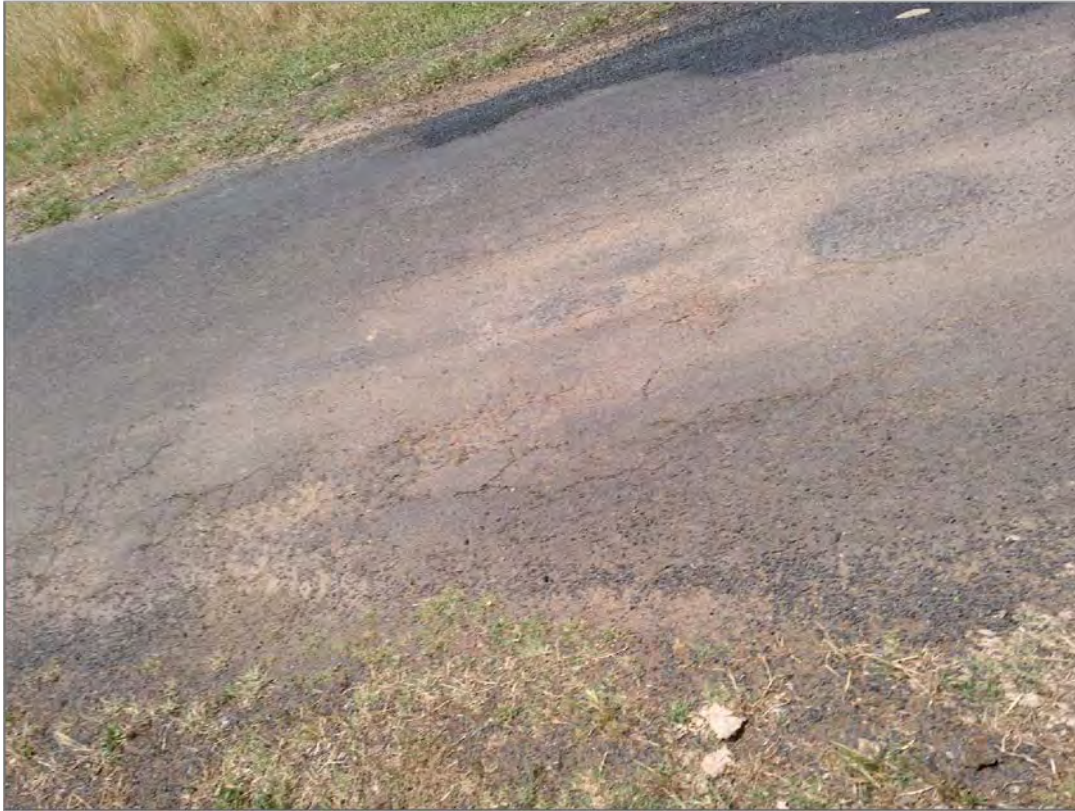
S203 – Damage on Road due to Floodway

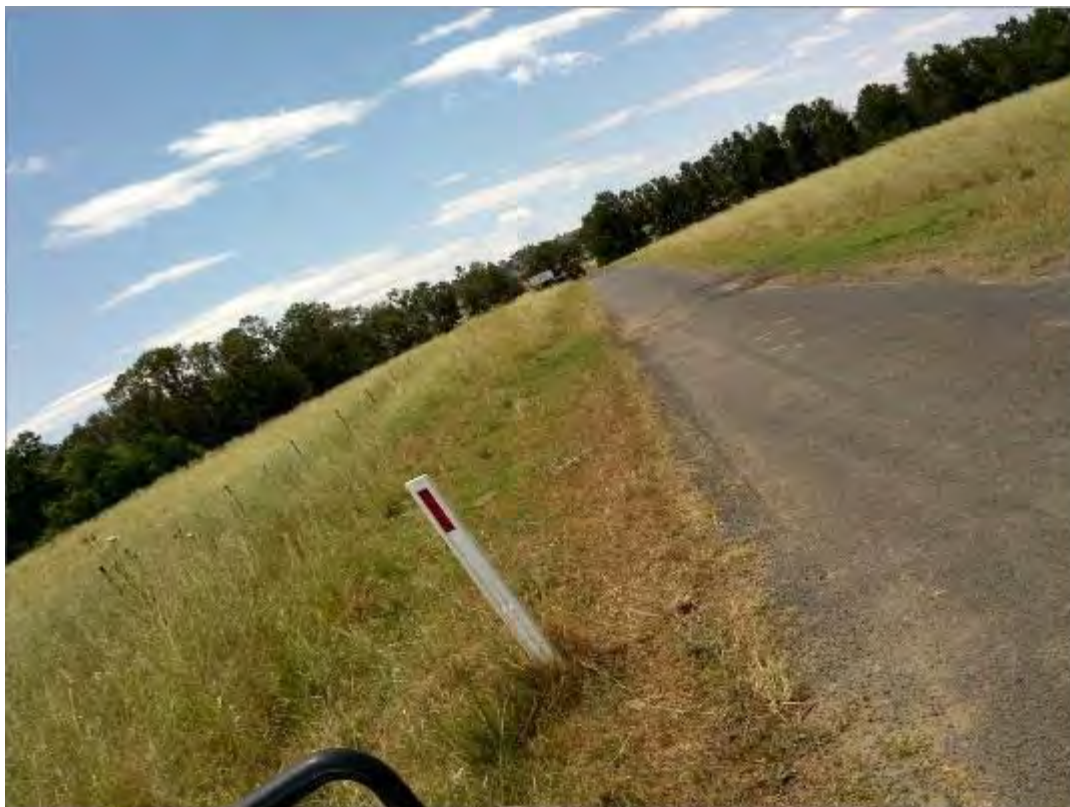
Bitumen floodway

Road is in poor condition,

**S204 – View to East**

Upgrade required

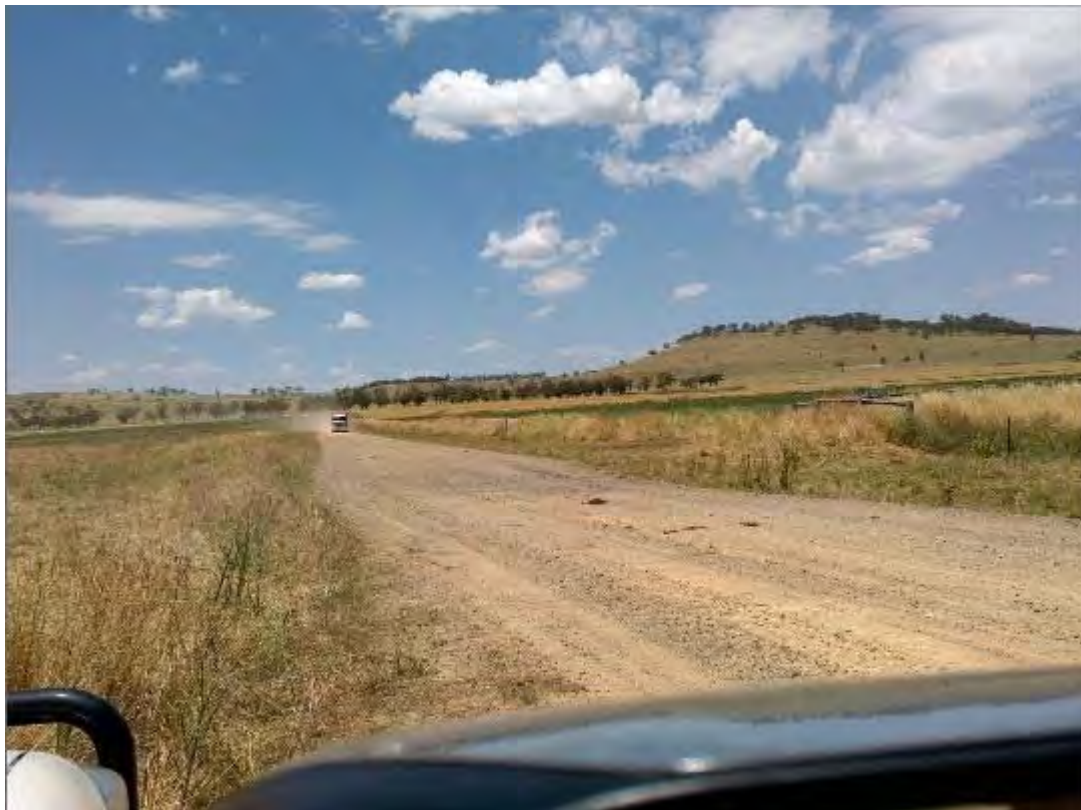
Floodway

Poor Condition,

**S205 – View to South**

Upgrade likely required

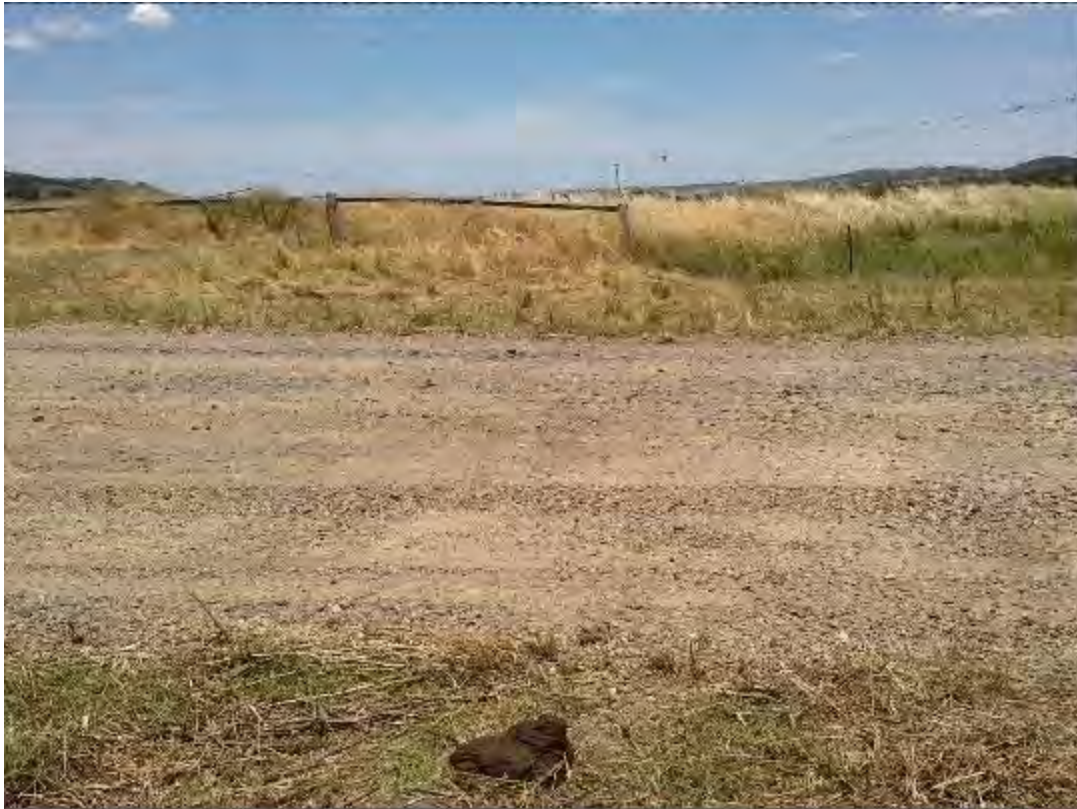
S205 – View of Floodway

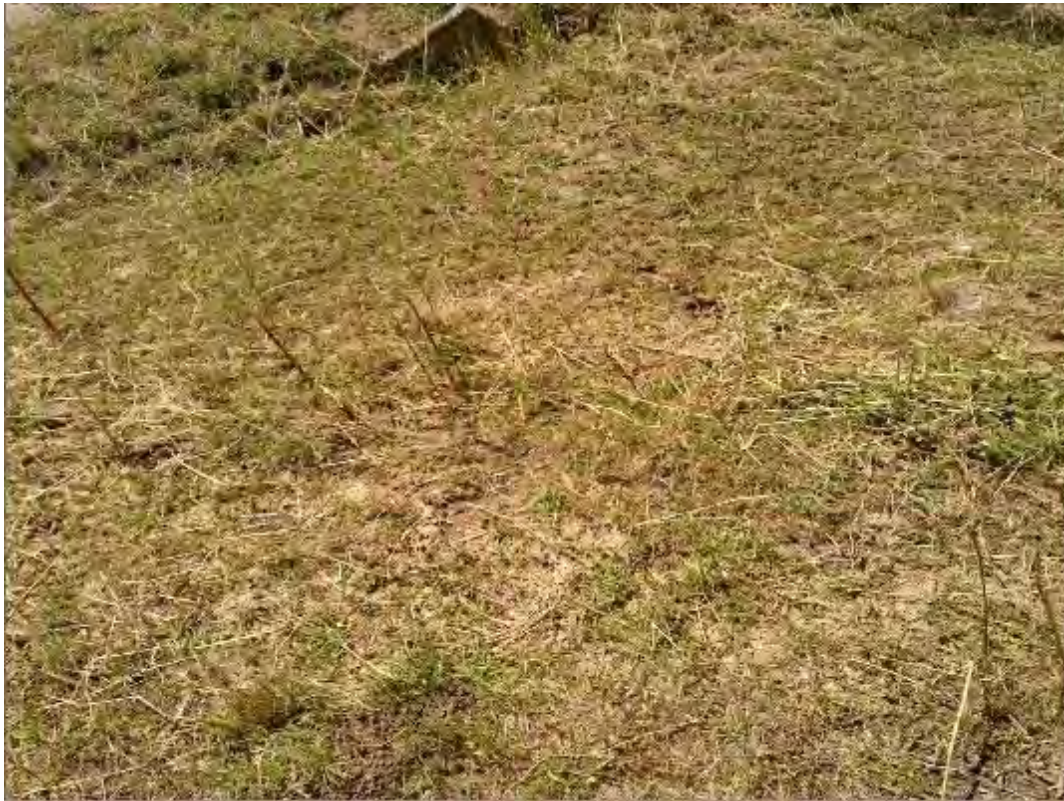
**S206 – Yarrowonga Rd - 400m North of Rotherwood Rd Intersection**  
Culvert blocked, Dimensions Unknown

S206 – Culvert shown top of Image

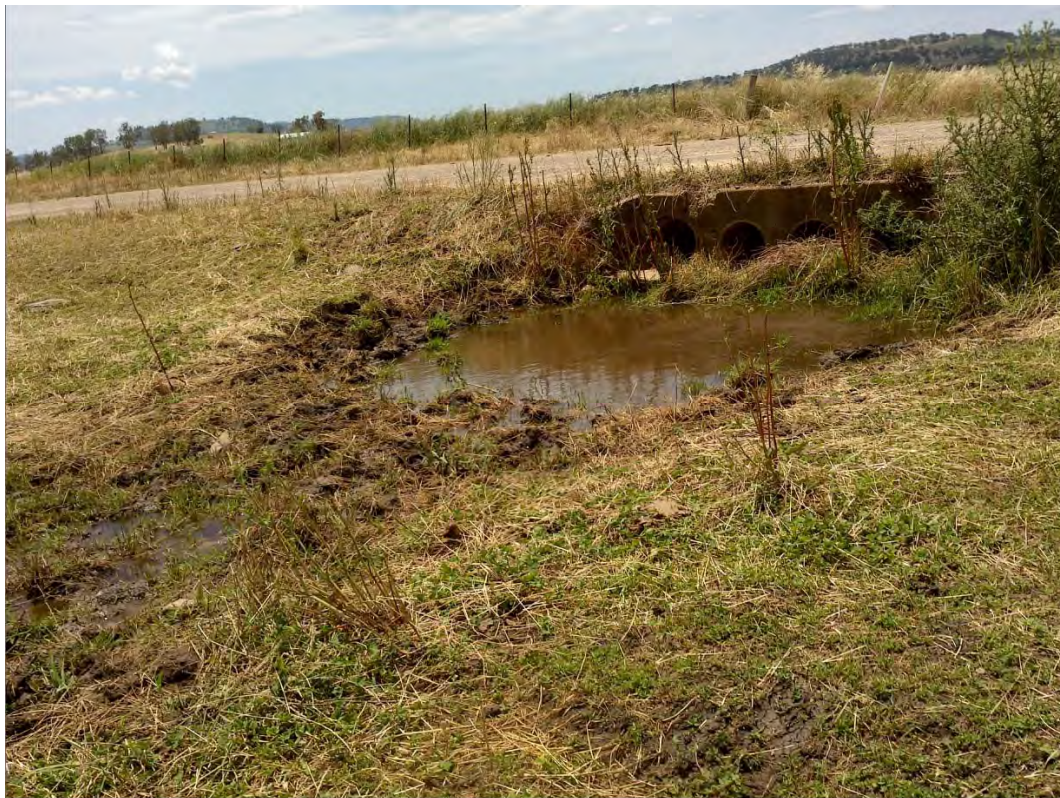
**S207 – Yarrowonga Rd - 800m North of Rotherwood Rd Intersection**  
4-450mm Pipe Culvert  
Fair Condition and Serviceable

**S207 - Yarrowonga Rd - 400m North of Rotherwood Rd Intersection**

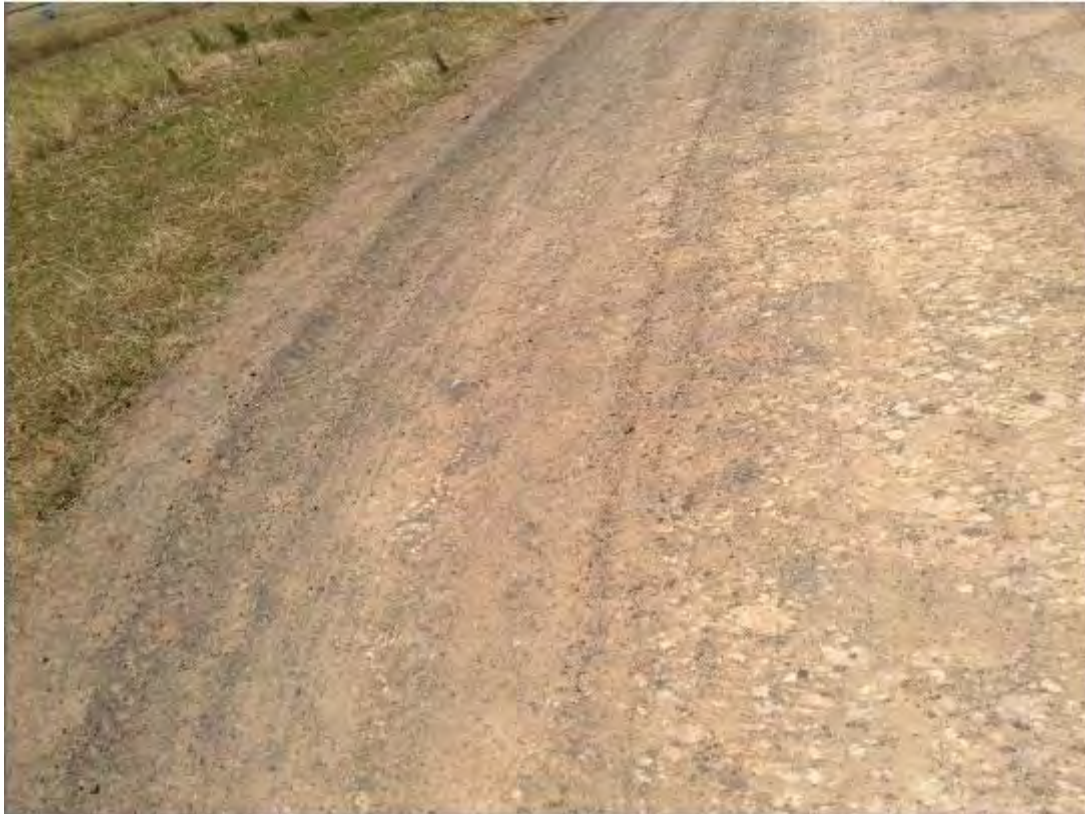
**S208 – Yarrowonga Rd - 1000m North of Rotherwood Rd Intersection**  
Pipe Culvert of Unknown Dimension,  
Unknown Condition

S208 – View towards culvert

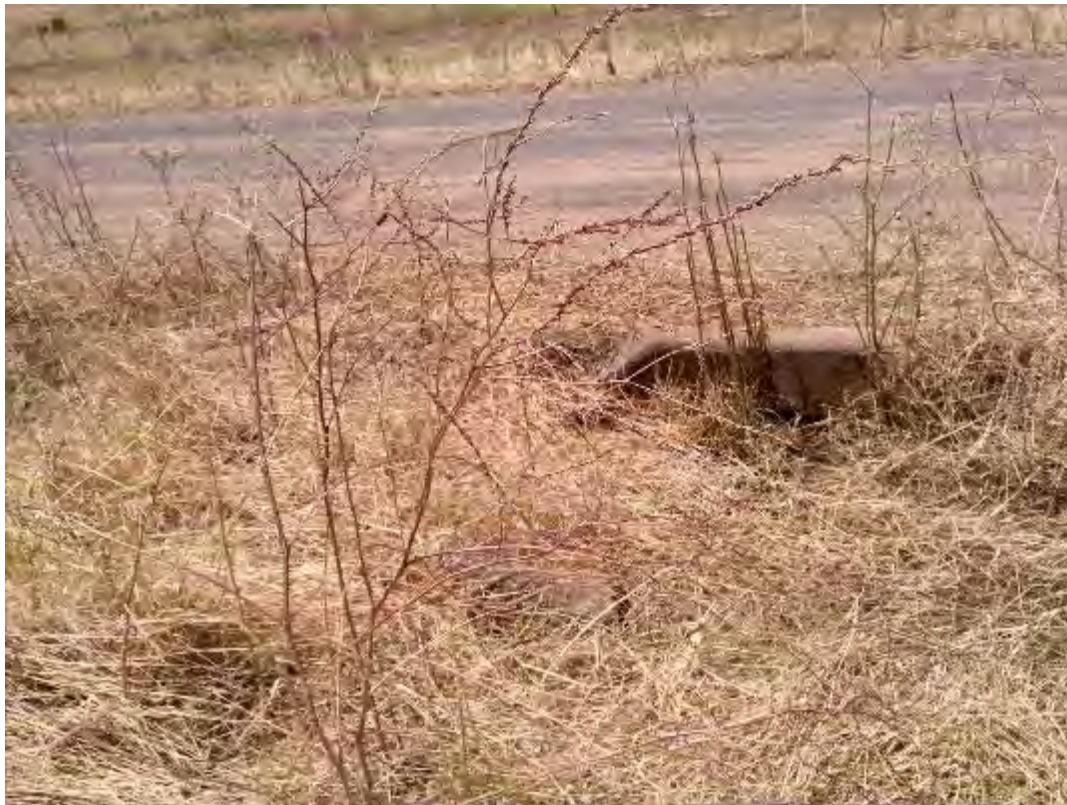
**S209 – Yarrowonga Rd - 1400m North of Rotherwood Rd Intersection**  
Pipe Culvert is blocked  
Poor Condition and Serviceable, will require maintenance or alternatively upgrade

S209 –Blocked Pipe Culvert

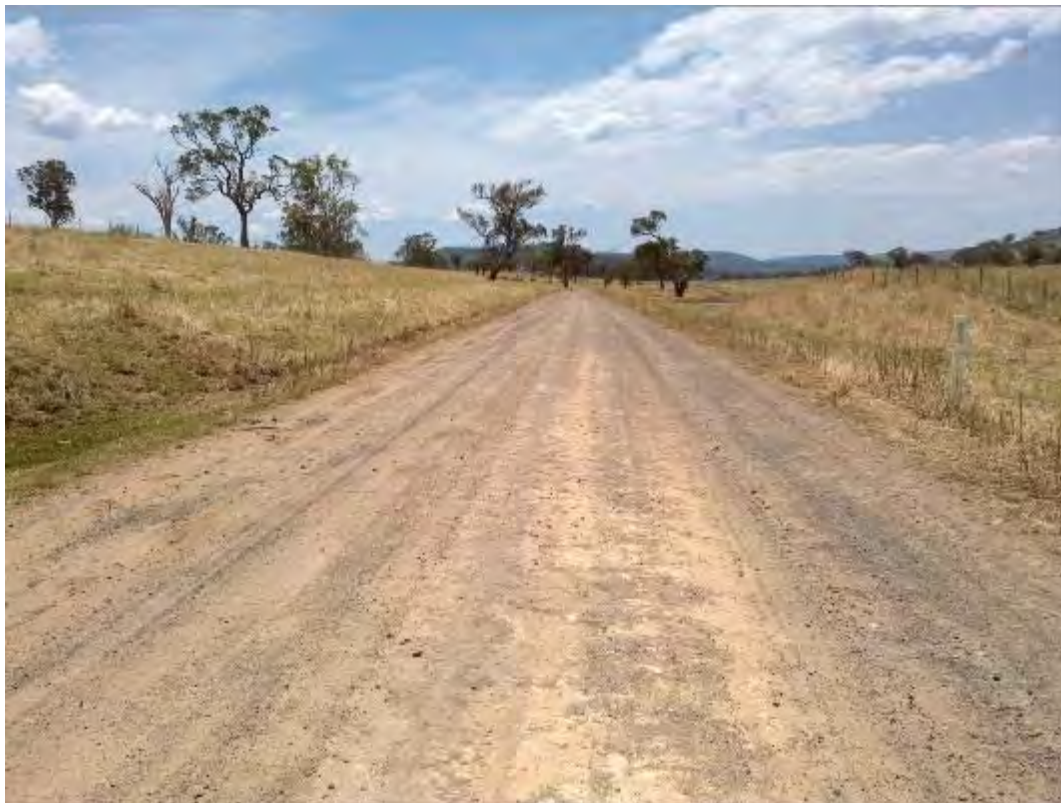
**S210 – Yarrowonga Rd - 1700m North of Rotherwood Rd Intersection**  
Blocked Pipe Culvert,  
Unknown Condition, will require maintenance

S210 – View to North

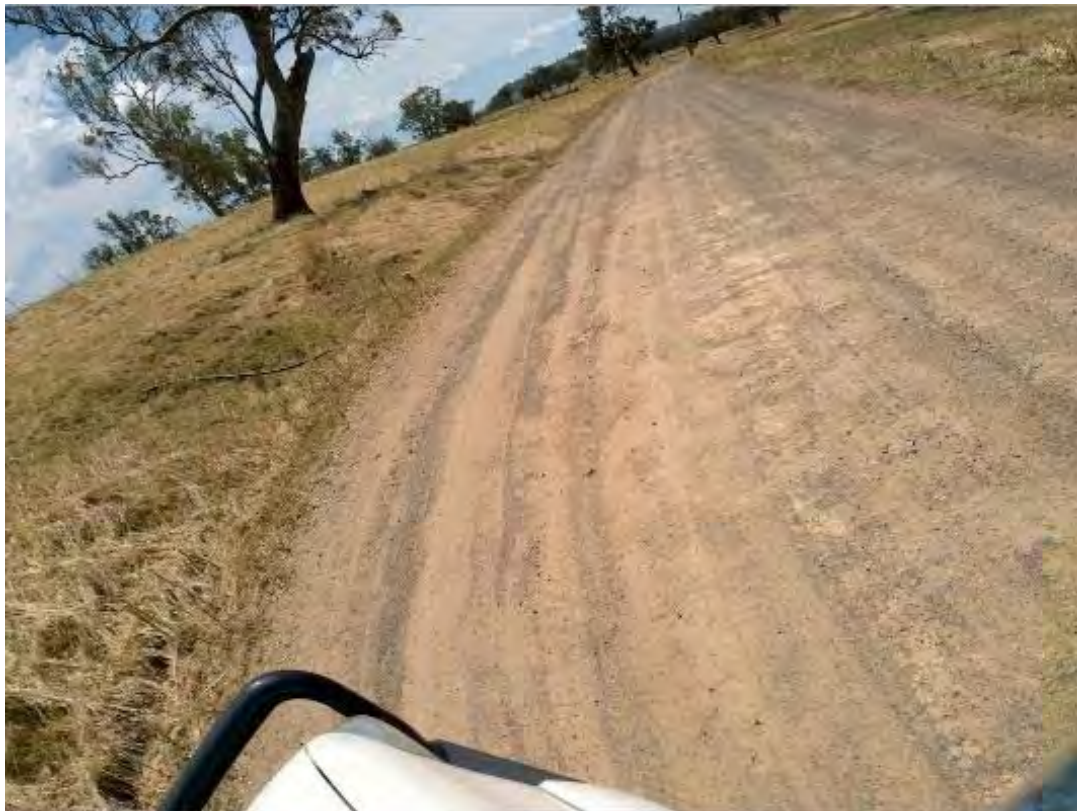
Blocked Pipe Culvert, no photo of culvert

Unknown Condition, may require maintenance or upgrade

S211 – View to North

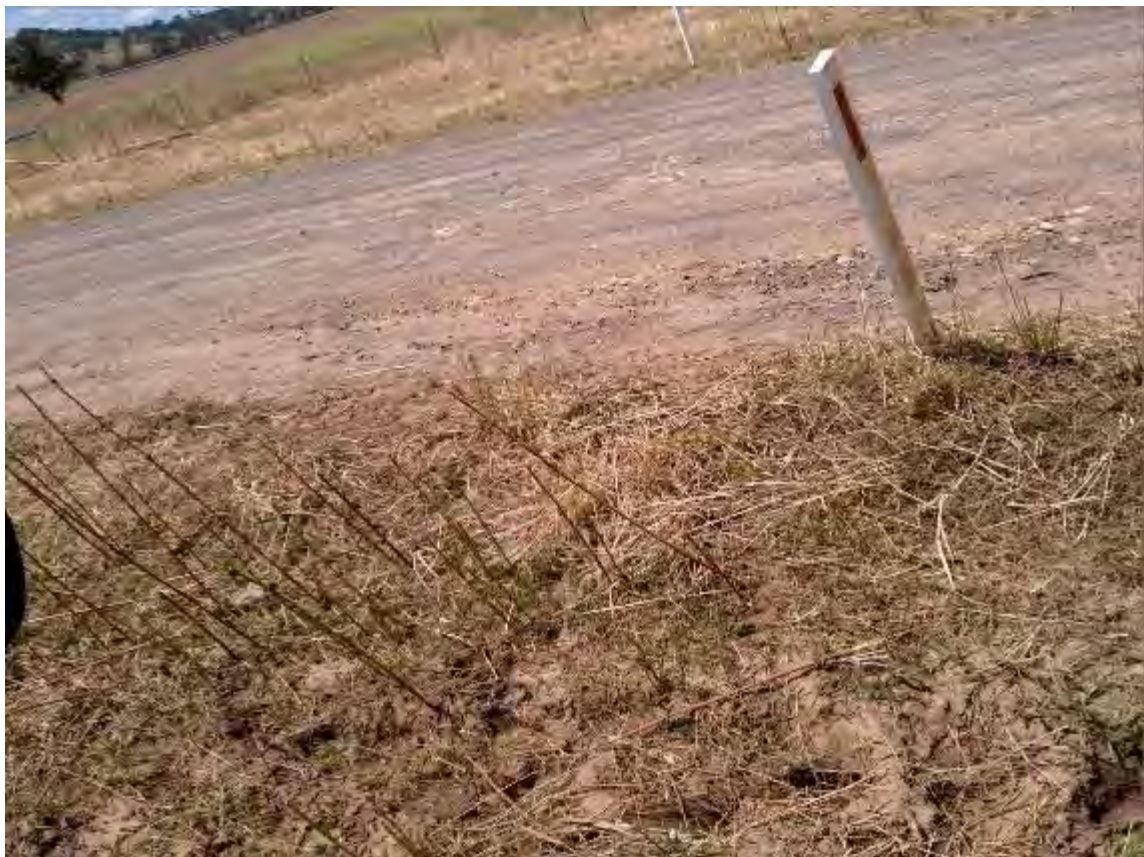
Blocked pipe culvert,  
Condition Unknown,  
Will require maintenance or upgrade

S212 – Blocked Culvert at bottom of image

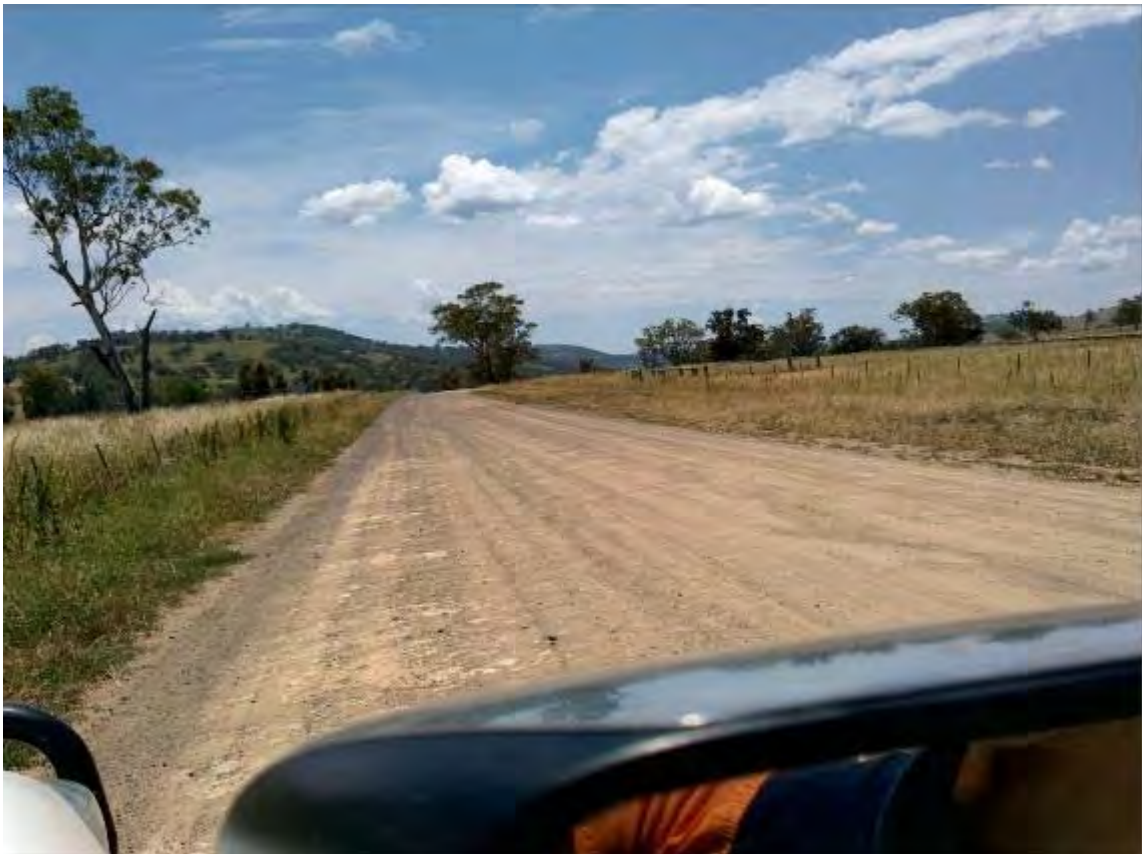
**S213 - Yarrawonga Rd - 3300m North of Rotherwood Rd Intersection**  
Need culvert for this Location

S213 – Water Damage on Road

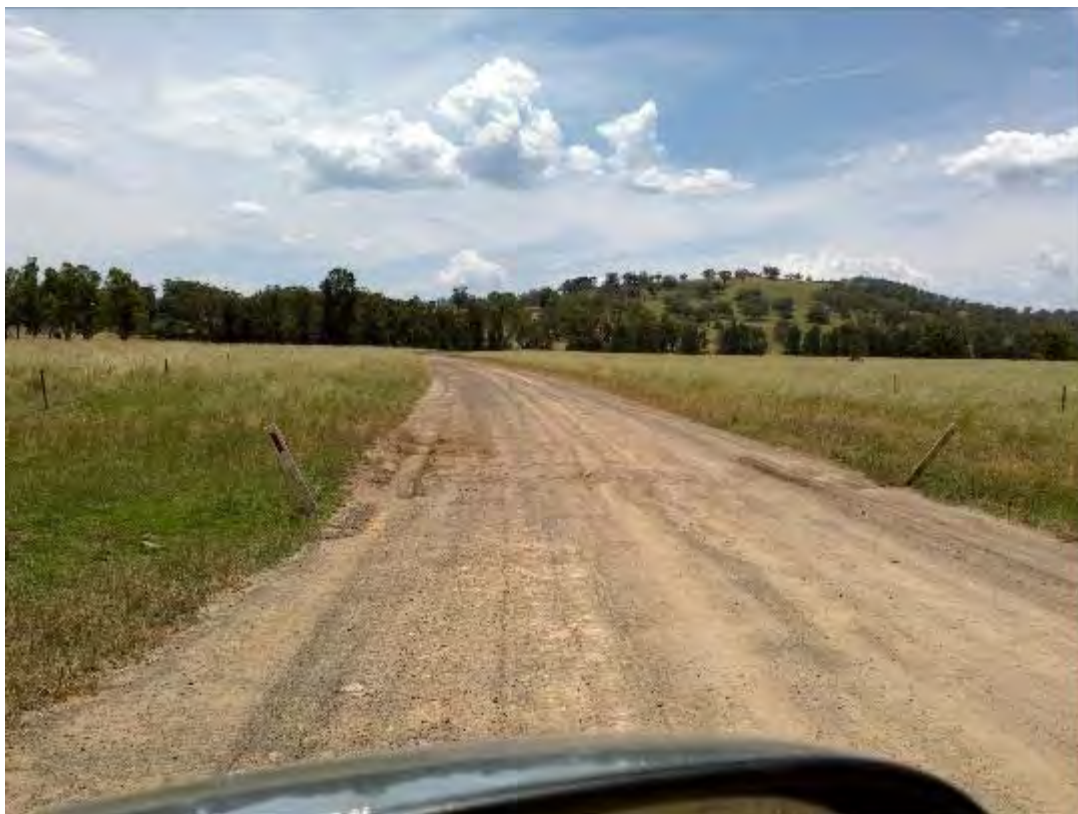
**S214 – Yarrawonga Rd - 3700m North of Rotherwood Rd Intersection**  
Blocked Pipe Culvert,  
Condition Unknown, will require maintenance or upgrade

S214 – View to North

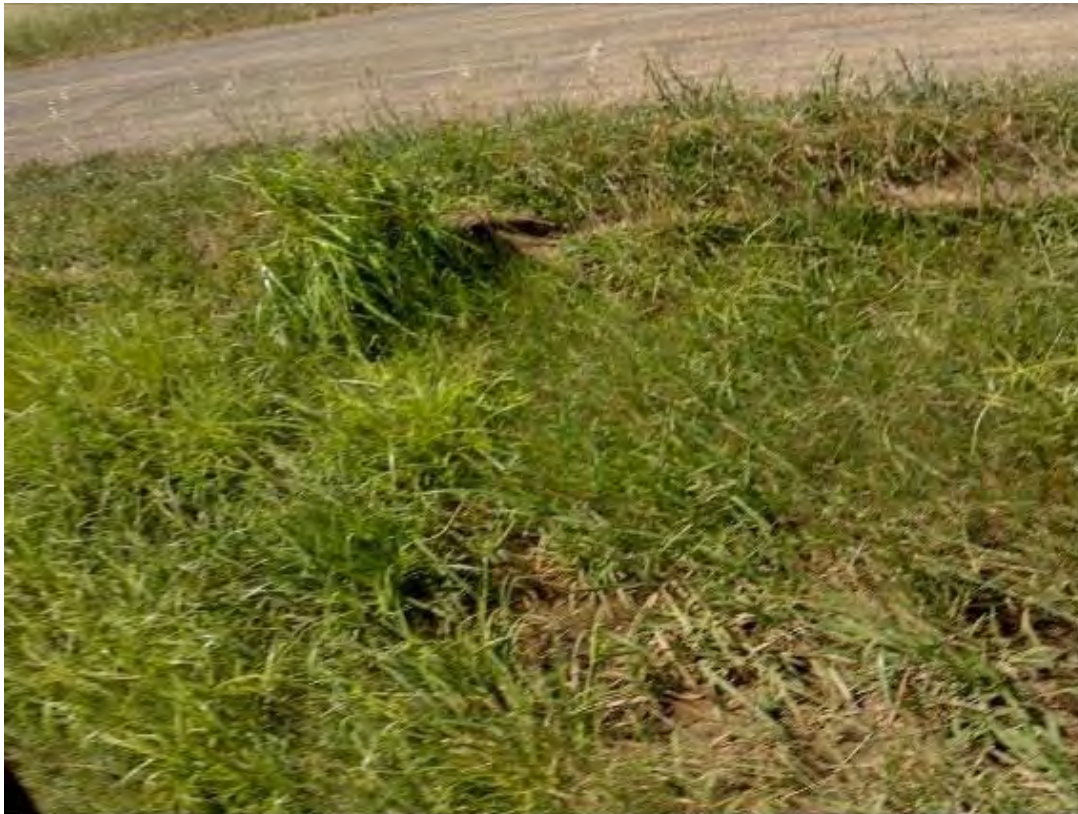
Blocked Pipe Culvert

Poor Condition, will likely require maintenance or upgrade

### S215 – Blocked Pipe Culvert

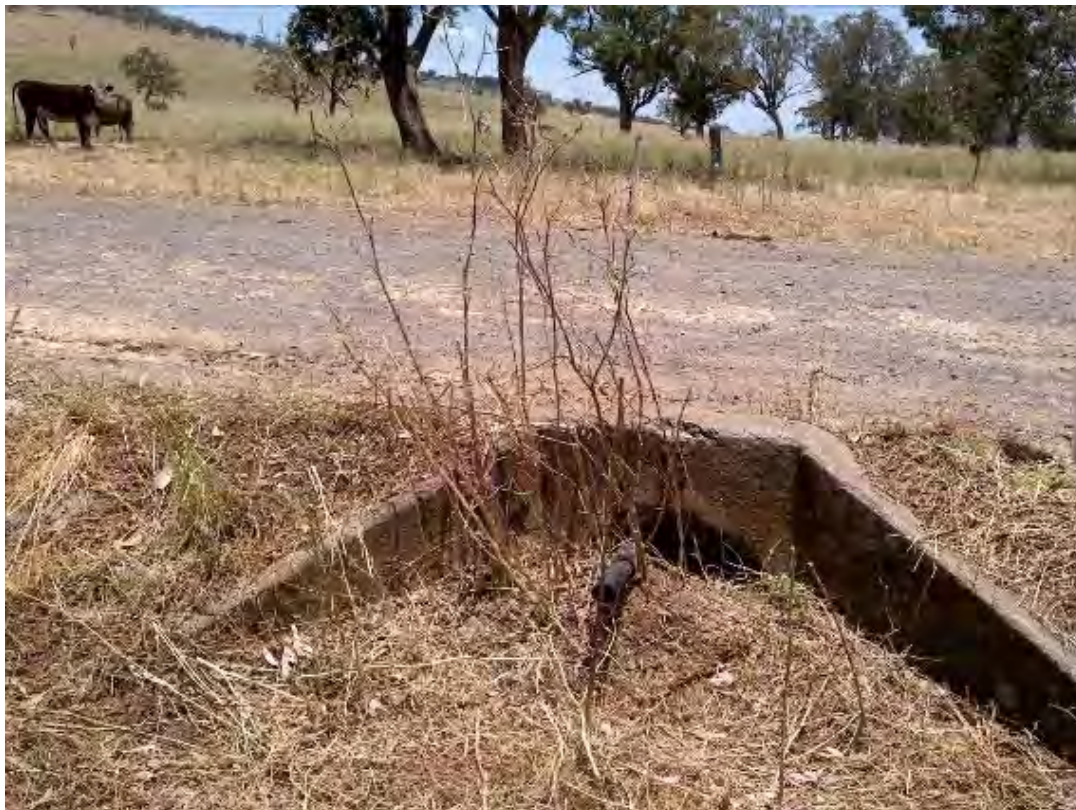
**S216 – Rotherwood Rd - 300m South of Yarrawonga Intersection**  
Blocked 450mm Pipe Culvert  
Poor Condition and Serviceable

S216 – Blocked 450mm Pipe Culvert

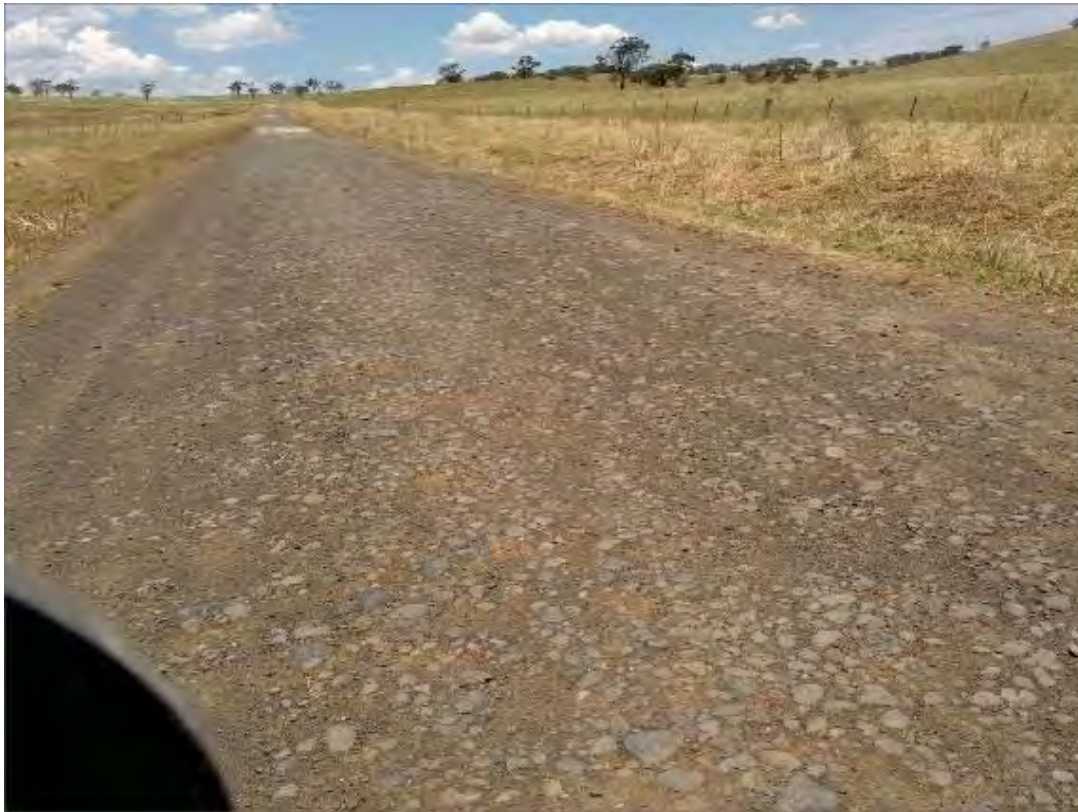
S216 – View to South, Causeway down to Sub-Base Material

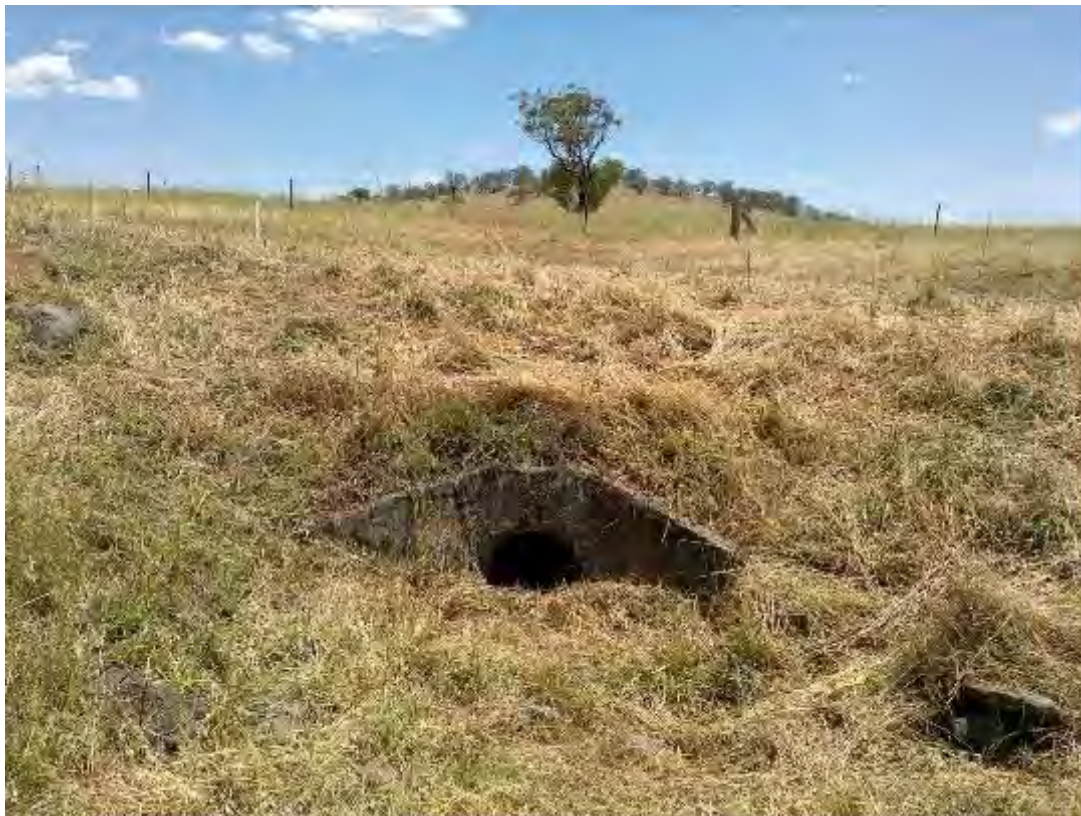
**S217 – Rotherwood Rd - 900m South of Yarrawonga Intersection**  
450mm Pipe Culvert  
Fair Condition and Serviceable

**S217 – 450mm Pipe Culvert**
