**S198 – Rotherwood Rd - 1600m West of Yarrawonga Rd**  
A Culvert is required for this location

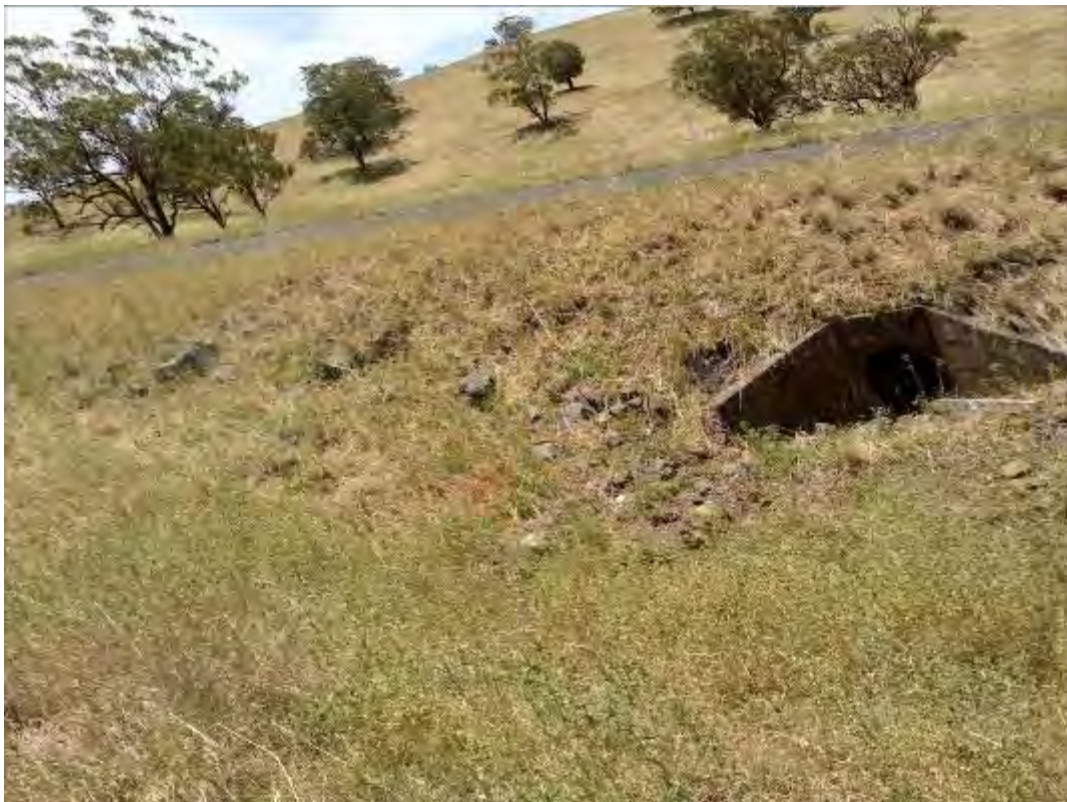
**S219 – Rotherwood Rd -1900m South of Yarrawonga Intersection**  
600mm Pipe Culvert  
Good Condition and Serviceable

**S219 – 600mm Pipe Culvert**

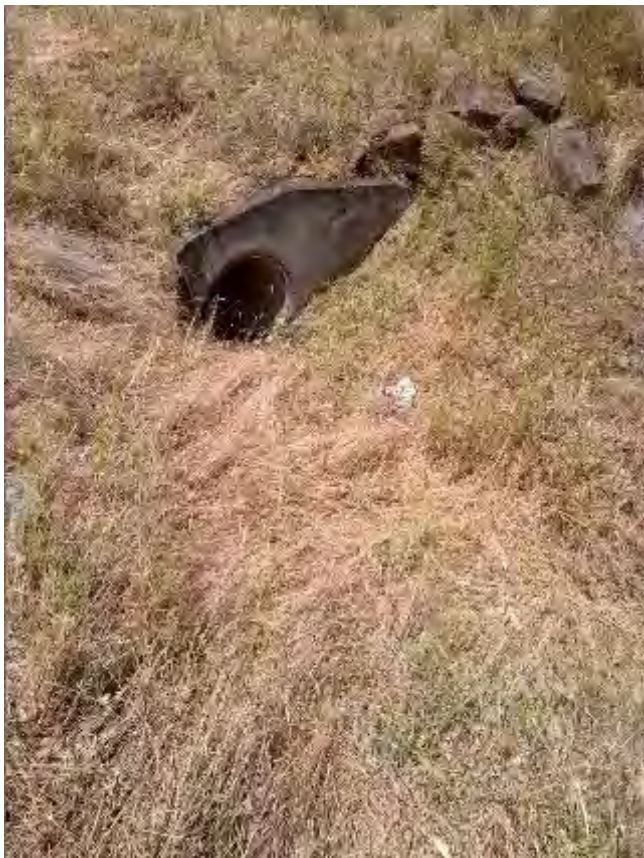
**S220 – Rotherwood Rd -2000m South of Yarrowonga Intersection**  
675mm Pipe Culvert  
Good Condition and Serviceable

S220 - 675mm Pipe Culvert  
Level 2, 39 Sherwood Road  
Toowong QLD 4066

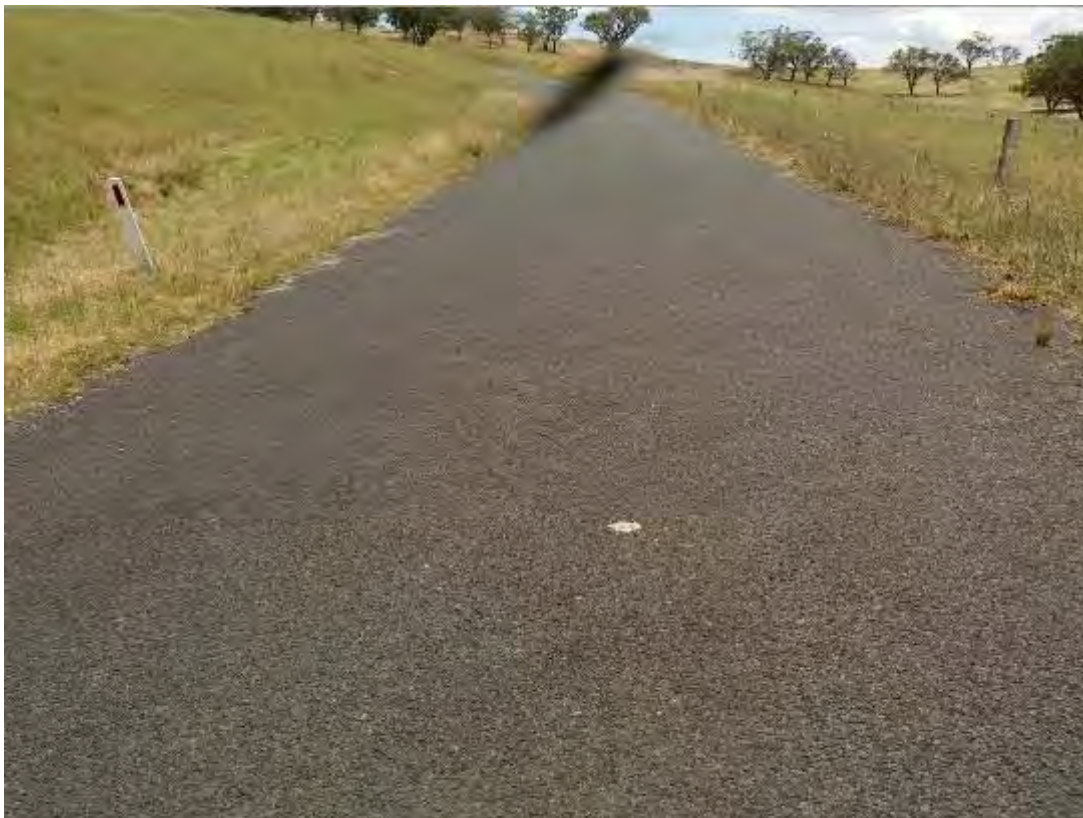
**S221 – Rotherwood Rd -2050m South of Yarrawonga Intersection**  
450mm Pipe Culvert  
Moderate Condition and Serviceable, may require maintenance

S221 – View to North

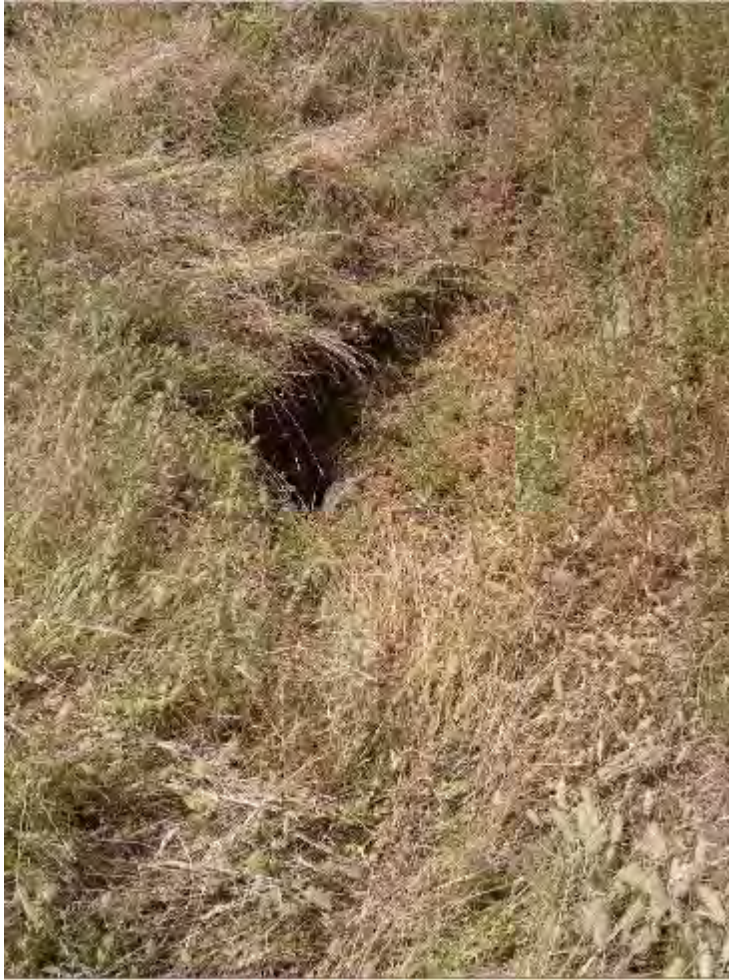
S221 - 450mm Pipe Culvert

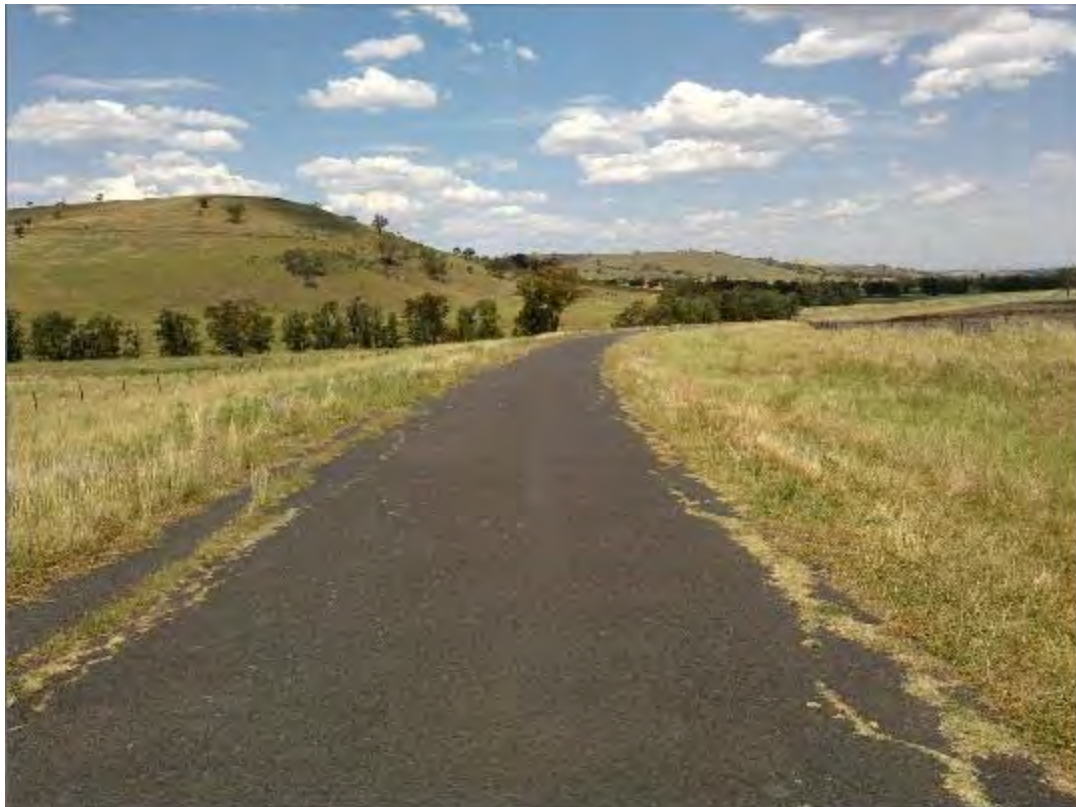
**S223 – Rotherwood Road-2650m South of Yarrawonga Rd intersection No  
Pipe culvert**

**S223 – View to South**

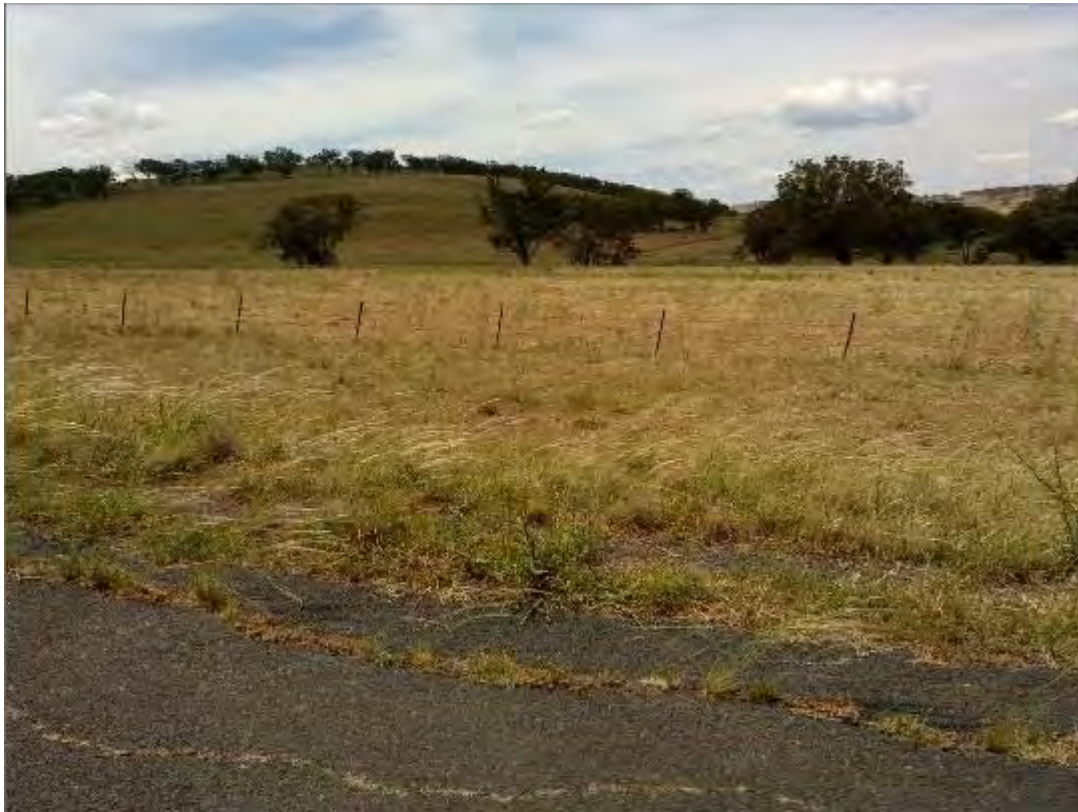
S223 – Road has signs of cracking and it being overgrown

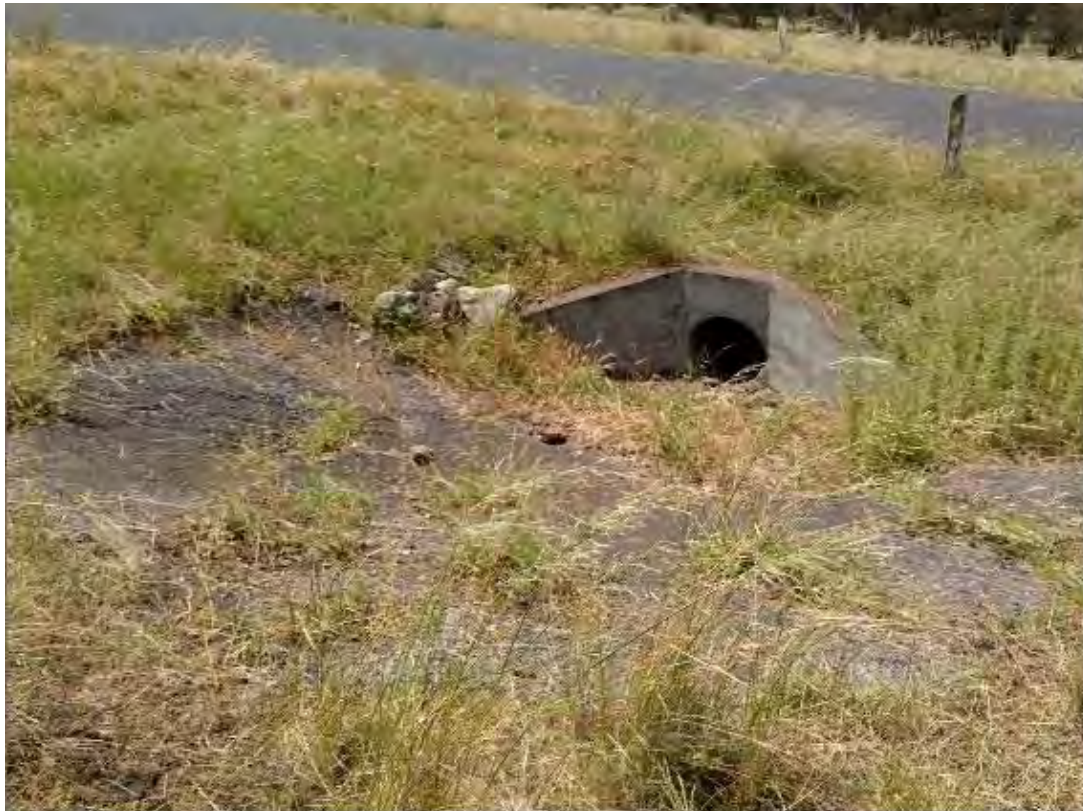
**S224 - Rotherwood Road-2700m South of Yarrawonga Rd Intersection**  
450mm Pipe Culvert  
Good Condition and Serviceable

S224 - 450mm Pipe Culvert

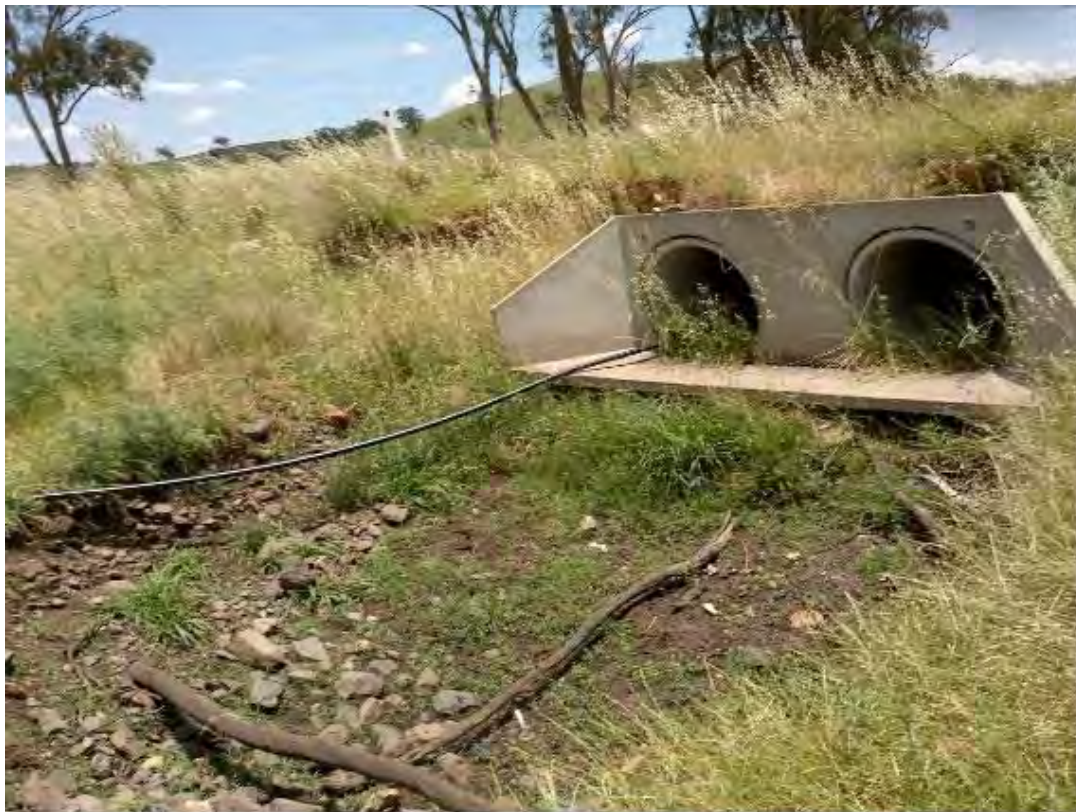
**S226 – Rotherwood Road-3400m South of Yarrowonga Rd intersection**  
Dual -900mm Pipe Culvert with scoured headwall  
Fair Condition and Serviceable

S226 - Dual -900mm Pipe Culvert with scoured headwall

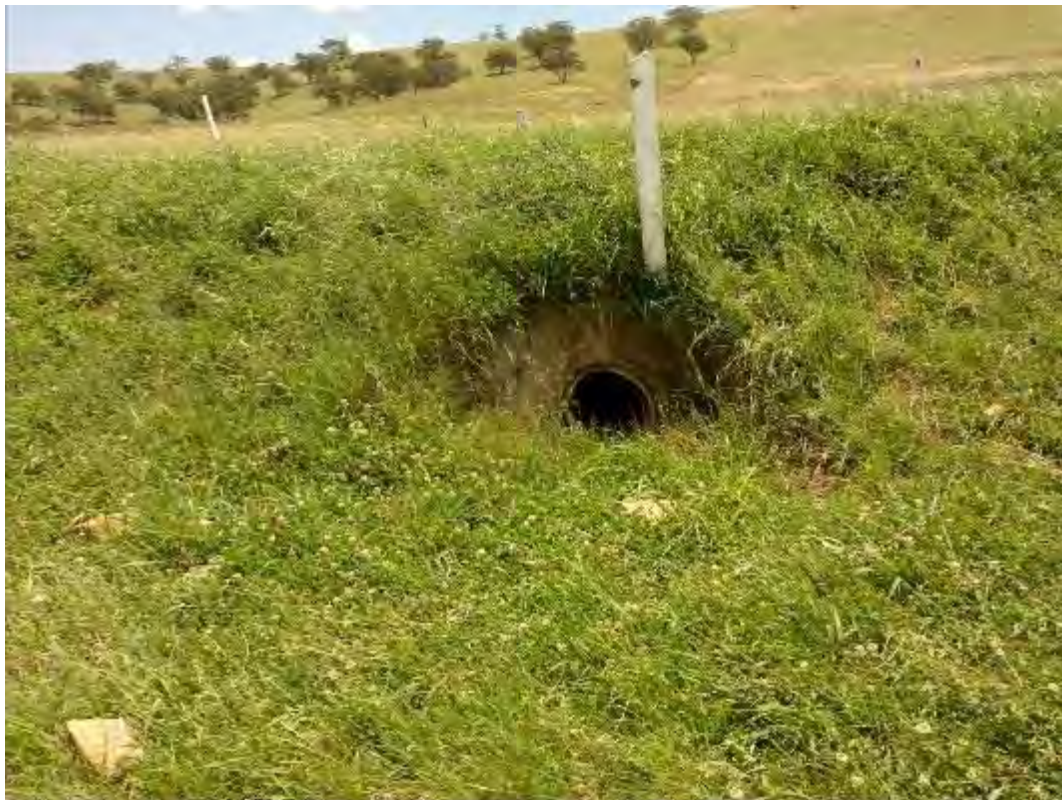
**S227 – Rotherwood Road-4100m South of Yarrawonga Rd intersection**  
375mm Pipe Culvert  
Fair Condition and Serviceable

**S227 – 375mm Pipe Culvert**

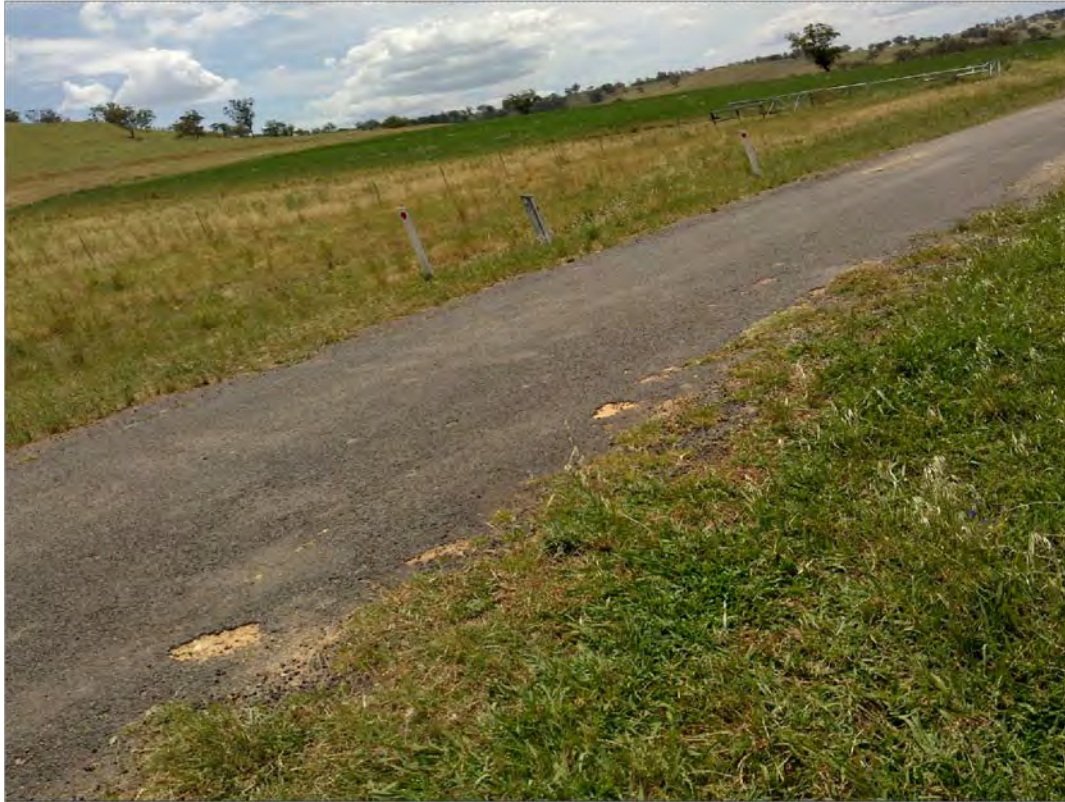
S227 – View to North

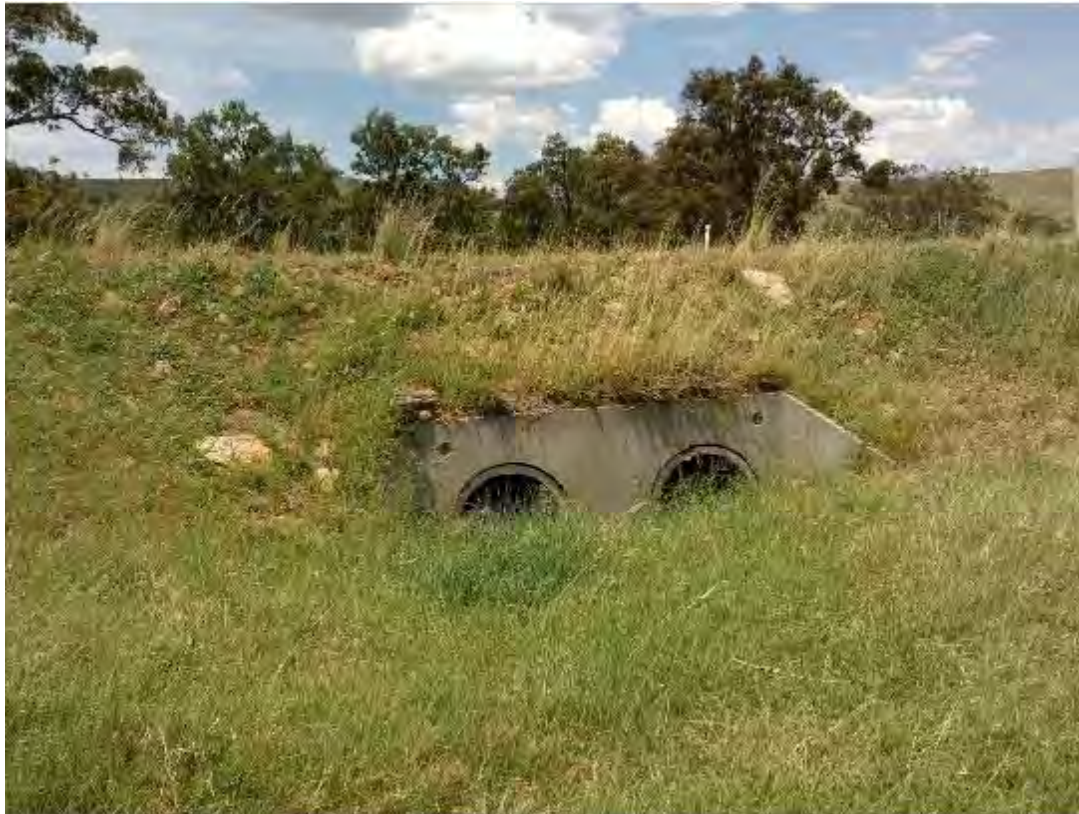
**S228 – Rotherwood Road-4300m South of Yarrawonga Rd intersection**  
Dual – 750mm Pipe Culvert  
Fair Condition and Serviceable

S228 – Dual – 750mm Pipe Culvert

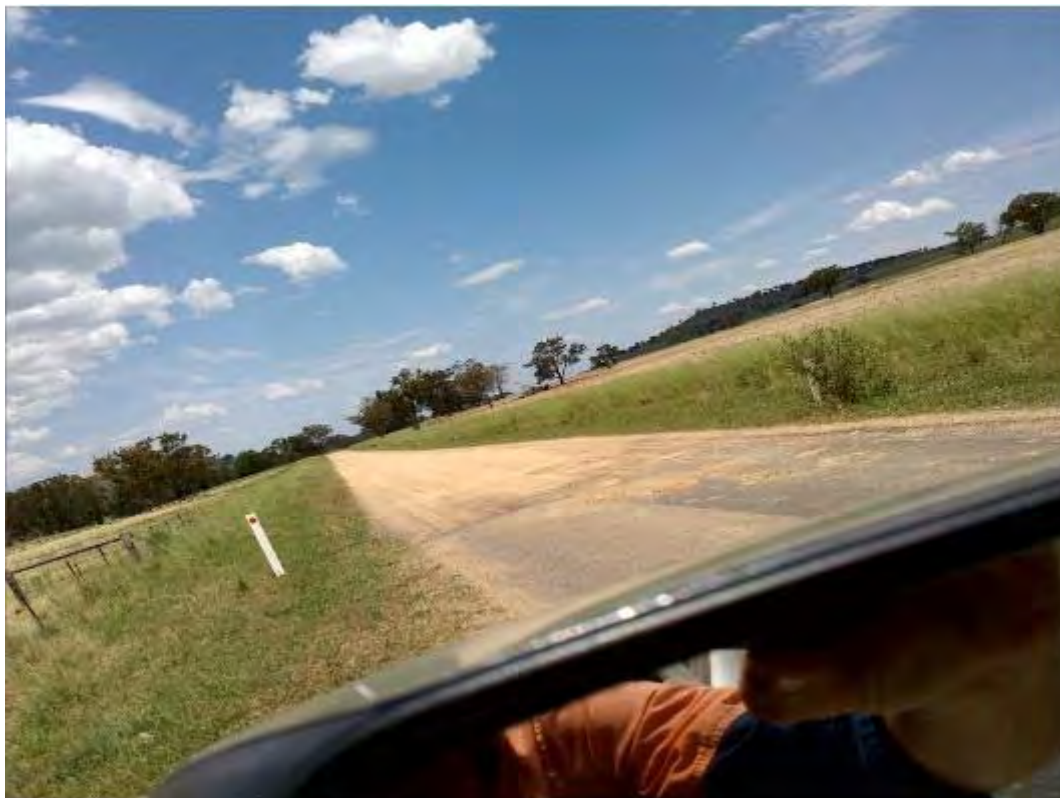
End of bitumen seal,

Pipe Culvert needed for this location as there are a number of potholes due to water damage

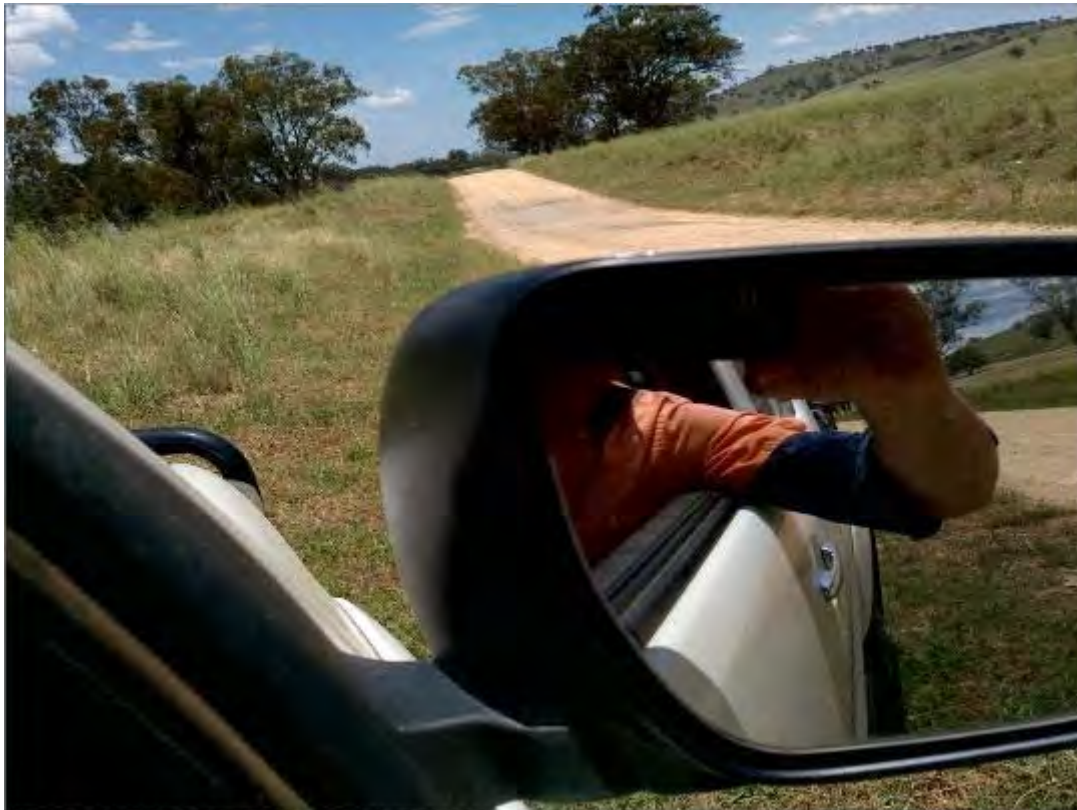
**S231 – Rotherwood Road-4900m South of Yarrawonga Rd intersection**  
Causeway  
Poor Condition and Serviceable, may need to be upgraded

**S231 – View to South**

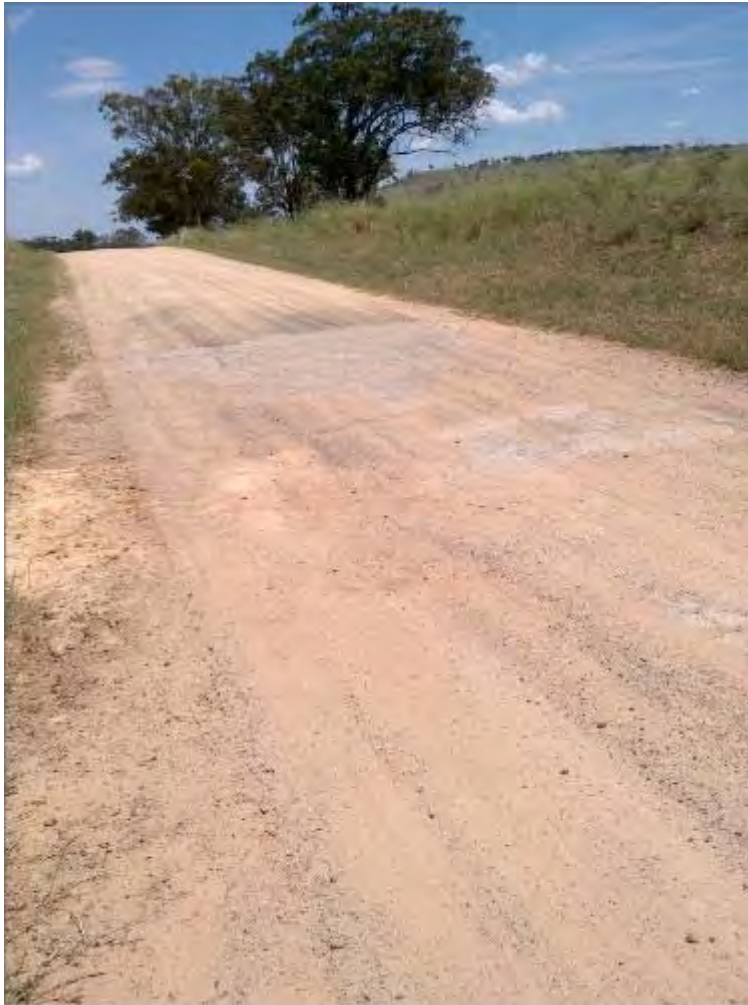
S231 – Causeway with damages

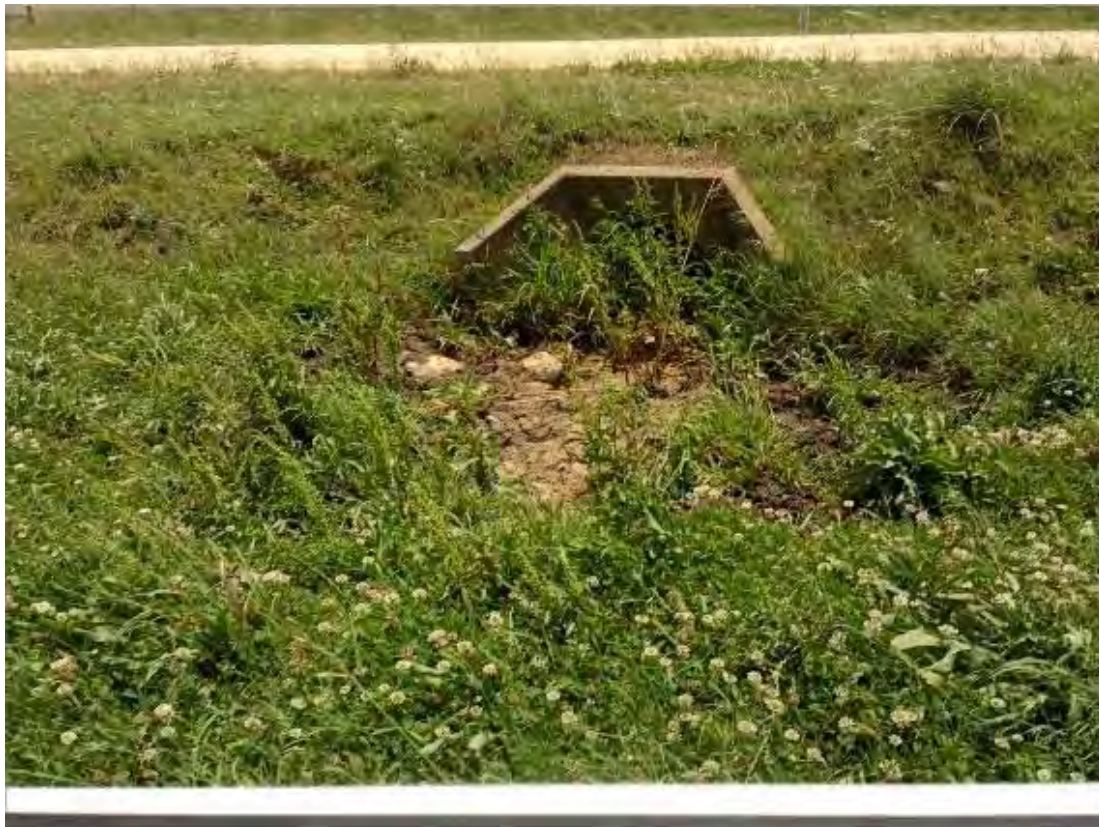
**S231a – Rotherwood Rd - 5500m North of Coolah Rd Intersection**  
525mm Pipe Culvert  
Fair Condition and Serviceable

S231a – 525mm Pipe Culvert

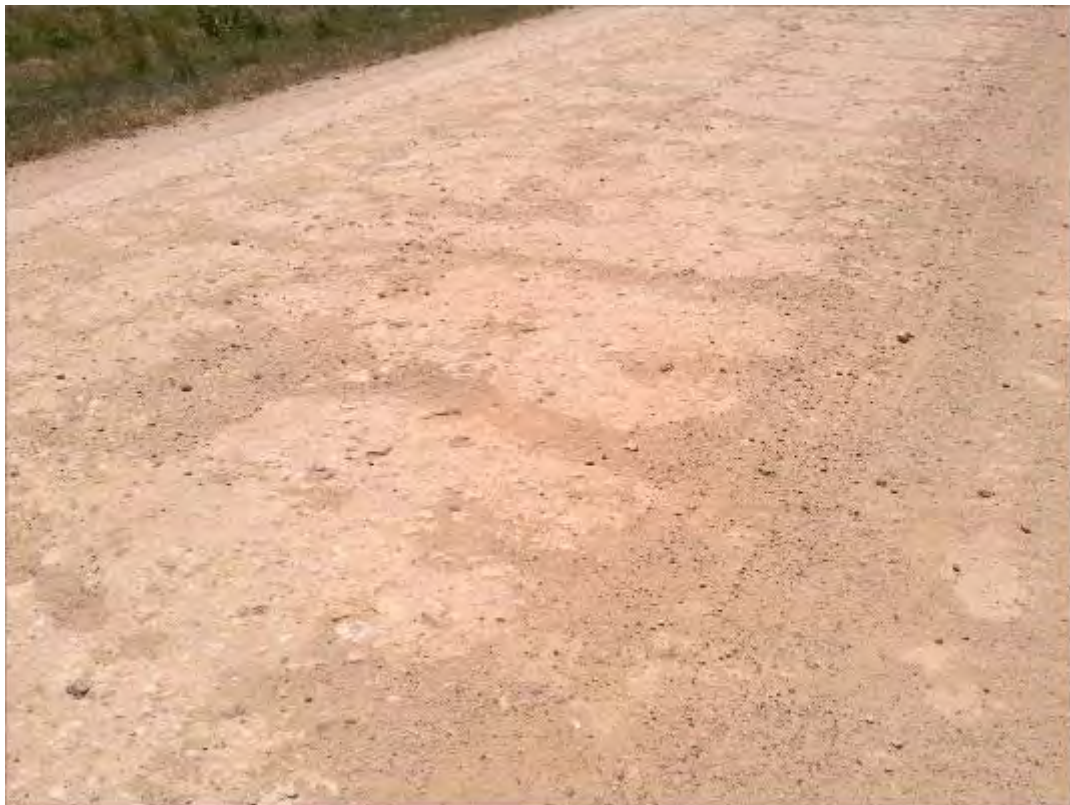
S232 – Road in poor condition

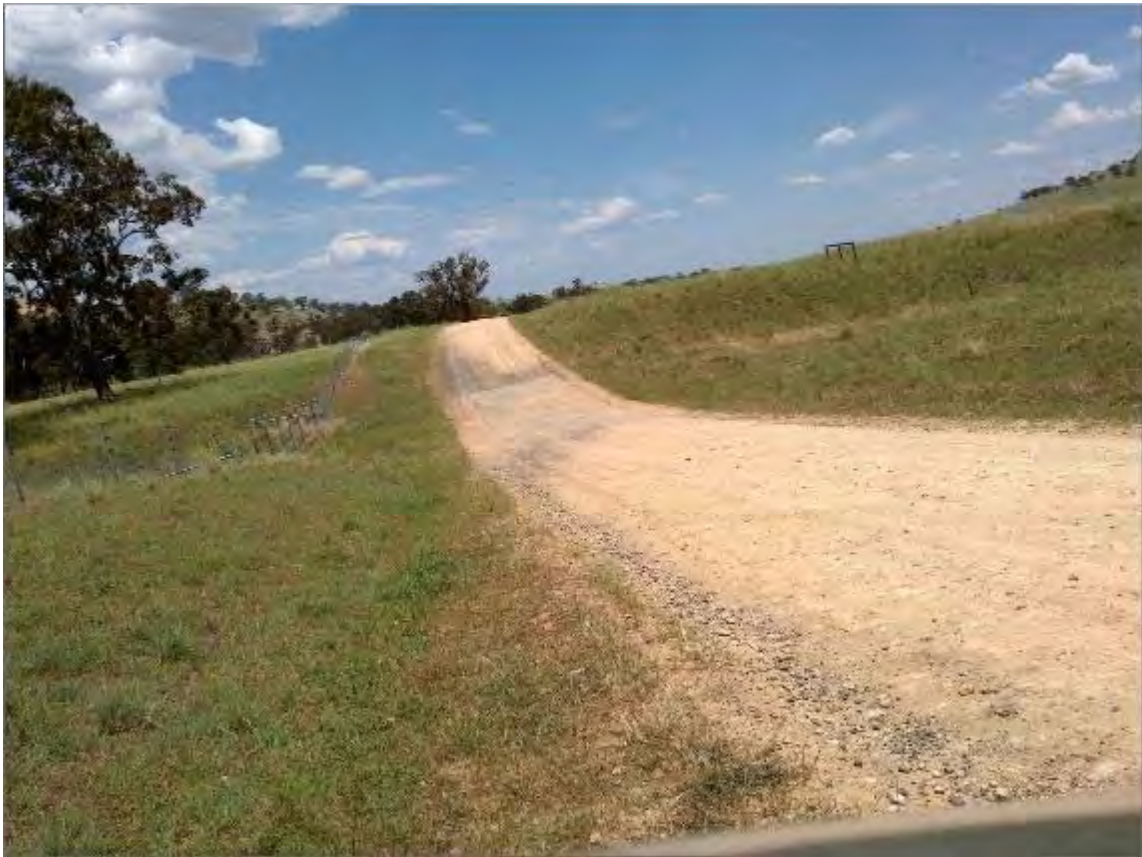
**S232 – Rotherwood Rd - 5400m North of Coolah Rd Intersection**  
Pipe Culvert of Unknown Dimensions  
Unknown Conditions

S232 – View to North and towards Location

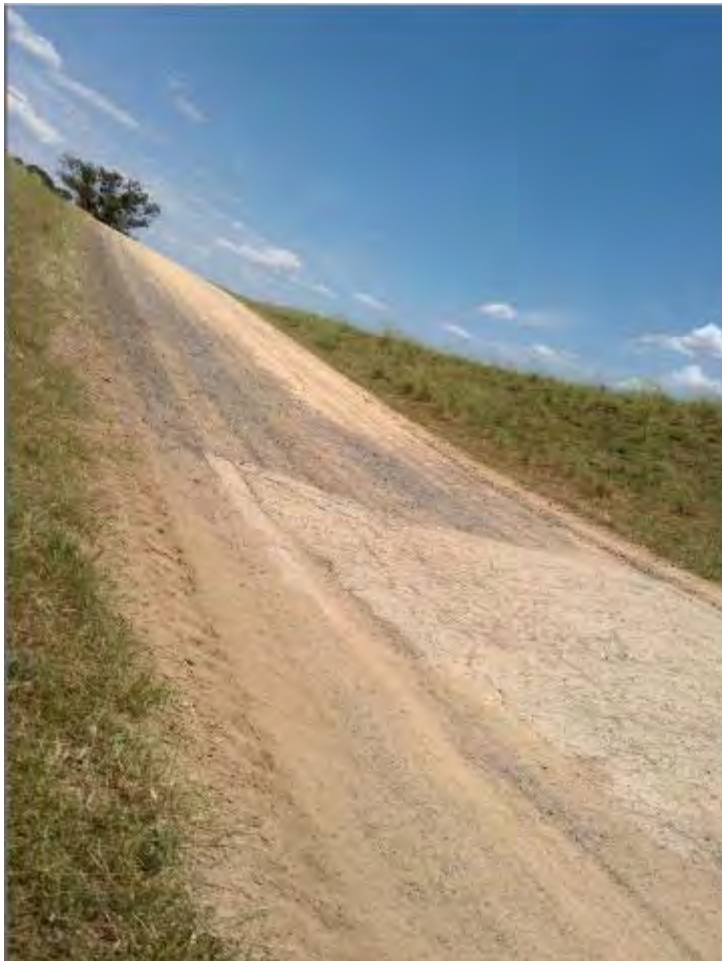
**S233 – Rotherwood Rd - 5300m North of Coolah Rd Intersection**  
Causeway, may require upgrade  
Poor Condition and Serviceable,

S233 – View to North

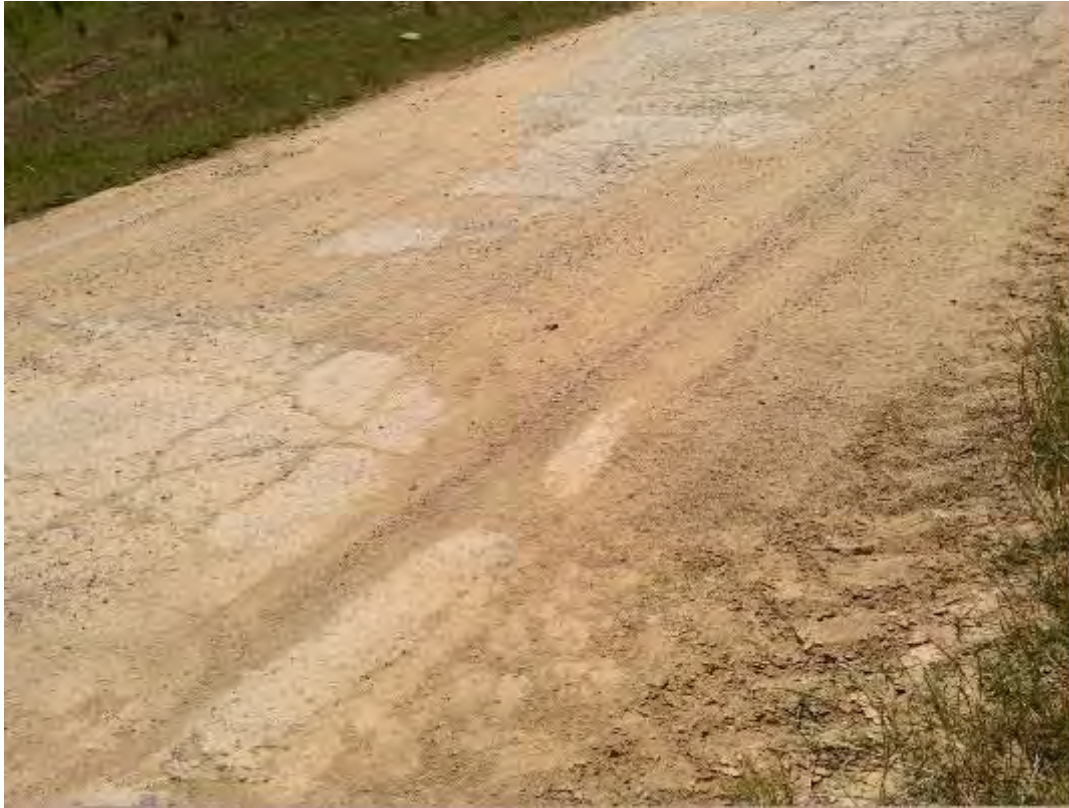
S233 – Causeway in Poor Condition

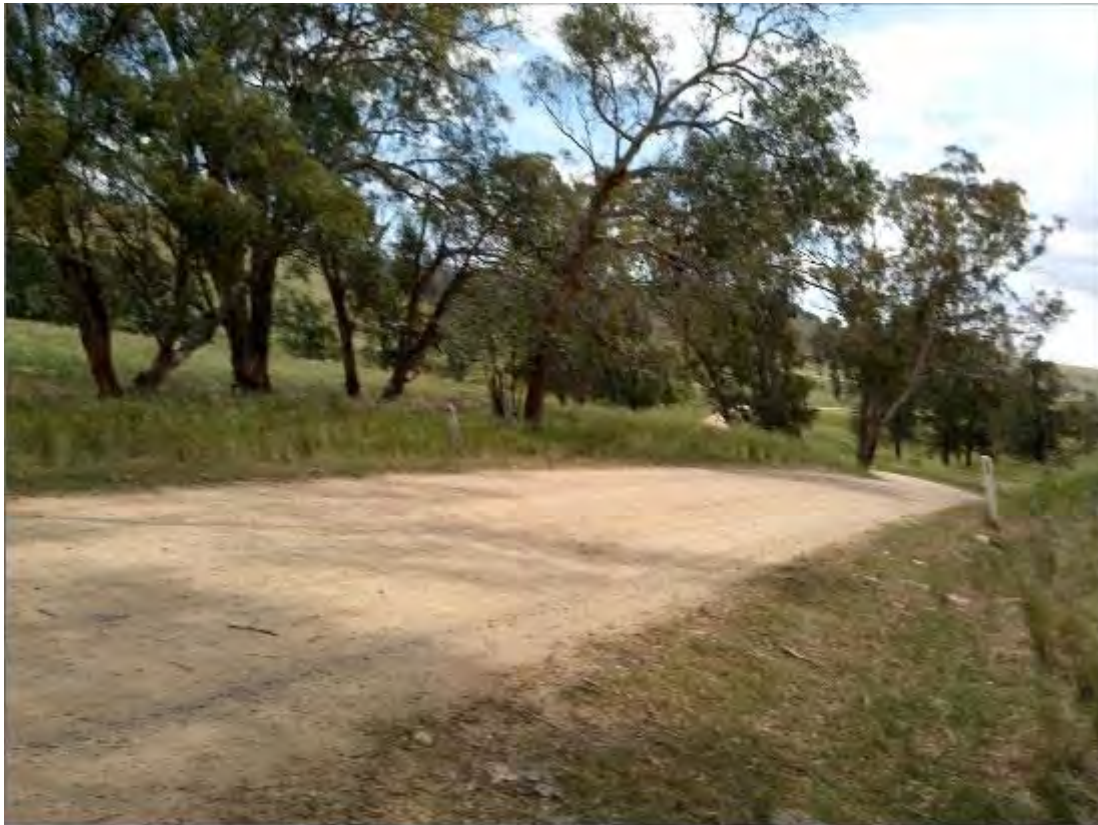
**S234 – Rotherwood Rd - 4700m North from Coolah Rd Intersection**  
Pipe Culvert of unknown dimensions  
Moderate Condition and Serviceable

**S234 – View to North**

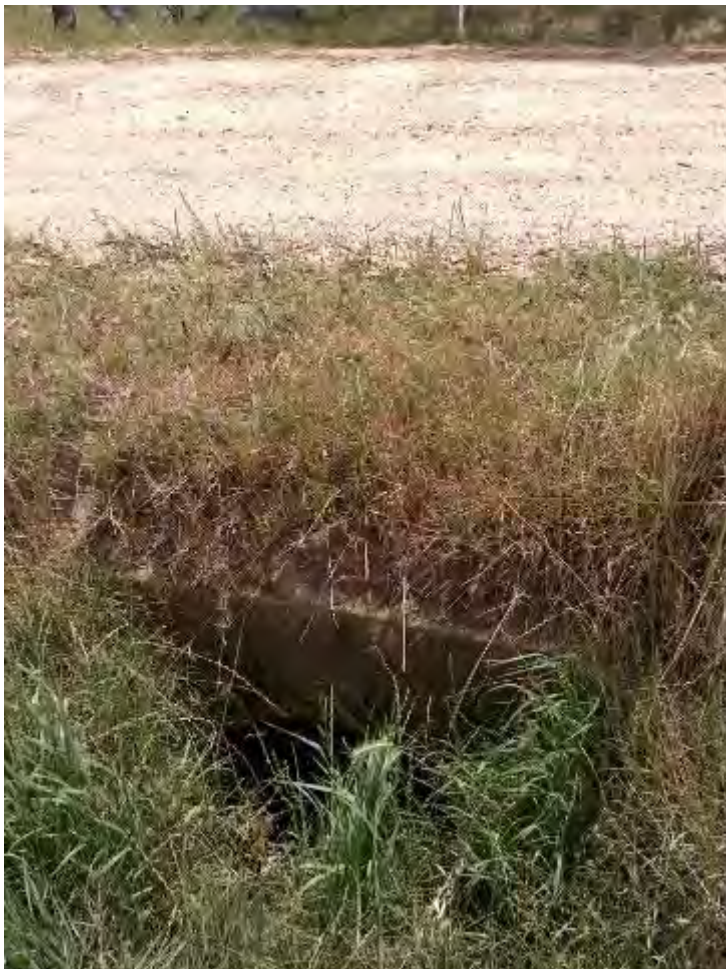
**S235 – Rotherwood Rd - 4600m North from Coolah Rd Intersection**  
600mm Pipe Culvert  
Moderate Condition and Serviceable

S235 - 600mm Pipe Culvert

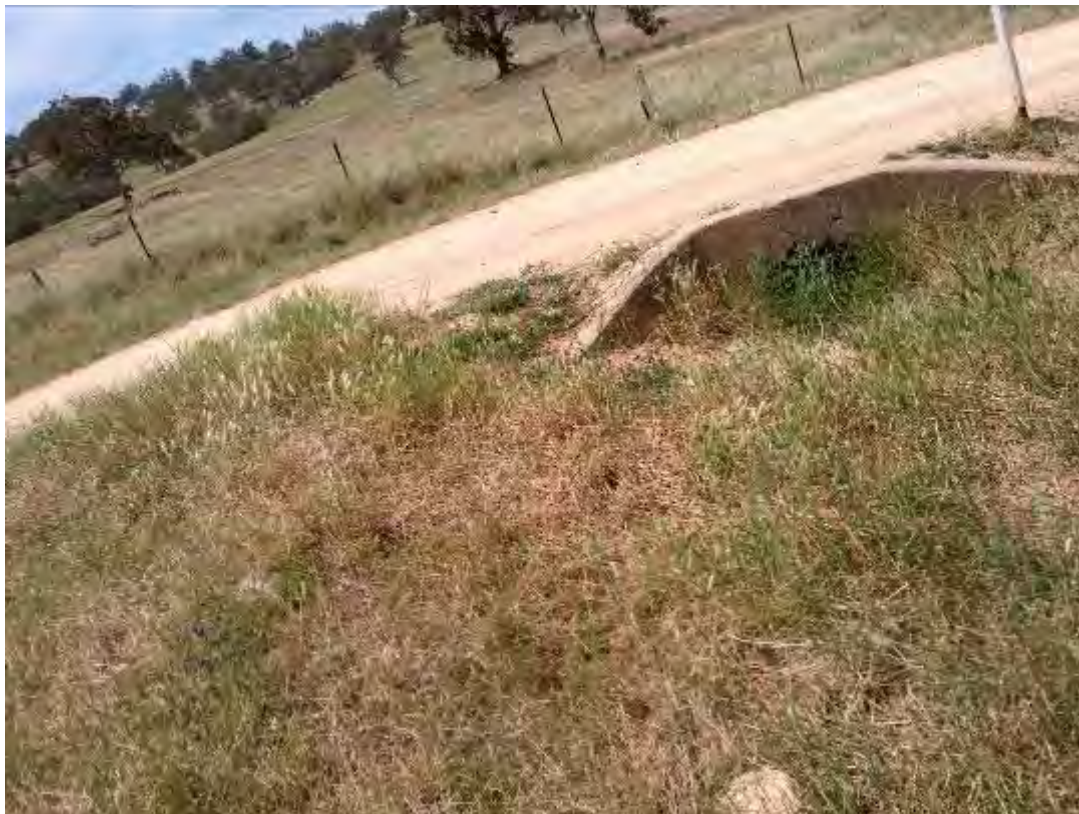
**S236 – Rotherwood Rd - 4600m North from Coolah Rd Intersection**  
450mm Pipe Culvert, Small crack on headwall  
Moderate Condition and Serviceable

**S236 – 450mm Pipe Culvert**

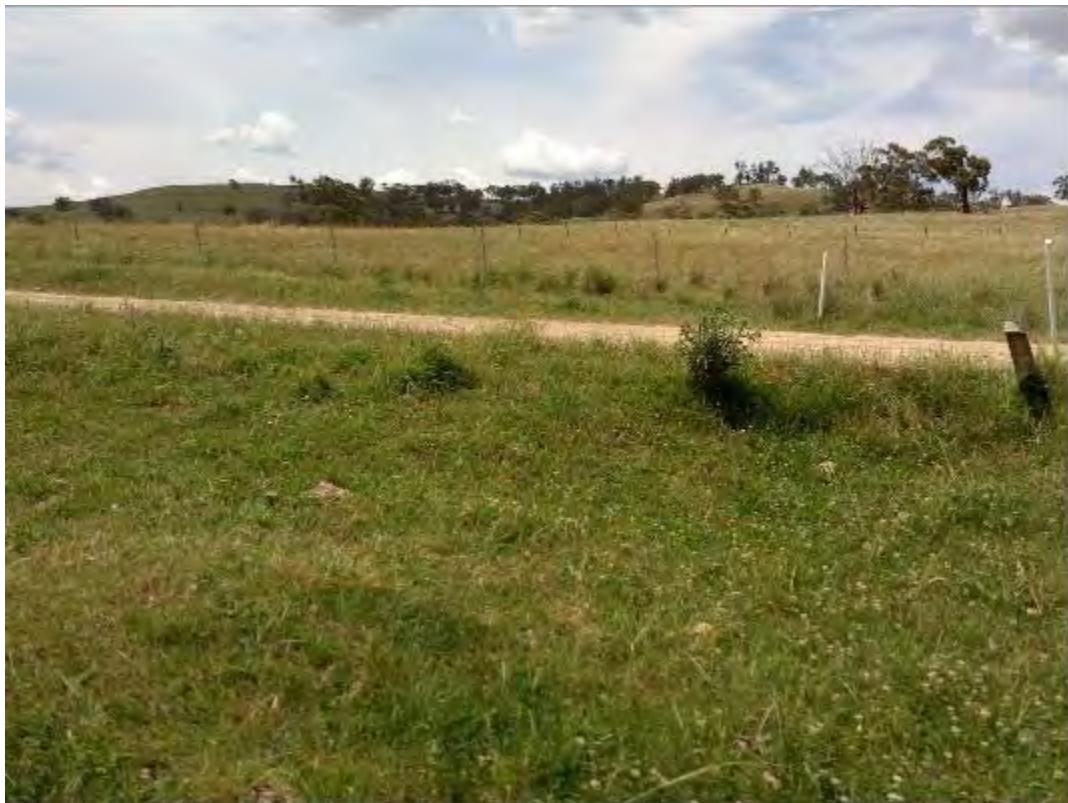
Poor Condition and Serviceable, Culvert is overgrown may require maintenance or upgrade

**S237 – Overgrown Culvert on Right Side of image**

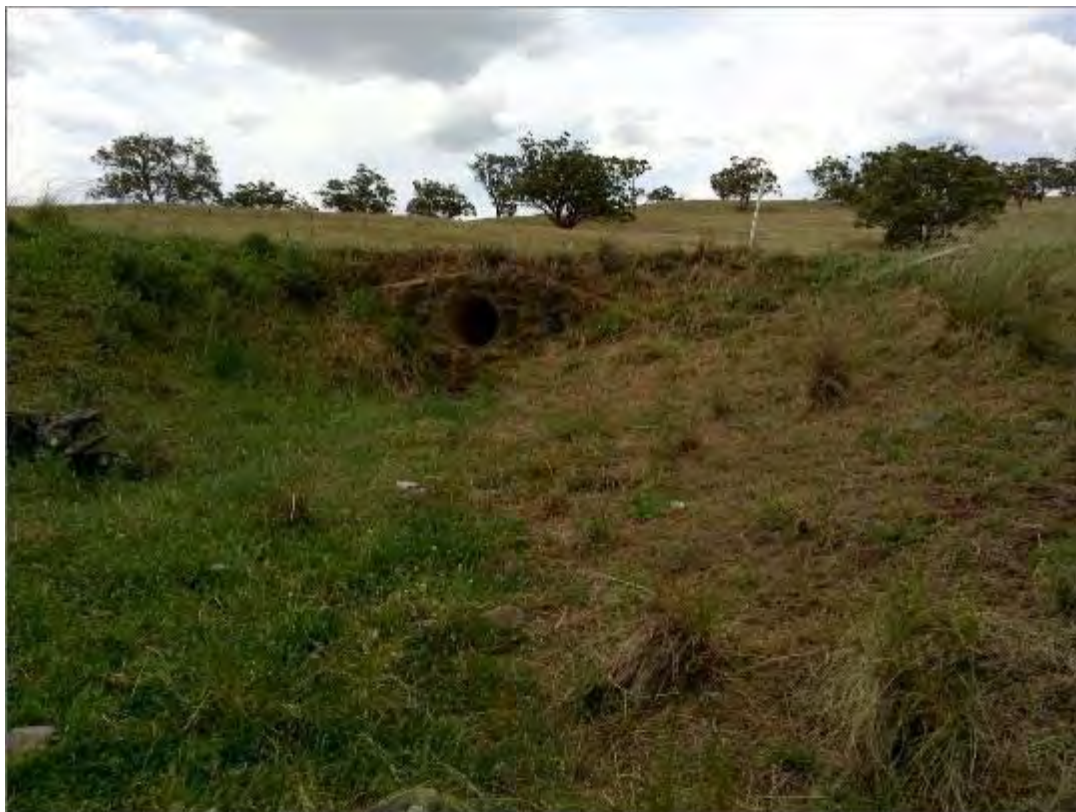
**S238 – Rotherwood Rd - 3900m North of Coolah Rd Intersection**  
750mm Pipe Culvert  
Good Condition and Serviceable

S238 – 750mm Pipe Culvert  
Level 2, 39 Sherwood Road  
Toowong QLD 4066

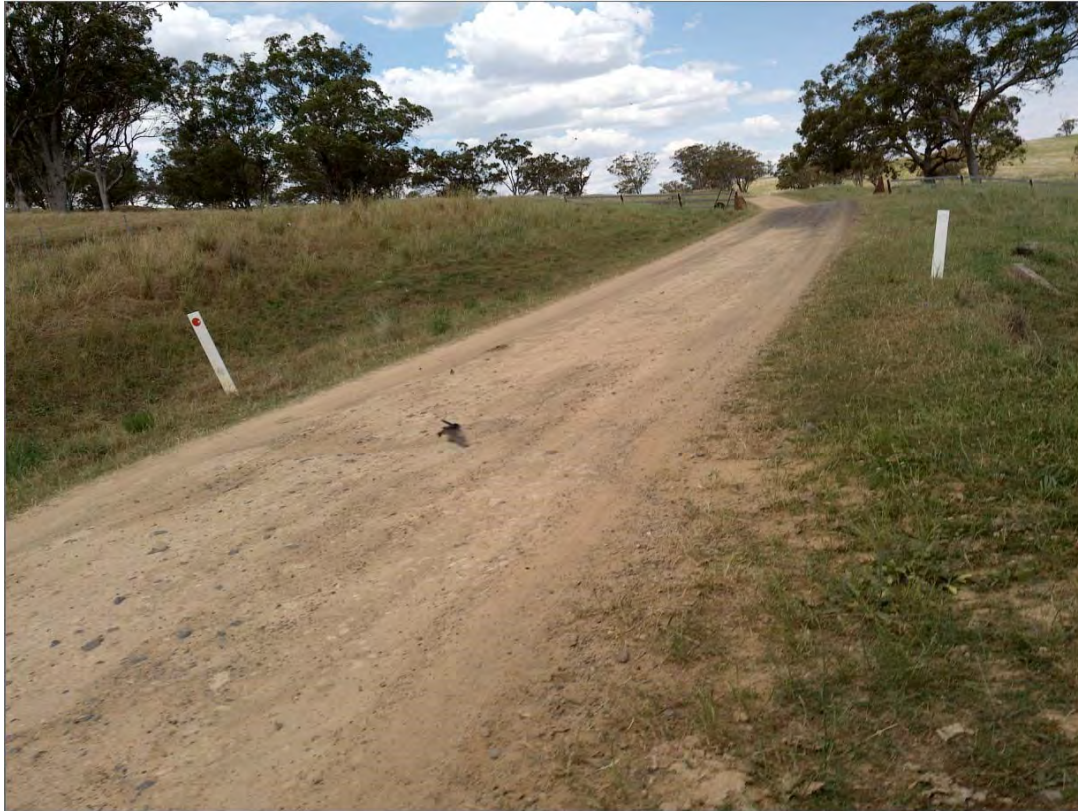
S238 – View to South

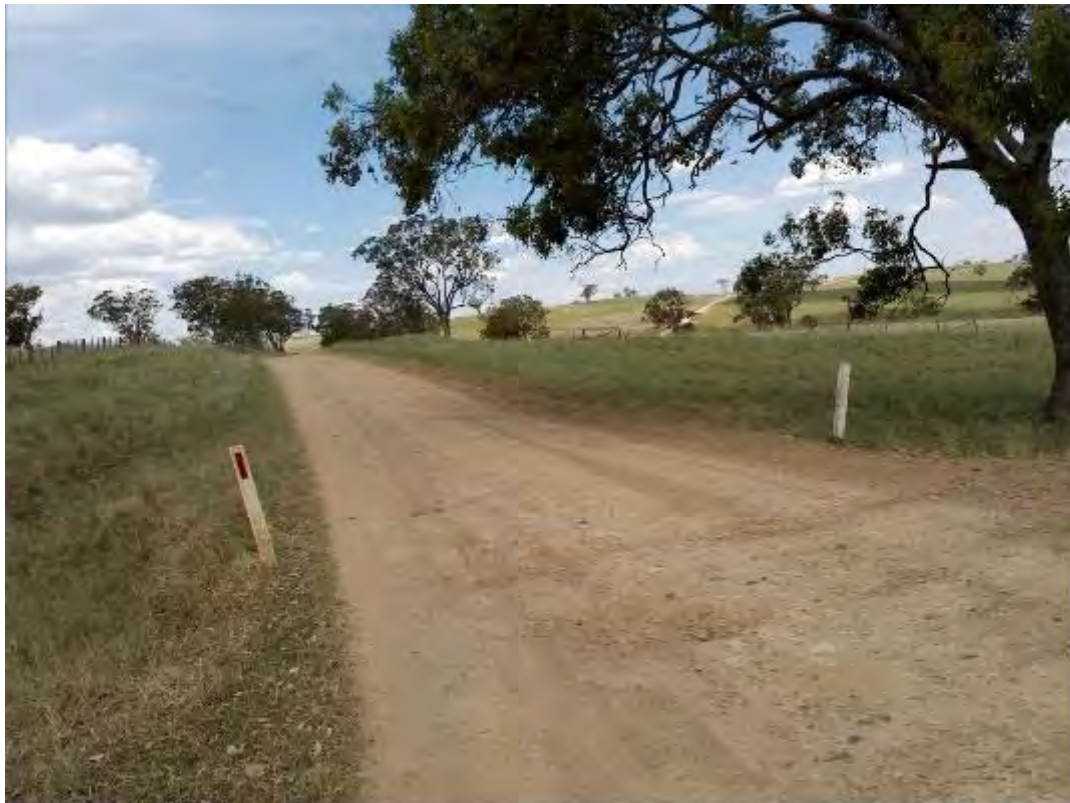
**S239 – Rotherwood Rd - 3700m North of Coolah Rd Intersection**  
525mm Pipe Culvert  
Fair Condition and Serviceable

**S239 – View to South**
