**S198 – Rotherwood Rd - 1600m West of Yarrawonga Rd**  
A Culvert is required for this location

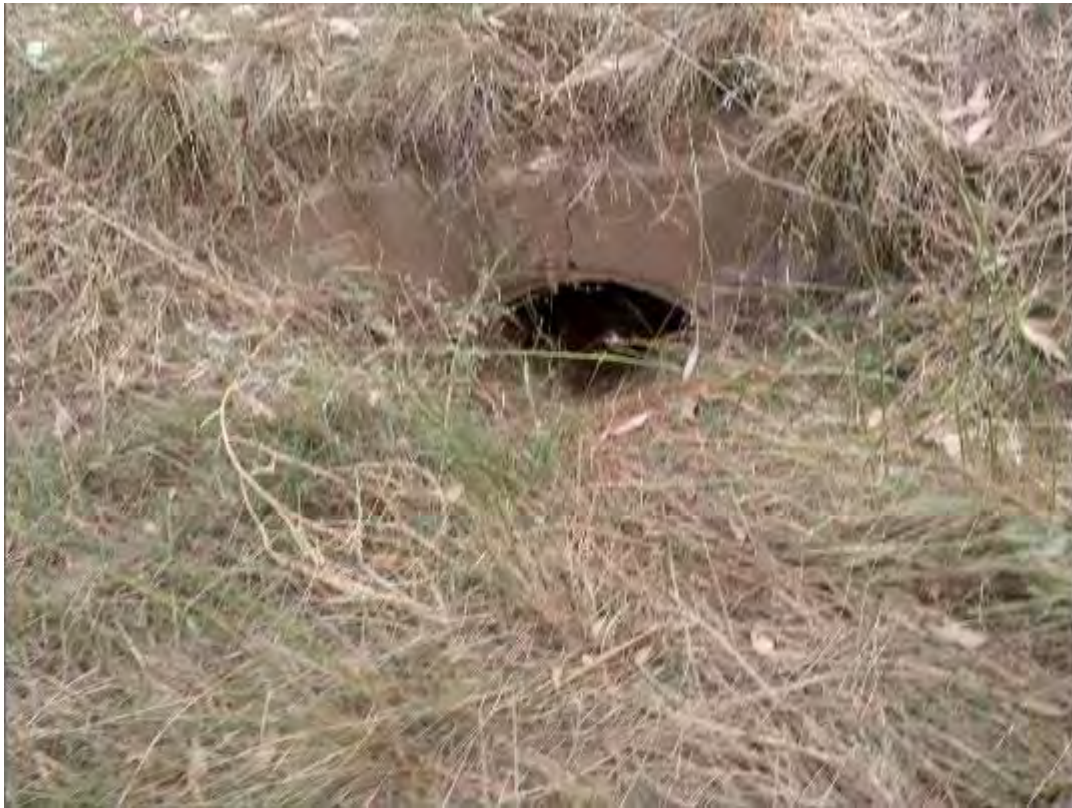
**S239 – Rotherwood Rd - 3700m North of Coolah Rd Intersection**  
525mm Pipe Culvert  
Fair Condition and Serviceable

S239 – 525mm Pipe Culvert

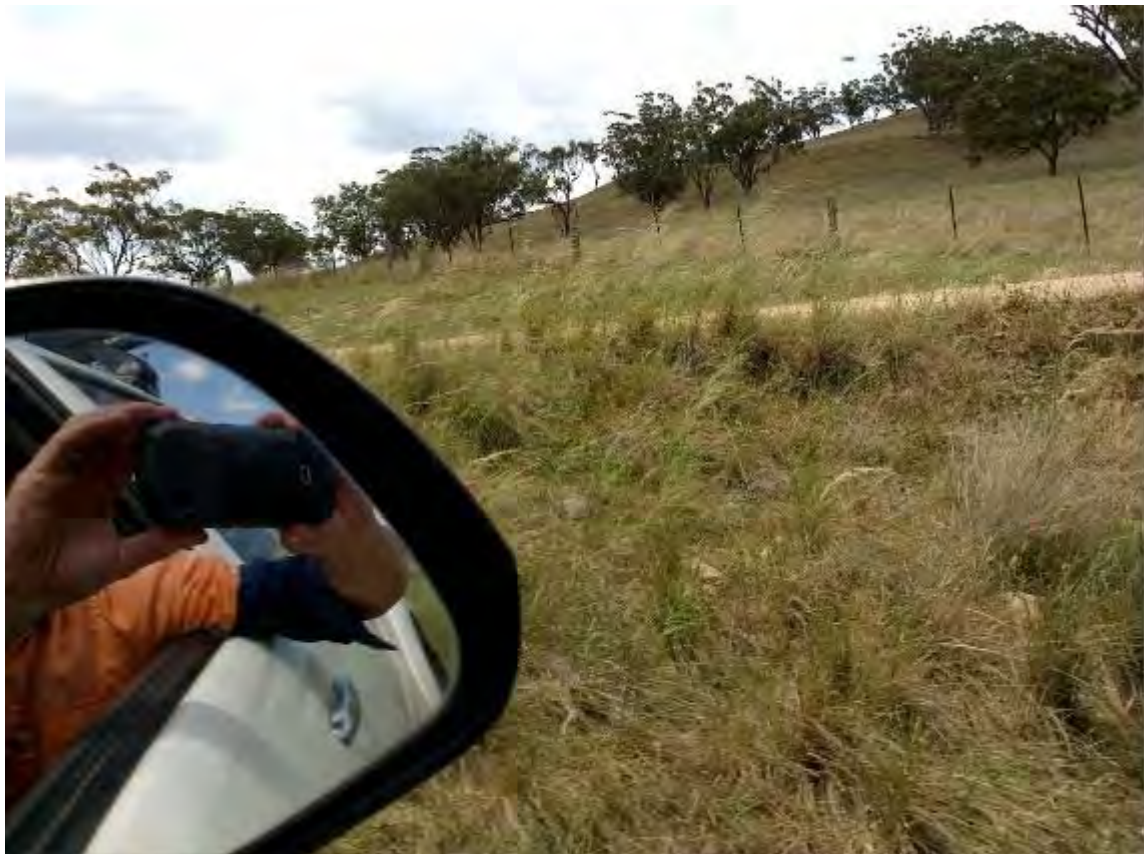
**S240 – Rotherwood Rd - 3600m North of Coolah Rd Intersection**  
Pipe Culvert of Unknown Dimensions  
Moderate Condition and Serviceable

S240 – Pipe Culvert Top Right of Image  
Level 2, 39 Sherwood Road  
Toowong QLD 4066

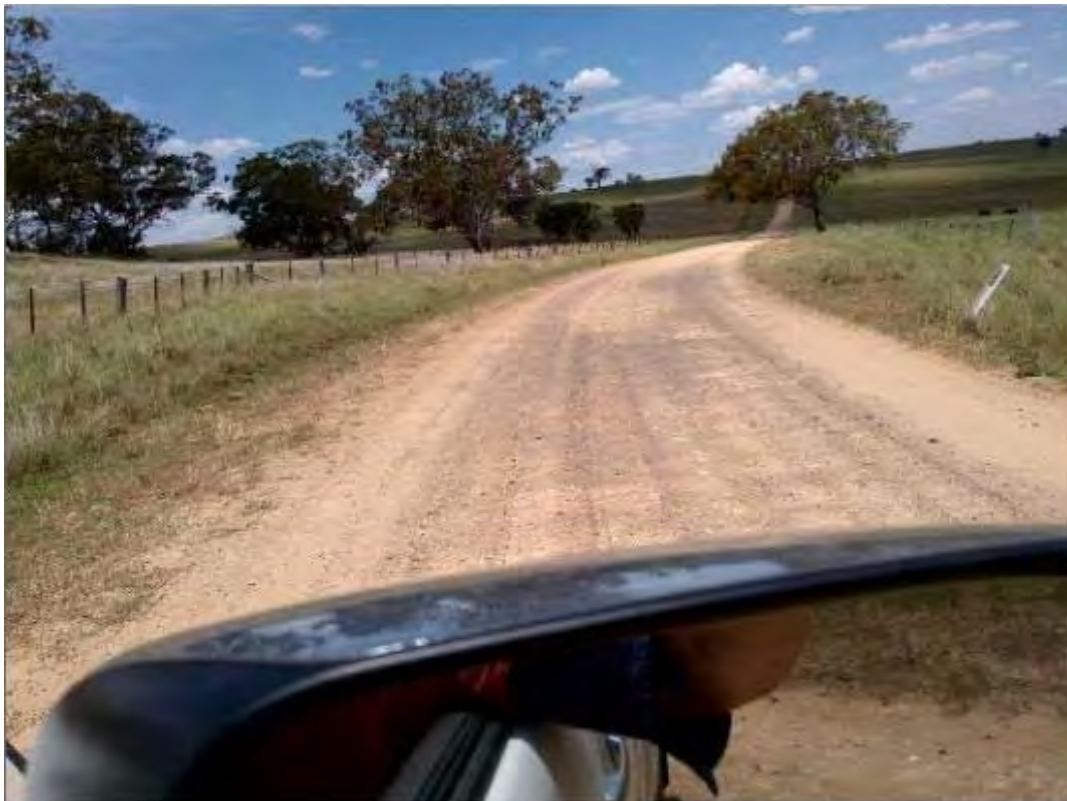
**S241 - Rotherwood Rd - 3550m North of Coolah Rd Intersection**  
Pipe Culvert of Unknown Dimensions  
Moderate Condition and Serviceable

S241 – View to South

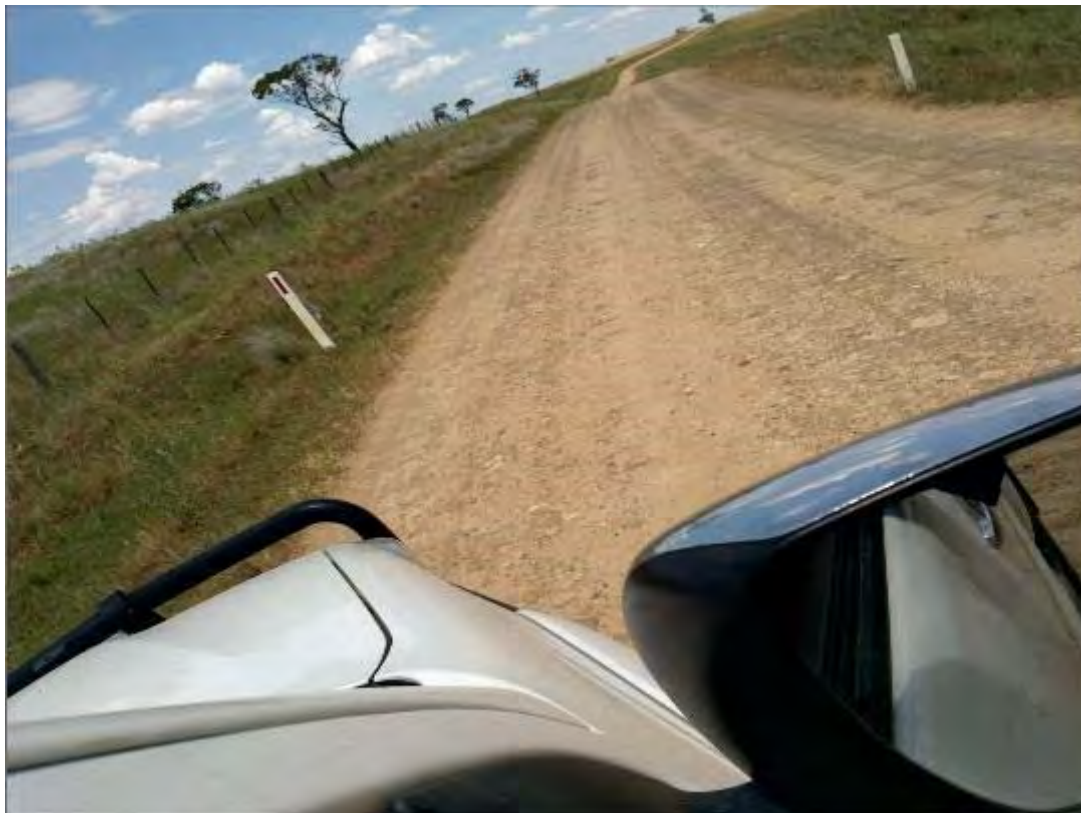
S242 – View to

**S242 – Rotherwood Rd - 2900m North of Coolah Rd Intersection**  
Pipe Culvert of Unknown Dimensions, Culvert is overgrown  
Moderate Condition and Serviceable, may require some maintenance

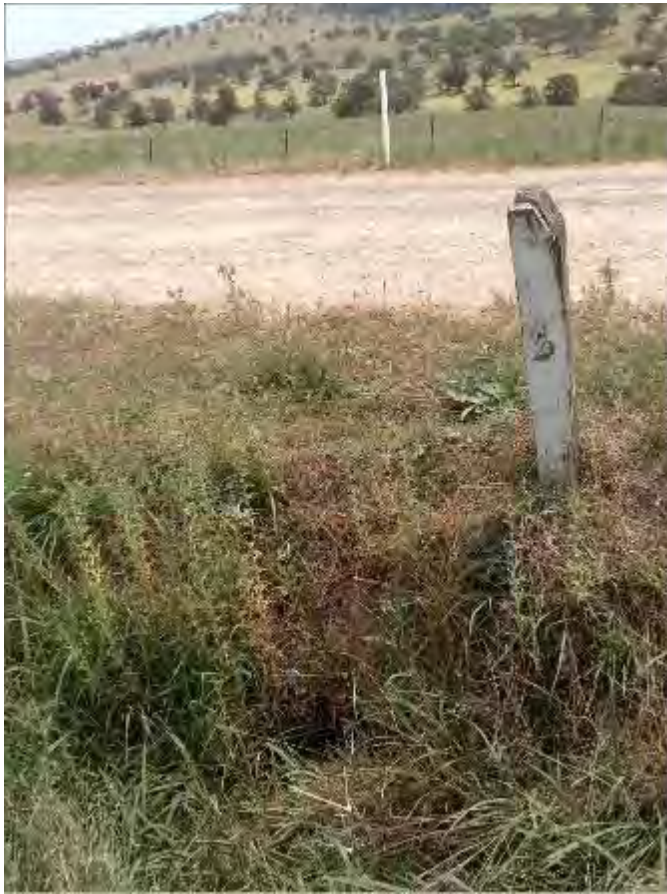
S242 – Overgrown Culvert

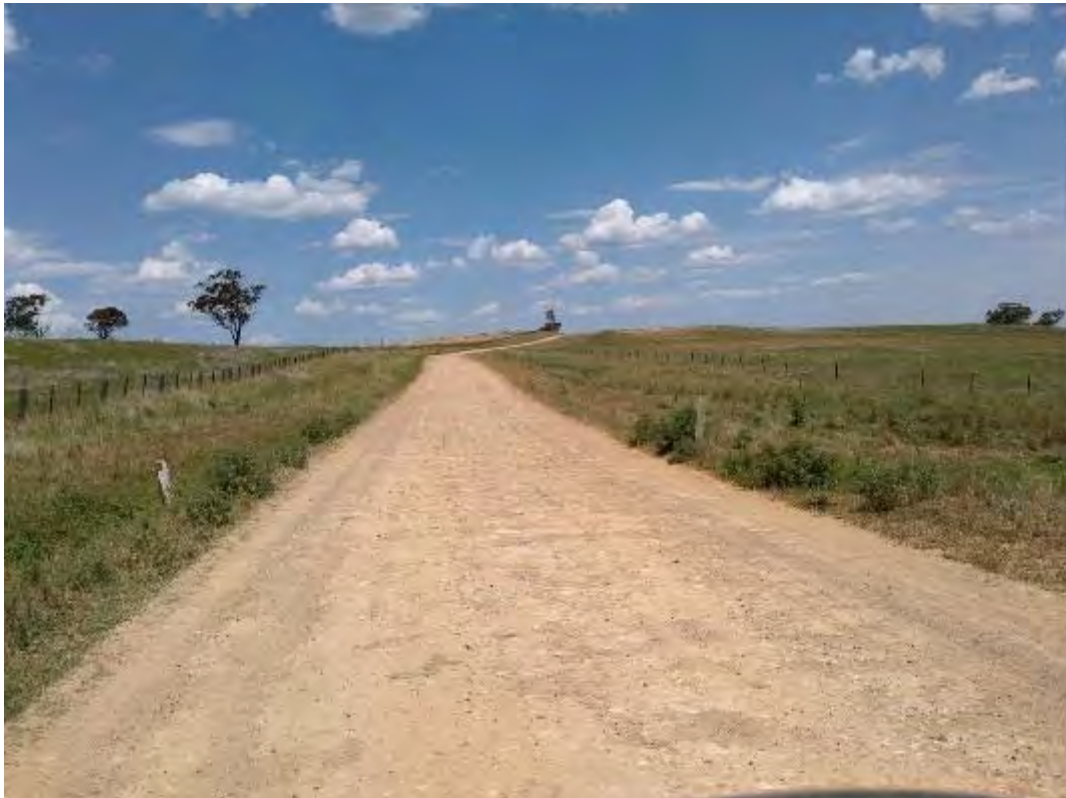
**S243 – Rotherwood Rd - 2600m North of Coolah Rd Intersection**  
Blocked Pipe Culvert,  
Moderate Condition

S243 – View to South

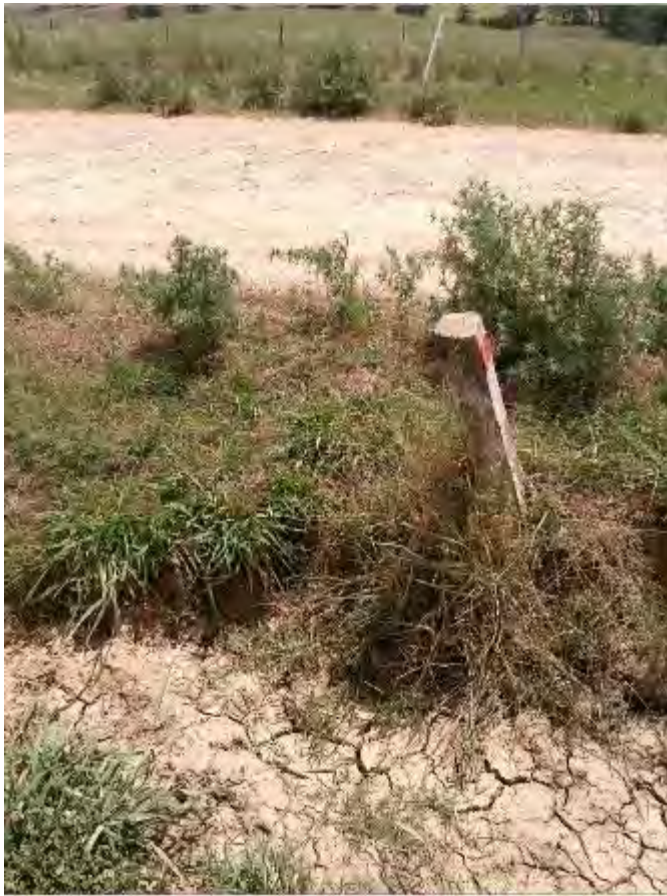
S243 – Blocked Pipe Culvert

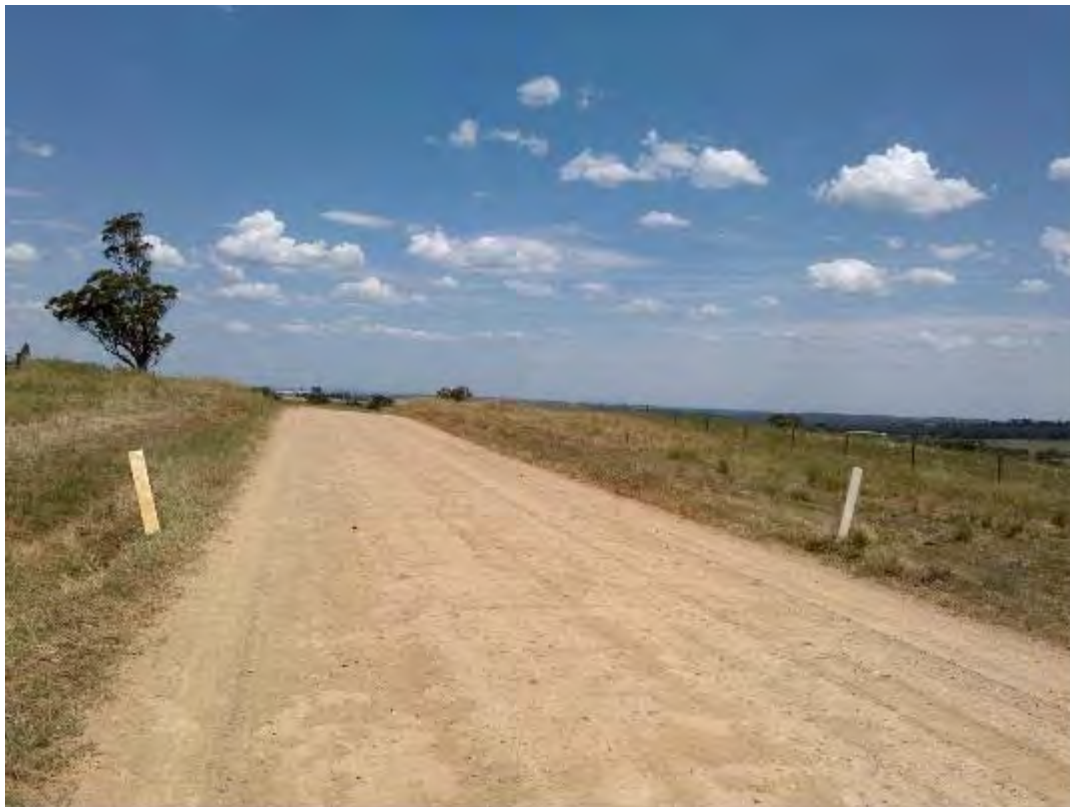
**S244 – View to South**

**S244 – Rotherwood Rd - 2100m North of Coolah Rd Intersection**  
450mm Pipe Culvert,  
Unknown Condition

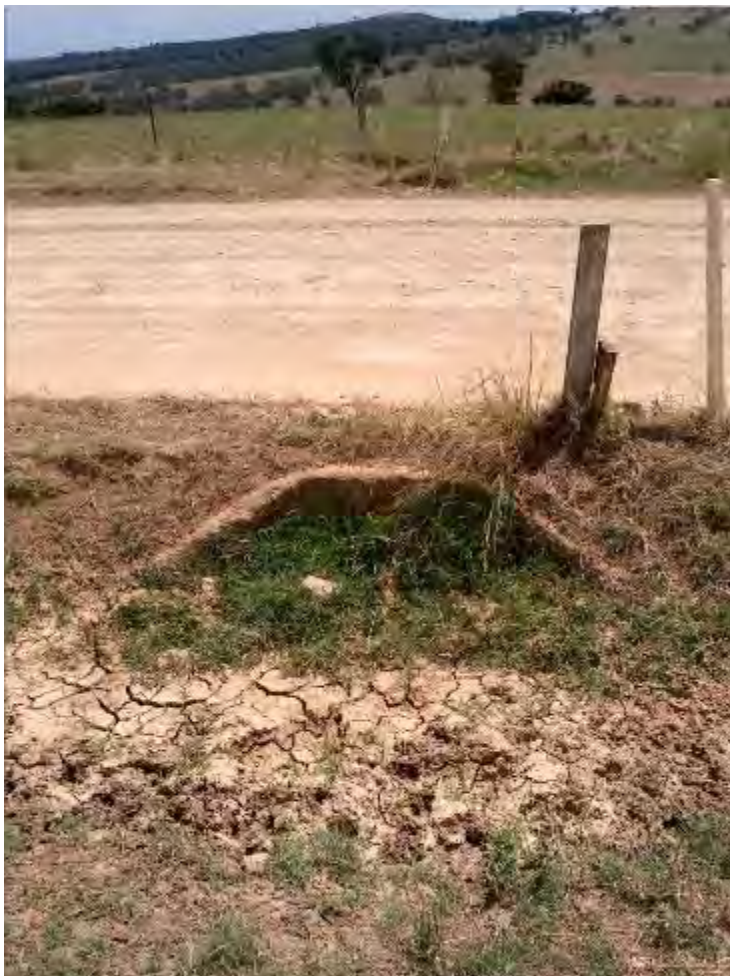
**S245 – Rotherwood Rd - 2100m North of Coolah Rd Intersection**  
Blocked Pipe Culvert of unknown Dimensions  
Poor Condition, may require Maintenance or Upgrade

S245 – Blocked Pipe Culvert

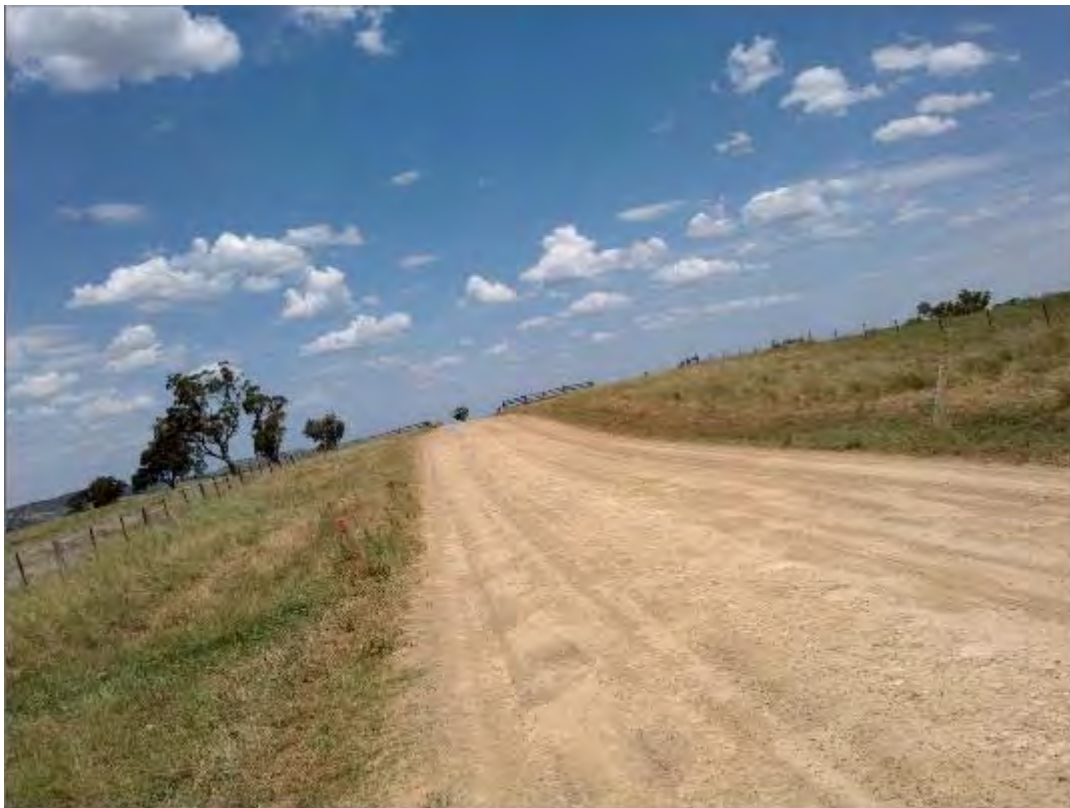
S246 – View to South

**S246 – Rotherwood Rd - 1800m North of Coolah Rd Intersection**  
Blocked Pipe Culvert  
Poor Condition and Serviceable, requires maintenance

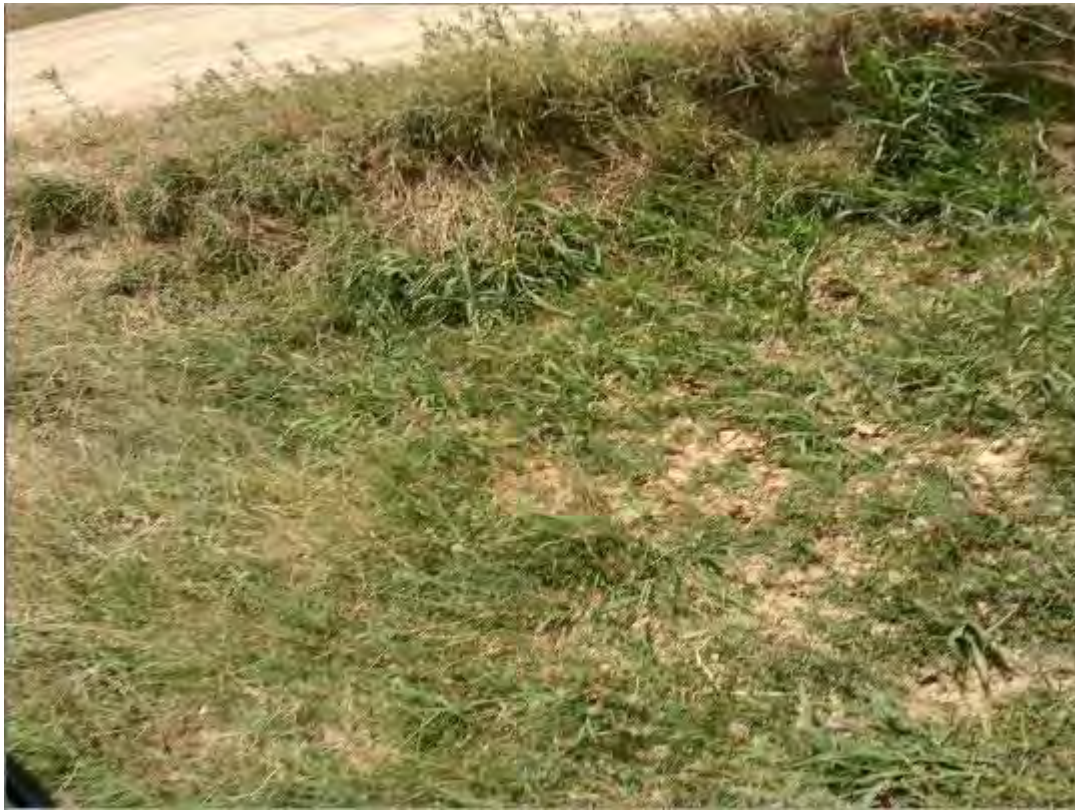
S246 – Blocked Pipe Culvert

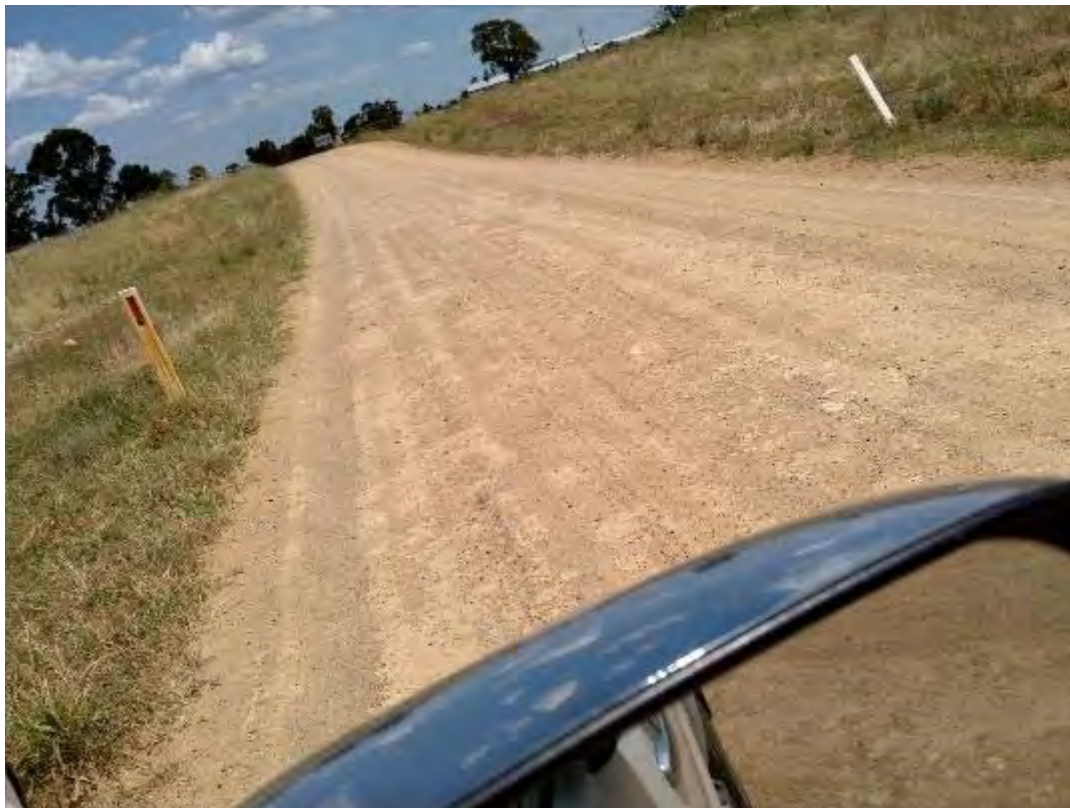
S247 - View to South

**S247 – Rotherwood Rd - 900m North of Coolah Rd Intersection**  
450mm Pipe Culvert  
Moderate condition and serviceable, requires maintenance.

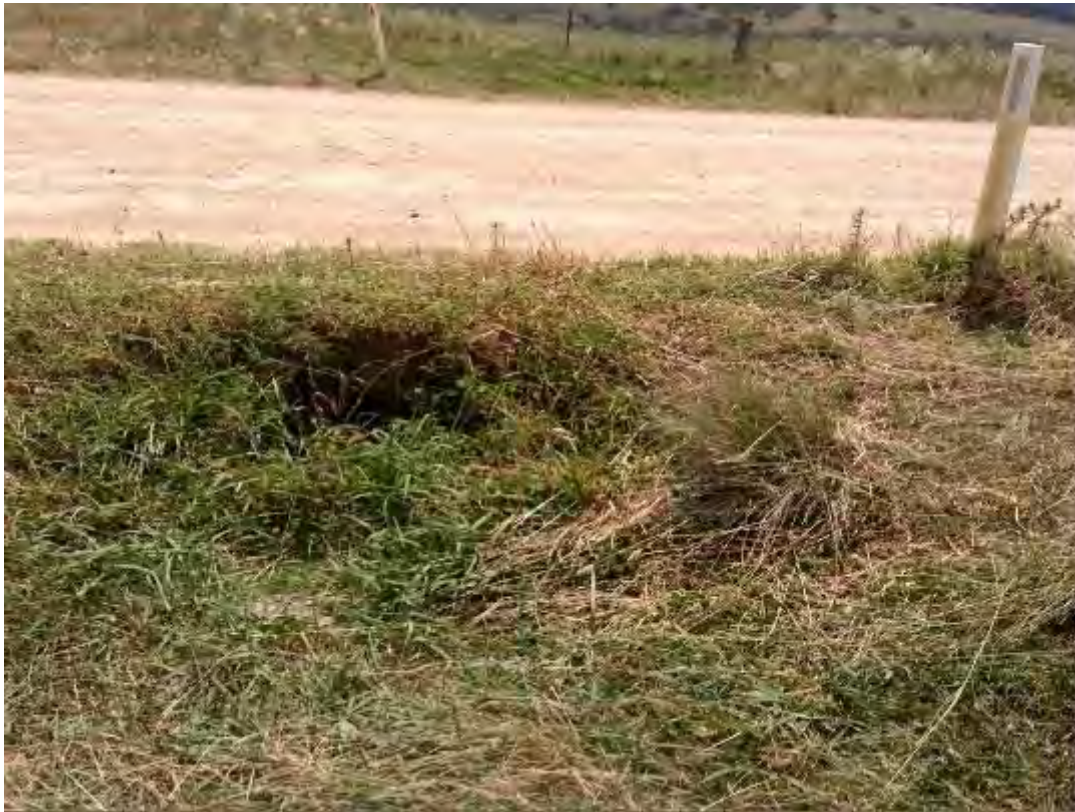
S247 – 450mm Pipe Culvert

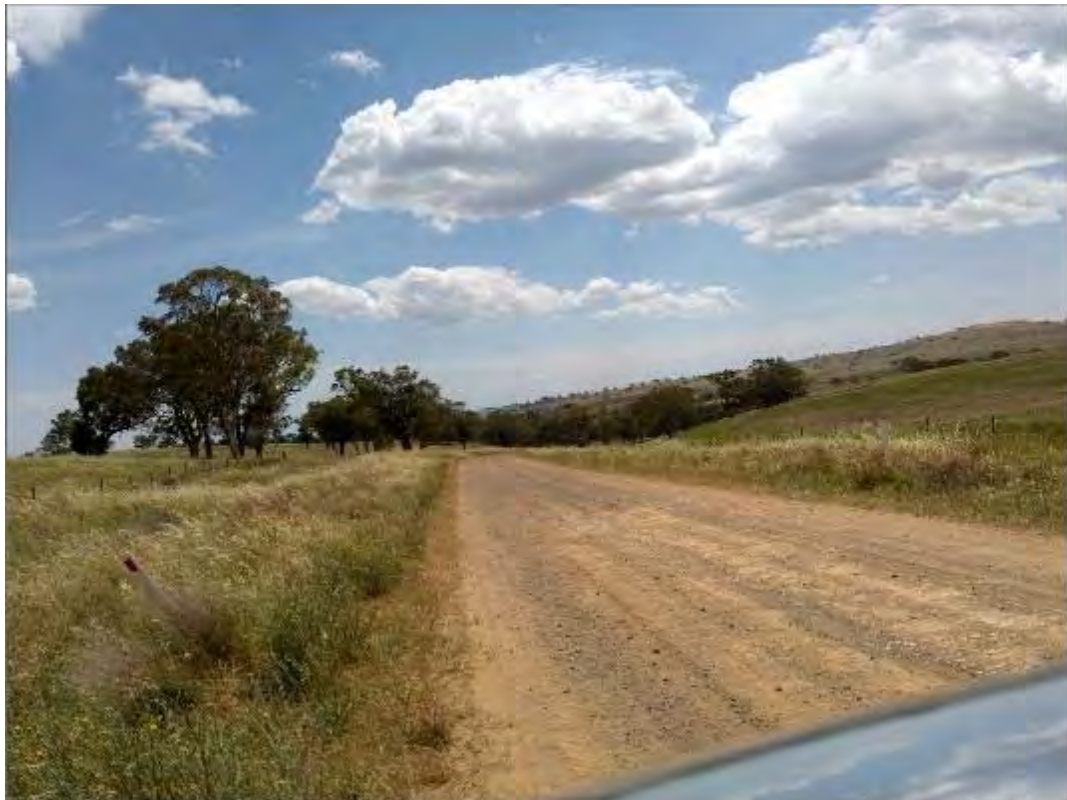
**S252 – View to East**

**S252 – Coolah Rd - 700m East of Rotherwood Rd Intersection**  
600mm Pipe Culvert  
Condition Unknown

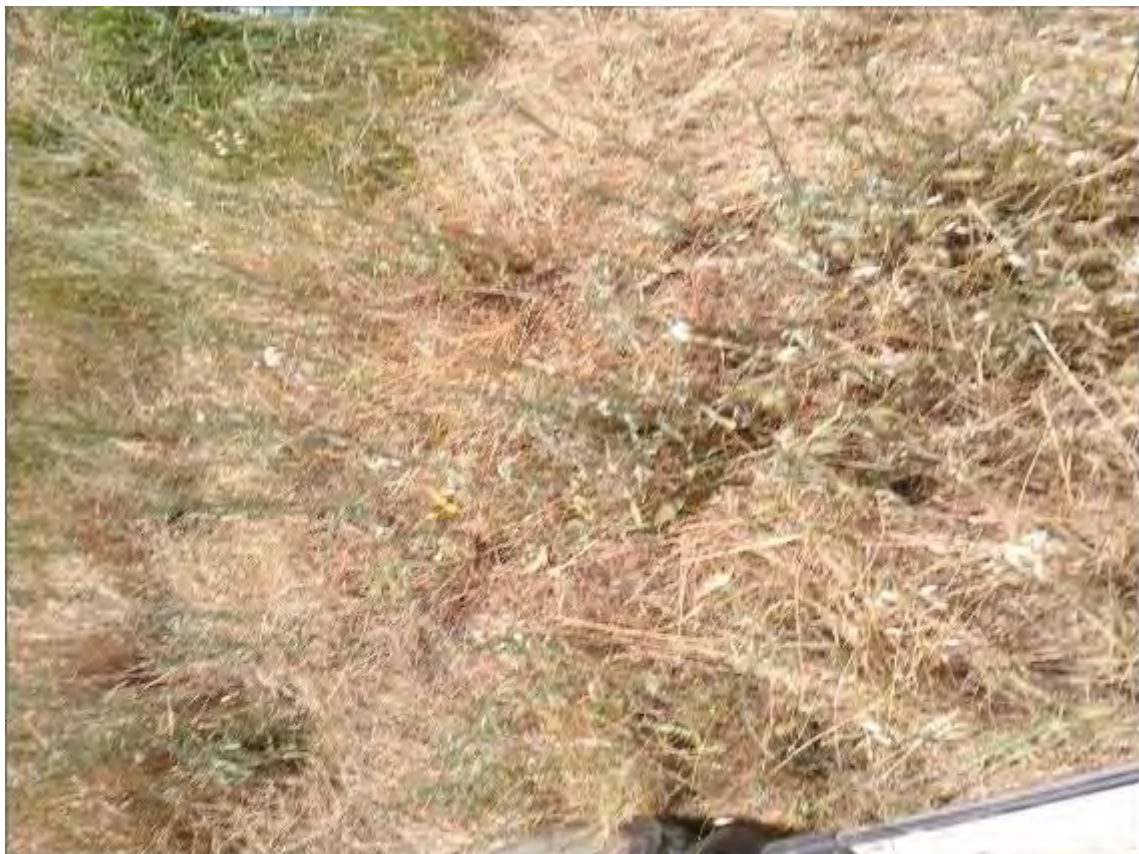
S253 – View in the direction of Culvert

**S253 – Coolah Rd - 1000m East of Rotherwood Rd Intersection**  
750mm Pipe Culvert  
Condition Unknown

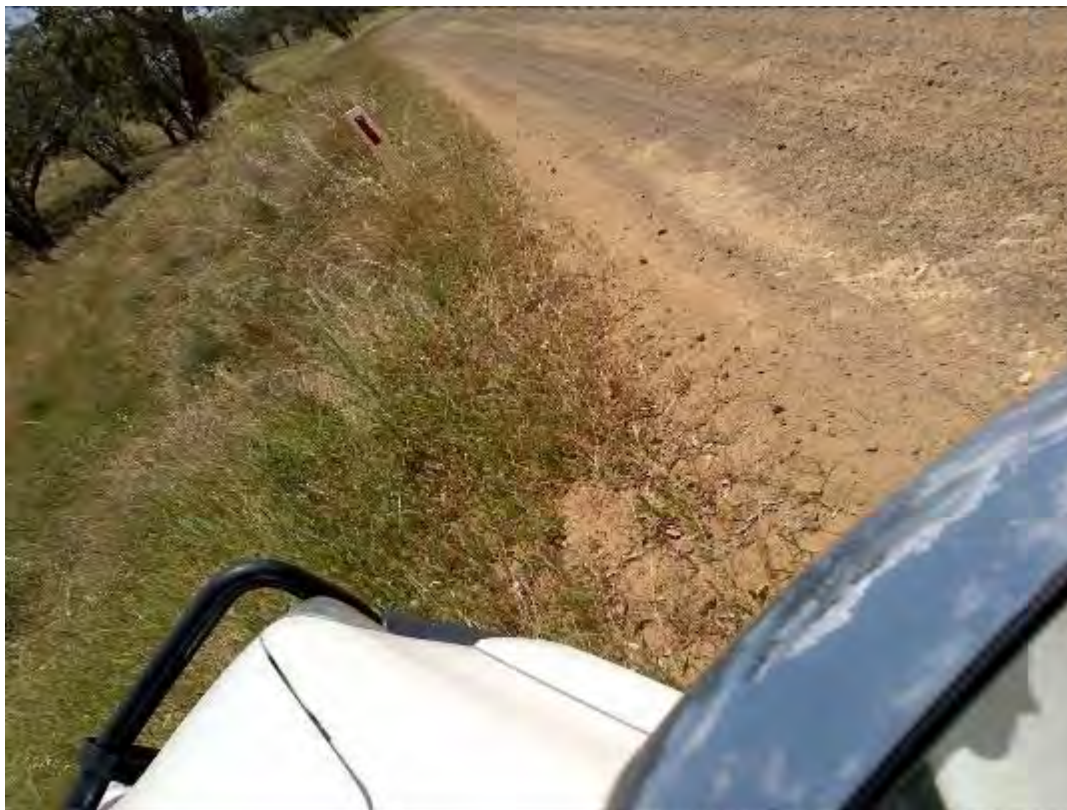
**S254 – View to East**

**S254 – Coolah Rd - 1100m East of Rotherwood Rd Intersection**  
675mm Pipe Culvert  
Fair Condition and Serviceable

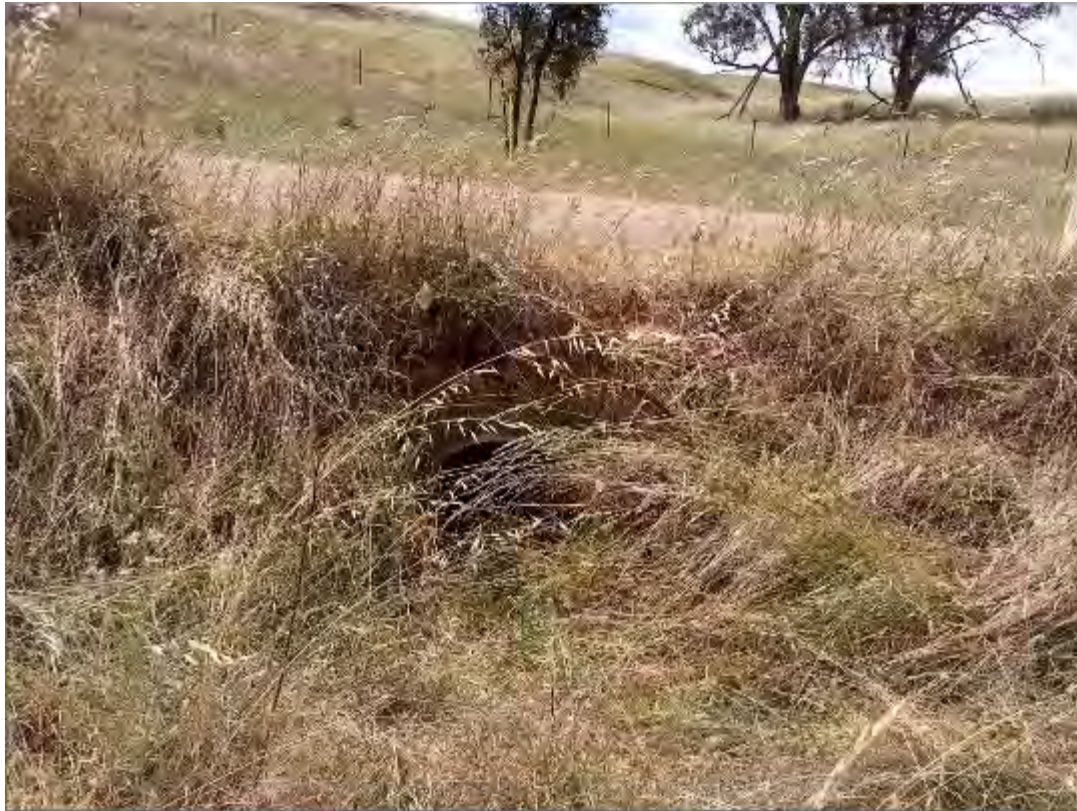
S254 - 675mm Pipe Culvert

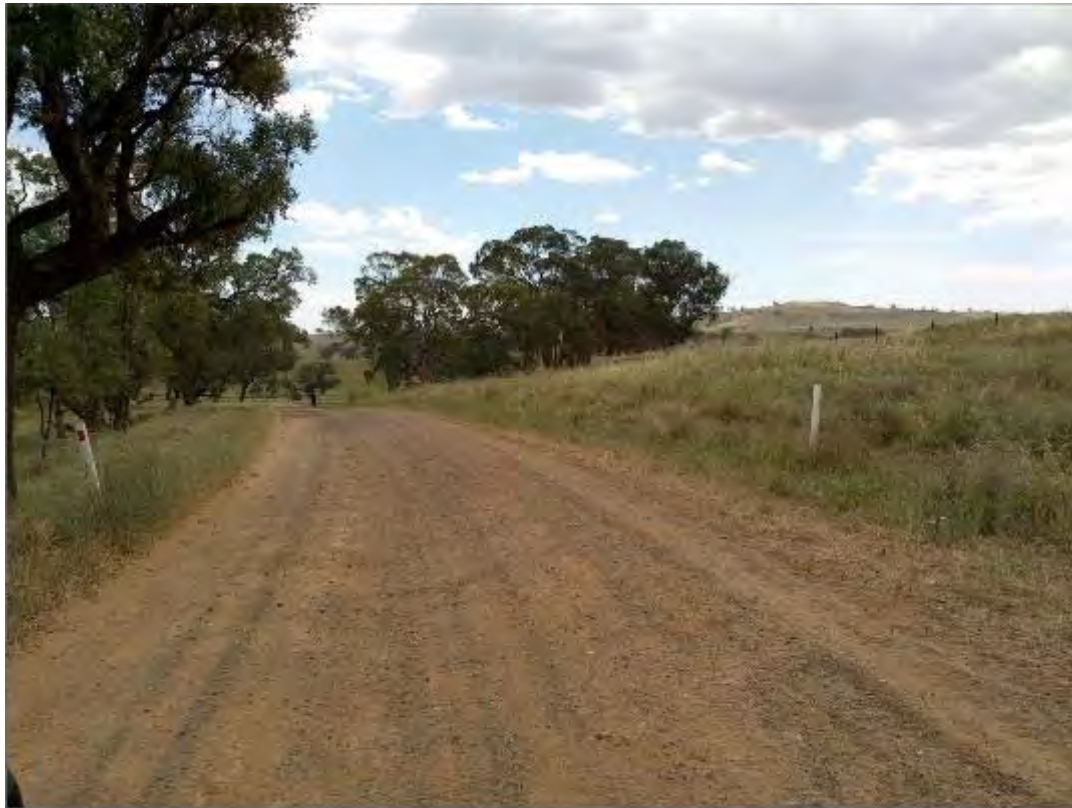
S254 – View to east

**S254 – Coolah Rd - 1400m East of Rotherwood Rd Intersection**  
Pipe Culvert of Unknown Dimensions  
Unknown Conditions

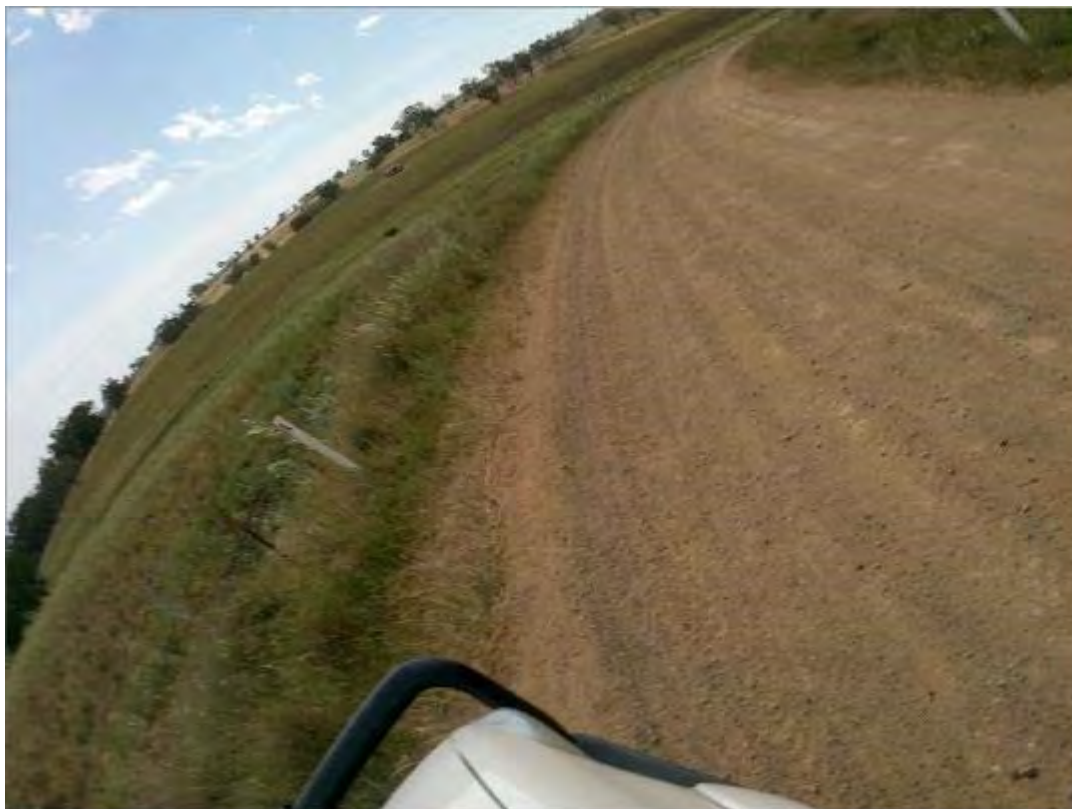
S255 – View to west

Pipe Culvert of Unknown Dimensions  
Unknown Condition

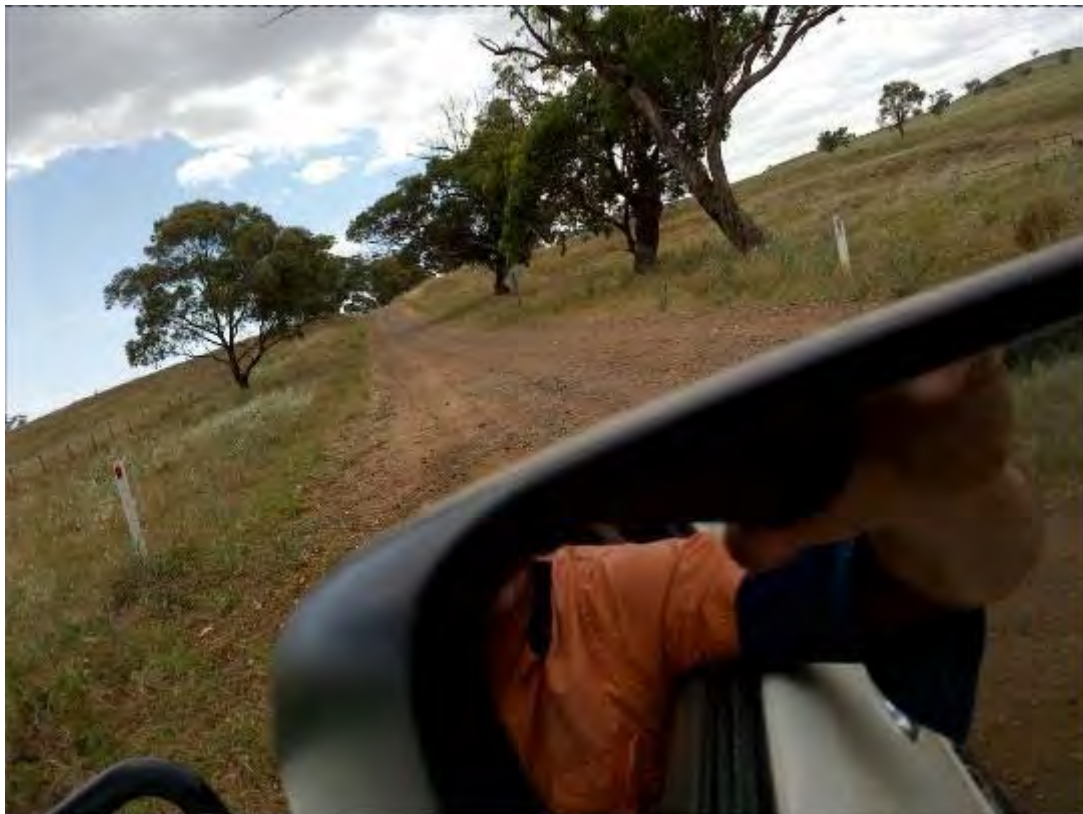
S256 – View to west

**S256 – Coolah Rd - 2300m East of Rotherwood Rd Intersection**  
Pipe Culvert of Unknown Dimensions  
Unknown Condition

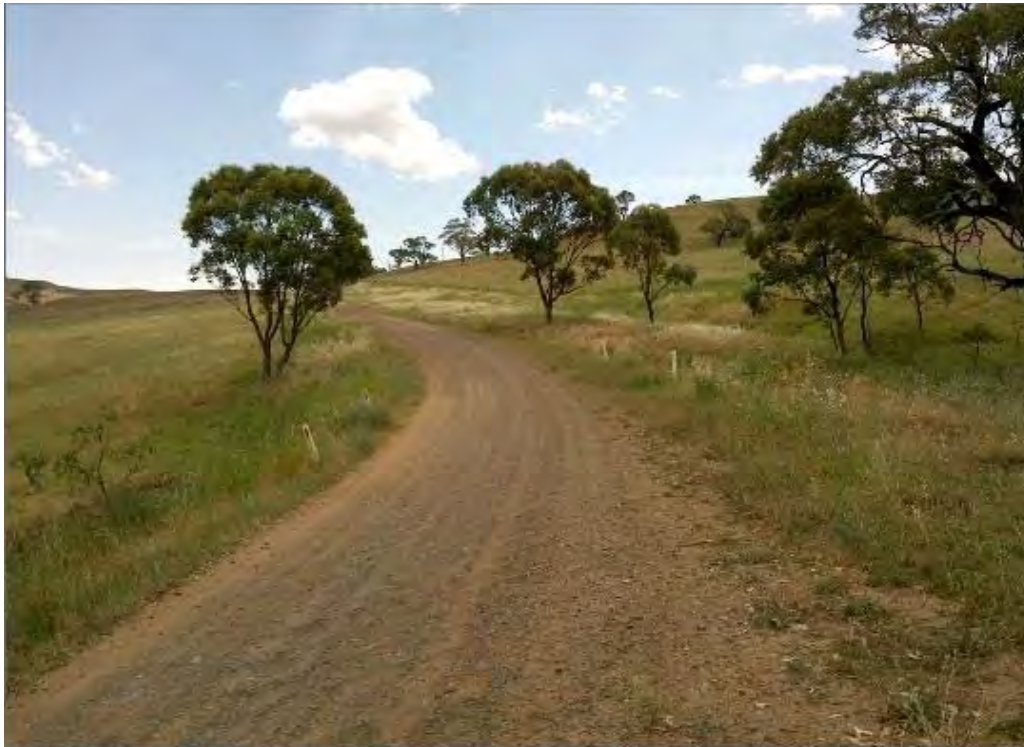
S258 – View to West towards location

**S258 – Coolah Rd - 3300m East of Rotherwood Rd Intersection**  
Pipe Culvert of Unknown Dimensions  
Horizontal Geometry and Trees to be surveyed to verify against proposed  
transport configurations
