**Rye Park Wind Farm  
Aboriginal Cultural Heritage Assessment Report**

A report to Epuron

October 2013

Proponent: Rye Park Wind Farm Pty Ltd  
Local Government Area: Yass Valley, Boorowa, and Upper Lachlan Shire Councils

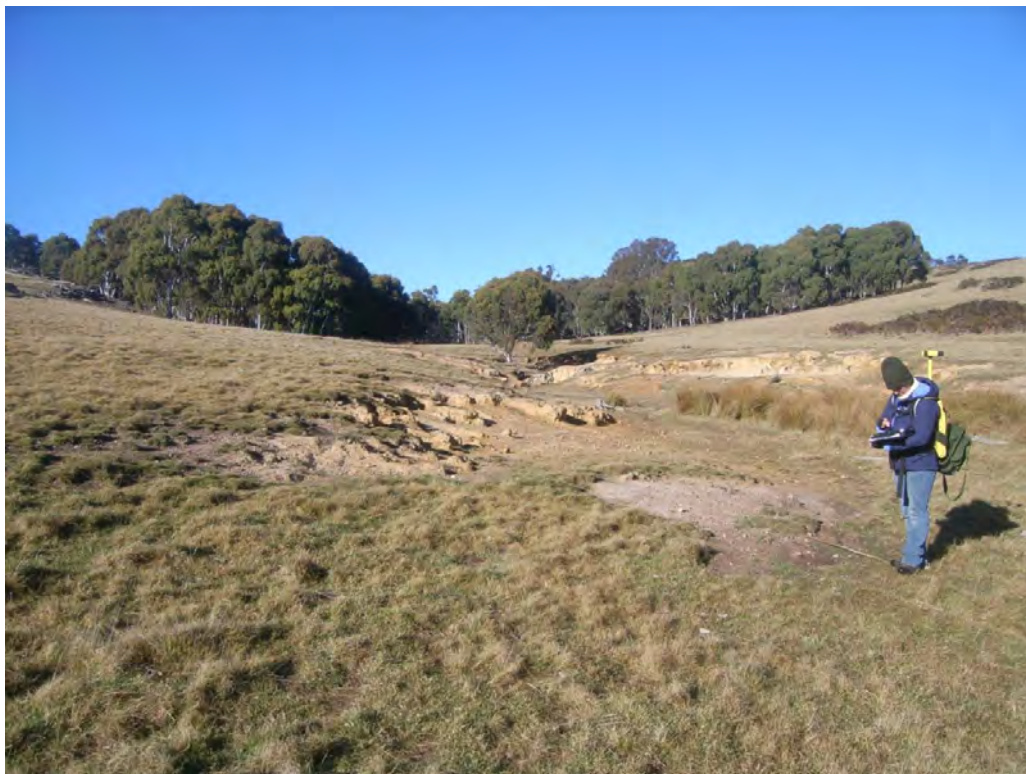
Plate 7 An typical example of gully erosion in drainage lines (south end of Survey Unit 14) .

1000 km<sup>2</sup> possessed a continuous channel, while streams with smaller catchments had less distinct channels often described by early commentators as chains of ponds. The naturalist Lhotsky, in 1834 described the ponds as follows: 'They are commonly round or oval basins of from 20 – 200 feet in diameter or length, excavated or sunk in the superficies of an alluvial soil, which is commonly of a rich kind ...' (cited in Wasson *et al.* 1998). The creeks located within the proposal area would all fall within the smaller catchment category as described above and, accordingly, are likely to have similarly possessed indistinct channels and chains of ponds. Now, however, these features are absent and instead channel incision has created eroded channels (for example, see Plate 7).
