APPENDIX F REVISED IMPACT AREA CALCULATIONS

Revised impact area calculations for the entire Yass Valley Wind Farm

RE: Further vegetation survey work at Yass Valley: Marilba Hills.

Additional survey at Coppabella Hills

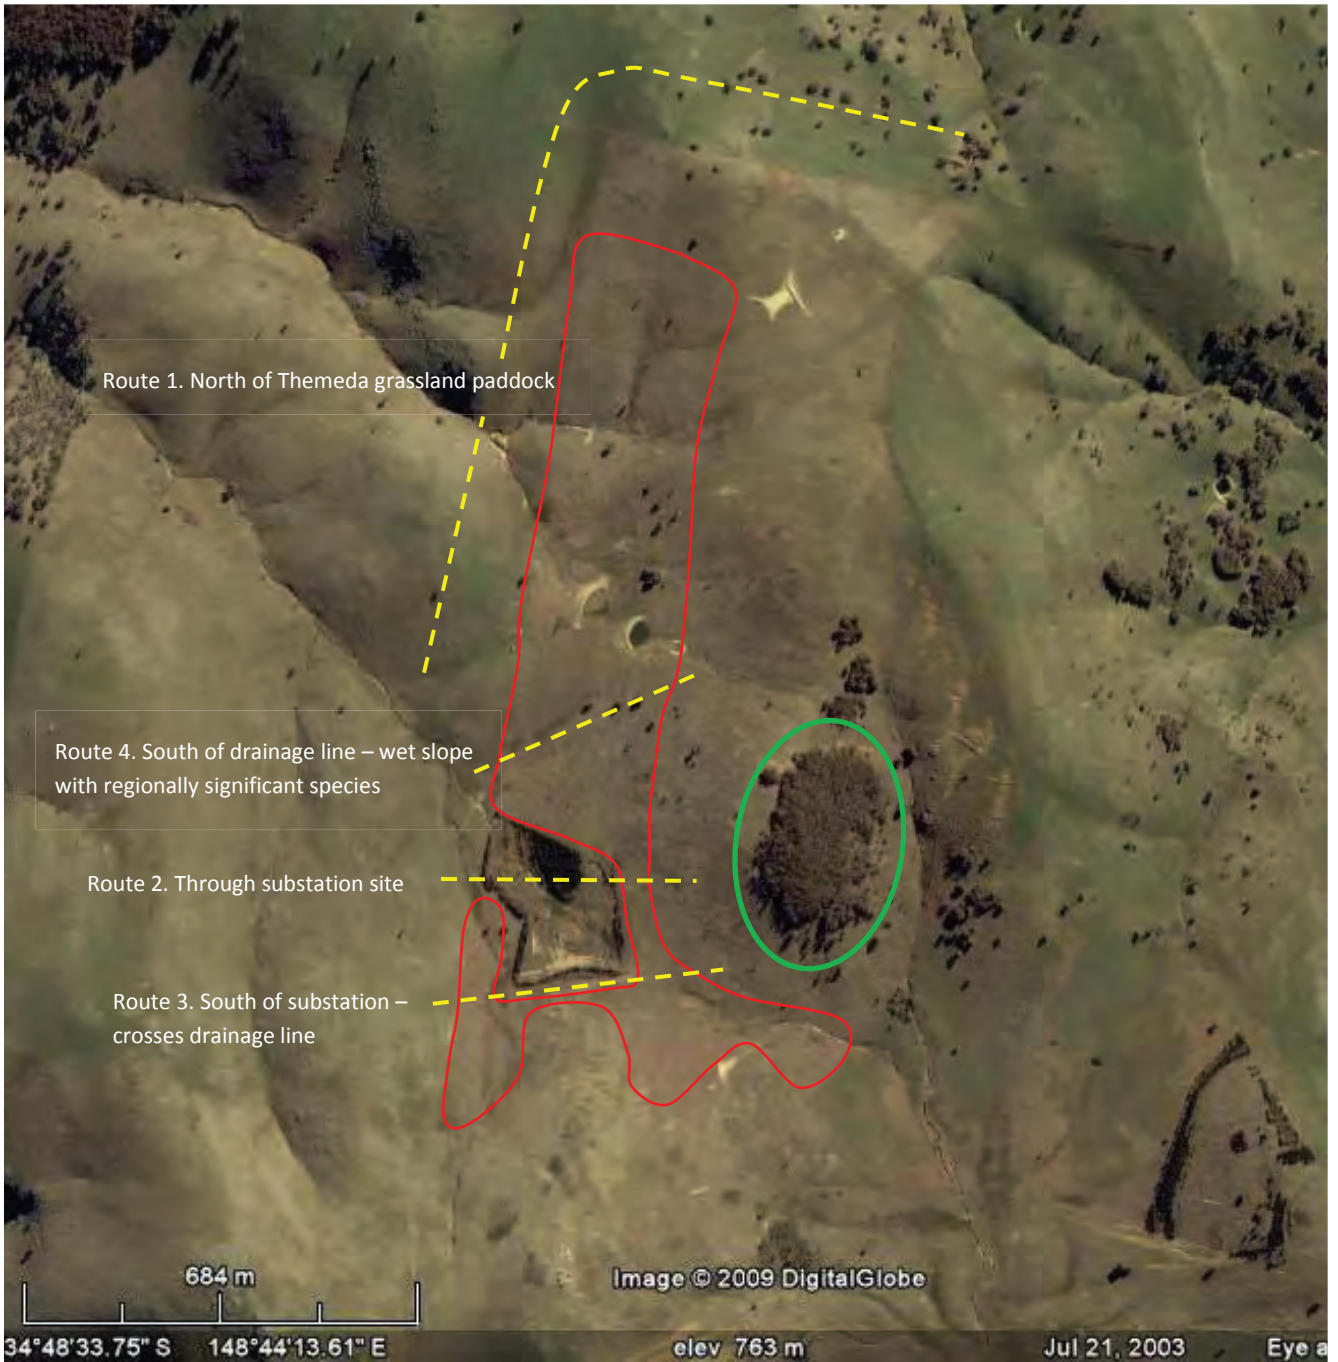
Figure 1: Forest remnant containing suitable habitat for the Burrinjuck Spider Orchid (green line) and approximate extent of the diverse secondary grassland (EEC) and Yass Daisy population (red line). Recommended routes for the road crossing are indicated by the dotted yellow lines (aerial image: Google Earth).

The forest fragment identified as potential habitat for the Burrinjuck Spider Orchid (Figure 1) was searched systematically by two botanists over a 1.5 hour period. The entire forest fragment was searched, employing north-south running transects each spaced 5-10m apart.

Figures 1, 2 and 3 clearly show the native grassland vegetation within the affected paddocks, contrasting with the greener low diversity native pasture in surrounding paddocks. The red polygon in Figure 1 shows the approximate extent of the diverse grassland and Yass Daisy population boundary. Remnant woodlands and native pastures dominated by Kangaroo Grass with a high diversity of native forbs are very uncommon in the region and have high conservation value. Kangaroo Grass is a keystone species in this community and its loss is generally associated with a drastic reduction in stand diversity.

Figure 1 identifies potential road crossing points (as indicated by the dotted yellow lines) to minimise impacts to the diverse grassland and Yass Daisy population. In order of preference these options are:

- **Route 1 is the preferred option since it avoids the diverse grassland paddock and Yass Daisy population altogether.**
- Route 2 passes through the proposed substation site. This site is already disturbed and of lower conservation value however it is not certain if the area can accommodate the substation as well as the access road.

- Route 3 passes south of the substation site. There are few Yass Daisy plants within 5-10 metres of the existing woodlot boundary. Some Yass Daisy plants and *Themeda* grassland would be disturbed along the western boundary of the property. This route would cross a moist drainage line.

- Route 4 passes through a 10 metre wide corridor alongside a drainage line. This area has no Kangaroo Grass or Yass Daisy but does support a range of regionally significant species. The corridor is within a seepage zone associated with the drainage line to the immediate north.

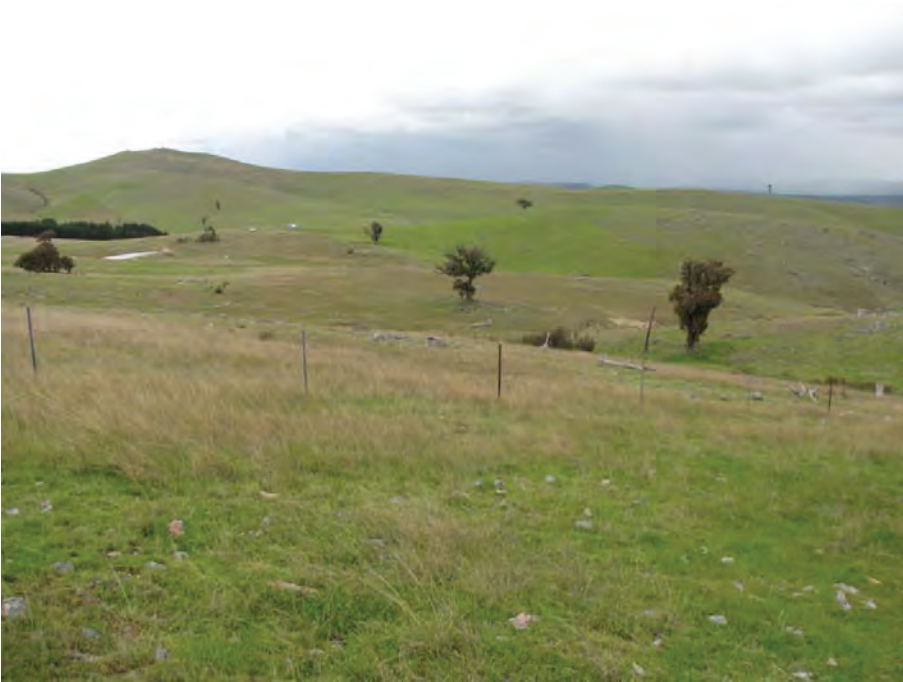
Figure 2: View from north-east of diverse grassland site looking south

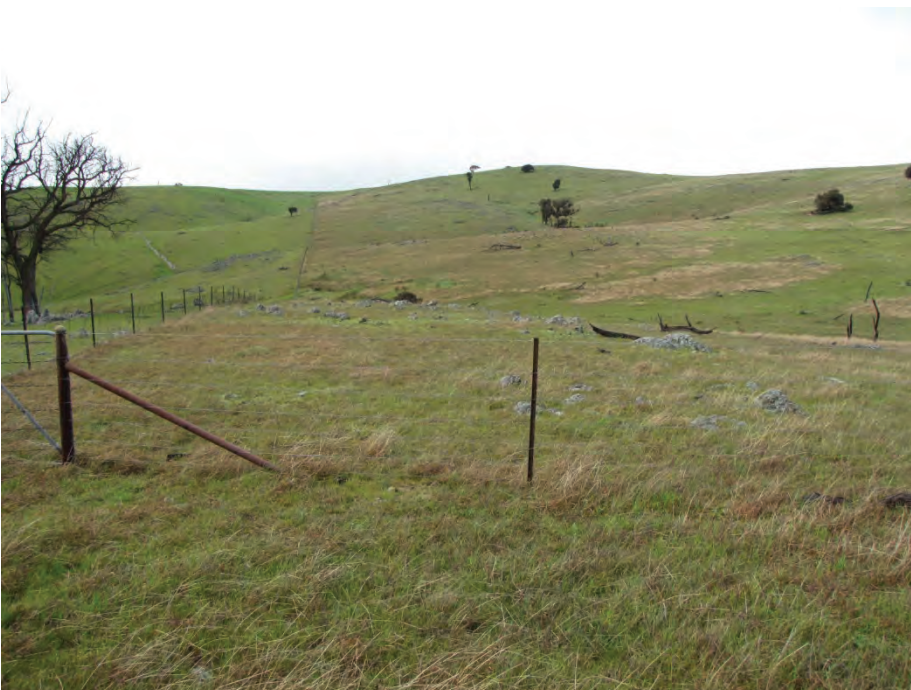
Figure 3: View of grassland looking north showing Kangaroo Grass patches (Yass Daisy habitat)

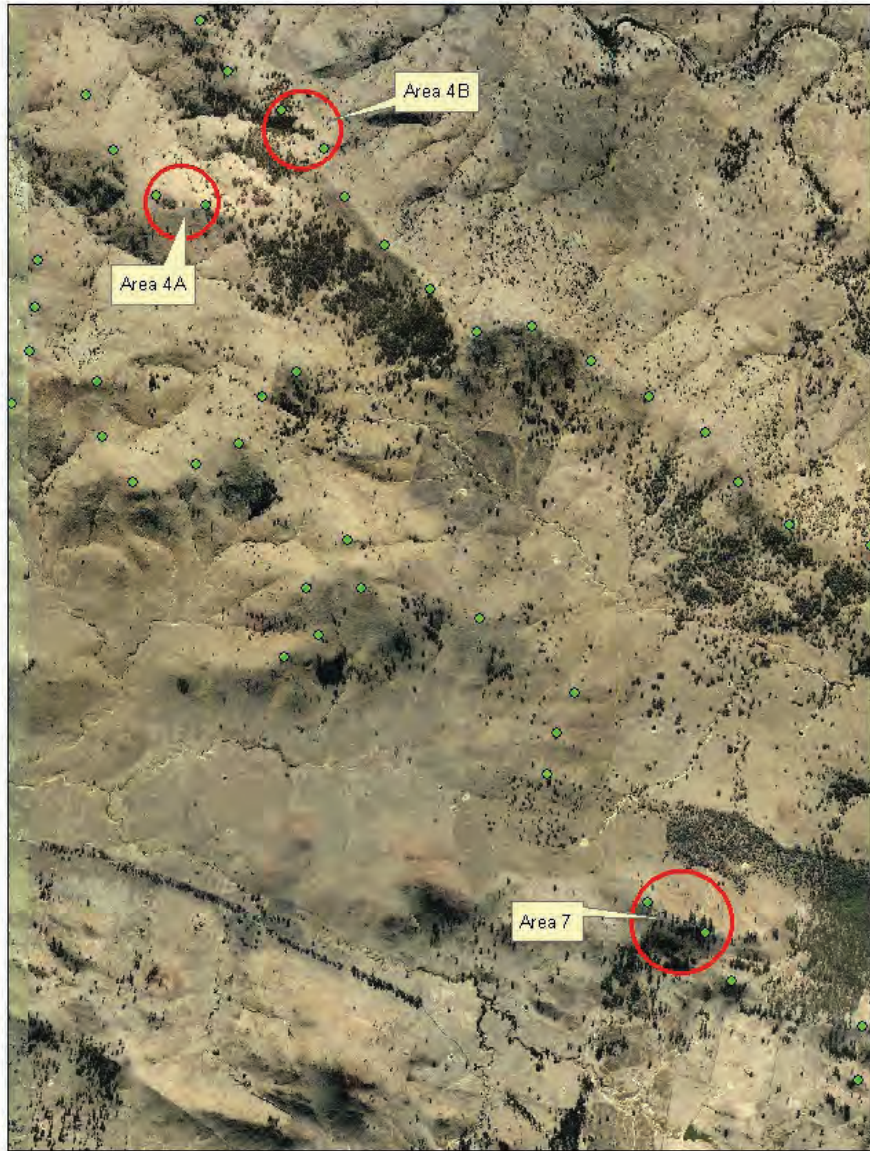
Figure 1-1.

Coppabella Additional Survey Areas
