APPENDIX 4  
NON INDIGENOUS HERITAGE ITEMS GAZETTEER

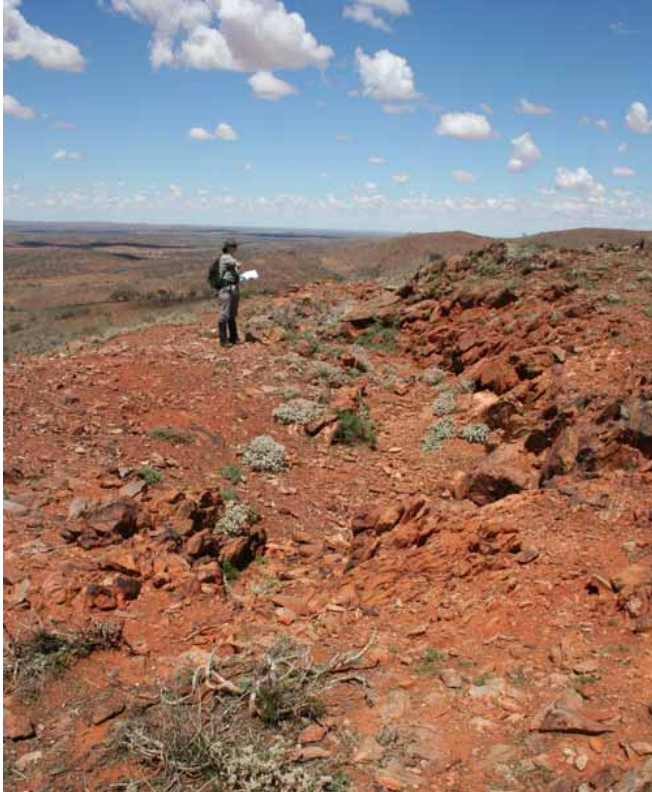
<p>SU90/HS2 Building platform and costeans</p>	<p>526901e 6480842n</p>
<p>This site complex comprises a couple of shallow costeans that extend for 5-10m with remains of a building platform adjacent. The building platform (c. 5m x 3m) is built up in the southeast and bordered in the northwest by a natural stone outcrop. Rock is also piled along the northeast of the platform and a possible collapsed hearth is visible in the southeast. There is a certain amount of excavation potential in and around the building platform; there is also broader research potential across the Survey Unit.</p>

<p>Costean at SU90/HS2, looking west</p>
<p>SU90/HS3 Forge</p>	<p>526722e 6480822n</p>
<p>Approximately 100metres south of the mine workings (SU90/HS1) there is a small, rectilinear stone feature that appears to be the remains of a small forge hearth. The stone mound measures approximately 1.5m by 1.5m and 0.5m high; there are pieces of metal slag visible in and around the stonework. There is a high potential for subsurface finds in and around the forge while the complex as a whole displays excellent survey potential that could enhance current knowledge and understanding of mining in the local area.</p>

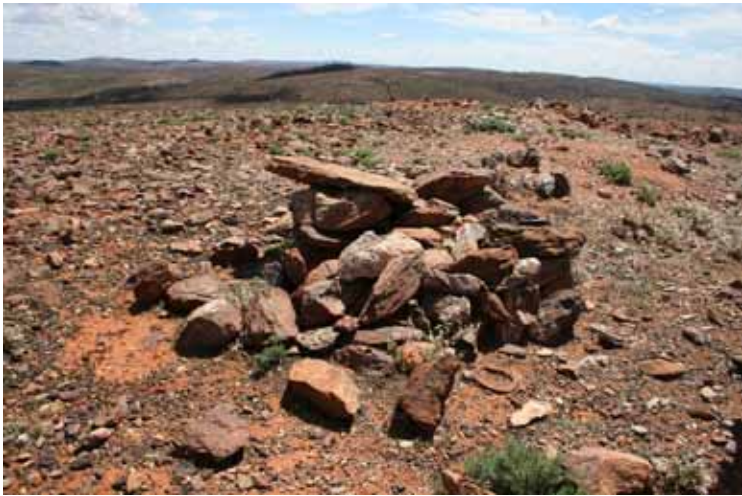
<p>Remains of the forge at SU90/HS3, looking north</p>

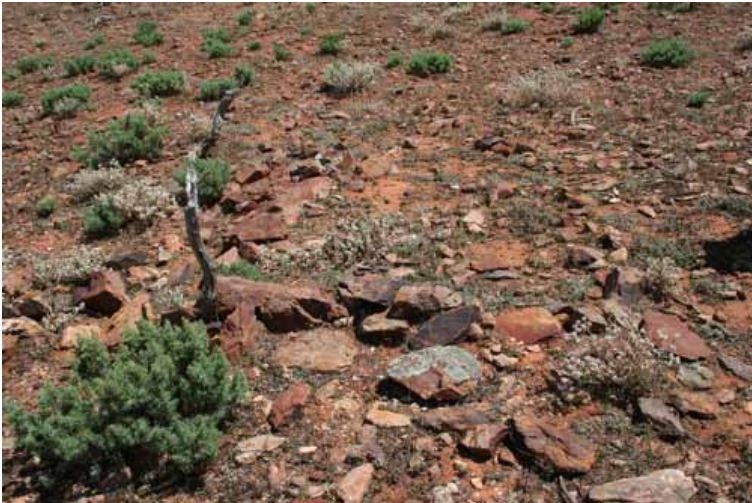
<p>SU90/HS4 Building platform</p>	<p>526718e 6480788n</p>
<p>Further to the south there is an additional building platform (c. 3m x 2m) with two courses of stone rubble around part of its perimeter and a piece of mulga in one corner; another possible hearth is located 30 metres further to the south. There is a high potential for subsurface finds in and around the building platform while the complex as a whole displays excellent survey potential that could enhance current knowledge and understanding of mining in the local area.</p>

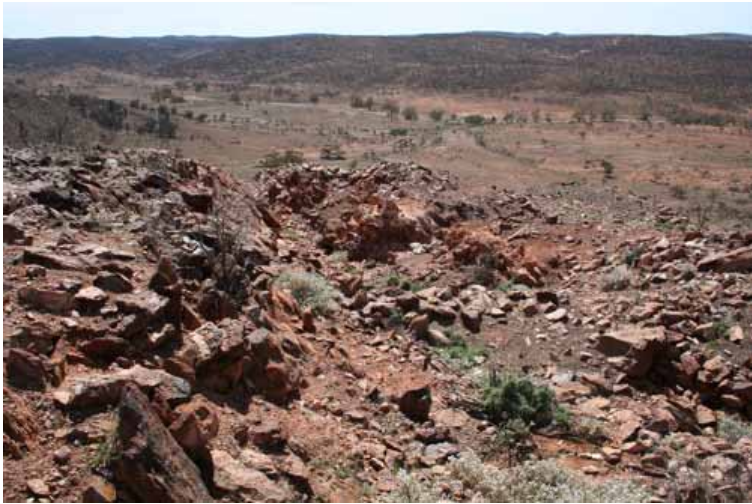
<p>SU92/HS1 Mine workings</p>	<p>527273e 6480984n</p>
<p>At the eastern end of Survey Unit 92 there are a series of costeans and prospecting pits that appear to be associated with the extraction of iron oxide across this section of the ridgeline, known as the Iron Duke mine (LC 177). The workings in this survey unit consist of a series of costeans that extend east to west on the upper slopes and crest; these features cover an area of approximately 200m x 100m. In addition there are traces of a road that leads eastward towards Lakes Grave Creek. There are a few small stone packed walls adjacent the costeans and prospecting pits, these appear to be loading areas where ore was transferred onto carts. The area surrounding the workings is largely devoid of artefacts; one rusted tin observed. The potential for subsurface material is low due to the skeletal nature of soils in this landform and the absence of cultural features likely to contain deposit.</p>

<p>Mine workings at SU92/HS1 looking east towards Lake's Grave Creek</p>

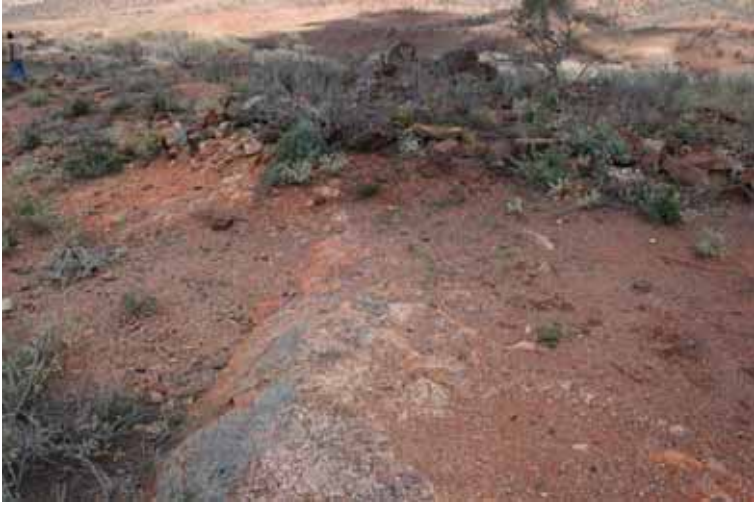
<b>SU93/HS1 Road</b>	<b>526660e 6480590n</b>
<p>On the spur crest to the south of Survey Unit 90 there are remains of an old road that traverses Survey Units 93 and 94 and extends past SU94/HS1 and SU94/HS2 beyond to Lakes Grave Creek.</p> <p>The road consists of a track (2-3m wide) that has been cut up the spur line and is in places cut into the local bedrock. Sections of the track are also packed up with roughly coursed rubble.</p>

<p>Section of the road in Survey Unit 93 (SU93/HS1) with stones built up along western edge of the track, looking west.</p>

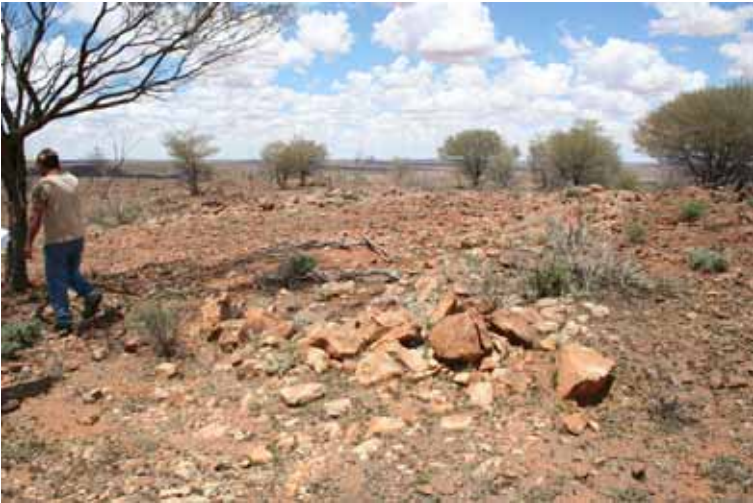
<p>SU94/HS2 Building platform</p>	<p>526767e 6480349n</p>
<p>Approximately 40m to the southeast of the forge there is a large levelled area (c. 15m x 10m) that is roughly rectangular. Stone is built up on the western and northern side of this feature, while the eastern side corresponds to a natural stone outcrop that extends along the boundary of the levelled area. This feature is on the southern side of the road that extends along the spur. The only historical artefact observed at this location was a horseshoe. It is unclear how this site relates to SU94/HS1, although it is likely to have been a storage area or form of animal housing that related to mining activities on the ridgeline to the north (SU90/HS1–HS4 &amp; SU92/HS1). This site is in fair condition; it displays a certain amount of excavation potential.</p>

<p>Levelled area at SU94/HS1, looking southeast</p>
<p>SU141/HS1 Farming equipment/stockpile</p>	<p>526678e 6478571n</p>

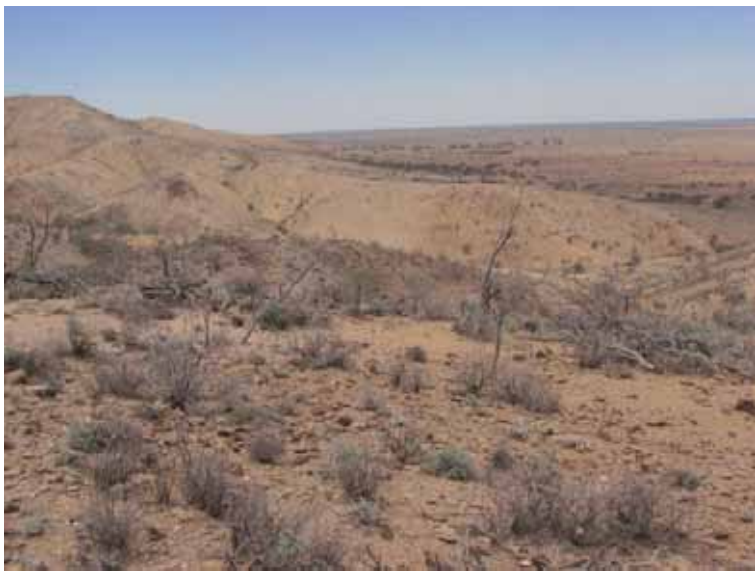
<p>SU191/HS1 Building platform</p>	<p>522296e 6487120n</p>
<p>This site comprises the well preserved remains of a shack that appears to date to the early to middle twentieth century. The platform measures approximately 2m by 3m and is oriented east-southeast to north-northwest; it is cut in on the eastern side and built up along the western edge. There is a rough windbreak of dead finish around the western and southern sides. There are six mulga posts <i>in situ</i> including four corner posts that are about 80cm high and have pieces of wire still attached, there are also two central posts in the centre of the eastern and western ends that are 1.5-2m high. In addition there is a metal spike in the centre of the southern side with wire coming off it. All four of the corner posts have wires tethered to metal pegs and stakes that are also still <i>in situ</i>. There is an assortment of metal pegs scattered around the site. The southwestern corner of the platform is built up with a stone retaining wall and there are a number of large stones along the northern side. Artefacts associated with the site include fragments of glass scattered across the platform, oil tins, food tins, bottle glass and pieces of machinery located adjacent the platform and a piece of what appears to be a flue. Diagnostic items include a Wolfes Aromatic Schnapps Bottle (c.1920s) a can for milk powder with a use by date of 1953 and assorted Vacuum Oil tins (early-mid twentieth century).</p>

<p>SU191/HS1 general view looking south</p>

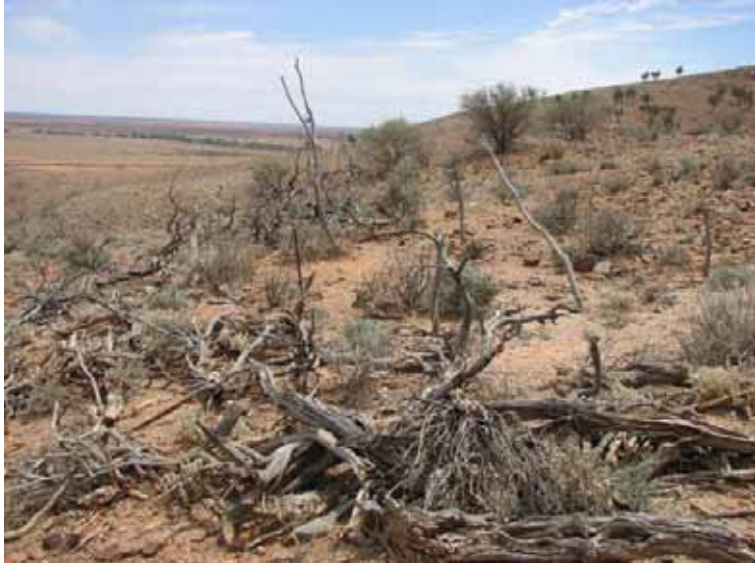
<p>SU191/HS1 looking north. Note brush fencing in foreground and mulga posts at corners of platform</p>

<p>There is extensive slopewash across the platform that has acted to protect any cultural deposit below. Approximately 80% of the platform appears to be intact. There are entrances to mines located approximately 100m to the north of the site. There is a blue-grey mullock associated with these mines. In addition there are similar mine workings on the slopes to the southeast and traces of a pathway that leads from the site to those workings. This site appears to be the remains of a miner's hut/tent from the first half of the twentieth century. It displays good research potential both at the platform itself and across the broader area that includes the associated mine workings and the hut at SU190/HS2.</p>

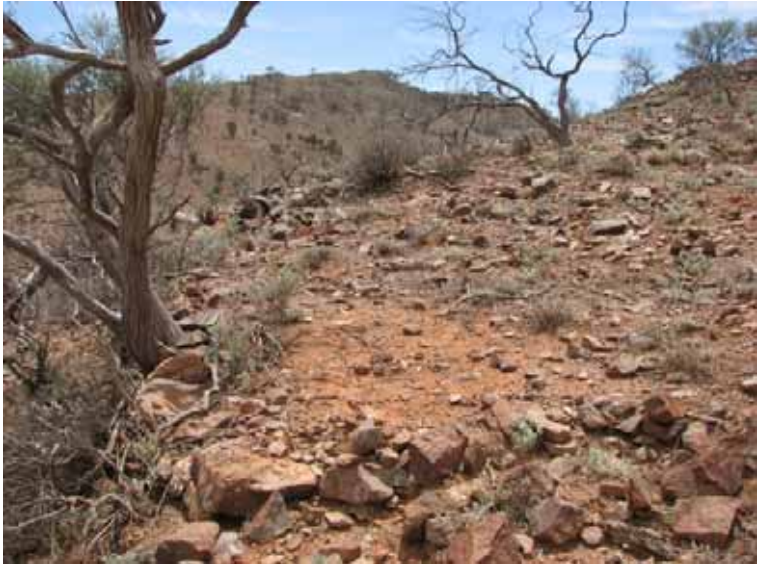
<p>SU191/HS2 Building platform</p>	<p>522268e 6487130n</p>
<p>Located approximately 40 metres down slope from SU190/HS1 there are the remains of a second, smaller structure. This site measures approximately 2m by 1.2m and is aligned north south with stone built up on the southern and western sides to form a level platform. There is a clear glass, screw top, bottle associated with the site; it is stamped with the year 1951. Given the apparent association with SU190/HS1 and the presence of artefacts from the middle of the twentieth century it is likely that this site relates to prospecting that took place in the Barrier Ranges following the end of World War II. The site is in fair condition and displays moderate to high potential for subsurface finds.</p>

<p>SU191/HS2 looking northeast</p>
<p>SU191/HS3 Road</p>	<p>522132e 6487128n</p>
<p>Extending west from SU191/HS1, past SU191/HS2 and beyond down onto the Mundi Mundi Plain there is a rough roadway evidenced by a cleared corridor 2-3 metres wide. This feature appears to have been the main access route to the hut sites described above and the mines that they were presumably associated with. The road runs in a more or less straight line to the west from SU191/HS2 to GDA 521797e 6487248, at which point it turns southwards and within 50 metres is effectively obscured by rill erosion.</p>

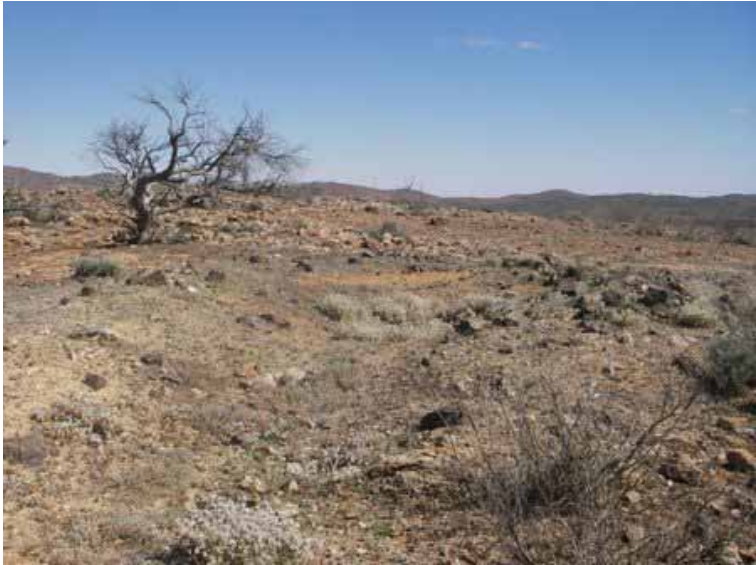
<p>SU226/L1 looking 300°</p>

<p>SU226/HS1 Costean</p>	<p>525845e 6482125n</p>
<p>This site comprises a single mining costean measuring approximately 10m long by 4m wide and 1m deep. There are also additional mine workings a short distance away to the southwest. This site is in close proximity to mining leases LC226 and LC180</p>
