BOWMANS CREEK
WIND FARM

ABORIGINAL CULTURAL HERITAGE ASSESSMENT REPORT

BOWMANS CREEK WINDFARM

BOWMANS CREEK, NSW

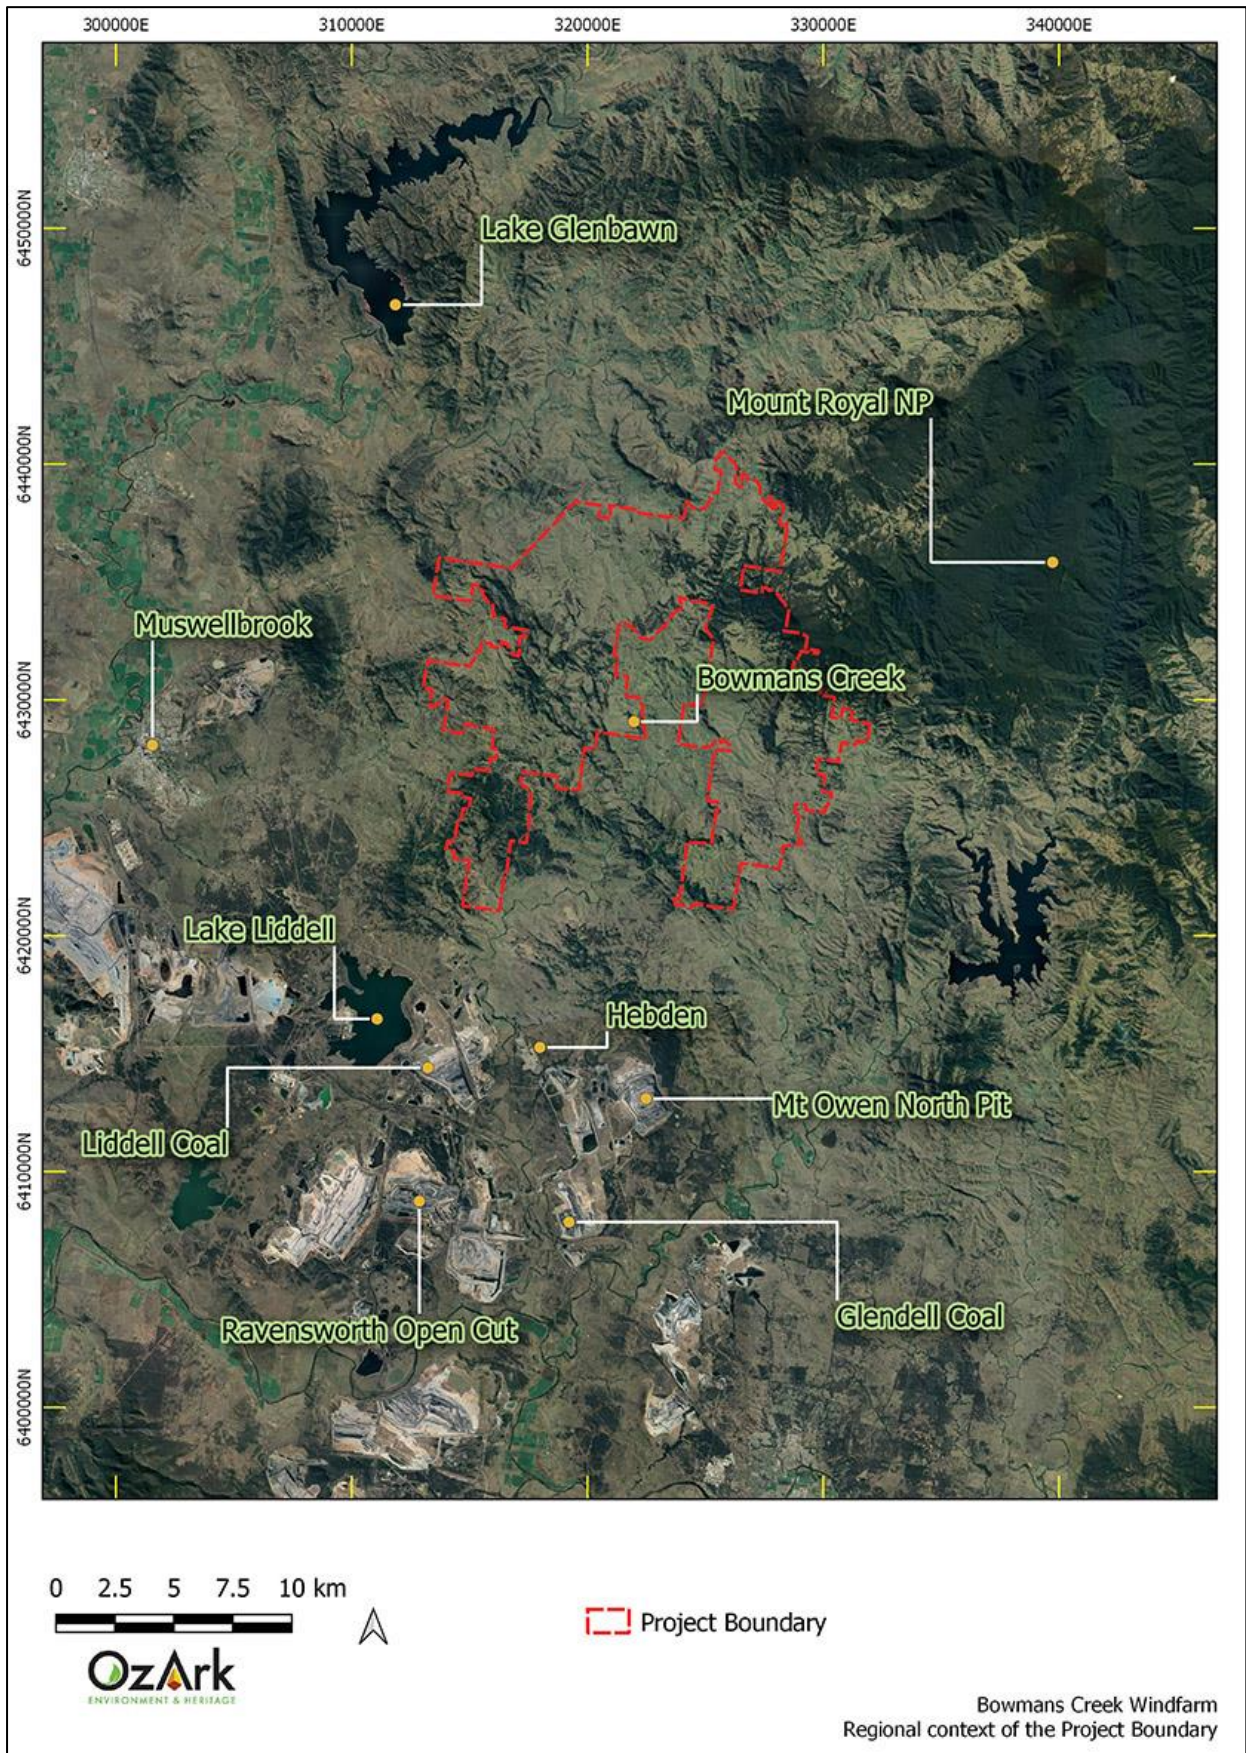
Figure 1-1: Regional context of the Project Boundary.

Mount Royal National Park is located at least 5 km to the northeast of the Project Boundary. Lake St Clair is over 10 km to the southeast and Lake Liddell over 6 km to the southwest of the Project Boundary. Project components within the Project Boundary are at greater distances from these localities. The southern-most part of Glenbawn Dam is over 15 km from the closest proposed turbine. The Project Boundary is shown within its regional context on **Figure 1-1**.

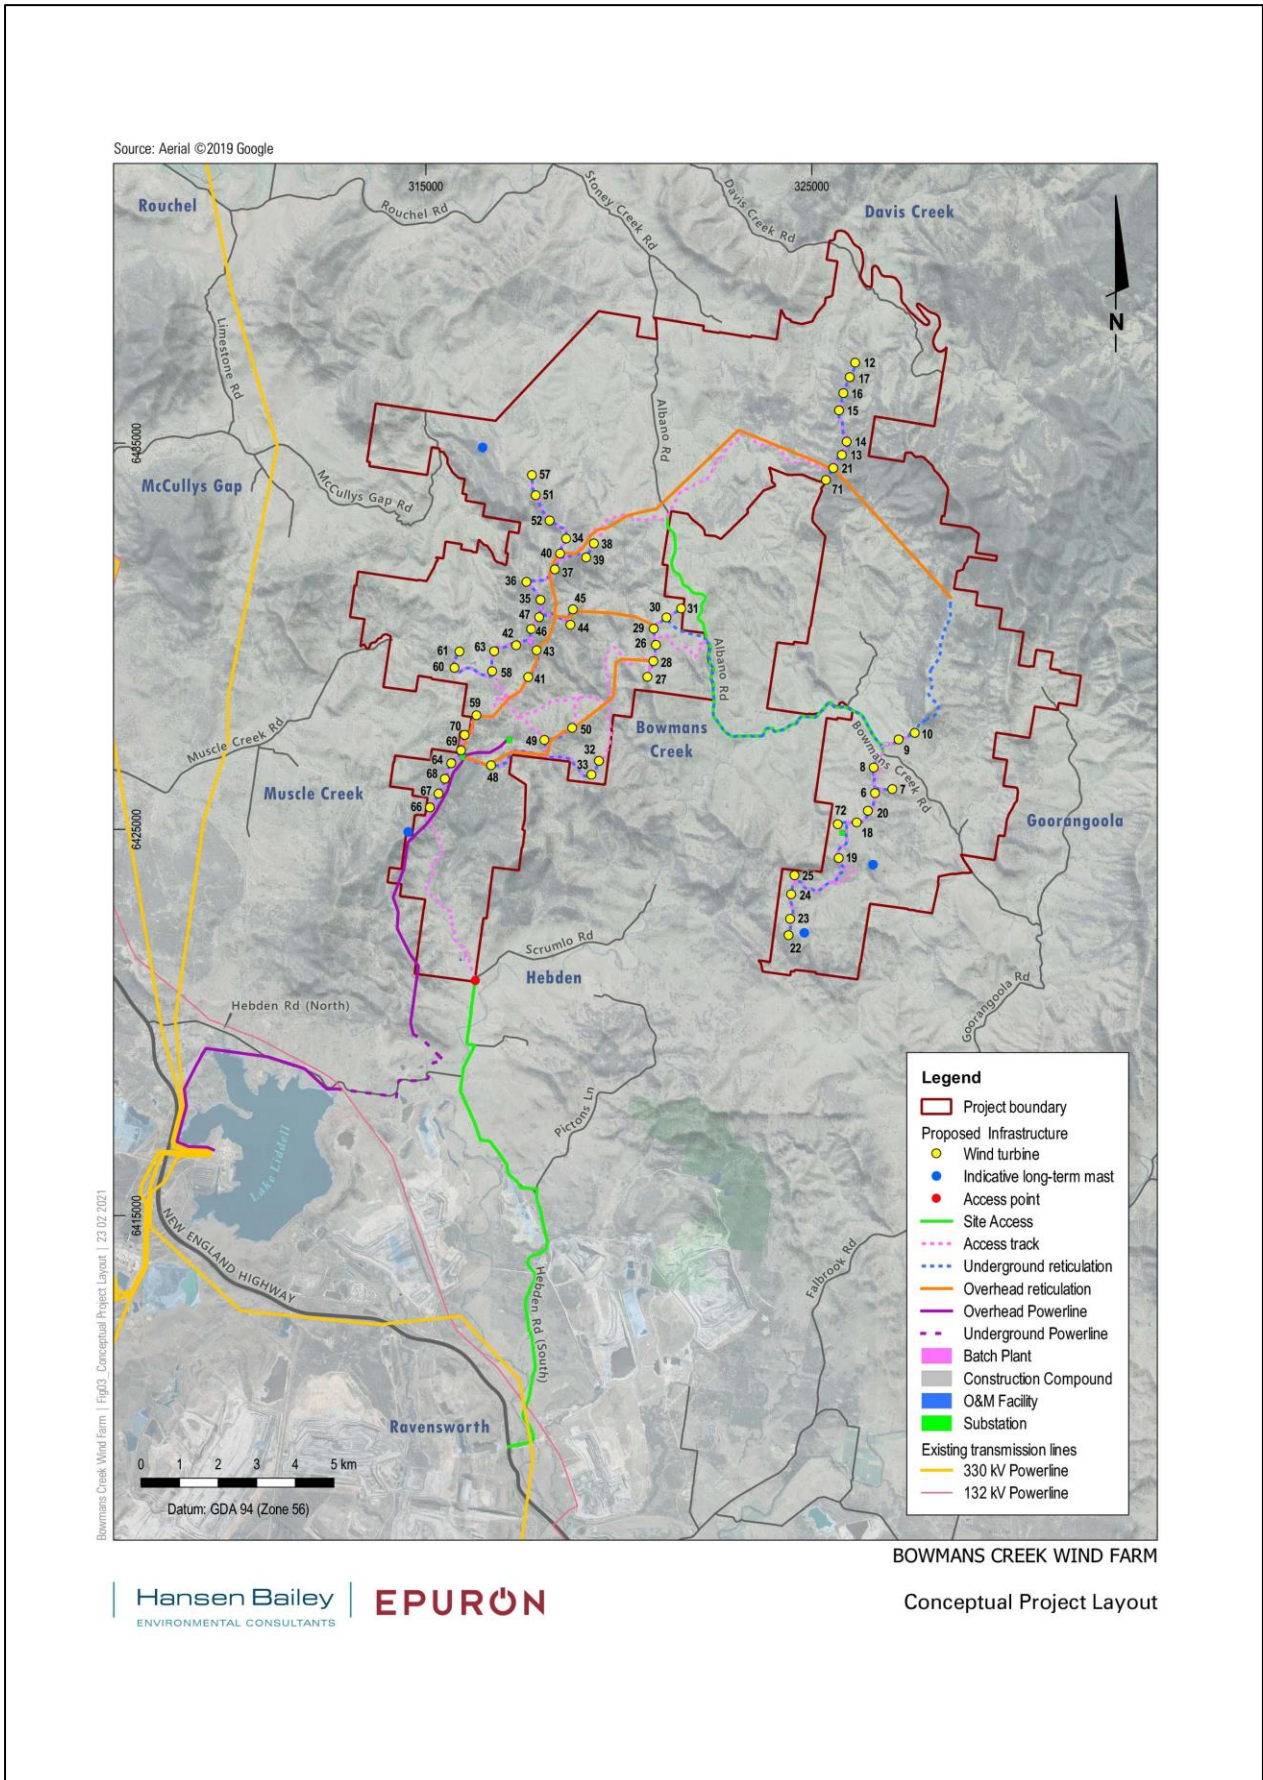
Figure 1-2: Conceptual project layout.

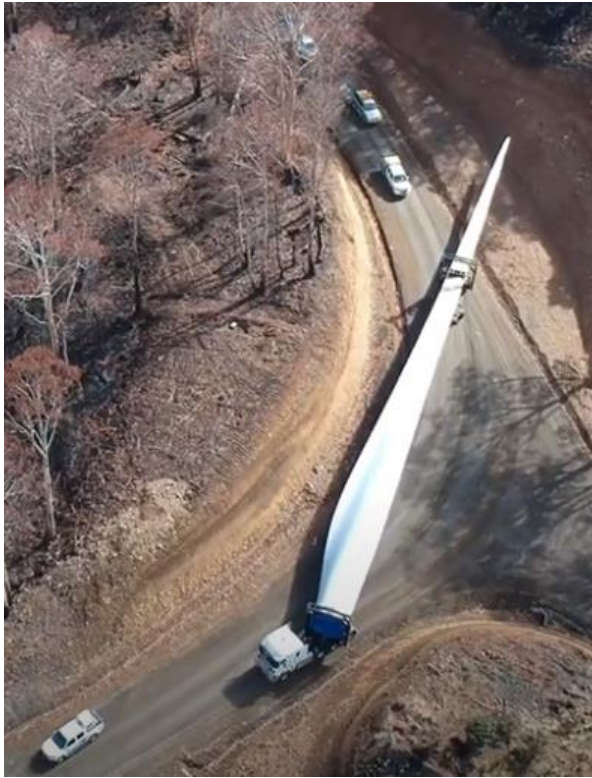
<p>1. A view of impacts associated with the construction of turbine foundations (Photo source: Engineers Australia: <i>Design and Construction. Aspects of Foundations for Onshore Wind Turbines</i>).</p>	<p>2. Construction of the turbine foundations involves a localised impact including the area of foundations, as well as soil stockpiles and construction vehicle parking areas (photo source: Vestas, Collector Wind Farm, NSW).</p>

The turbine maximum height (blade tip height) will be 220 m. Turbine foundation construction causes high, localised impacts. To assist with the visualisation of the degree of impact associated with transporting turbines to their location and the construction of the turbines themselves, a number of indicative photos are included on **Figure 1-6**. These photos indicate that most of the Survey Boundary surrounding turbine locations could be impacted to some degree, either from the excavation of turbine foundations, or from impacts associated with soil stockpiles, material laydown and construction vehicle use.

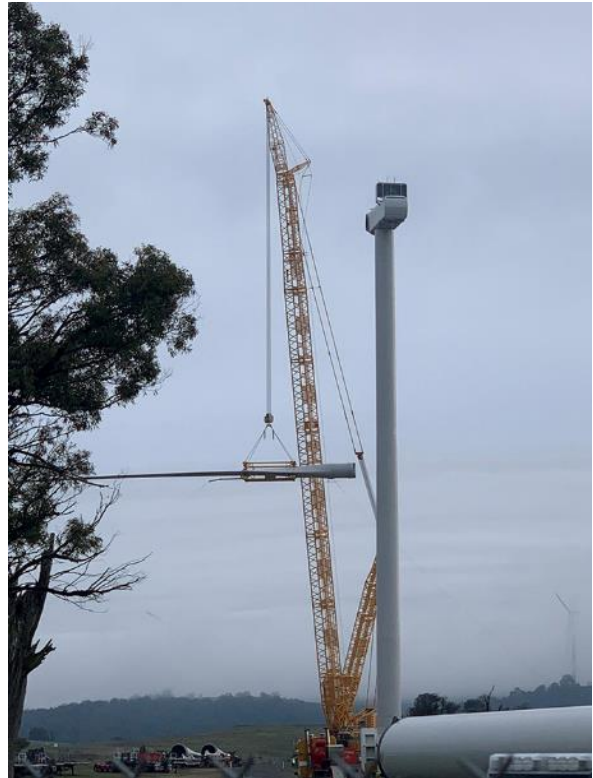
3. Transporting the turbine elements requires substantial access tracks given the length of the components being transported (photo source: Goldwind. Cattle Hill Wind Farm, Tasmania).

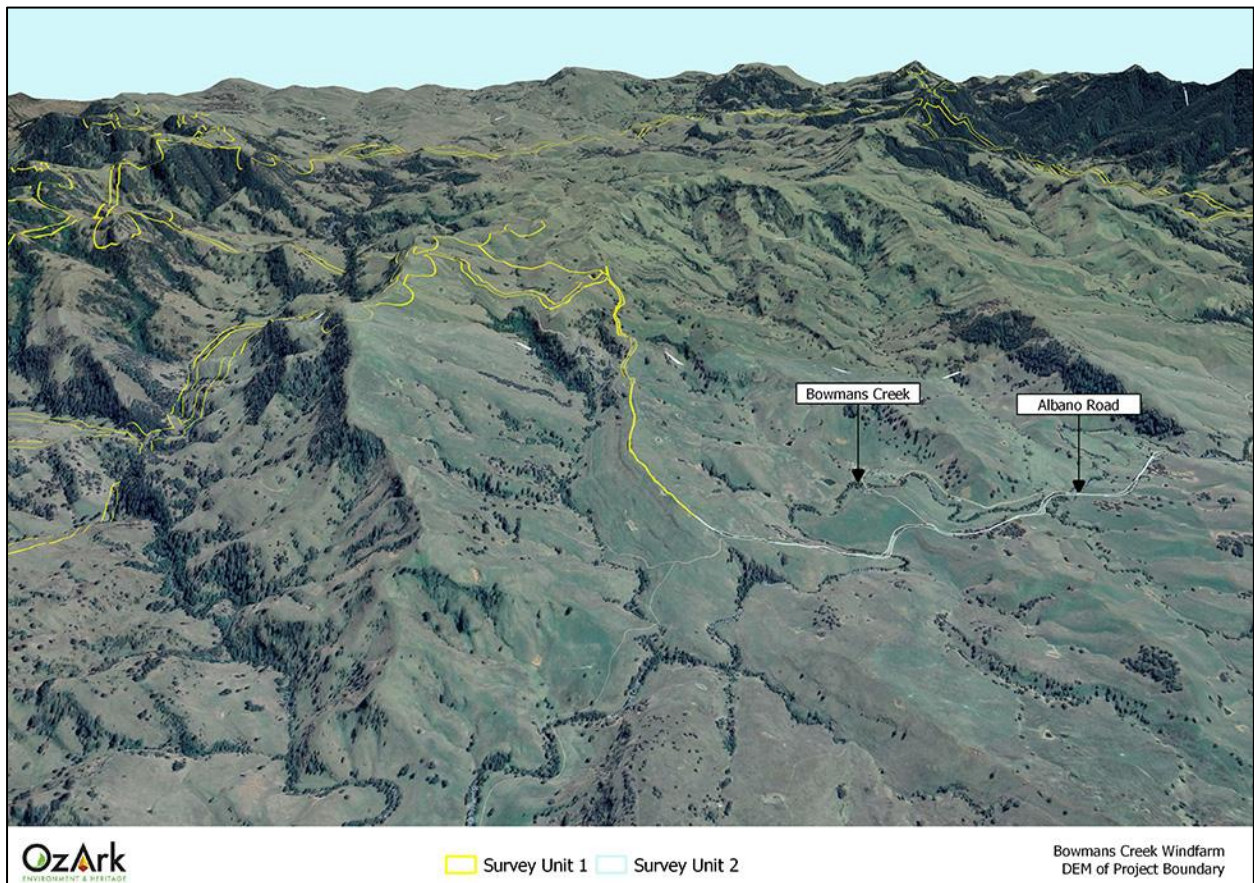
Figure 4-1: DEM model of a portion of the Survey Boundary showing topography.

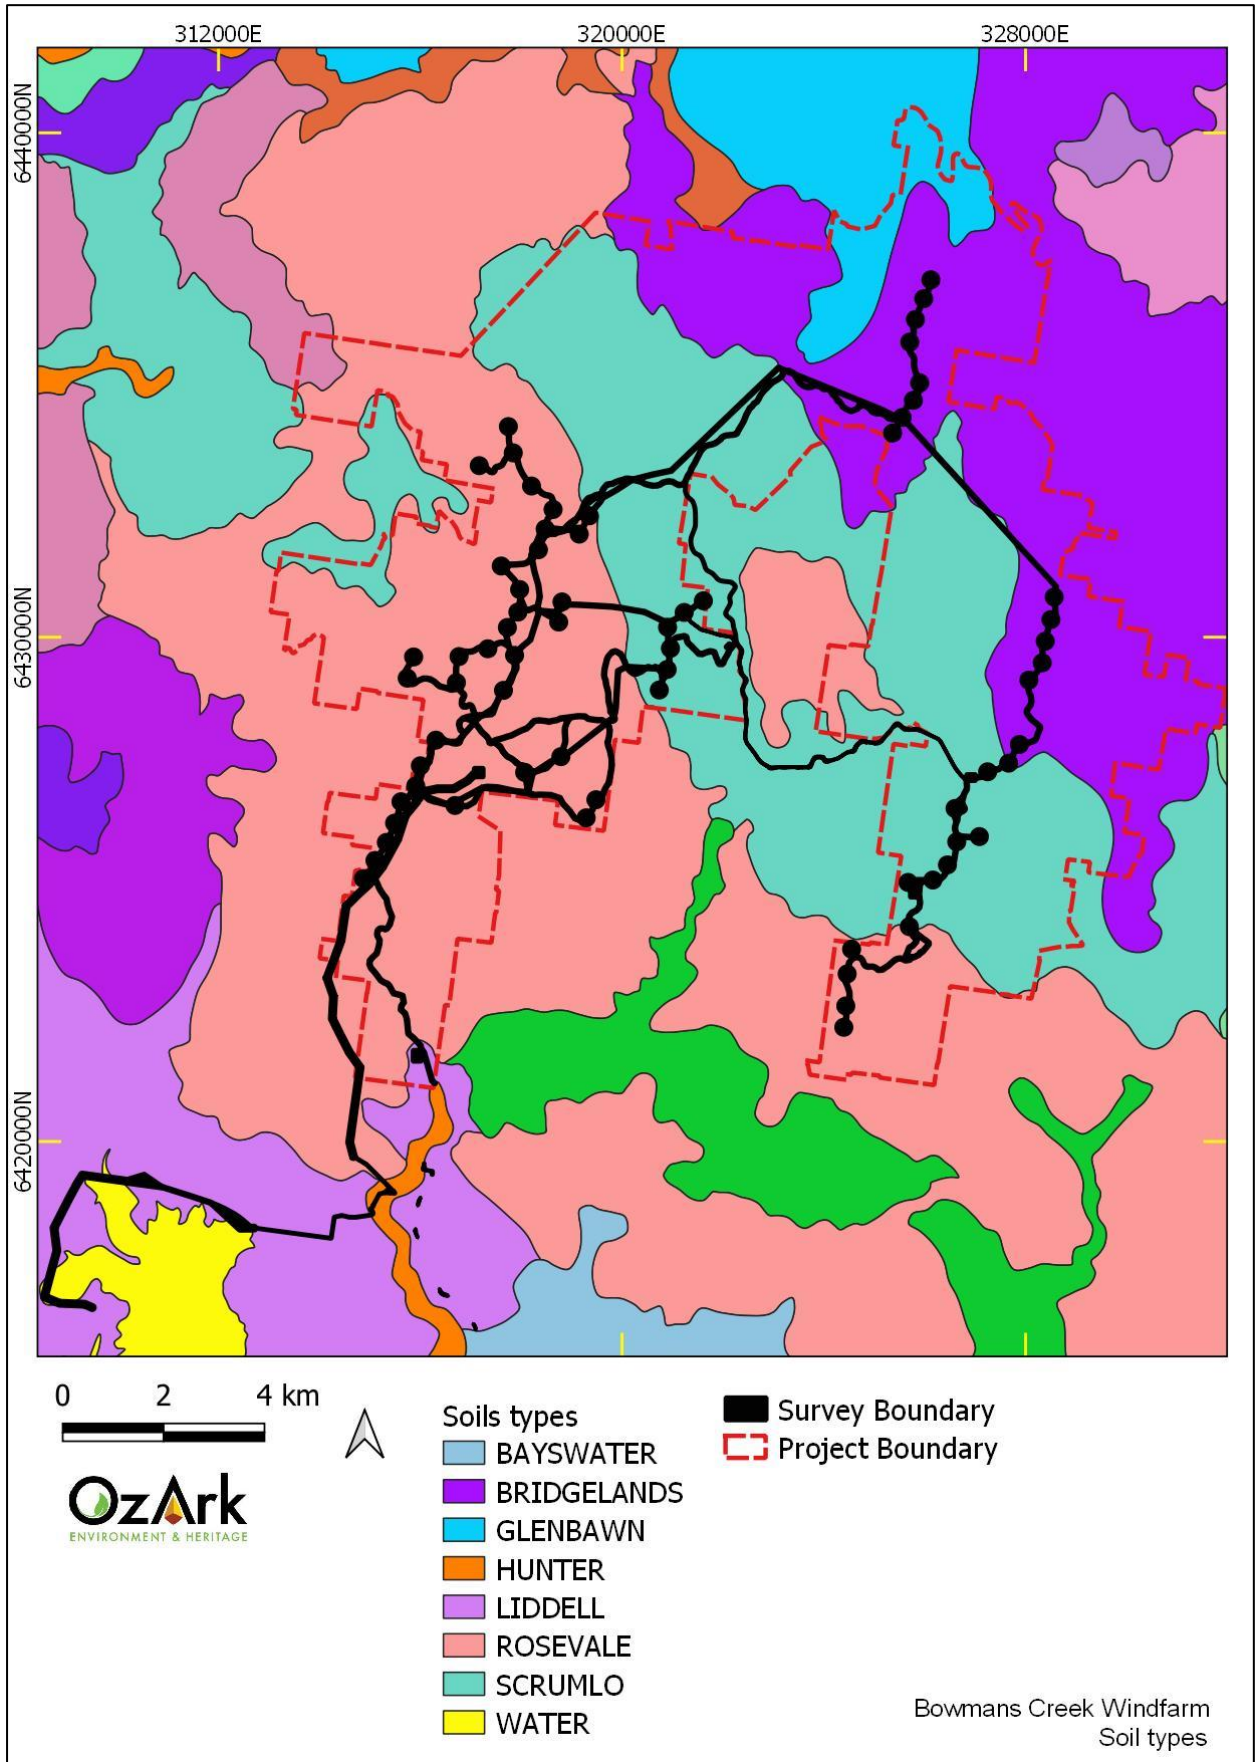
Figure 4-4: Map showing the soil landscapes associated with the Survey Boundary.

In the Soil Landscapes of the Singleton 1 :250,000 Sheet (Kovac and Lawrie 1991), the southern portion of the Survey Boundary is mapped as the Liddell Soil Landscape (**Figure 4-4**). The main soils are yellow Soloths on slopes, with some yellow Solodic soils on concave slopes. Earthy and Siliceous sands are found on mid to lower slopes. Red Soloths, red Solodic soils and red podsollic soils are also known to be present. Minor sheet erosion is common, with some minor rill erosion. In drainage lines, there may be moderate gully erosion and salting may be a feature.

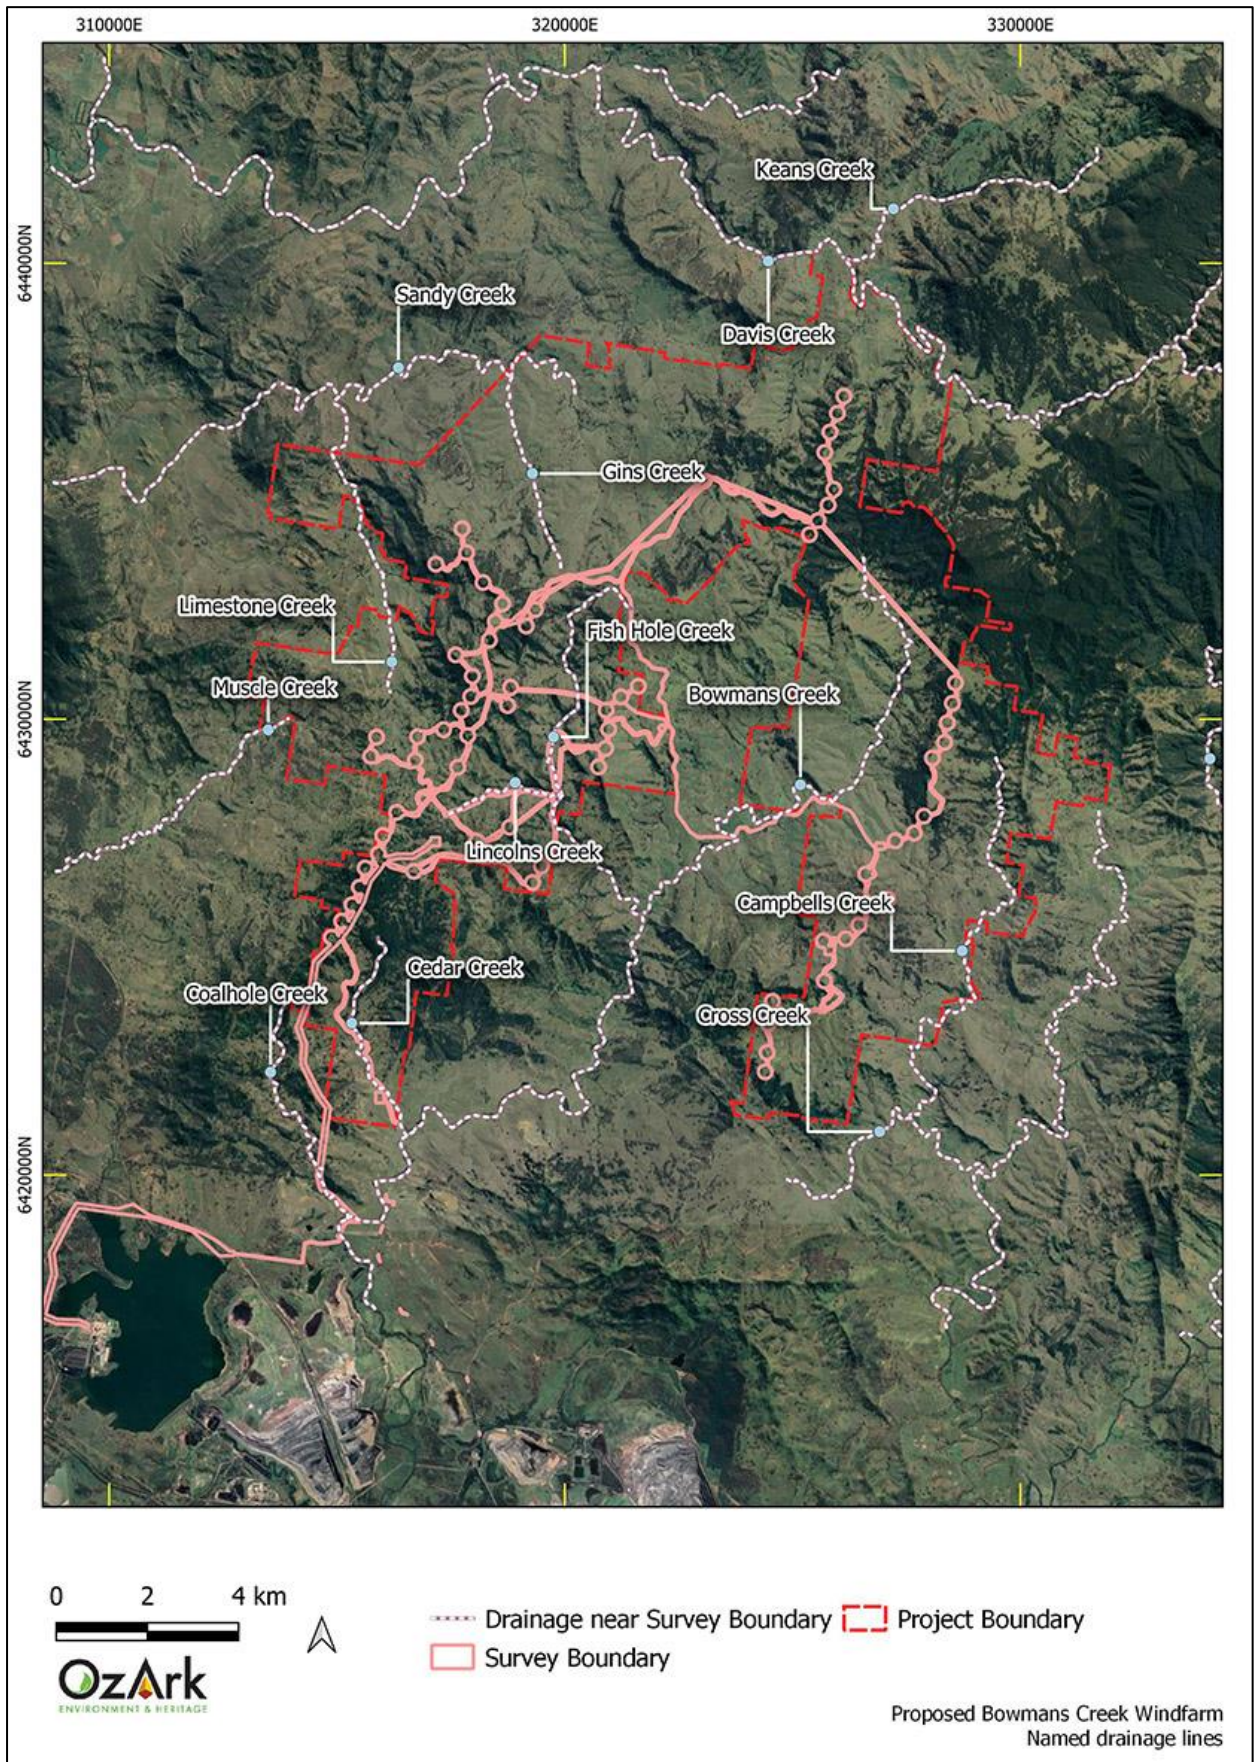
Figure 4-5: Aerial showing the main named waterways associated with the Survey Boundary.

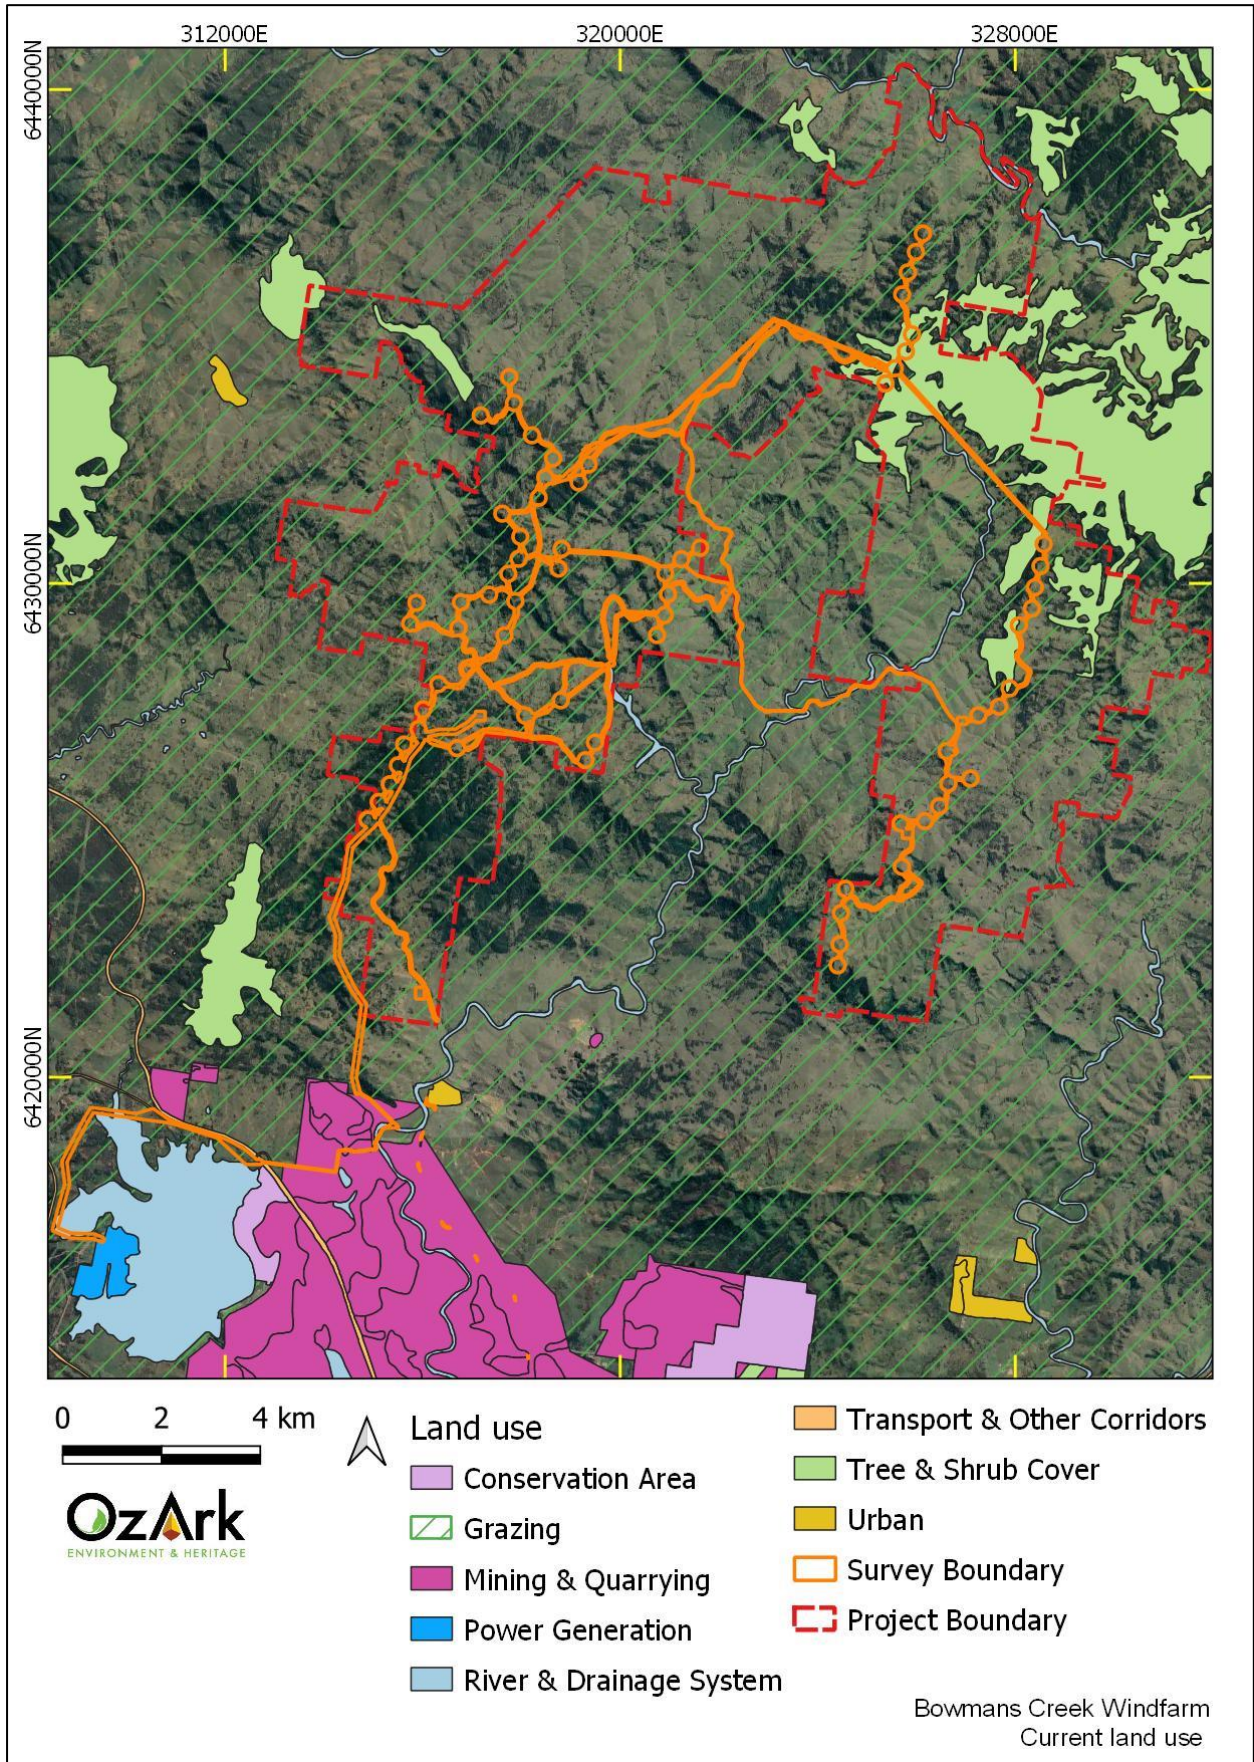
Figure 4-8: Aerial showing the Survey Boundary in relation to current land use.

The predominant land use of the Survey Boundary is grazing (**Figure 4-8**). The establishment of the grazing industry involved the widespread clearance of native vegetation and the introduction of heavy, hard hoofed animals. The extent of clearing was noted during the survey where even the steepest slopes have been laboriously cleared.

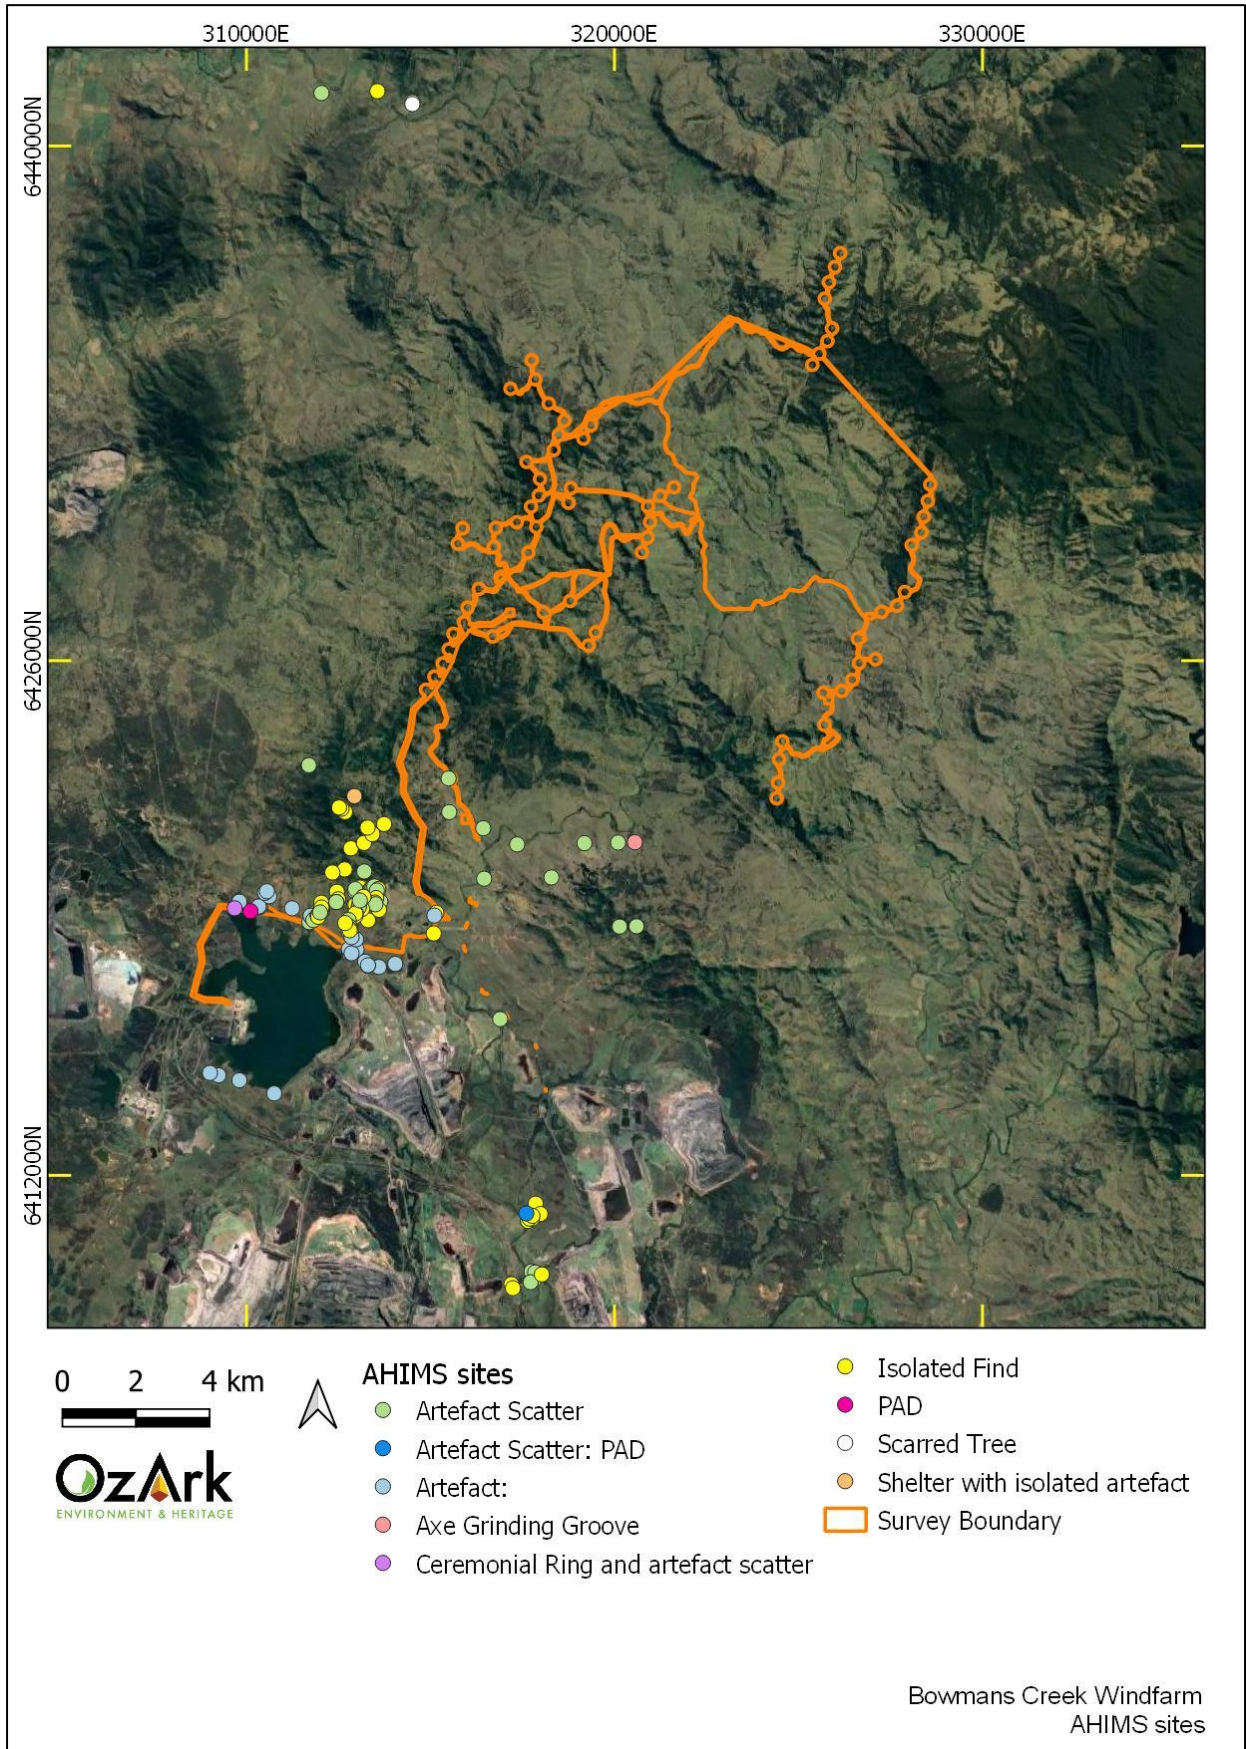
Figure 5-1: Location of previously recorded AHIMS sites in relation to the Survey Boundary.

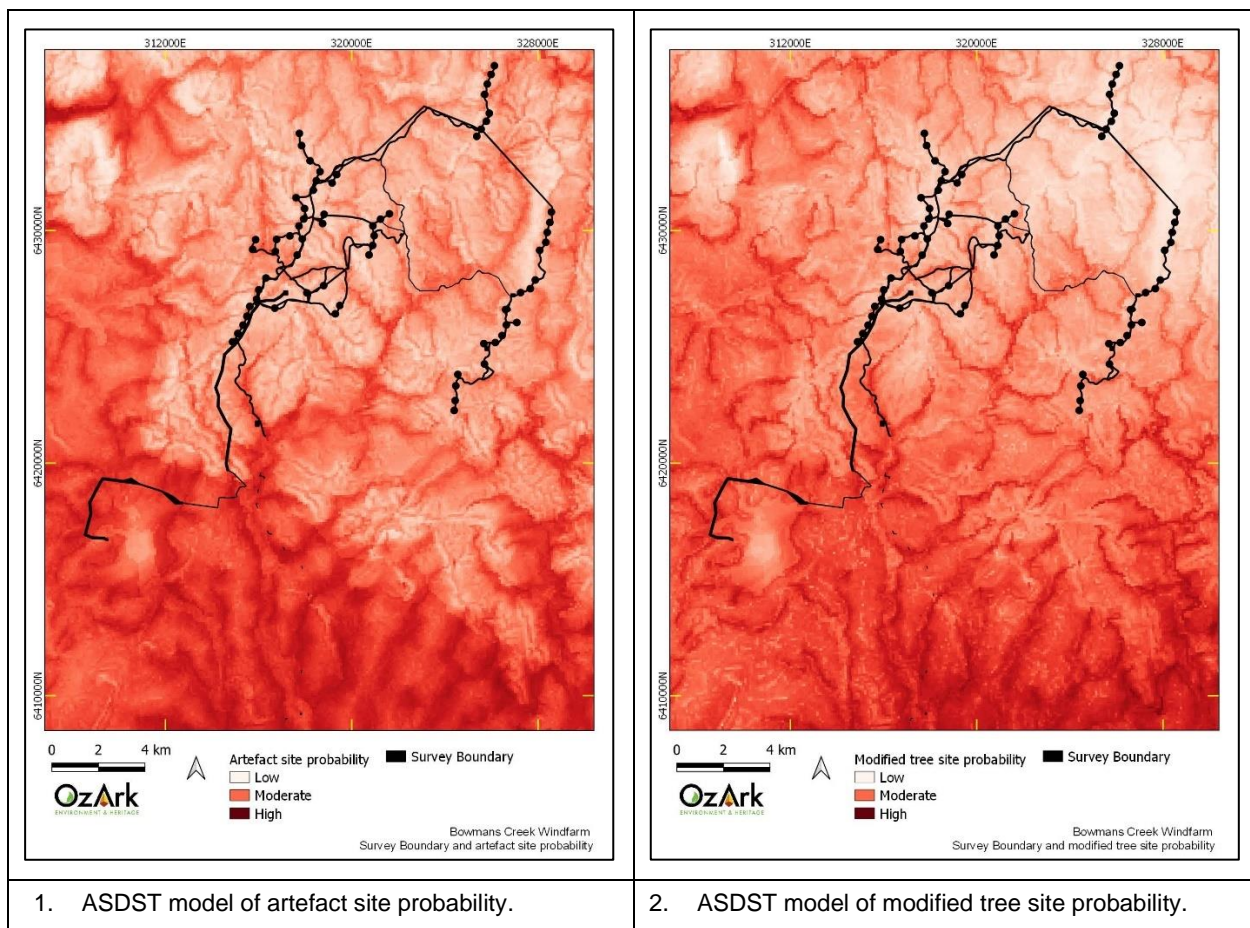
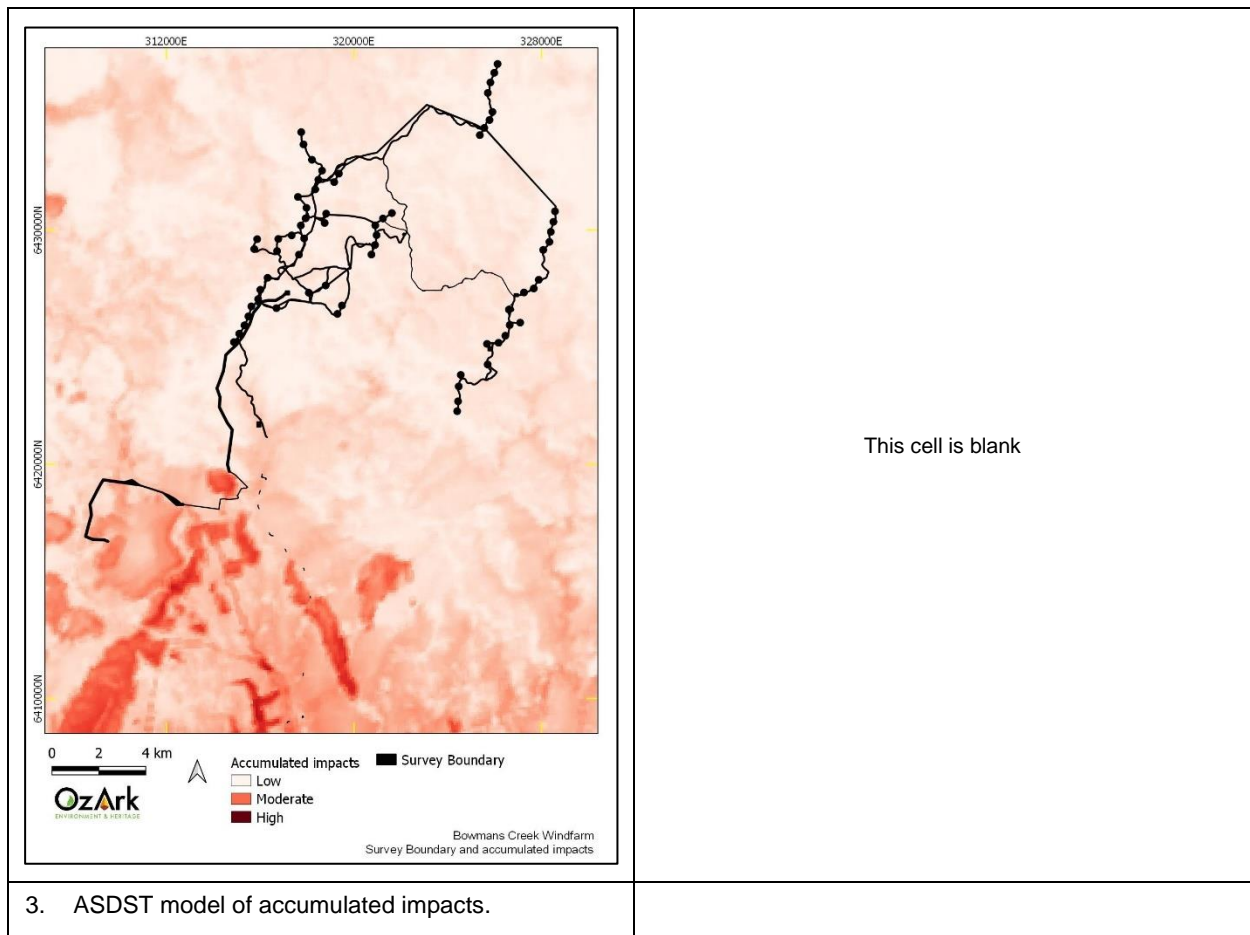
Figure 5-2: ASDST models and the Survey Boundary.

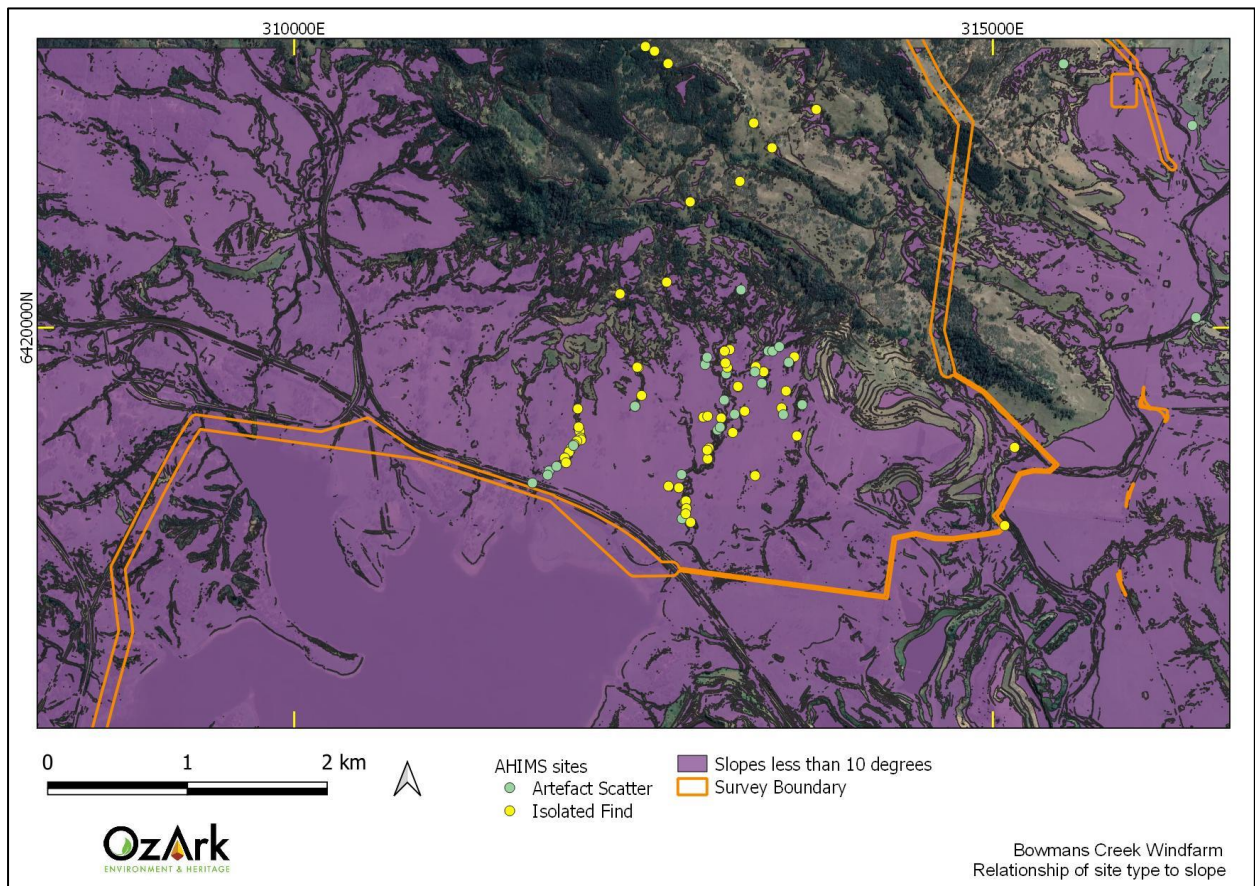
Figure 5-3: Aerial showing the relationship between degree of slope and the recording of artefact scatters and isolated finds.

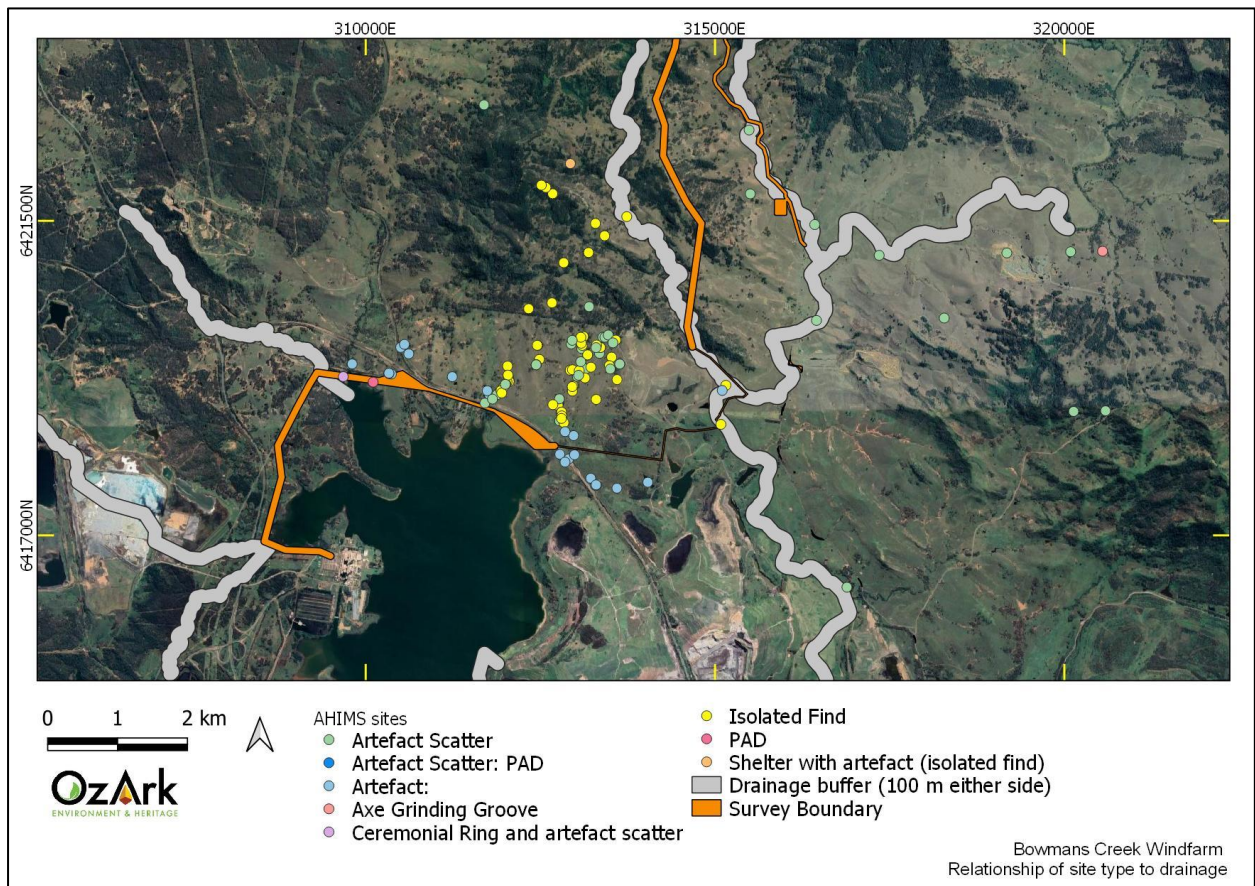
Figure 5-4: Aerial showing the relationship between the distance to water and the recording of sites.

When the distance of previously recorded sites to drainage is mapped, the correlation is very uncertain, although across the state there has been an observed strong relationship between waterways and site location (**Figure 5-4**).

The lack of any sort of correlation in the landforms surrounding the Survey Boundary is probably due to the lack of systematic survey, as well as the cluster of sites recorded by Tocomwall in the Hillcrest property (Tocomwall 2017) that skew the data as this area was subjected to full survey.

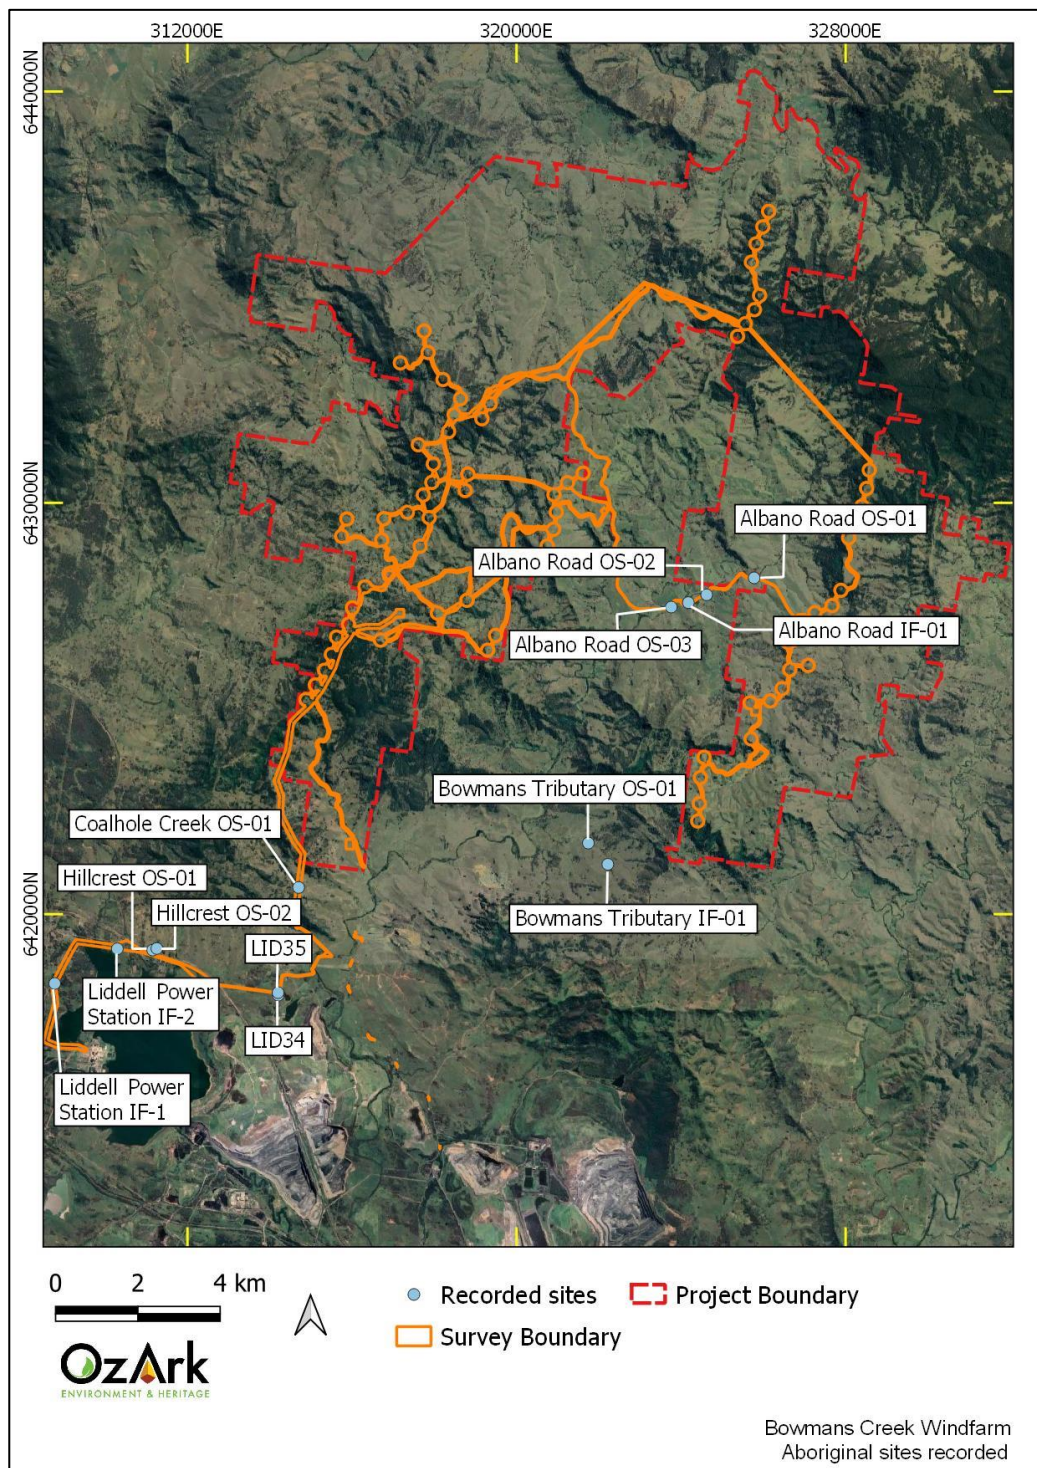
Figure 6-2: Aerial showing all sites recorded during the assessment.
