BOWMANS CREEK
WIND FARM

ABORIGINAL CULTURAL HERITAGE ASSESSMENT REPORT

BOWMANS CREEK WINDFARM

BOWMANS CREEK, NSW

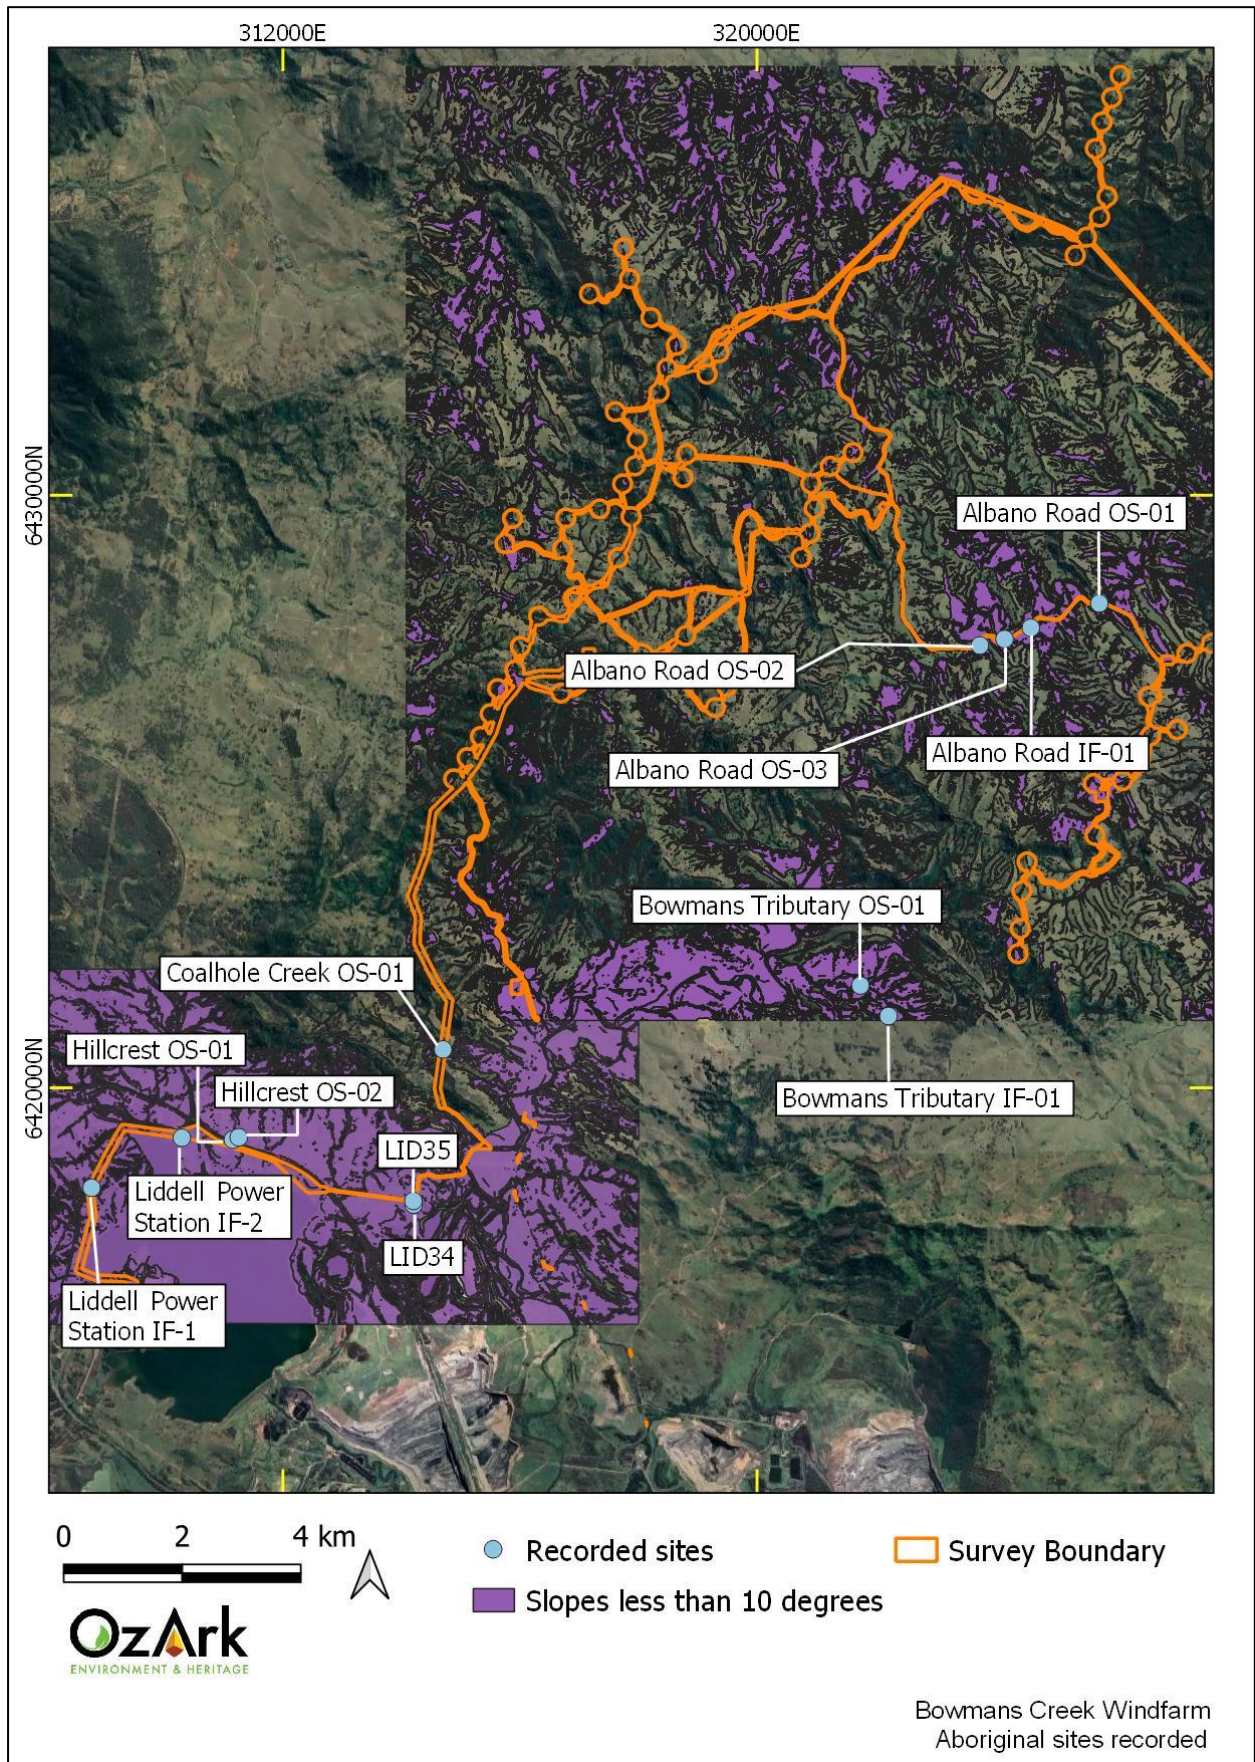
Figure 7-1: Aerial showing the relationship of recorded sites with degree of slope.

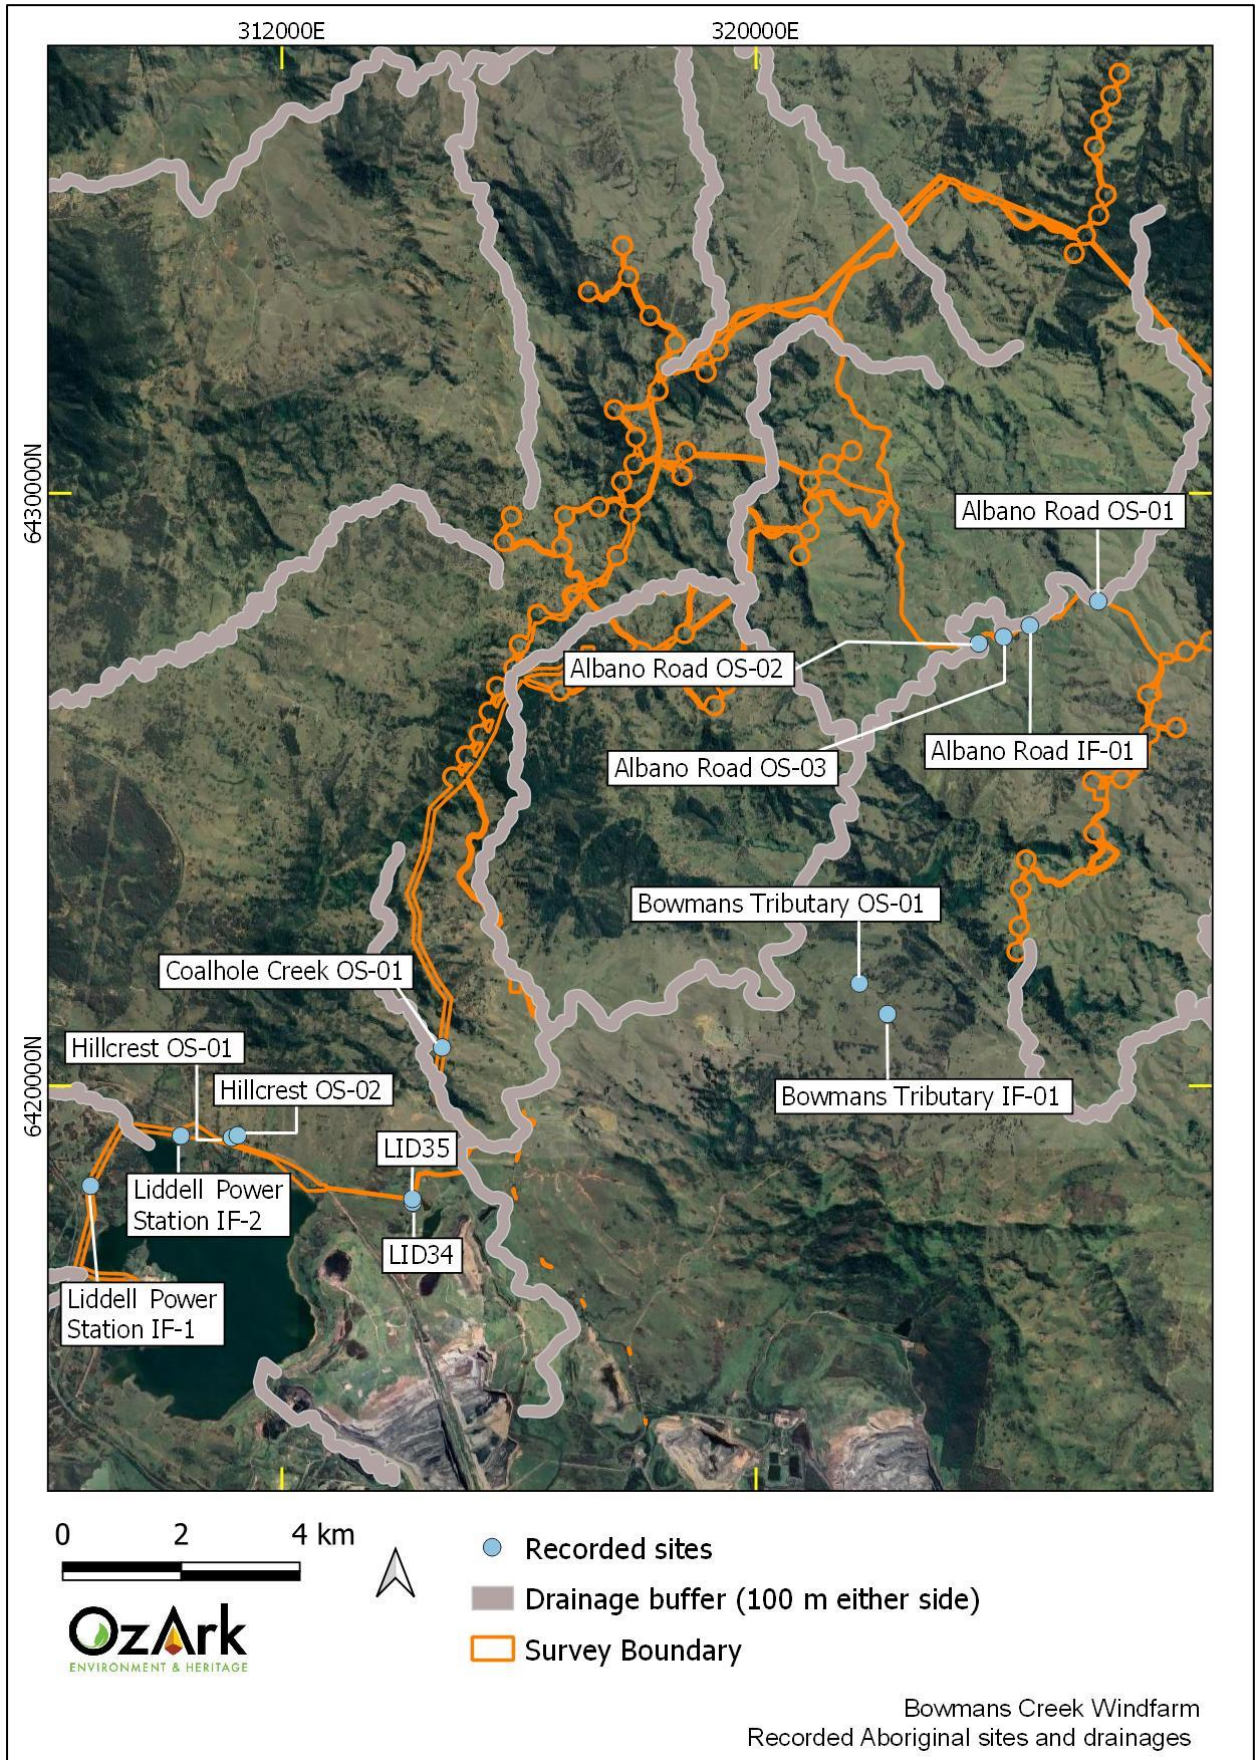
Figure 7-2: Aerial showing the relationship of recorded sites with drainage.

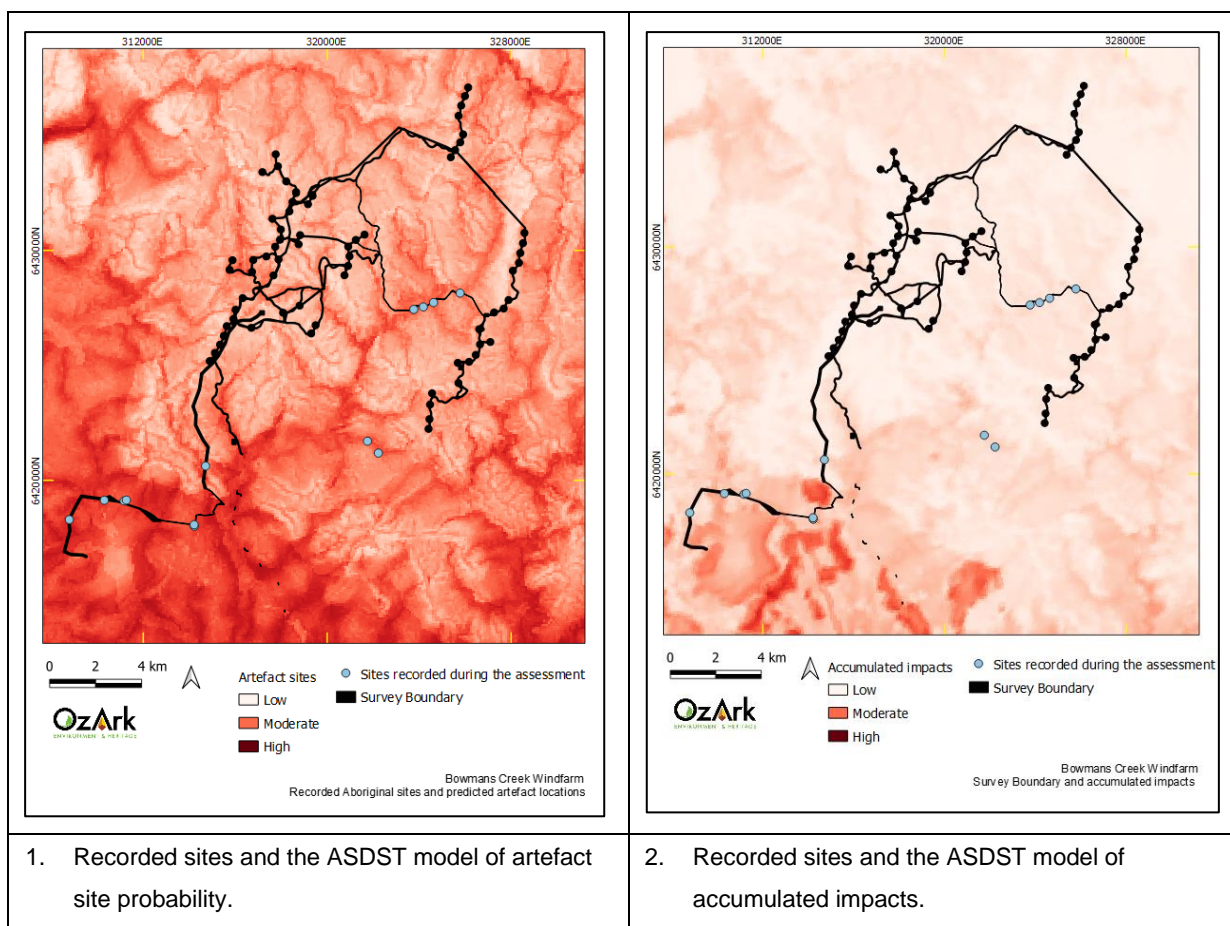
Figure 7-3: Recorded sites in relation to ASDST models.

In **Section 5.5.1** the ASDST models were used to develop a predictive model for site location. When the recorded sites are plotted against these models, the veracity of the models can be demonstrated. An examination of **Figure 7-3** allows the following observations to be made:

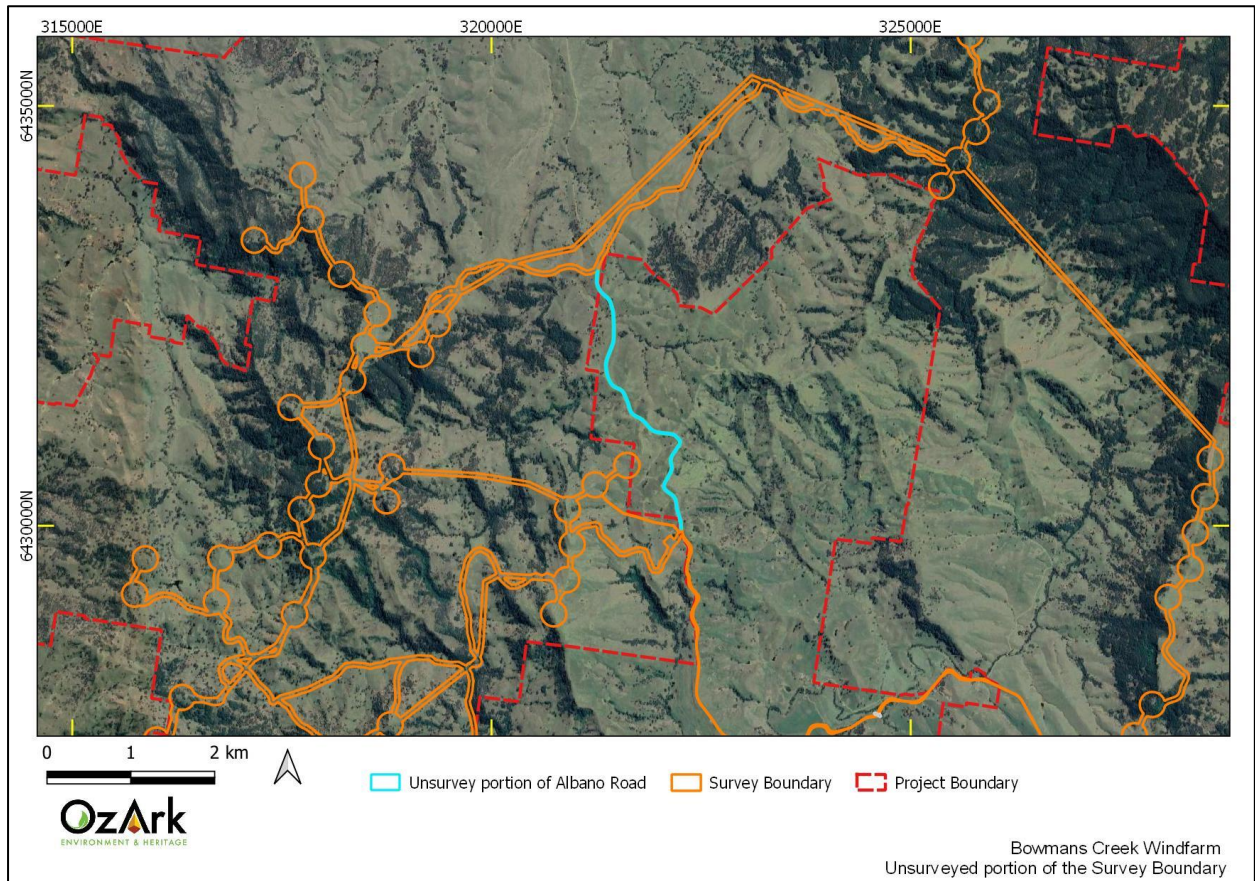
Figure 9-1: Aerial showing the unsurveyed portion of the Survey Boundary.
