# PROPOSED WIND FARM TOWERS CENTRAL HIGHLANDS TASMANIA

# RECONNAISSANCE LANDSLIDE RISK ASSESSMENT

Cromer, W. C. (2022). Reconnaissance landslide risk assessment, proposed wind farm towers, Central Highlands, Tasmania. Unpublished report for Epuron by William C. Cromer Pty. Ltd., 6 July 2022.

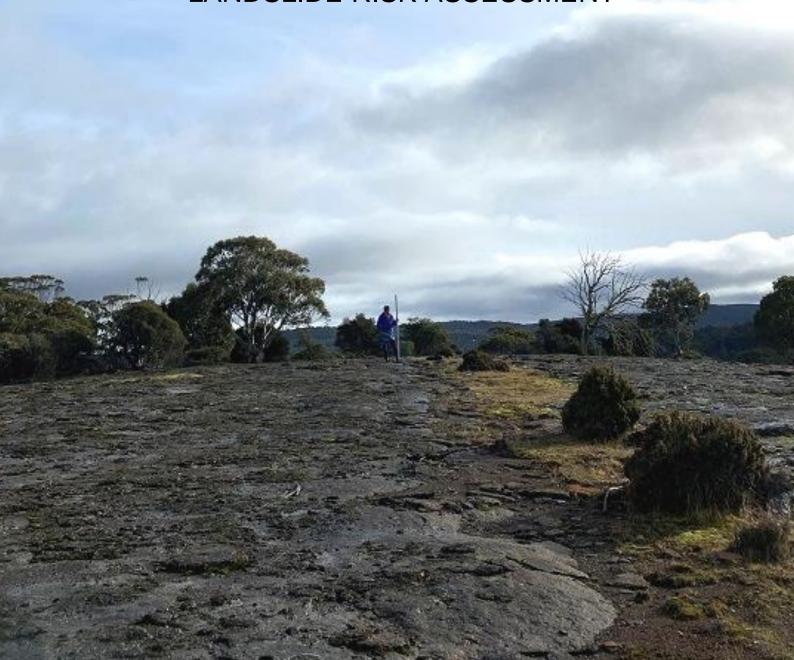
# Cover

View north towards proposed turbine tower T1 (centre), at an elevation of about 975mASL on an un-named hill bordering St. Patricks Plains and about one kilometre east of the Highlands Lake Road. In-situ Jurassic-age high strength dolerite bedrock is fully exposed over the site, showing well-developed exfoliation and columnar jointing.

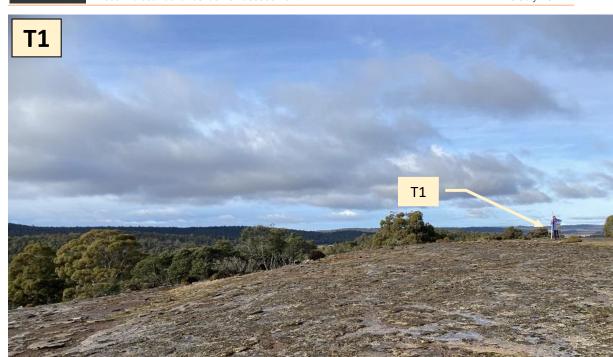
Plate T1-1 (above). View south near proposed tower T1 (at right), showing in-situ, high-strength Jurassic dolerite bedrock with well-developed curved exfoliation joints parallel to land surface (vertical spacing c. 0.02 – 0.2m). Plate T1-2 (below). View southwest near proposed tower T1 (at centre left), showing in-situ high strength Jurassic dolerite bedrock with (a) well-developed curved exfoliation joints parallel to land surface (vertical spacing c. 0.02 – 0.2m), and (b) subvertical polygonal joints (red arrows). These polygons are the eroded tops of subvertical dolerite columns. The jointing may extend for considerable depths into the bedrock., and columns may be cut by subhorizontal joints. The staff is 2m high.

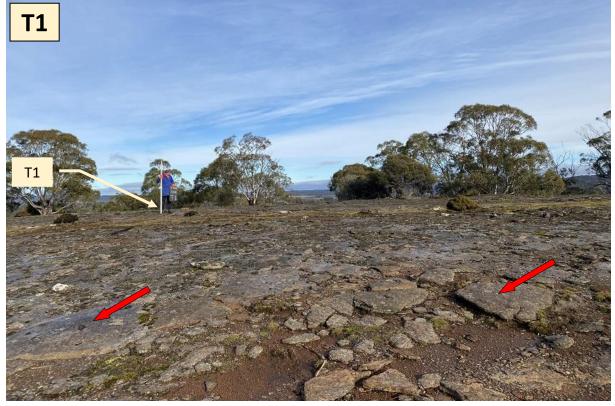
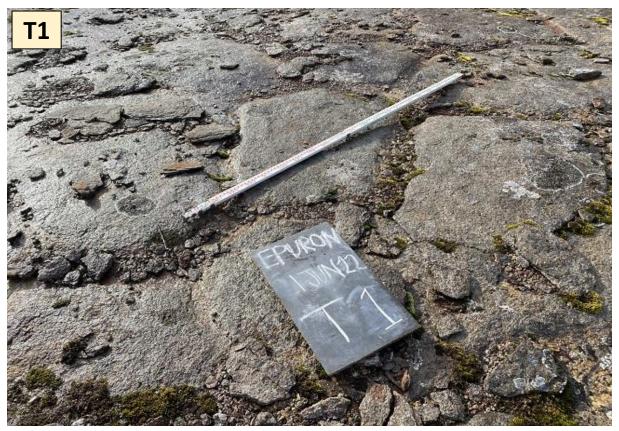
Plate T1-3 (above). Detail of polygonal jointing near T1. Plate T1-4 (below). View southwest from near T1, over a large exfoliated outcrop of high strength dolerite. St. Patricks Plains are in the background.

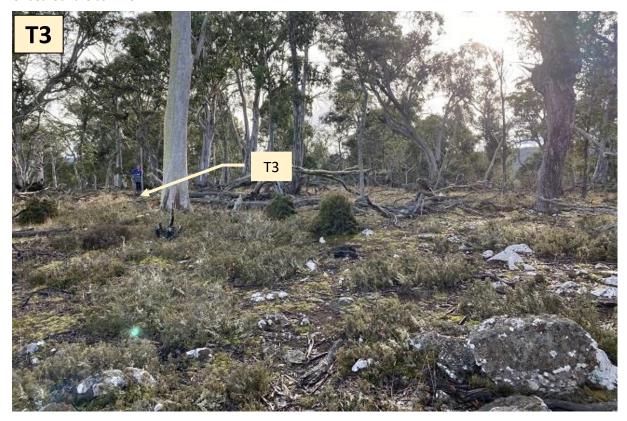
Plate T3-3 (above). View south southeast from near T3. Well-developed exfoliated joint surfaces in highstrength Jurassic-age dolerite. The staff is 3m high.

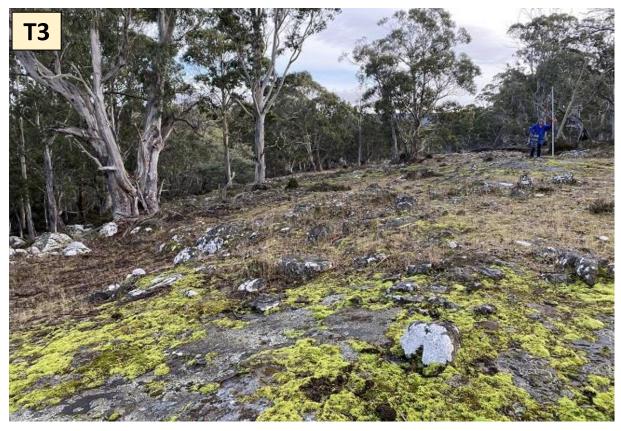
Plate T3-4 (below). View north towards T3 (off-camera to right). Dolerite cobbles and boulders float litters the ground, and outcrops of exfoliated high-strength bedrock are common. The staff is 3m high.

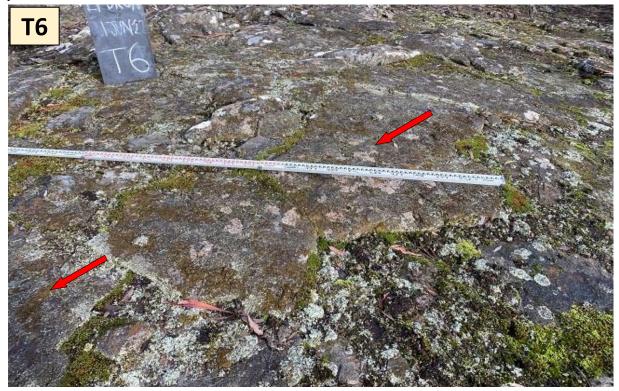
Plate T6-3 (above). View north and slightly upslope towards T6. Dolerite cobbles and boulders float litters the ground, and outcrops of exfoliated high-strength bedrock are common. The staff is 3m high. Plate T6-4 (below). Exfoliated, high-strength Jurassic dolerite (curved joints parallel to land surface) with subvertical polygonal joints (red arrows). These polygons are the eroded tops of subvertical dolerite columns. The jointing may extend for considerable depths into the bedrock., and columns may be cut by subhorizontal joints.

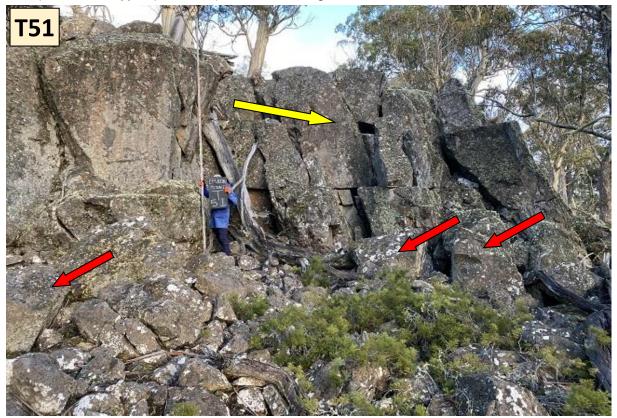
Plate T51-1 (above). View south towards T51, a slightly lower area between two raised dolerite outcrops [a subdued one at camera (see Plates T51-3 and T51-4); the second, higher one in background; see below]. Plate T51-2 (below). View south (site T51 is behind the camera). This outcrop of high strength dolerite shows prominent subvertical north-south jointing. The blocks have slid west (to right) and slightly downslope (yellow arrow), with some topples (red arrows). The staff is 5m high.

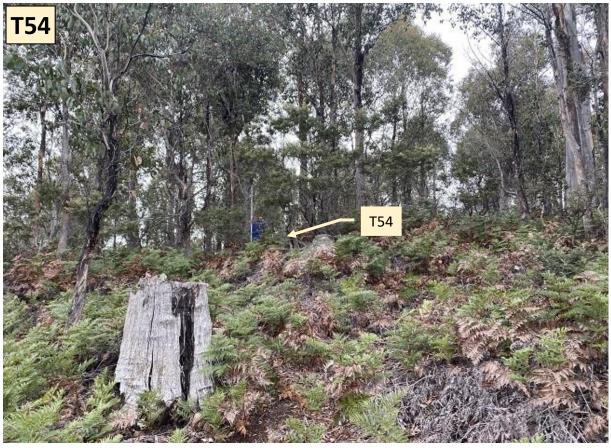
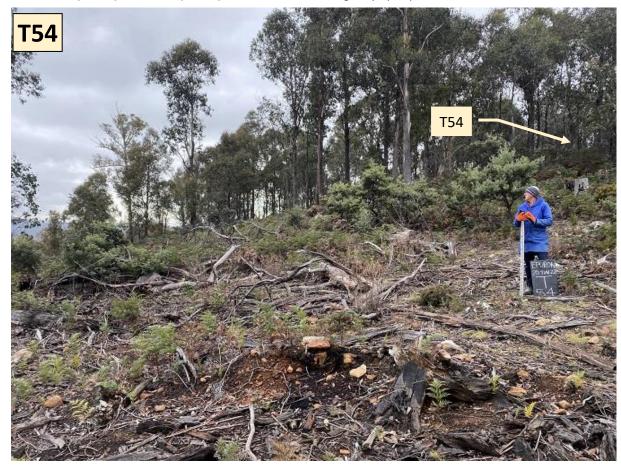
Plate T54-3 (above) and T54-4 (below). Views southeast and gently upslope towards T54.

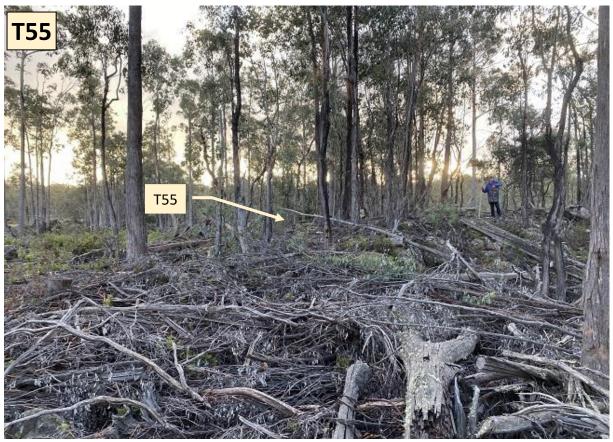
Plate T55-3 (above). View south towards T55, on gently sloping ground with a sparse float of dolerite cobbles and boulders.

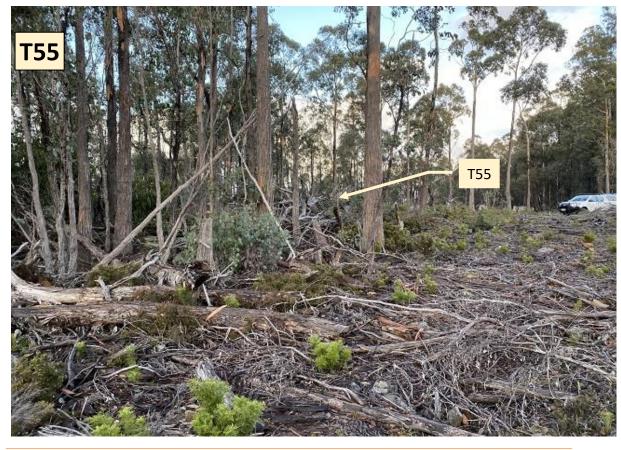
**Plate T55-4 (below).** View southeast towards T55. The ground at the site rises very slightly to the north.
