APPENDIX 2 - DRAINAGE AND CREEK CROSSING STRUCTURES

Note: Road names are based on Google Maps

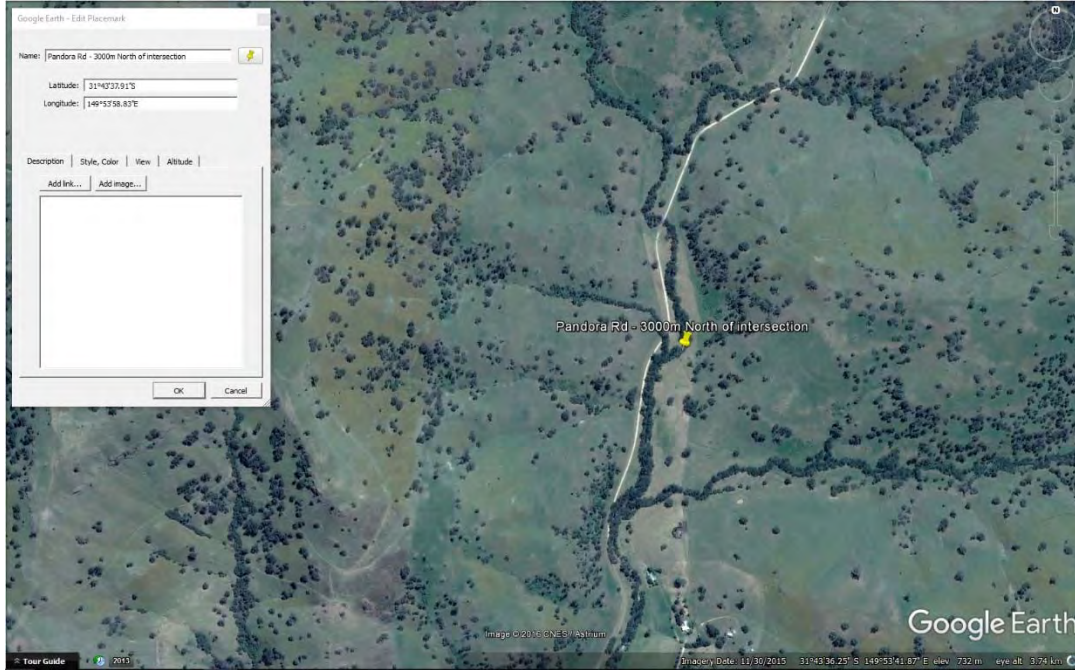
S001 – Location Plan

S001 – Pandora Rd – 3000m North of Coolah Creek Intersection

4000mm Causeway

Survey recommended to verify compliance with vertical geometry requirements.

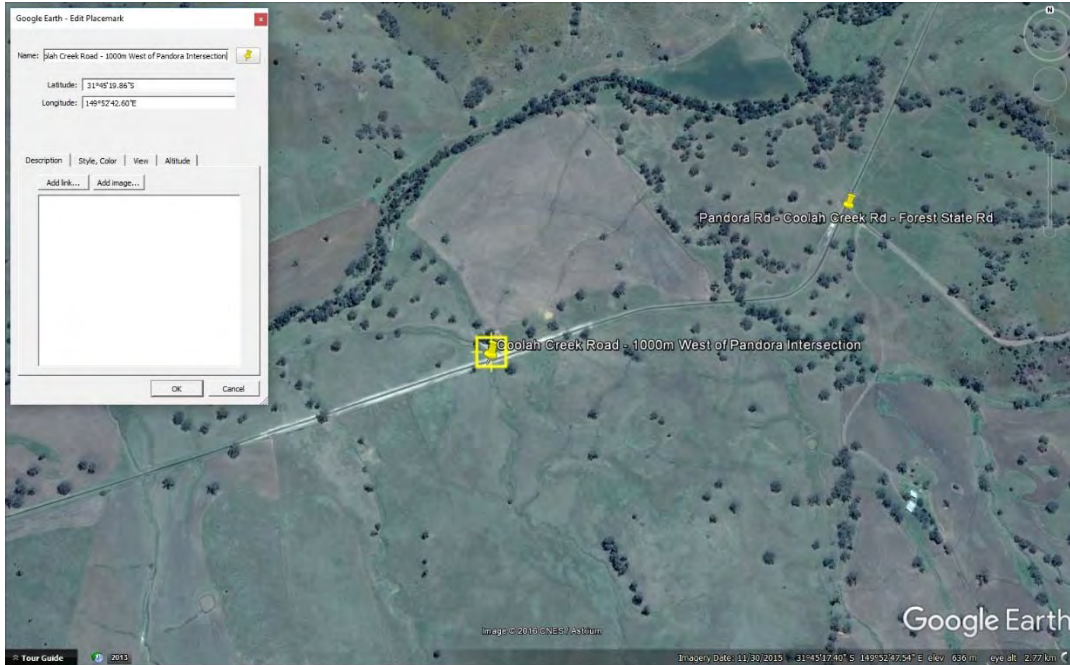
S002 – Location Plan

S002 – Coolah Creek Rd – 1000m West of Pandora Rd
4-750mm Pipe Culvert
Fair and Serviceable Condition, Good Internal Condition

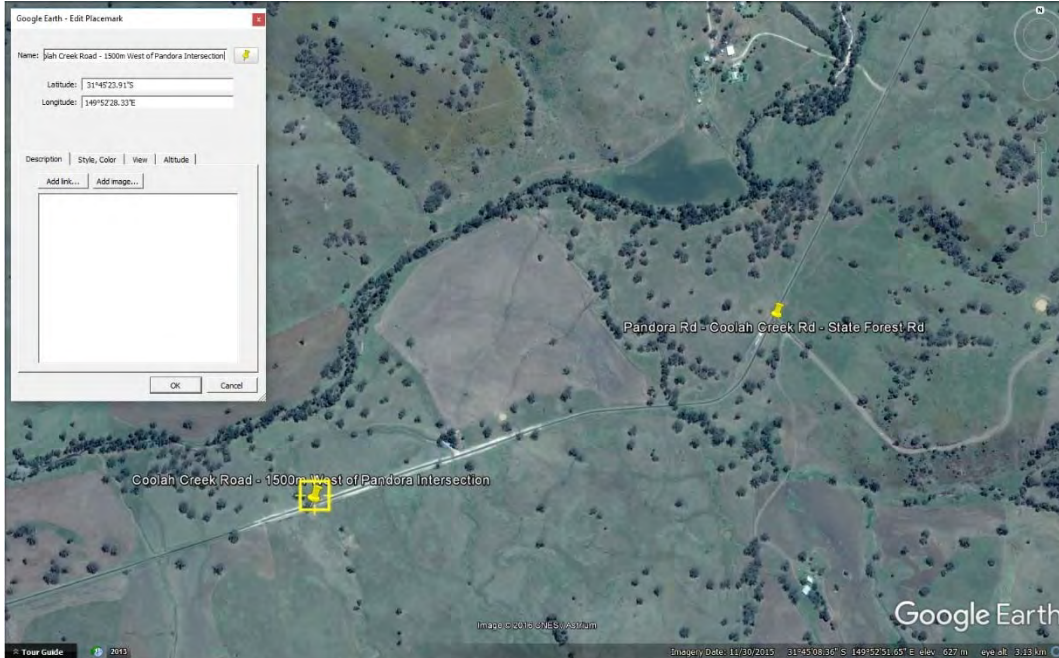
S003 – Location Plan

S003 – Coolah Creek Rd – 1500m West of Pandora Intersection

3-900mm Pipe Culvert
Good Condition and Serviceable

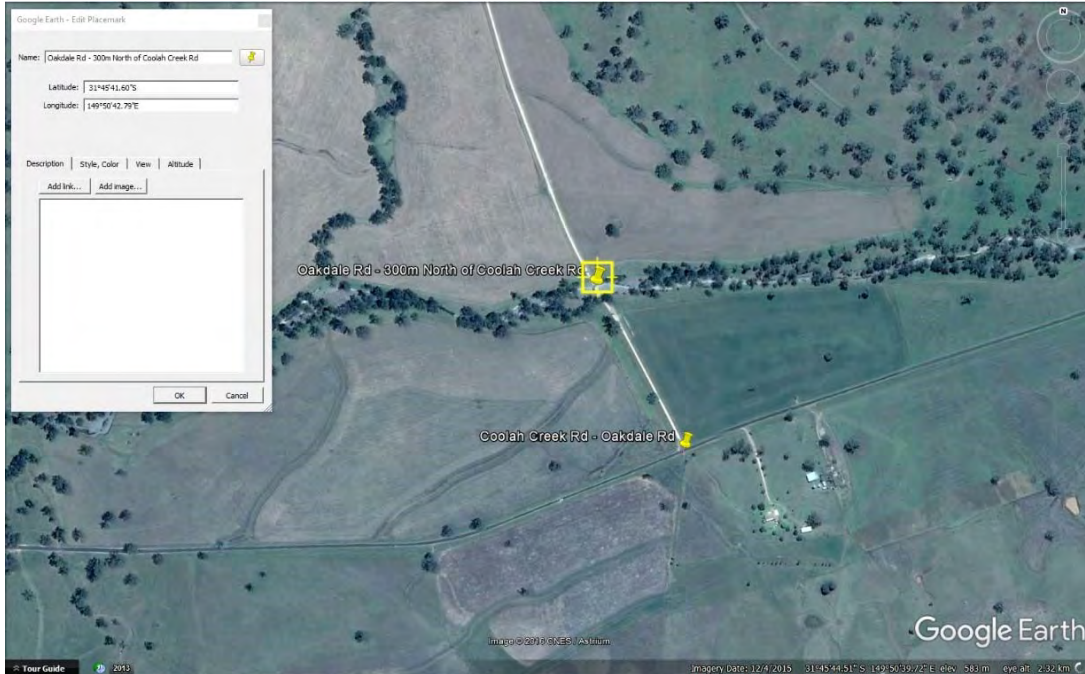
S004 – Location Plan

S004 – Oakdale Rd - 300m North of Coolah Creek Rd
Concrete Causeway, Submerged and Flood Prone.
Poor Condition and Serviceable. Upgrade likely required.
Surface on Causeway is slippery due to moss

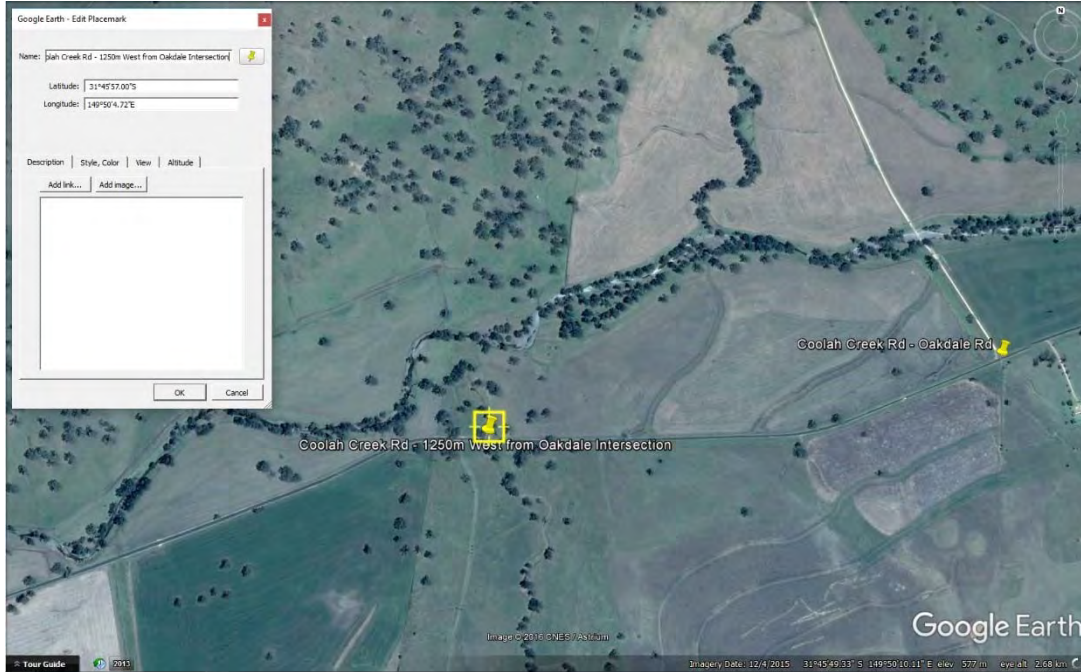
S005 – Location Plan

Concrete causeway with bitumen seal - 3-1200mm Pipe Culvert,
Entrance to culvert is blocked,
Further inspection of internal condition is required
Fair condition and Serviceable

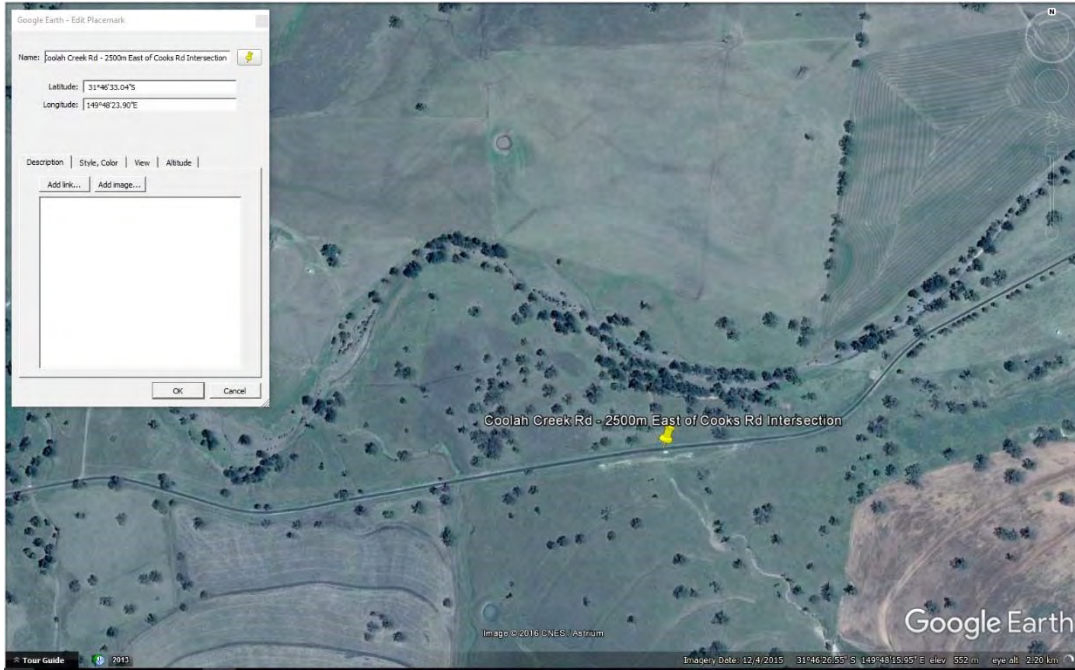
S006 - Location Plan

S006 – Coolah Creek Rd - 2500m East of Cooks Dr Intersection
1200mm Pipe Culvert
Good condition and Serviceable

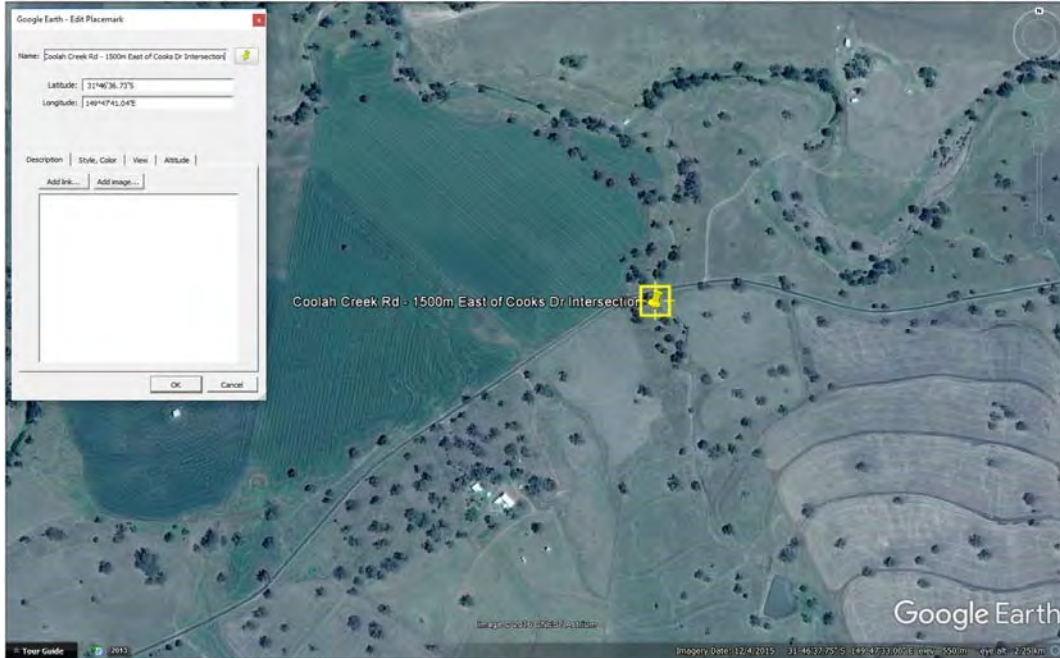
S007 – Location Plan

Concrete causeway 3-1050mm Pipe Culvert

Big invert cracks internally

Poor condition and serviceable, upgrade required.

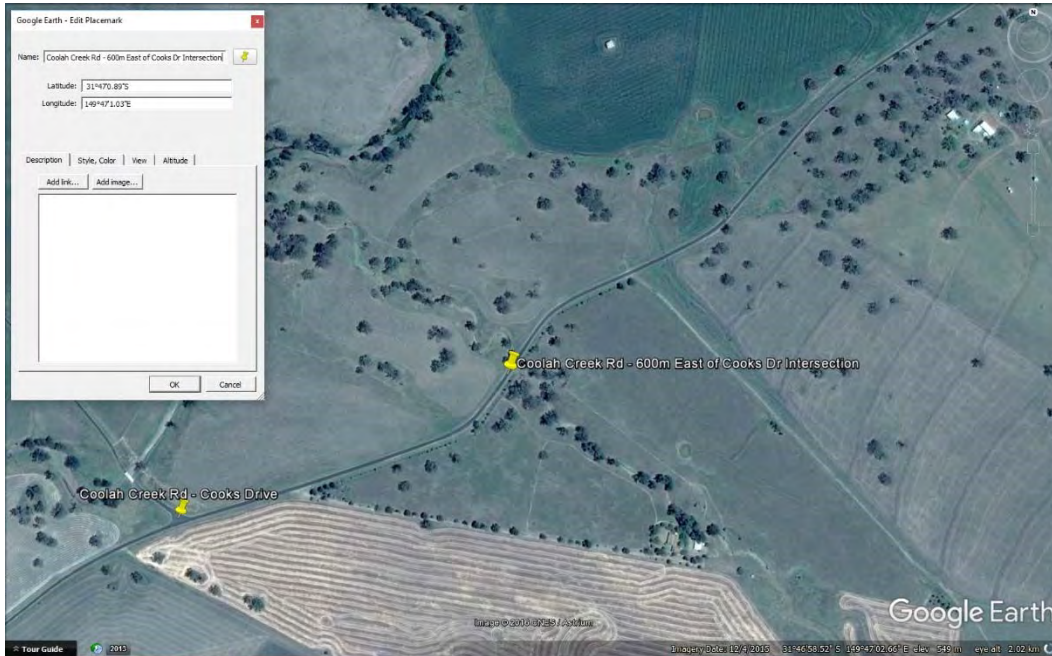
S008 - Site Location

S008 – Coolah Creek Rd - 600m East of Cooks Dr Intersection
3 -1200mm Pipe Culvert
Fair Condition and serviceable

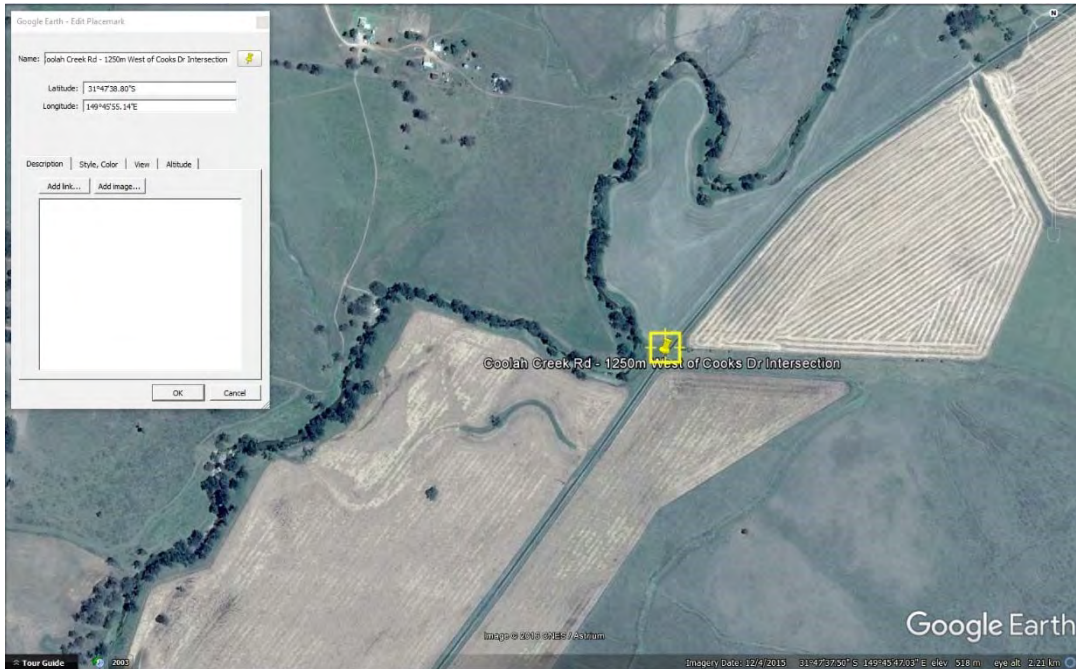
S009 – Location Plan

4-1200mm Wide-450mm High Reinforced Concrete Box Culvert – Skewed across road alignment.
Good Condition and Serviceable

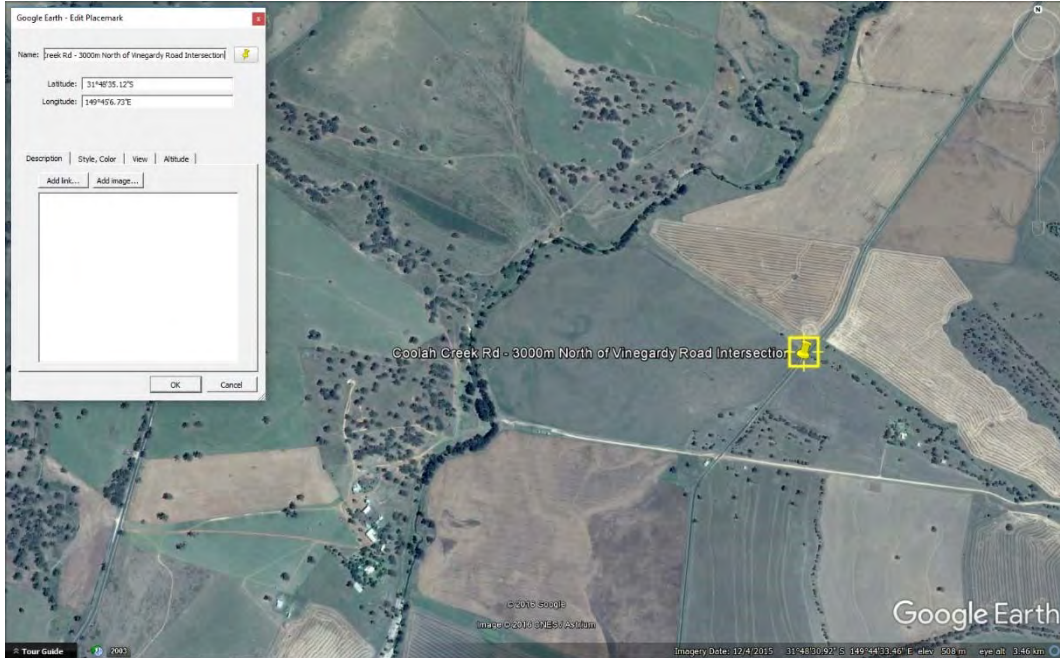
S010 – Location Plan

S010 – Coolah Creek Rd - 3000m North of Vinegaroy Road Intersection
3-1050mm Pipe Culvert
Moderate Condition and Serviceable. Poorly maintained.

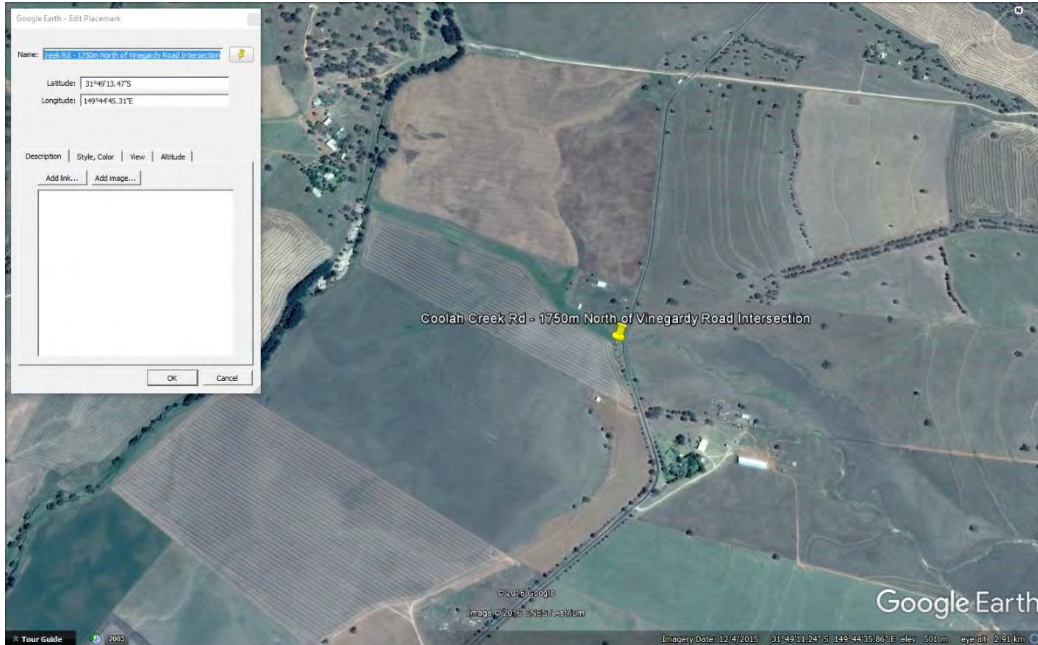
S011 - Location Plan

Concrete Causeway 3-1050mm Pipe Culvert

Internal Condition is satisfactory.

Good Condition and Serviceable

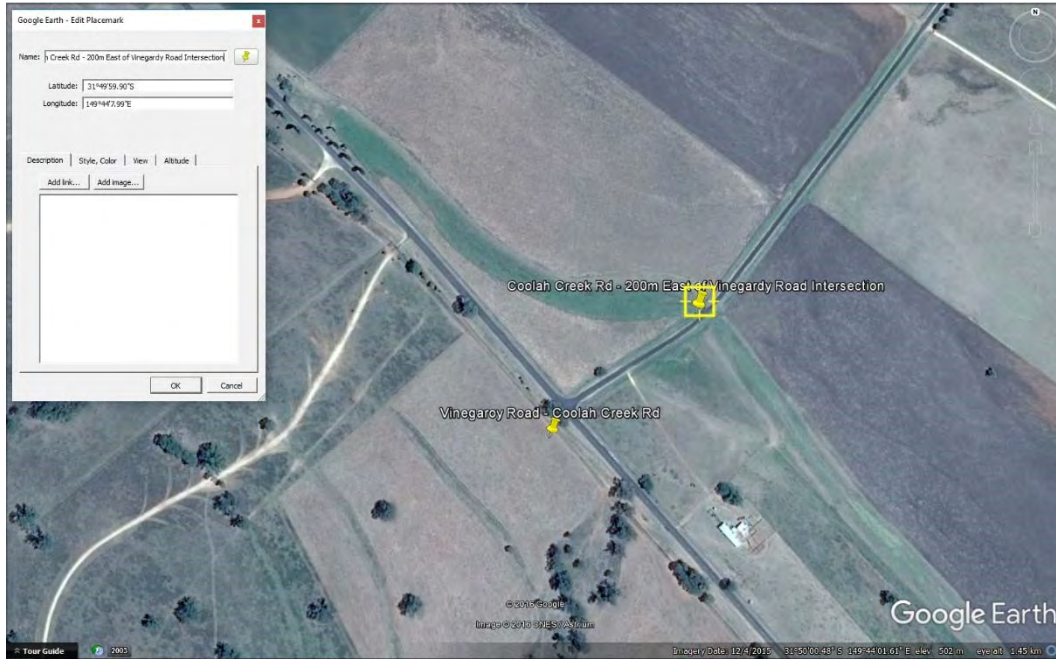
S012 – Location Plan

7500mm wide Concrete Causeway with bitumen seal,
3-750mm high-2400mm long reinforced concrete box culvert
Fair condition and serviceable

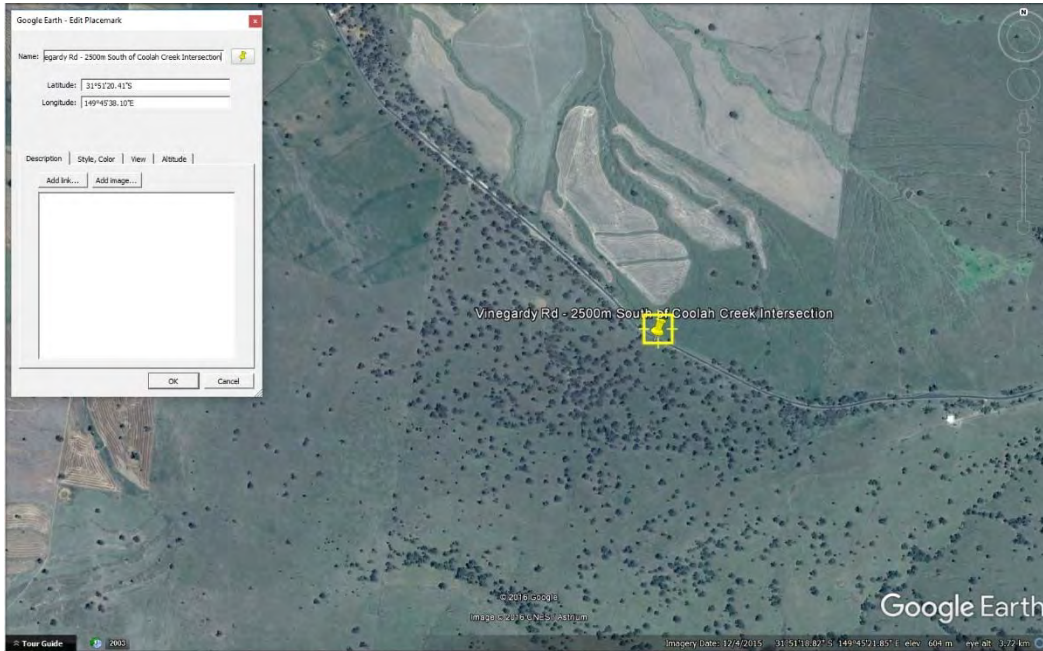
S013 – Location Plan

S013 - Vinegaroy Rd - 2500m South of Coolah Creek Intersection
1200mm Pipe Culvert
Good Condition and Serviceable

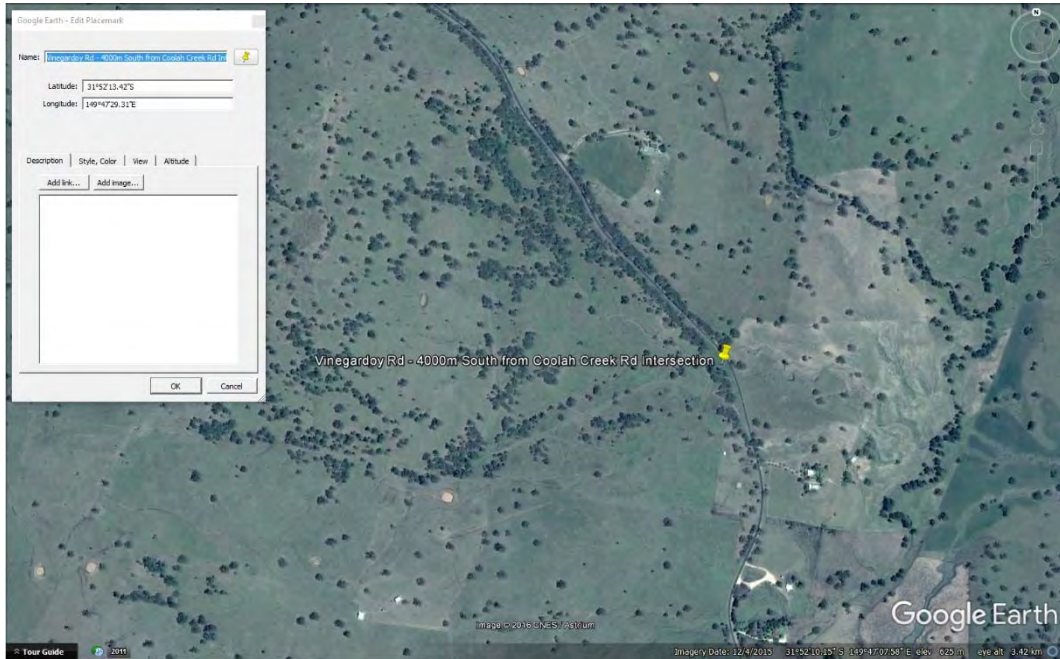
S014 – Location Plan

Causeway Dual-1200mm pipe culvert

Skewed and not level

Moderate condition and Serviceable

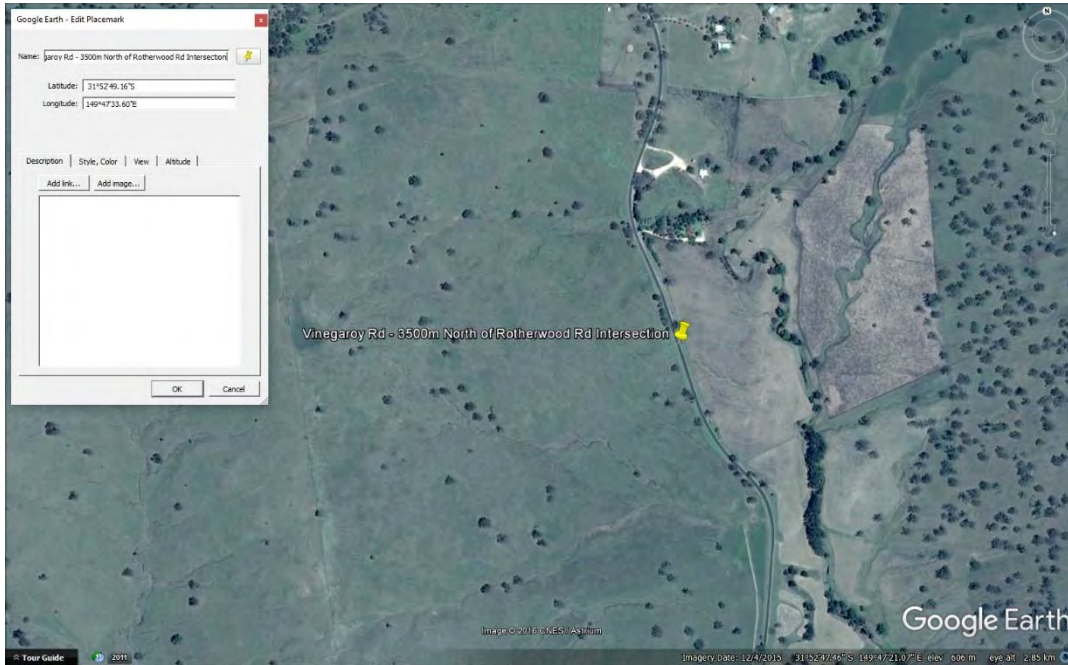
S015 – Location Plan

S015 - Vinegaroy Rd - 3500m North of Rotherwood Rd intersection
450mm pipe culvert
Fair condition and serviceable

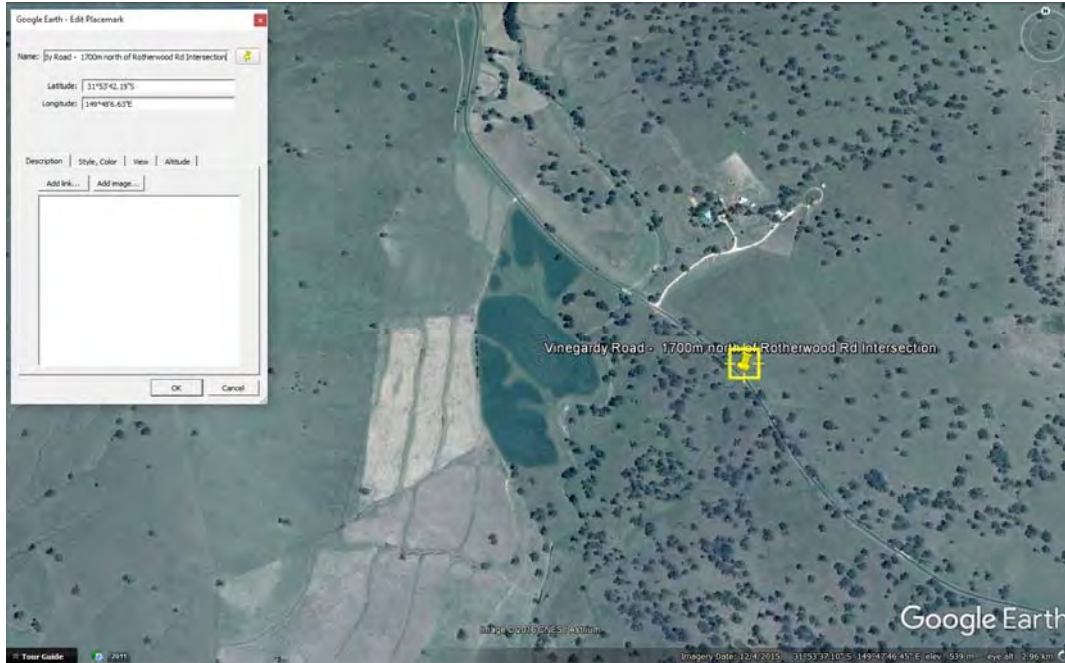
S016 – Location Plan

Dual 900mm Pipe Culvert.

Scouring of outlet visible.

Moderate Condition and Serviceable.

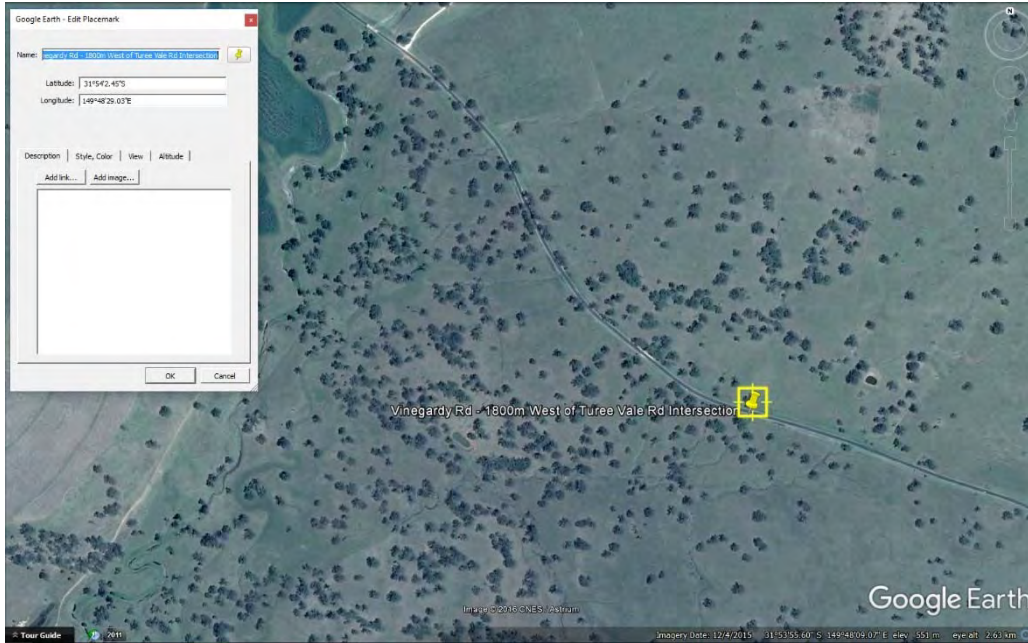
S017- Location Plan

Dual-1050mm pipe culvert

Fair condition and serviceable.

Poorly maintained.

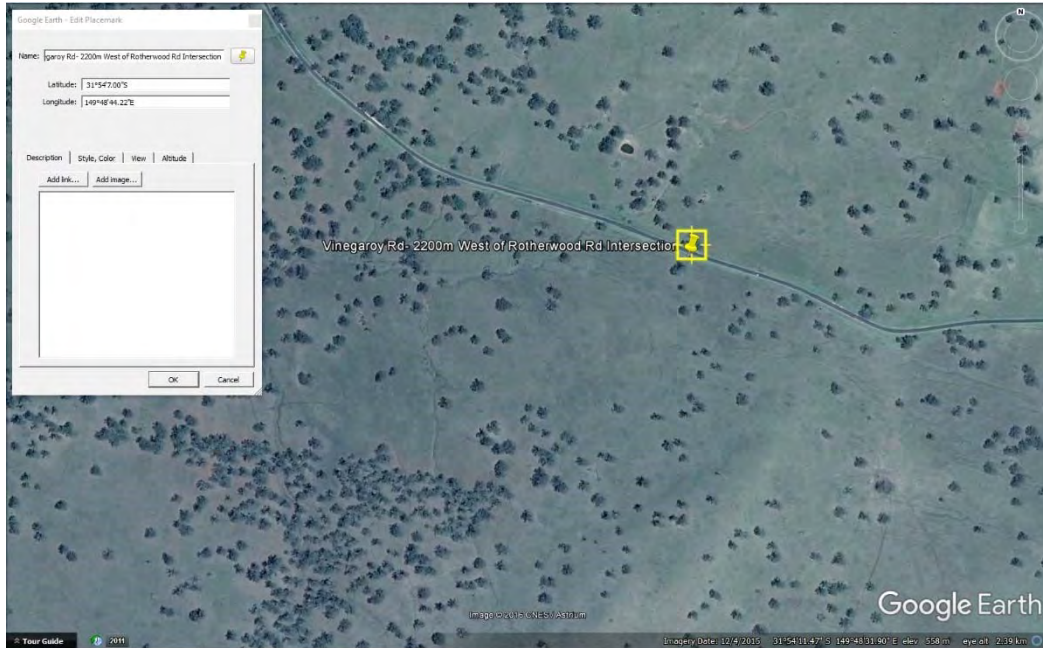
S018 – Location Plan

450mm Pipe Culvert

Moderate condition and serviceable. Maintenance required.

Currently blocked, to be reassessed prior to construction.

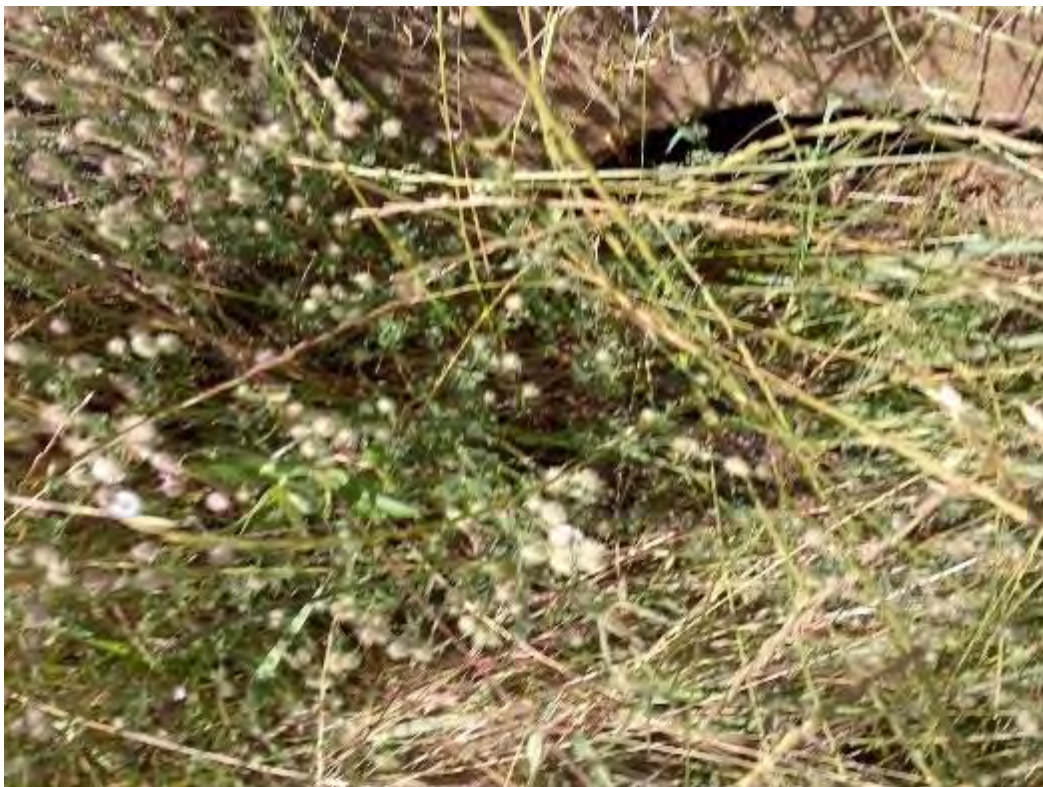
S018 – Blocked Pipe Culvert

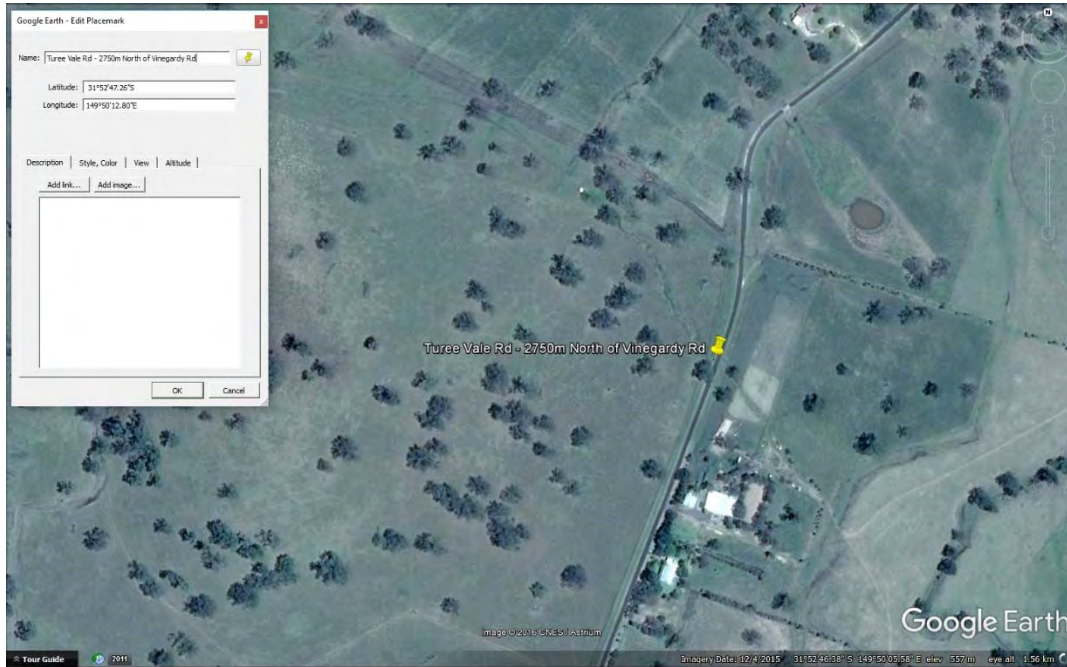
S019 – Location Plan

S019 – Turee Vale Rd - 2750m North of Vinegaroy Rd
Pipe culvert not accessible. Dimensions and condition unknown.
Maintenance required prior to construction to enable inspection.

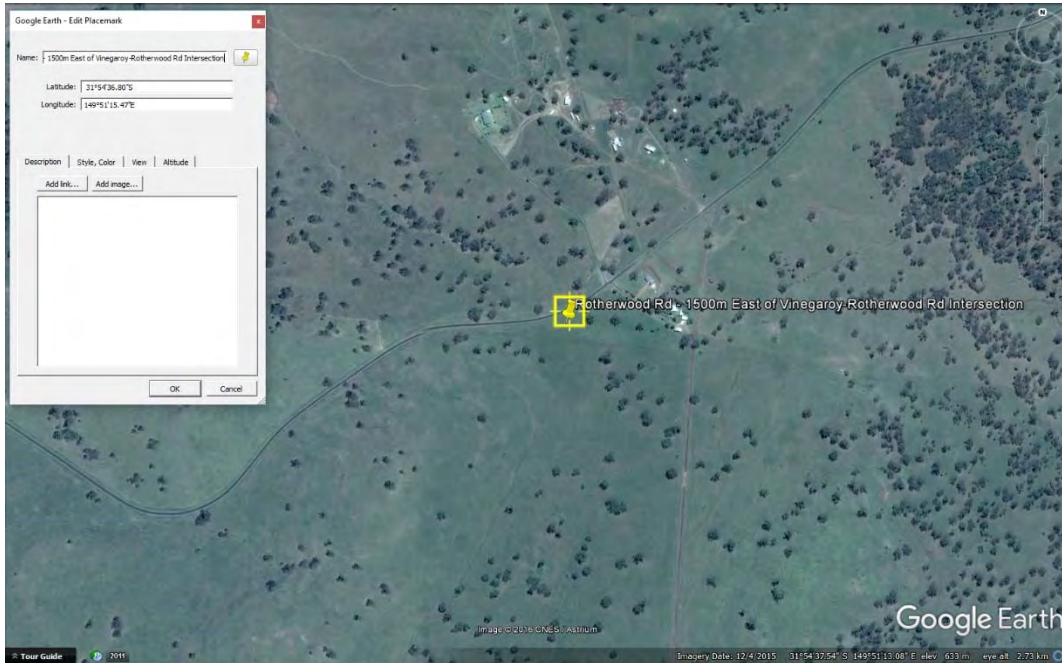
S023 – Location Plan

S023 – Rotherwood Road – 1500m East of Vinegaroy Intersection
Dual 1200mm-600mm Reinforced Concrete Box Culvert
Fair Condition and Serviceable

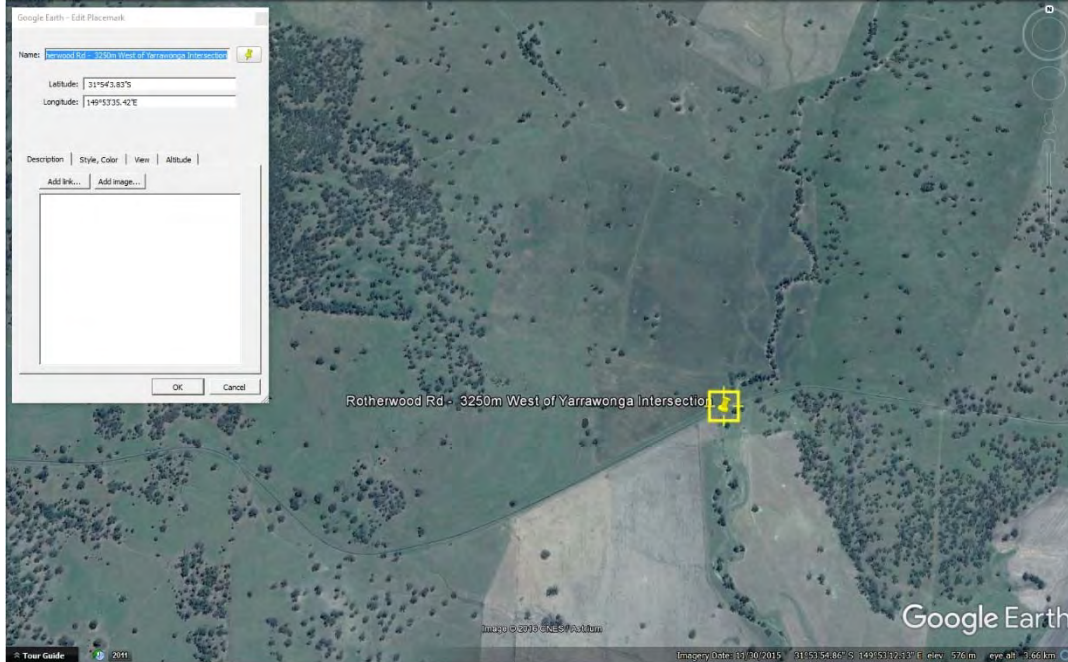
S024 – Location Plan

Causeway on Starkey Creek
Submerged and prone to flooding
Poor condition, upgrade required.

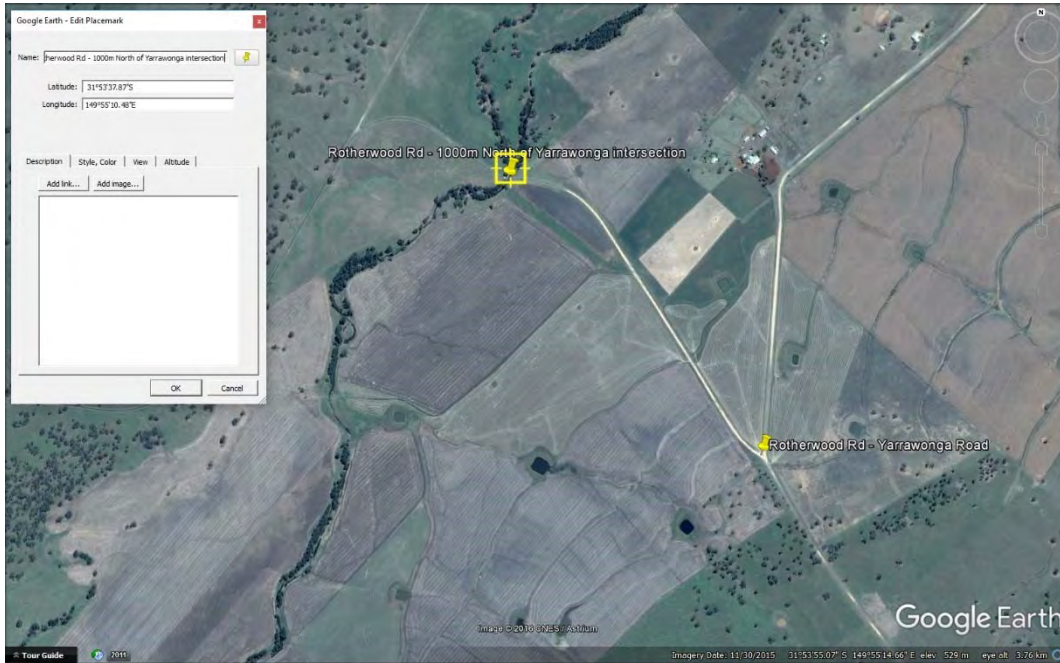
S025 – Location Plan

S025 – Rotherwood Road 1000m North of Yarrawonga Intersection
Concrete Causeway 750mm invert culvert
Fair condition and serviceable

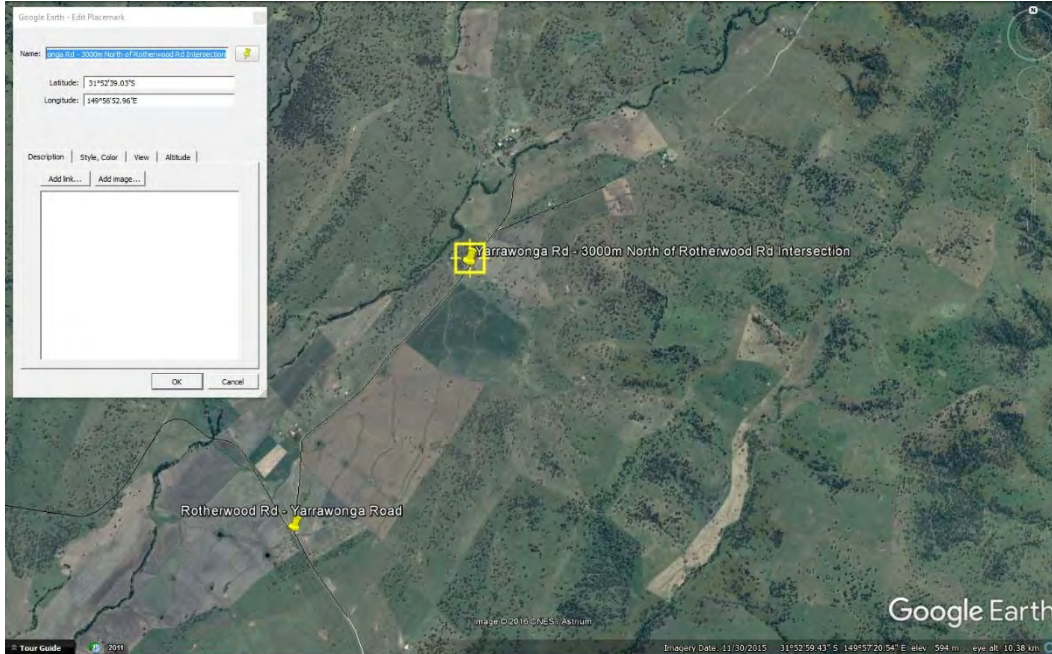
S026 – Location Plan

600mm Pipe Culvert

Blocked and inaccessible

Maintenance and further inspection required.

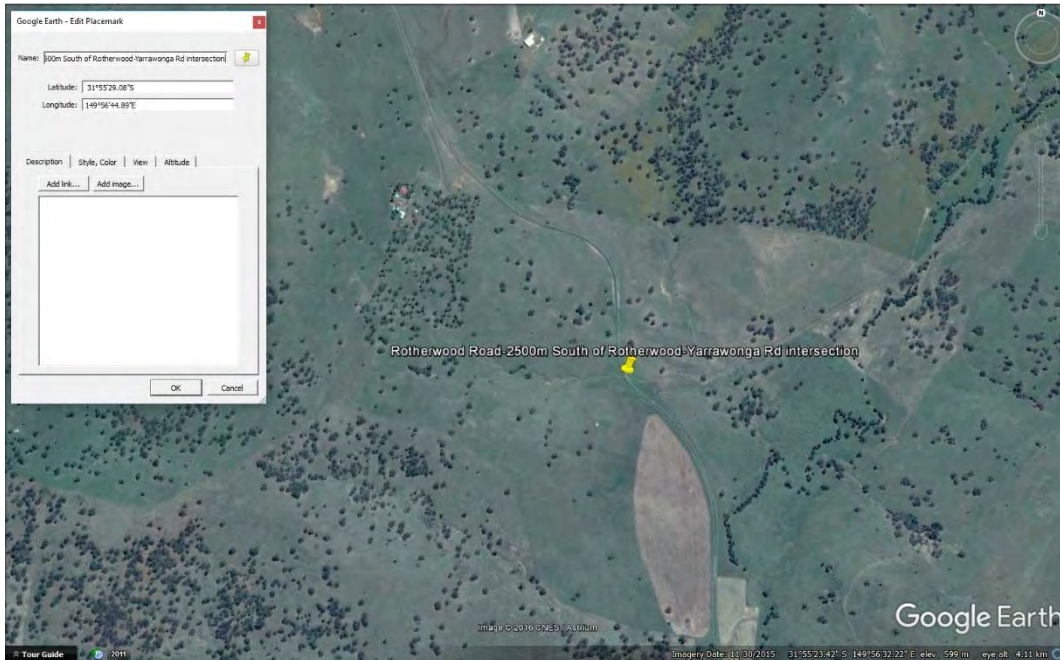
S027 – Location Plan

S027 – Rotherwood Road 2500m South of Rotherwood-Yarrowonga Rd intersection
Dual 1200mm pipe culvert
Moderate condition and serviceable

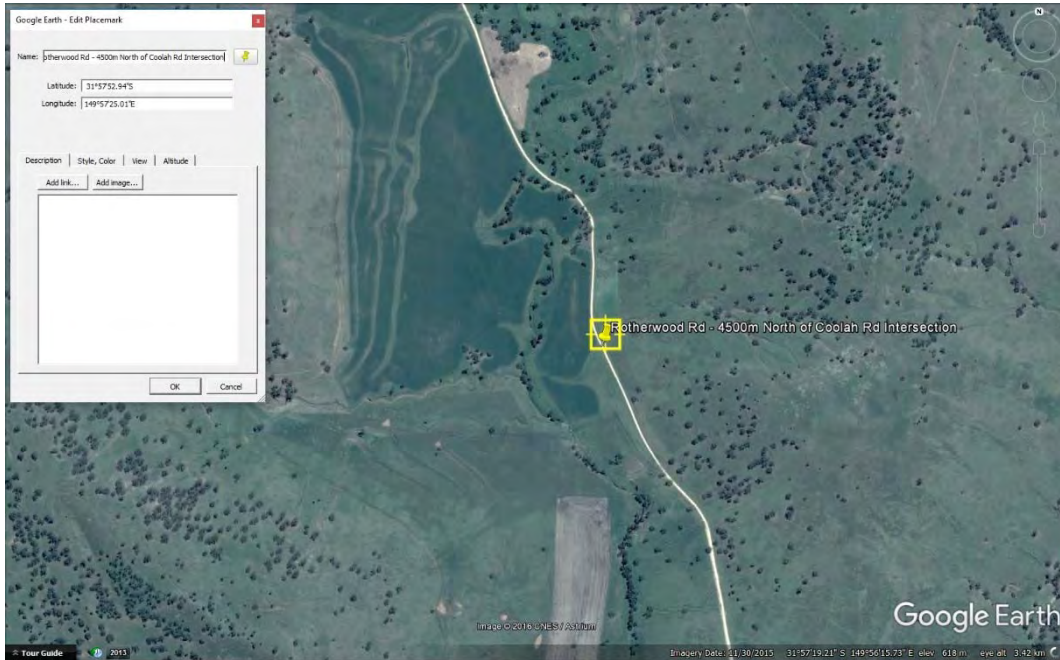
S029 – Location Plan

S029 – Rotherwood Road 4500m North of Coolah Rd intersection
Causeway, 900mm Pipe Culvert
Moderate Condition and Serviceable

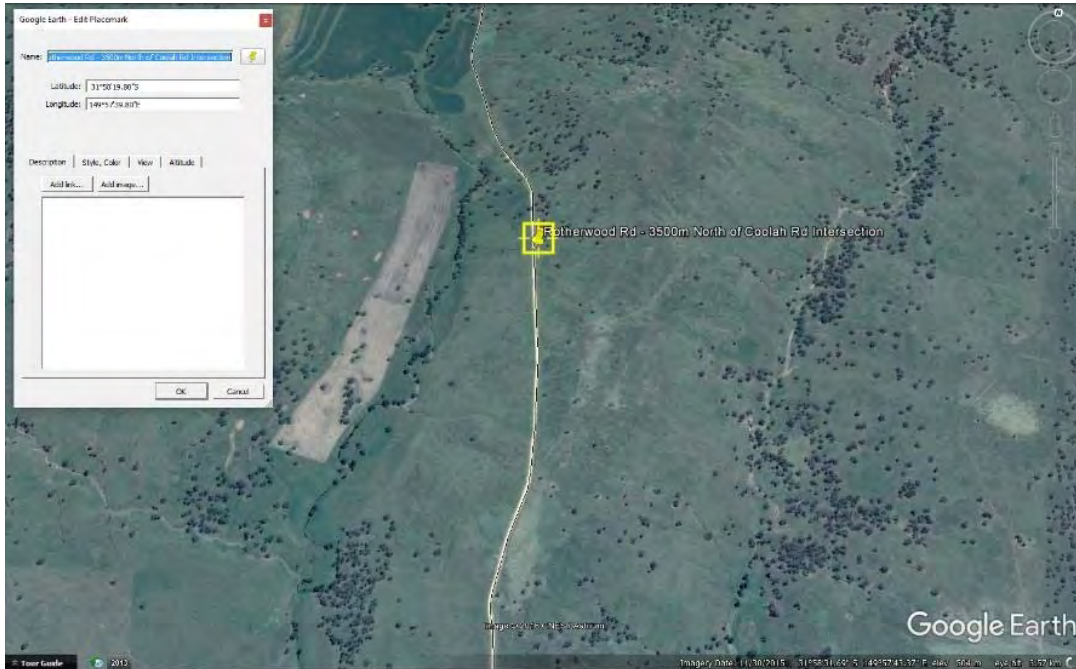
S030 – Location Plan

S030 – Rotherwood Rd - 3500m North of Coolah Rd Intersection

750mm Pipe Culvert

Cracked head wall,

No photo evidence of culvert but location of medium importance

Will require further inspection

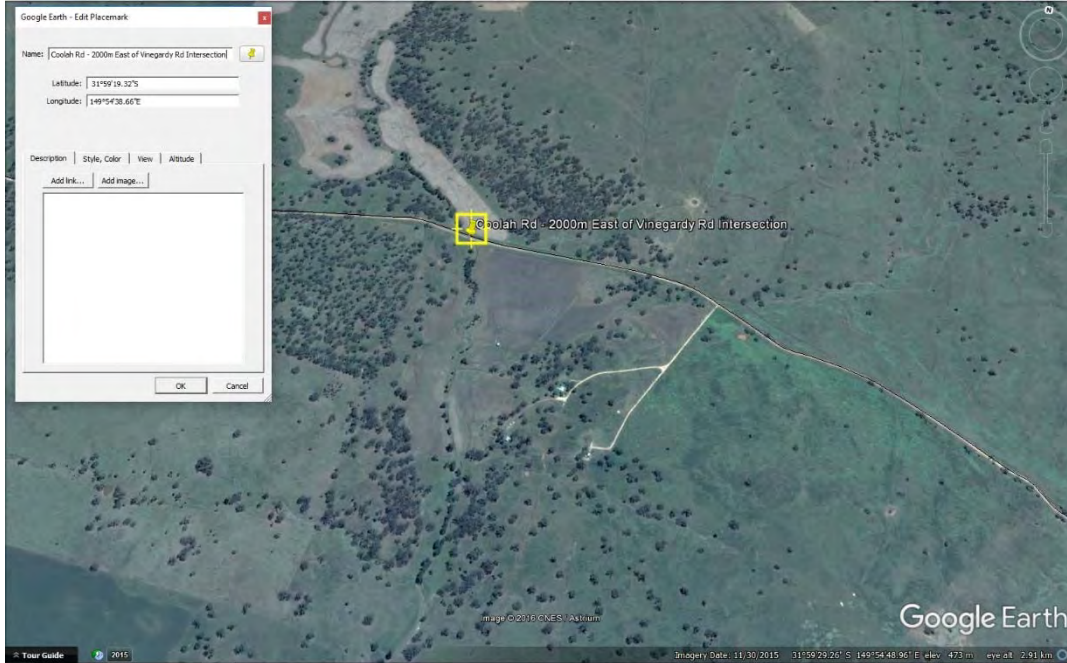
S031 – Location Plan

S031 - Coolah Rd - 2000m East of Vinegaroy Rd Intersection

Causeway

No culvert

Survey required to verify compliance with vertical geometry requirements of the proposed heavy vehicle configurations.

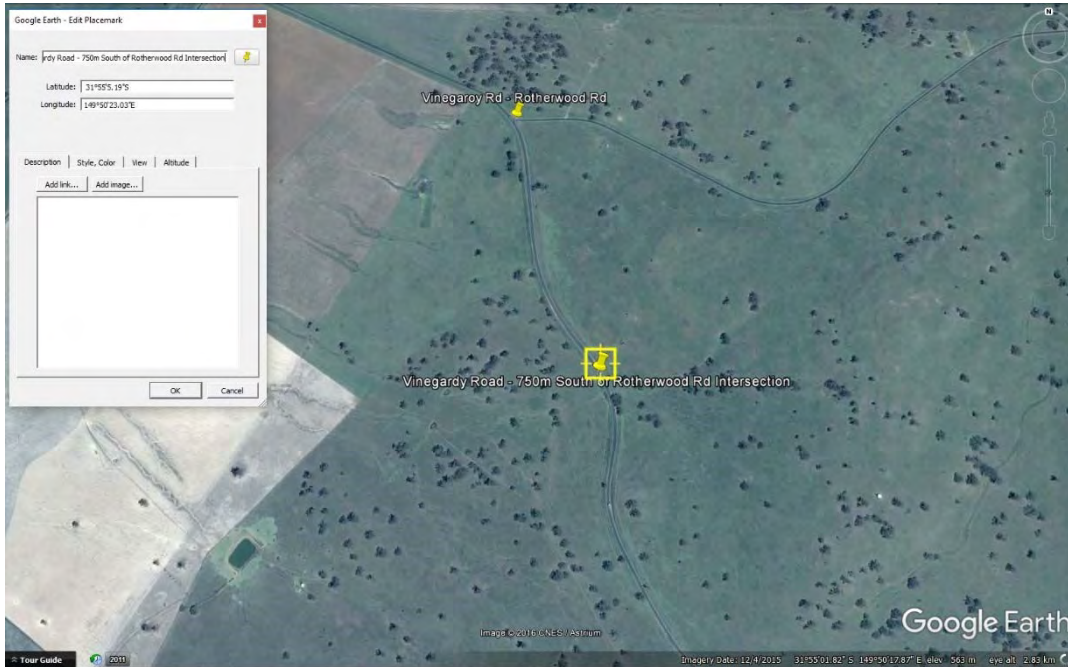
S032 – Location Plan

S032 – Vinegaroy Road – 750m South of Rotherwood Rd – Vinegaroy Rd Intersection
1200mm - 900mm Reinforced concrete box culvert
Moderate condition and serviceable

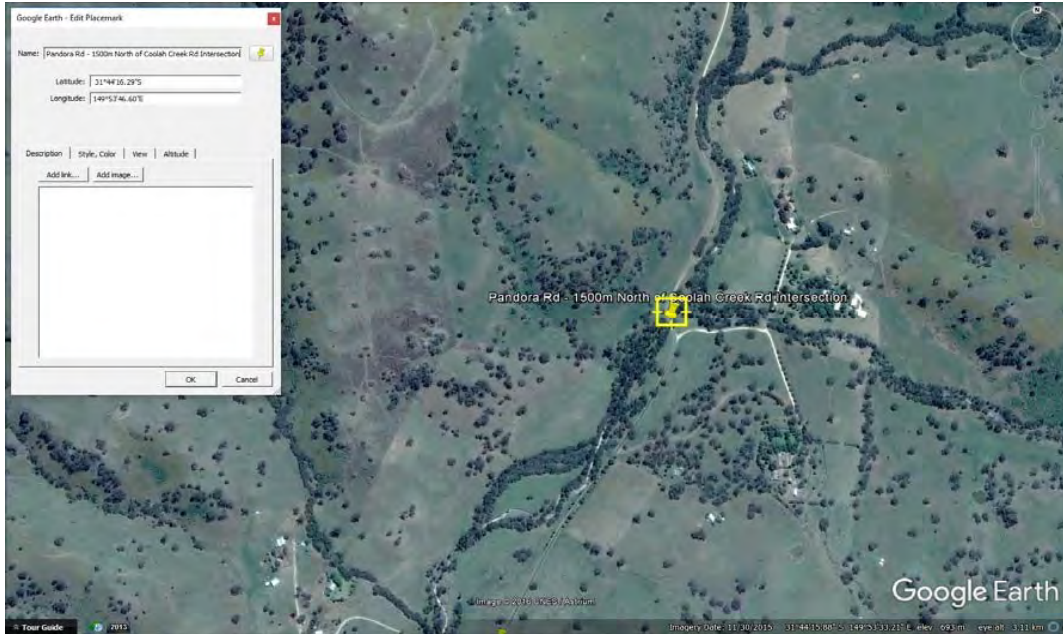
S033 – Location Plan

S033 – Pandora Rd – 1500m North of Coolah Creek Intersection

4000mm-20000mm Concrete causeway

Poor condition and serviceable

Upgrade may be required

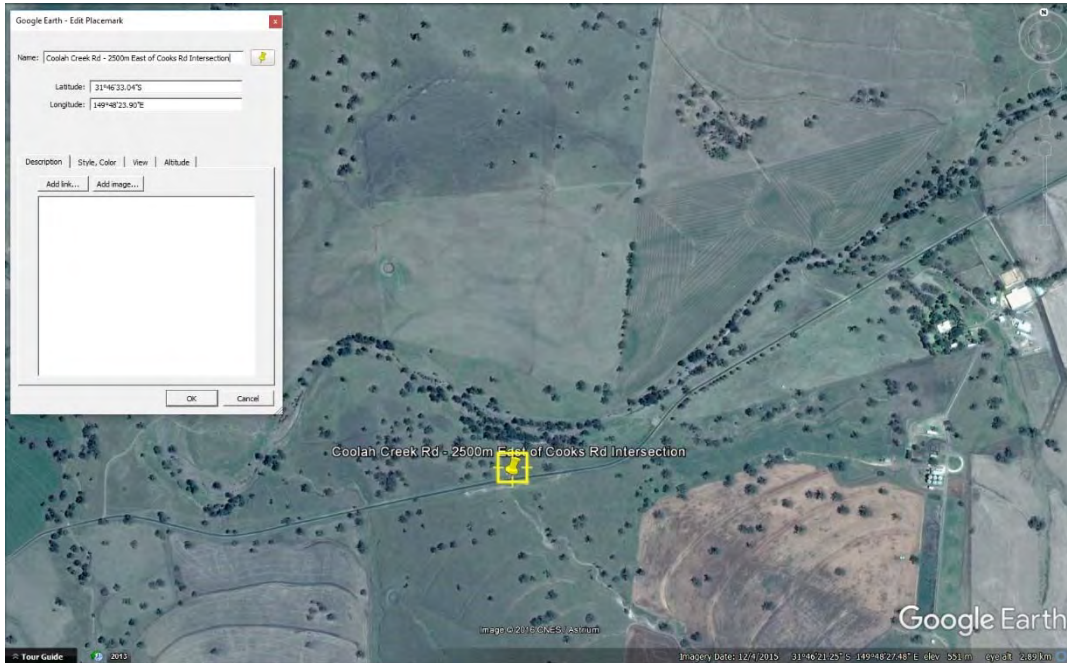
S034 – Location Plan

S034 - Coolah Creek Rd - 2500m East of Cooks Rd Intersection

Dual 1200mm pipe culvert and 900mm diameter pipe culvert drop inlet.
Good Condition and Serviceable.
