APPENDIX 2 - DRAINAGE AND CREEK CROSSING STRUCTURES

Note: Road names are based on Google Maps

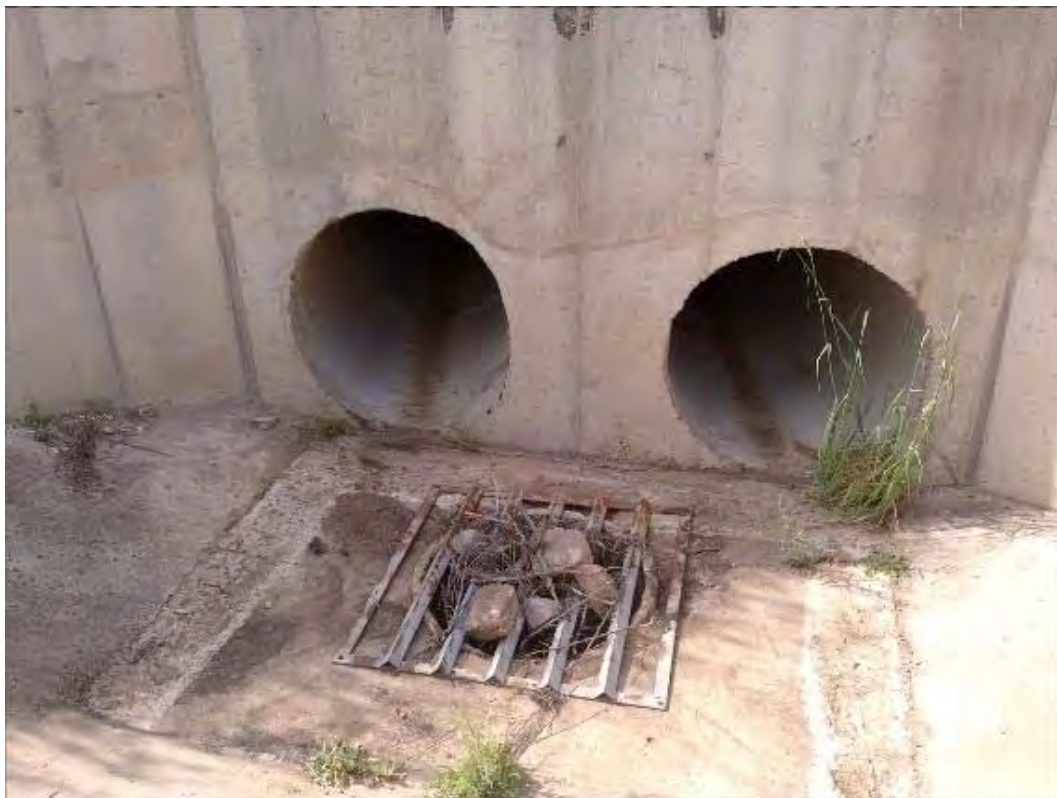
Dual 1200mm pipe culvert and 900mm diameter pipe culvert drop inlet.
Good Condition and Serviceable.

S034 – Dual 1200mm + 900mm pipe culvert drop inlet

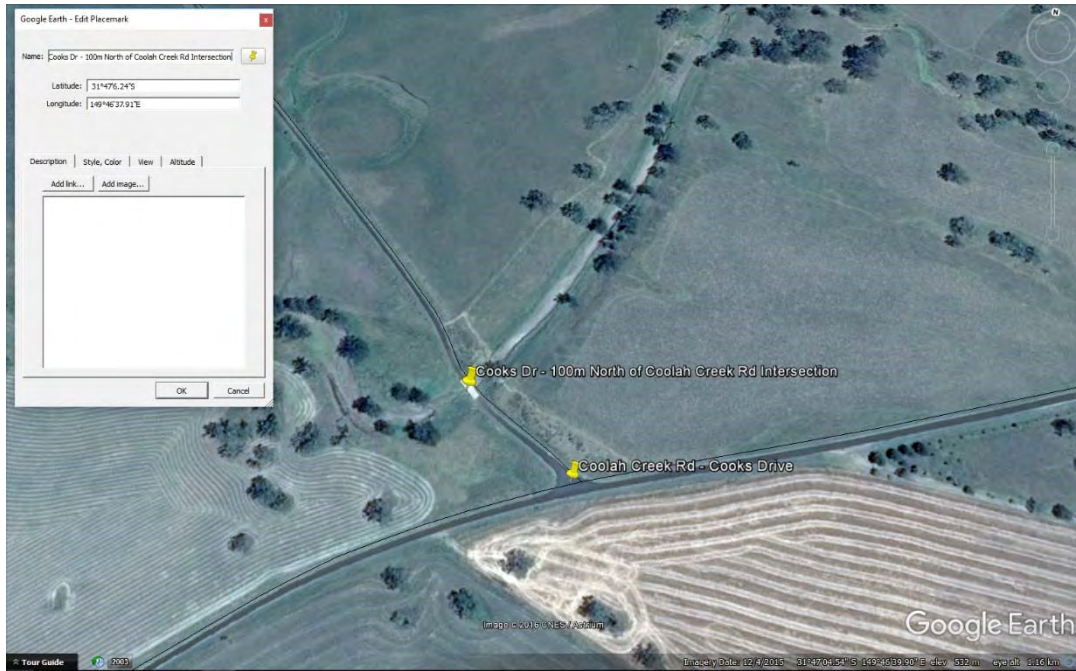
S035 - Location Plan

S035 – Cooks Dr - 100m North of Coolah Creek Rd Intersection

Approximately 4900mm-2000mm Floodway

Moderate condition and serviceable,

Survey required to verify compliance with vertical geometry requirements of the proposed heavy vehicle configurations.

Upgrade may be required.

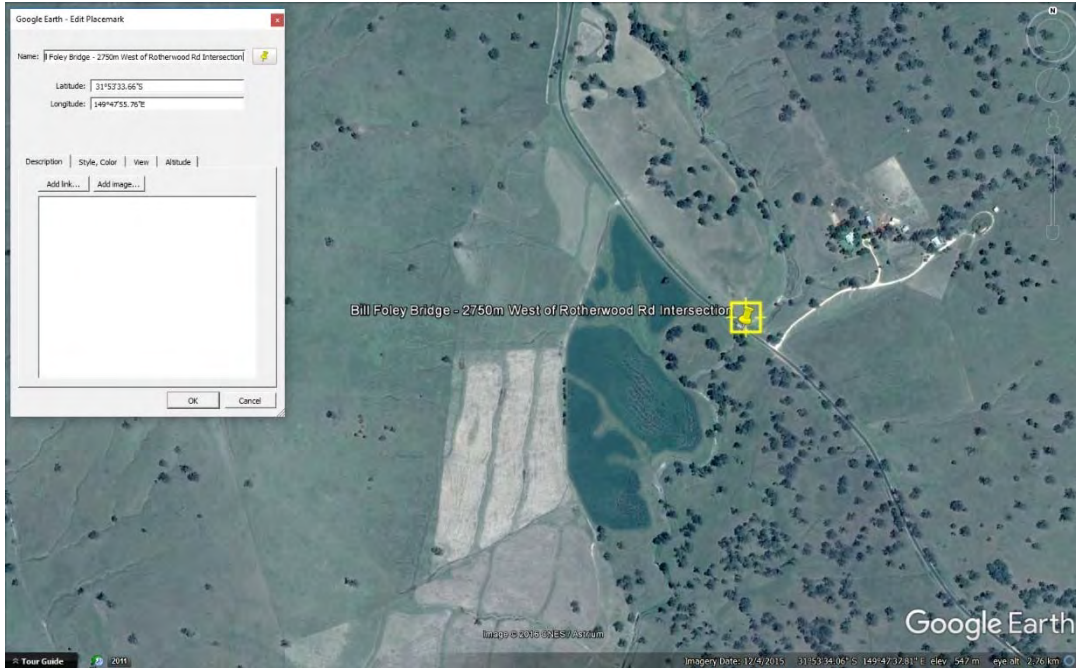
S036 – Location Plan

Bill Foley Bridge – 2750m West of Rotherwood Rd
Reinforced concrete bridge labelled “1965 DMR” on Croppy Creek
4 x 7600mm spans by 7500mm with 4 x 360mm columns/bents
Fair condition and serviceable

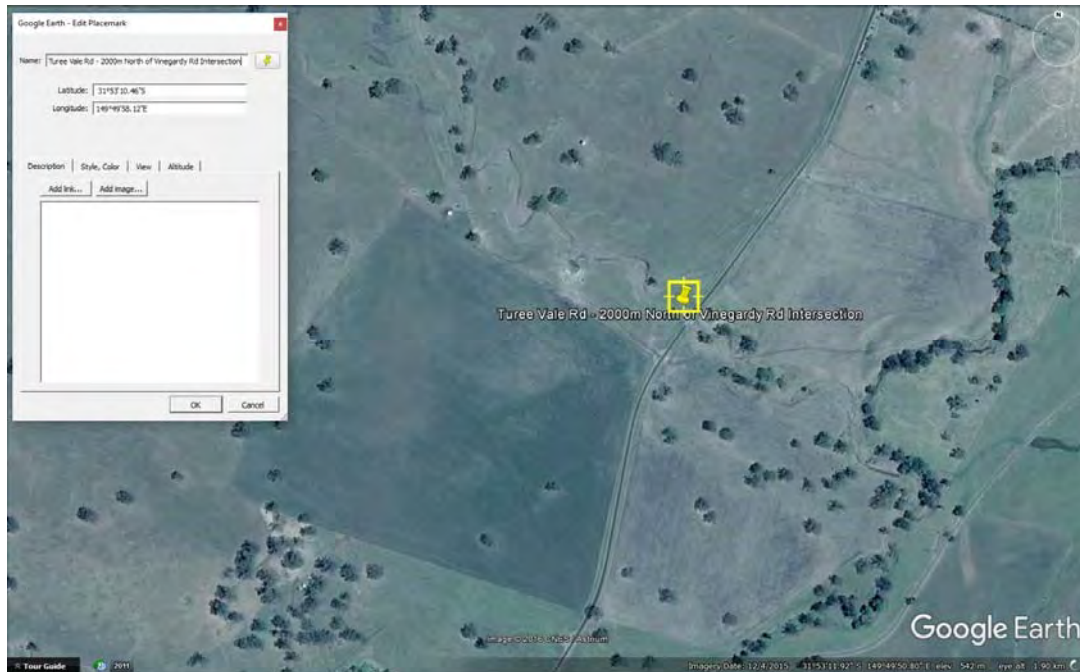
S037 – Location Plan

S037 – Turee Vale Rd - 2000m North of Vinegaroy Rd Intersection

5500mm by16000mm concrete causeway with 1250mm pipe culvert

Exposed reinforcing steel will require repair.

Survey required to verify compliance with vertical geometry requirements of the proposed heavy vehicle configurations.
