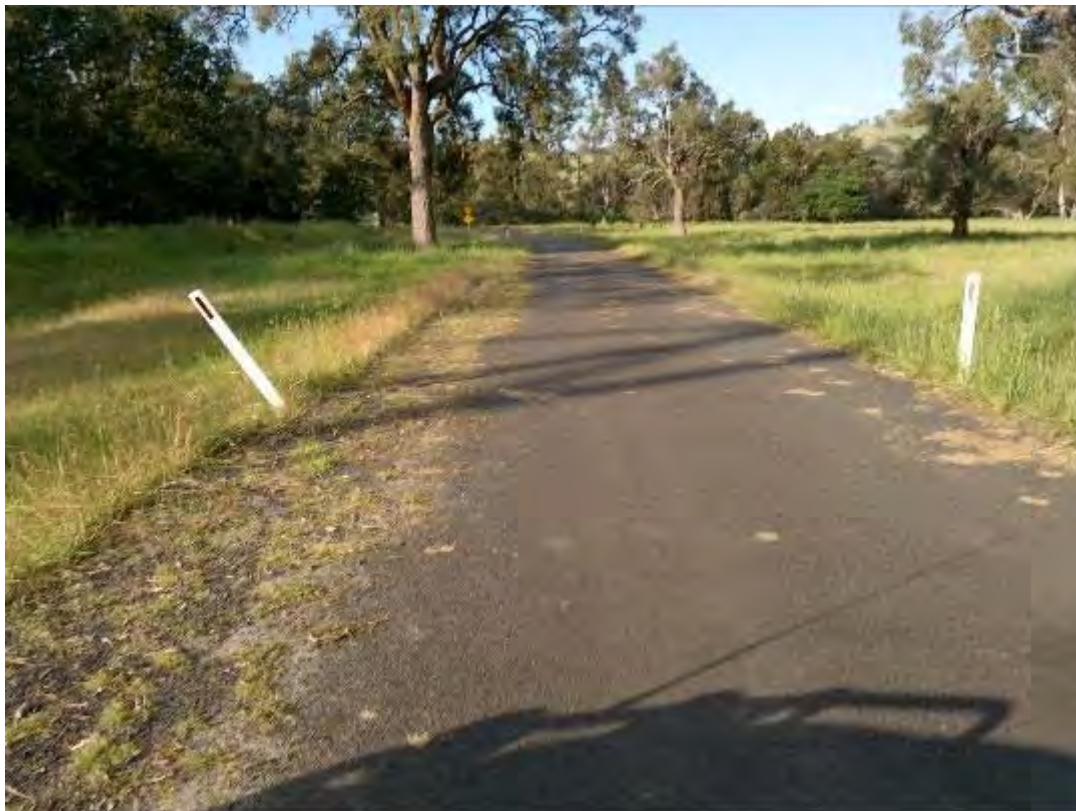
S060 – View to North

S060 – Pandora Rd – 1450m North of Coolah Creek Rd Intersection
300mm Pipe Culvert no headwall
Condition Unknown

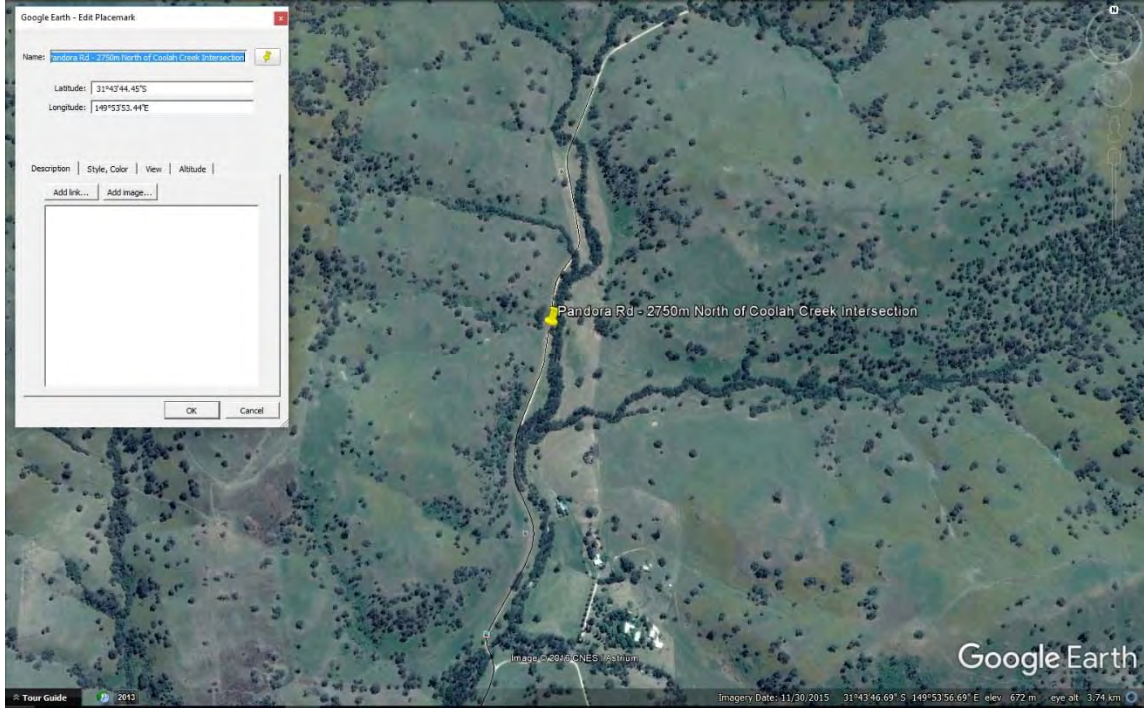
S062 - Location Plan

4000mm Concrete Causeway

Survey required to verify compliance with vertical geometry requirements of the proposed heavy vehicle configurations

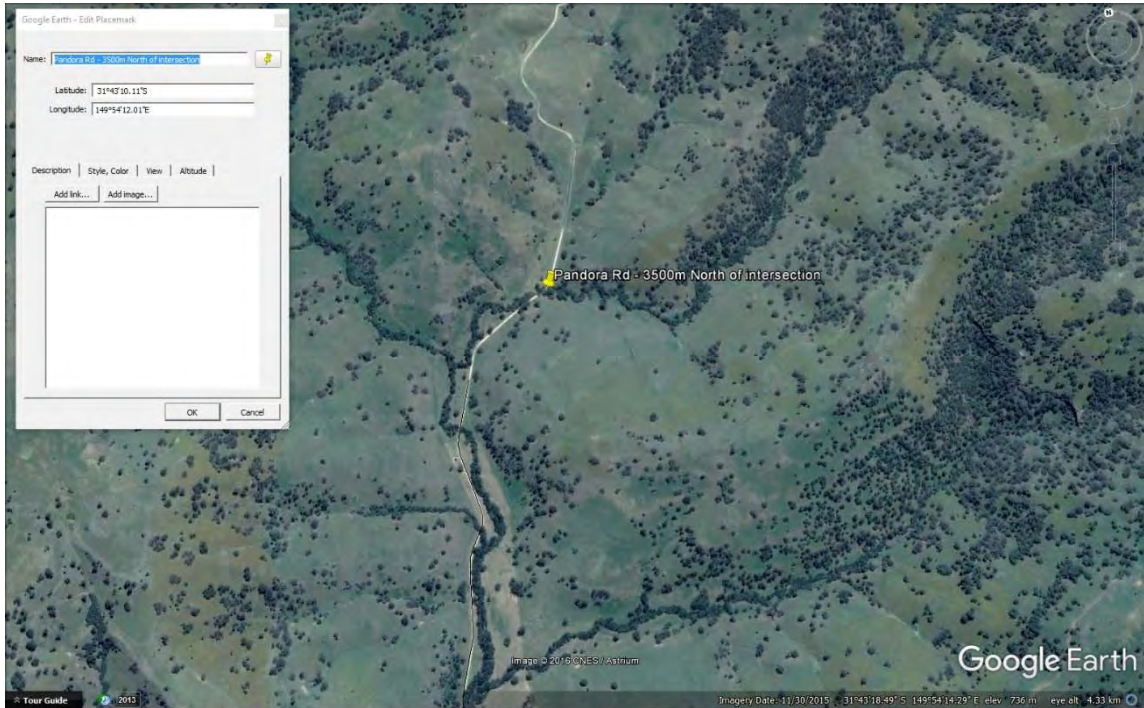
S063 – Location Plan

Causeway,
Partially submerged at time of inspection
Moderate Condition and Serviceable

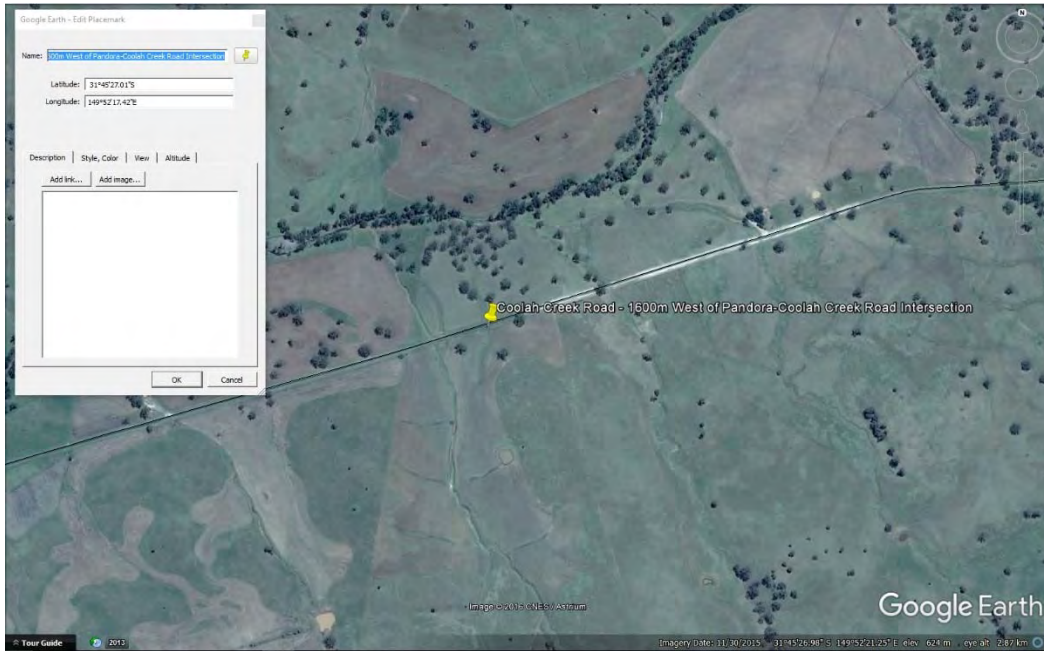
S064 - Location Plan

S064 – Coolah Creek Road - 1600m West of Pandora-Coolah Creek Road Intersection
Dual Pipe Culvert of approximately 600mm diameter.
Fair Condition and Serviceable

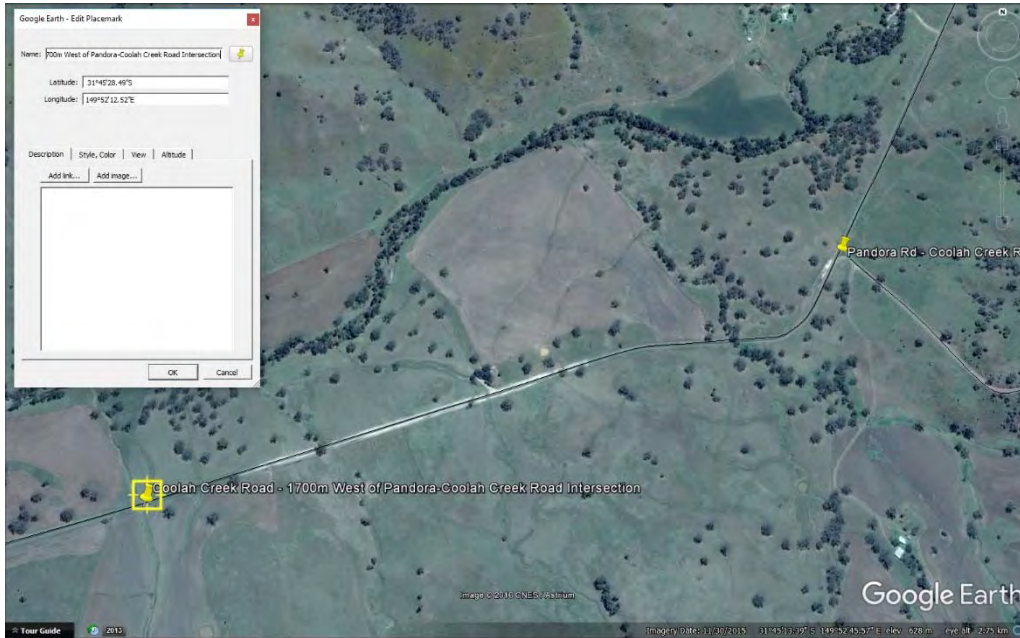
S065- Location Plan

S065 – Coolah Creek Road - 1700m West of Pandora-Coolah Creek Road Intersection
1350mm Pipe Culvert
Moderate Condition and Serviceable

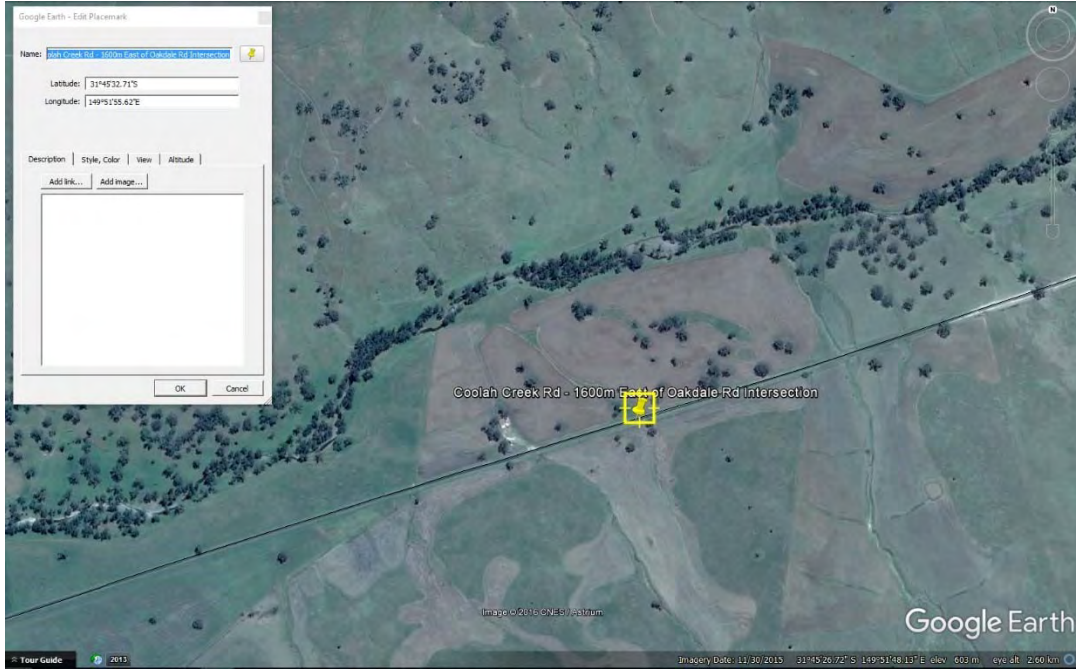
S066 – Location Plan

S066 – Coolah Creek Rd – 1600m East of Oakdale Rd Intersection
600mm Pipe Culvert
Moderate Condition and Serviceable

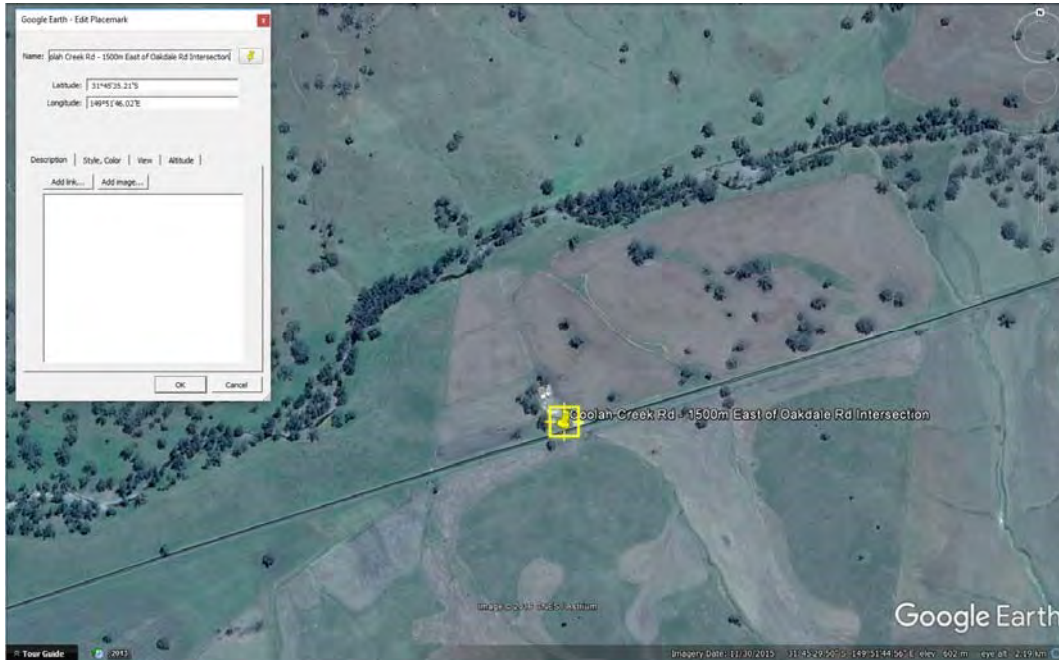
S067 – Location Plan

S067 – Coolah Creek Rd – 1500m East of Oakdale Rd Intersection
Concrete Causeway, 600mm Pipe Culvert
Fair Condition and Serviceable

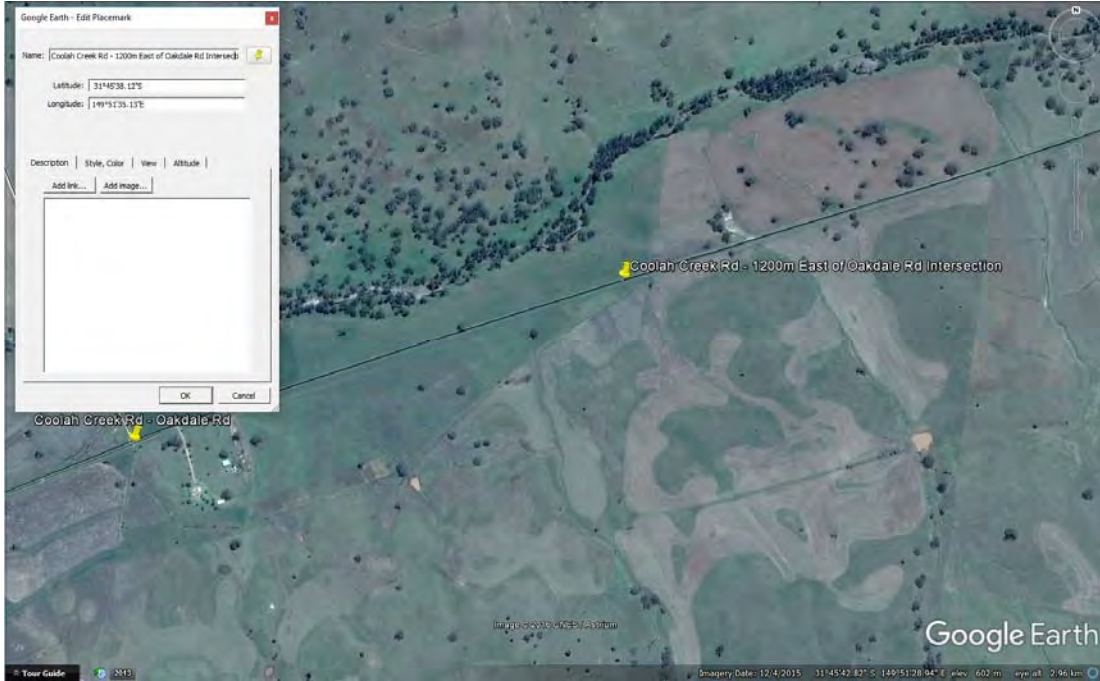
S068 – Location Plan

S068 – Coolah Creek Rd - 1200m East of Oakdale Rd Intersection
450mm Pipe Culvert
Fair Condition and Serviceable

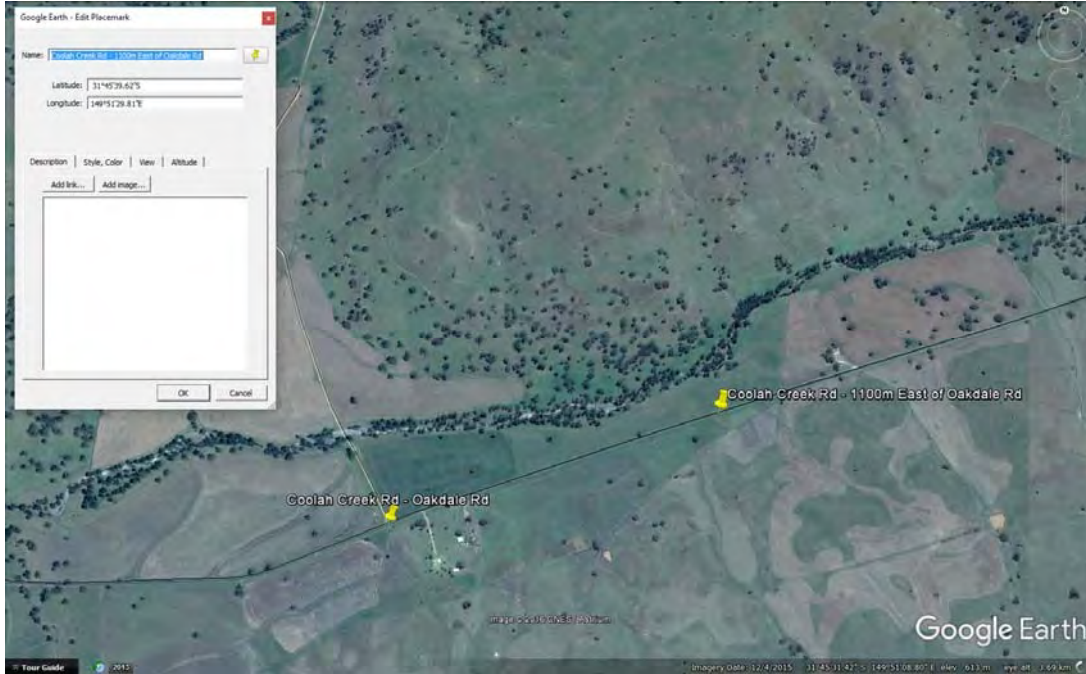
S069 – Location Plan

S069 – Coolah Creek Rd
Dual 450mm Pipe Culvert
Moderate Condition and Serviceable, May require some maintenance

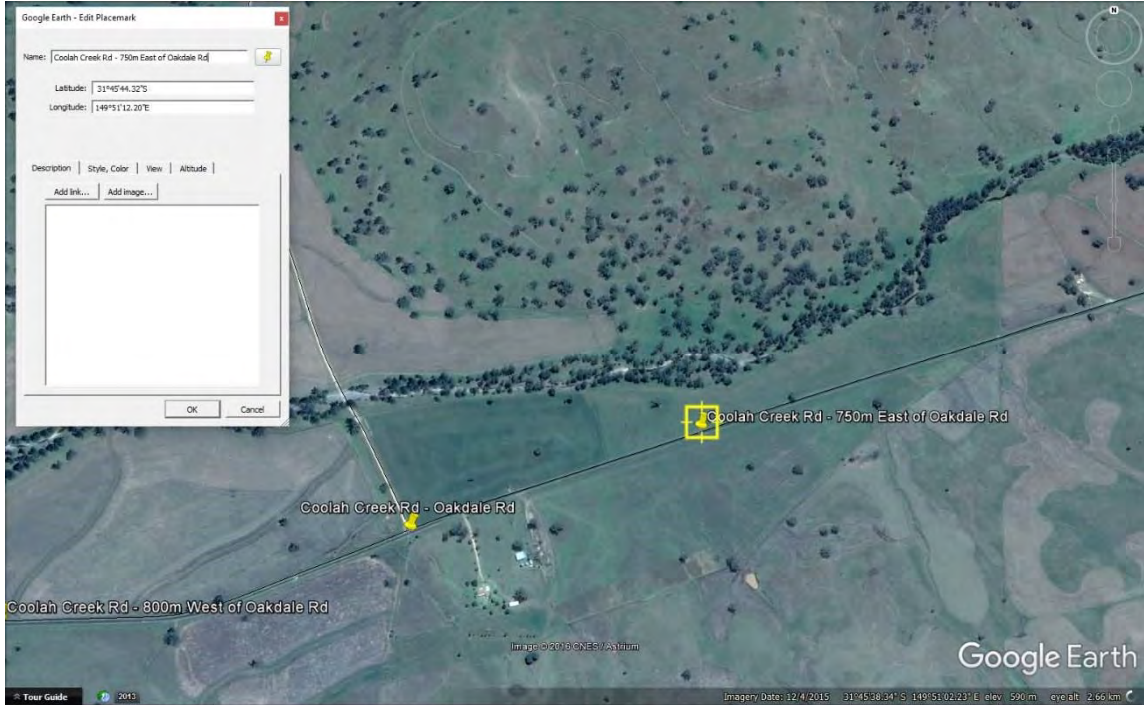
S070 – Location Plan

S070 – Coolah Creek Rd - 750m East of Oakdale Rd
450mm Pipe Culvert
Fair Condition and Serviceable

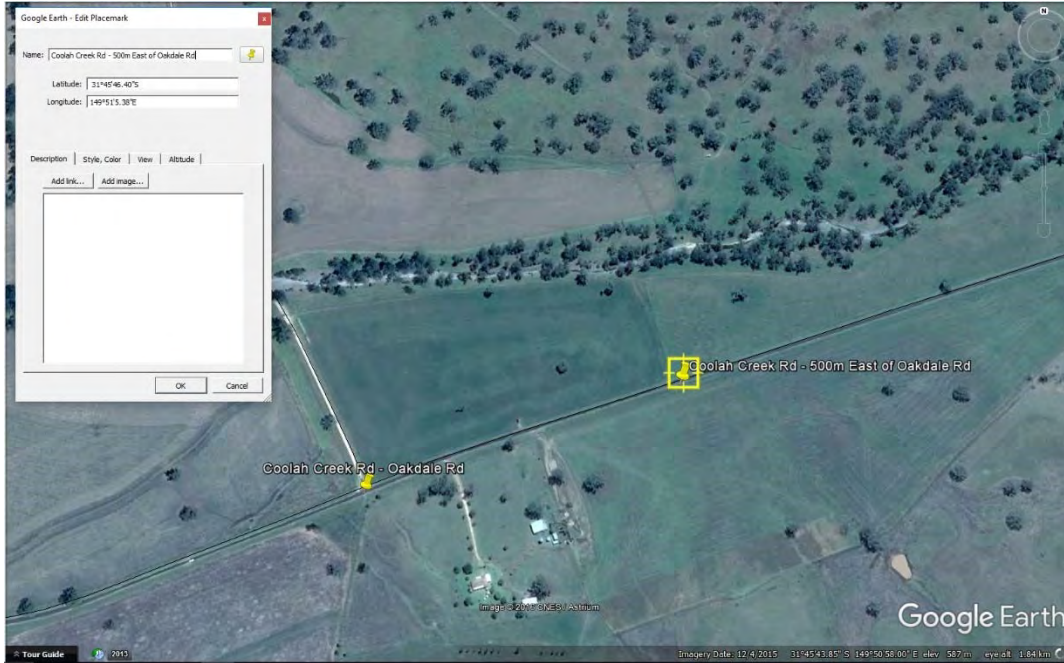
S071 – Location Plan

S071 – Coolah Creek Rd - 500m East of Oakdale
450mm Pipe Culvert
Good Condition and Serviceable

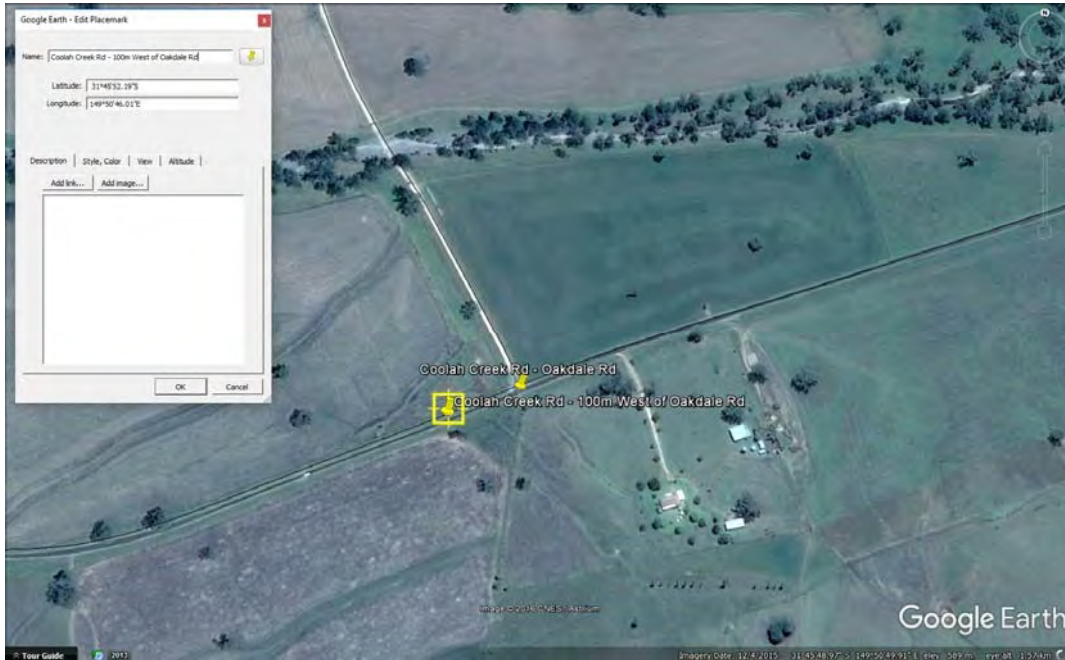
S072 – Location Plan

S072 – Coolah Creek Rd
Concrete Causeway, ~450mm Pipe Culvert
Causeway inaccessible condition unknown

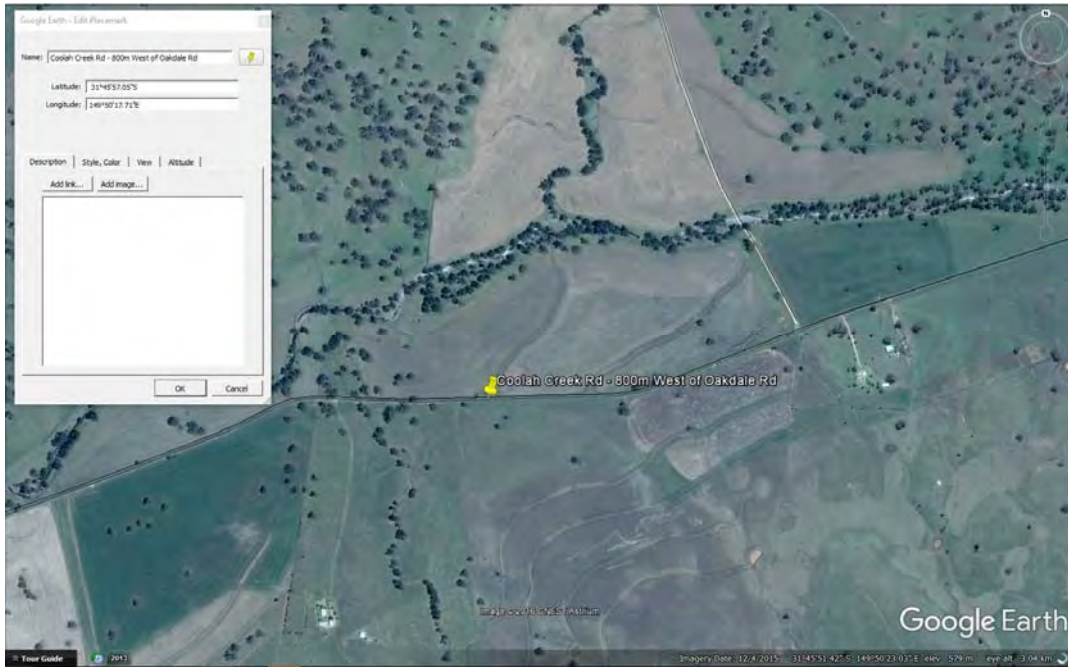
S073 – Location Plan

S073 – Coolah Creek Rd - 800m West of Oakdale Rd
450mm Pipe Culvert
Fair Condition and Serviceable

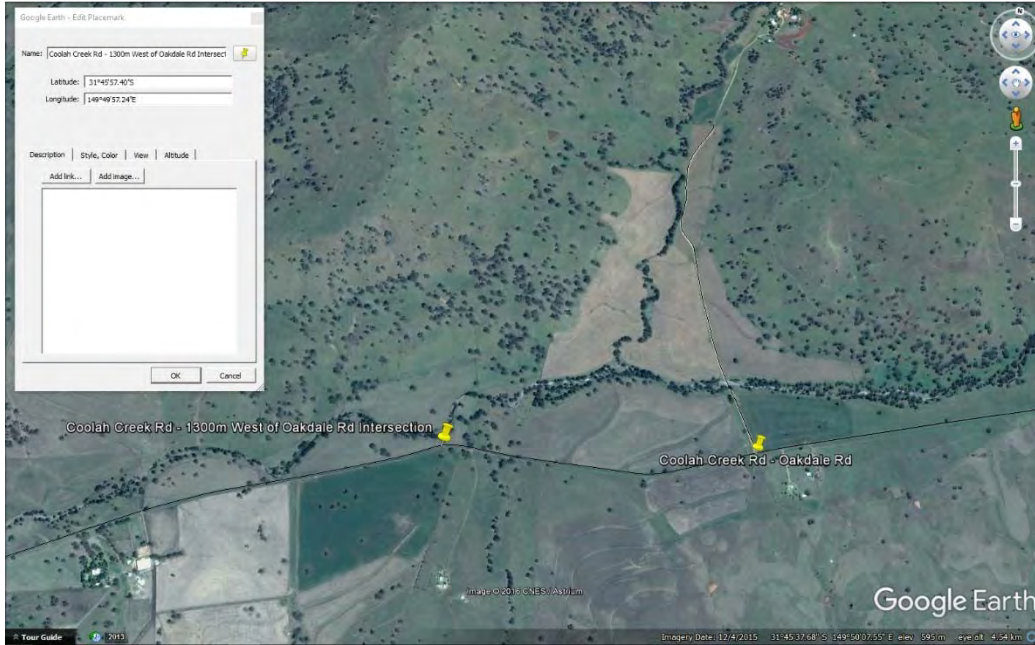
S074 – Location Plan

S074 – Coolah Creek Rd - 1300m West of Oakdale Rd Intersection
600mm Pipe Culvert
Fair Condition and Serviceable
