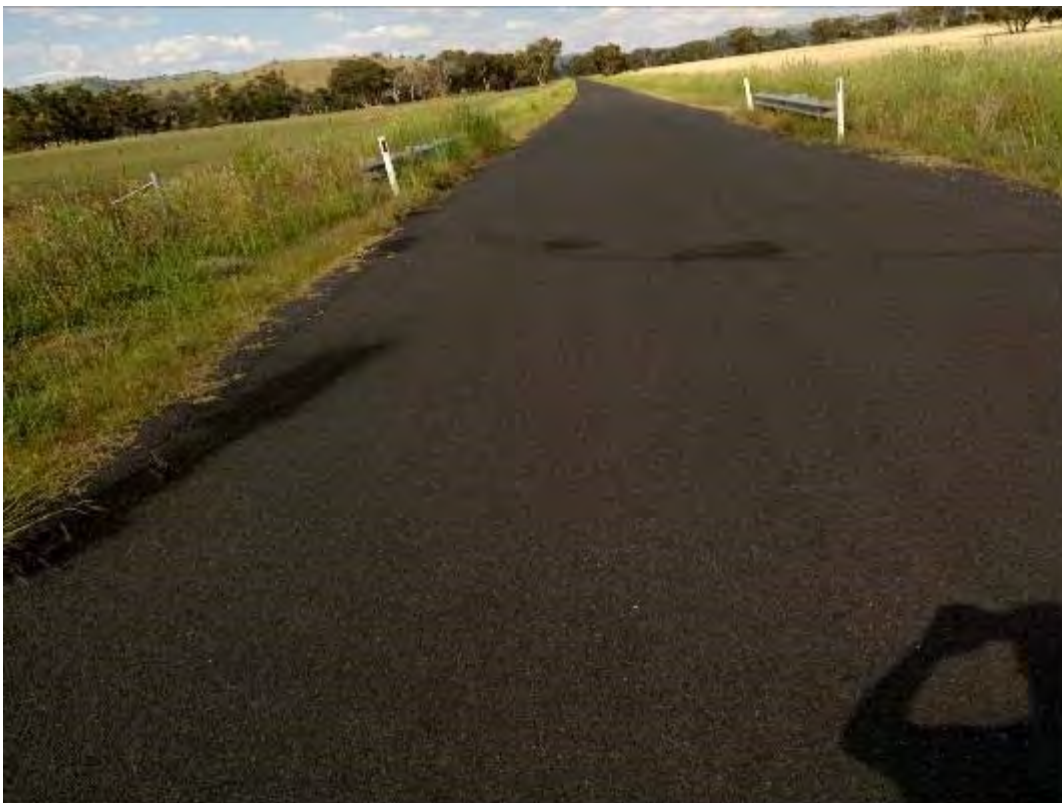
S075 – View to East

2 of approximately 1500mm Reinforced Concrete Box Culvert

Depth of Box Culvert unknown due to water flow

Fair Condition and Serviceable

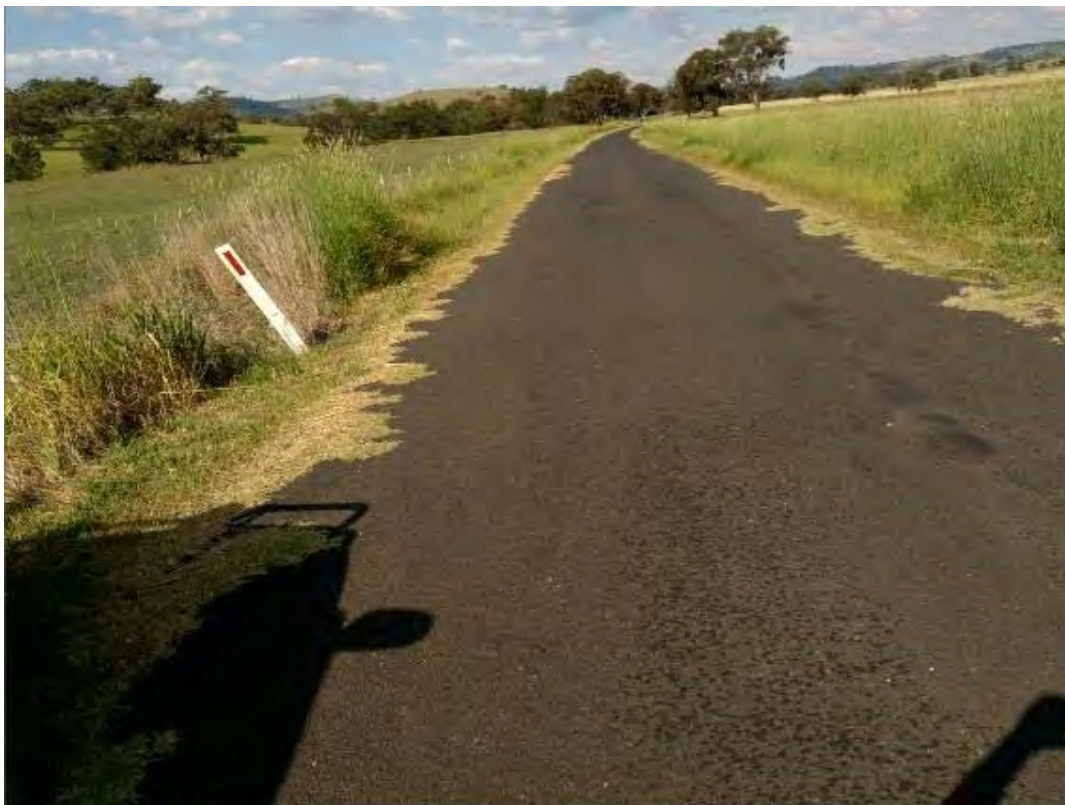
S076 – View to East

**S076 - Coolah Creek Rd - 2500m West of Oakdale Rd Intersection**  
450mm Pipe Culvert with broken headwall  
Moderate Condition and Serviceable

S076 - 450mm Pipe Culvert with broken headwall

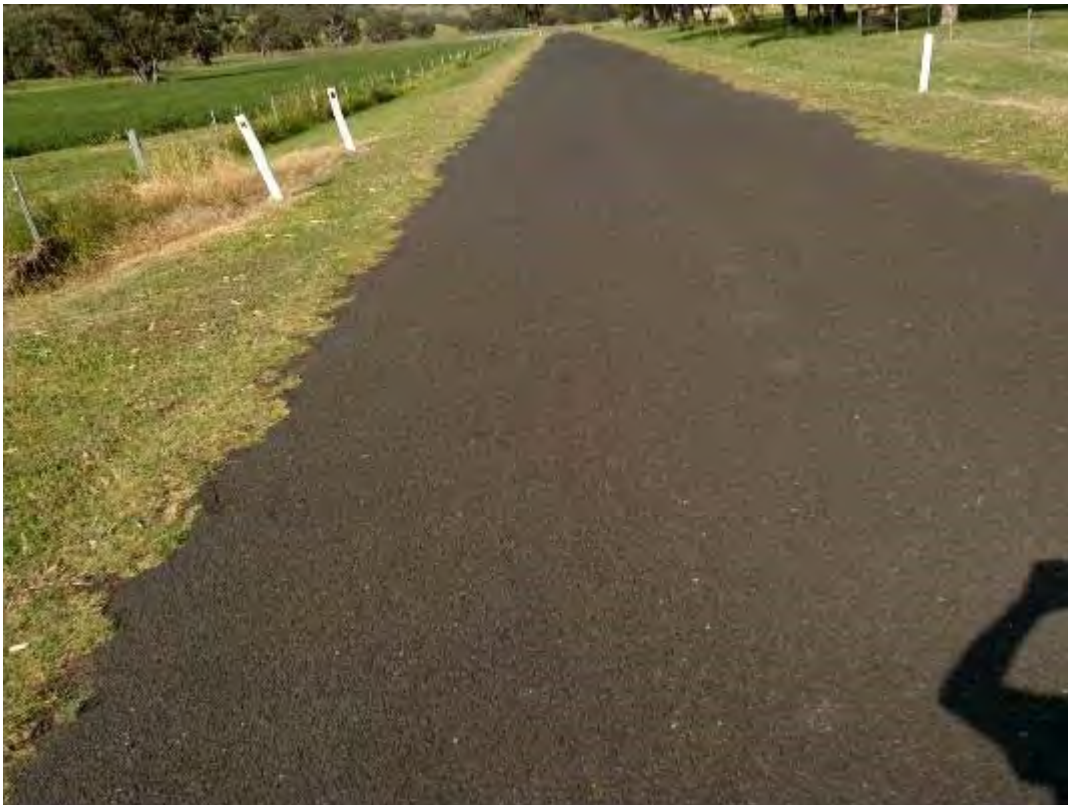
S077 – View to East

**S077 - Coolah Creek Rd - 4000m West of Oakdale Rd Intersection**  
3 of 900mm Pipe Culvert  
Fair Condition and Serviceable

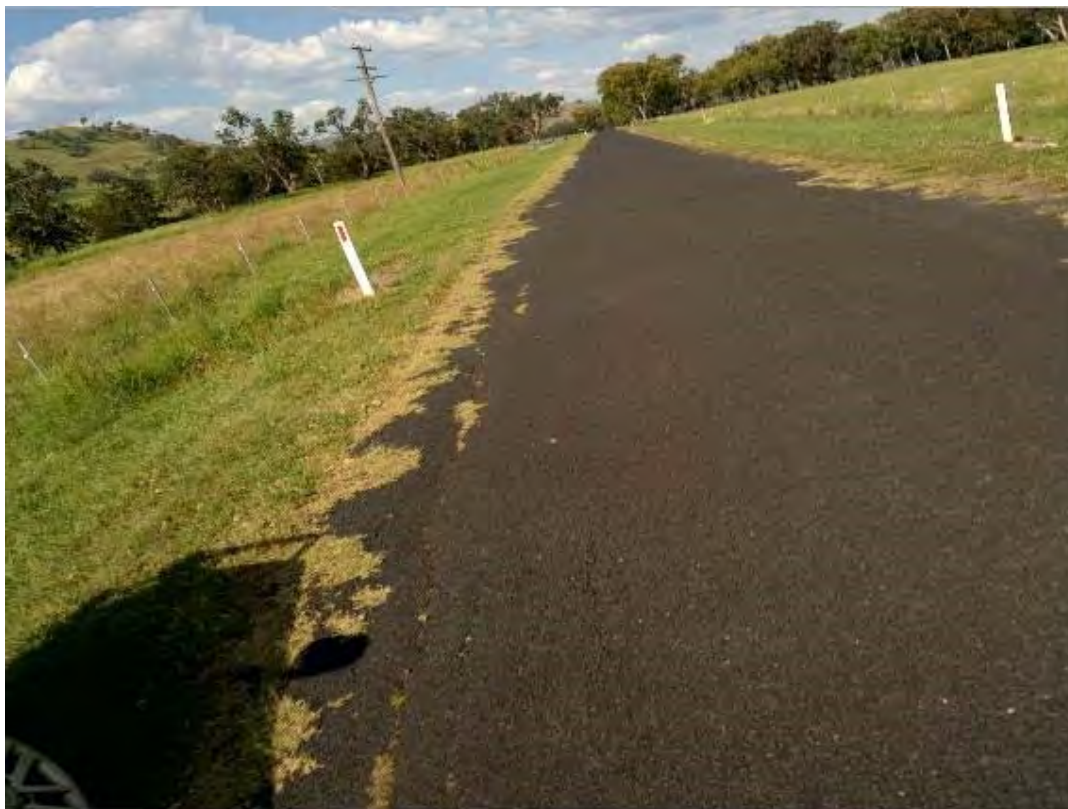
S078 - View to East

**S078 – Coolah Creek Rd - 3250m East of Cooks Dr Intersection**  
Concrete Causeway, 450mm Pipe Culvert,  
Moderate Condition and Serviceable

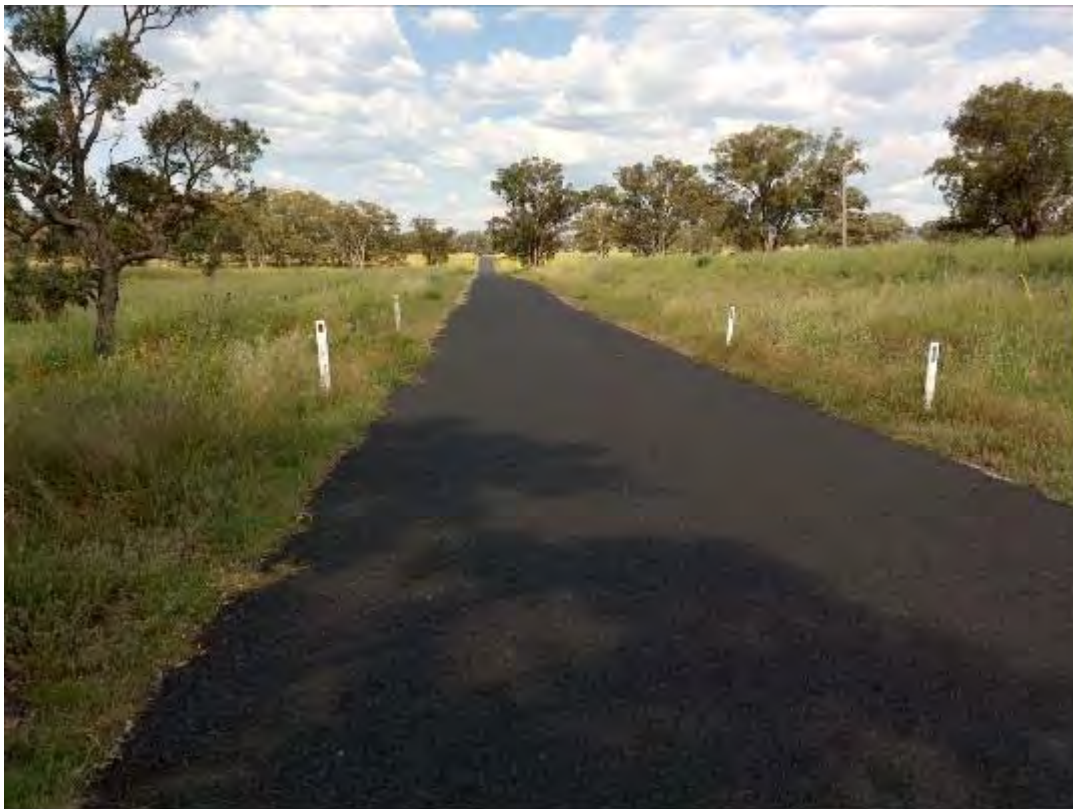
**S080 – View to North**

**S080 – Coolah Creek Rd - 2250m East of Coolah Creek Rd - Cooks Dr Intersection**  
450mm Pipe Culvert  
Fair Condition and Serviceable

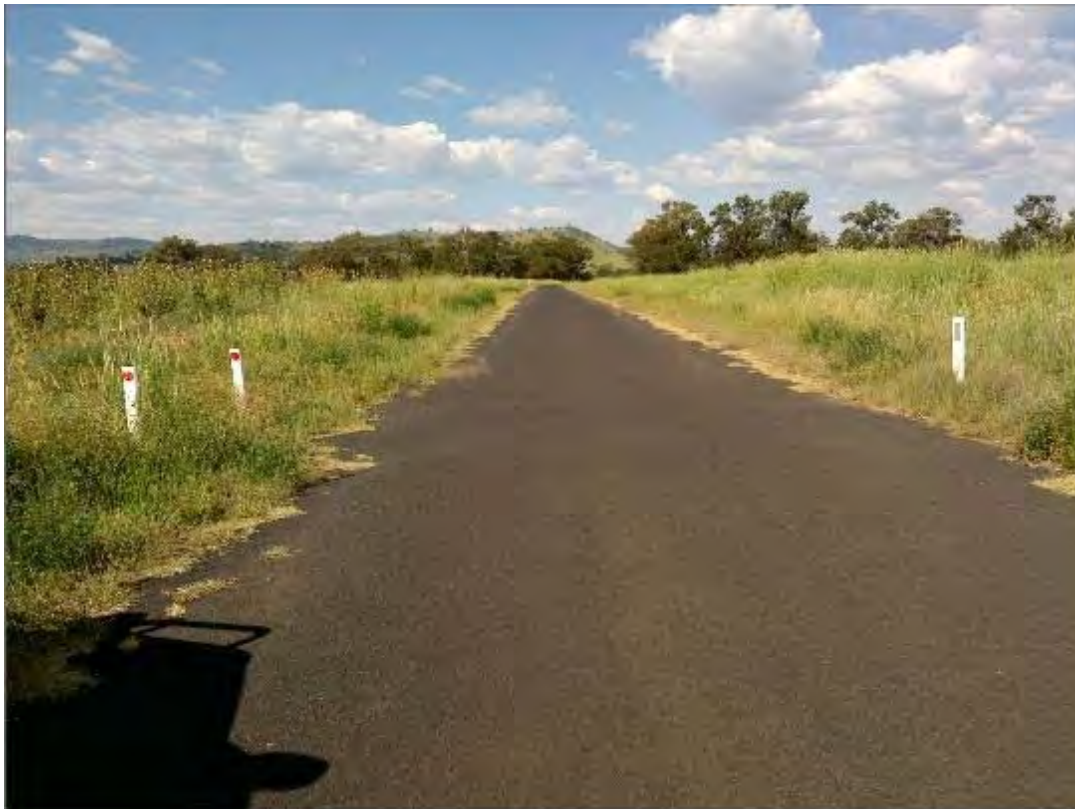
**S081 – View to East**

**S081 – Coolah Creek Rd - 1400m East of Coolah Creek Rd - Cooks Dr Intersection**  
600mm Pipe Culvert  
Good Condition and Serviceable, may require some maintenance

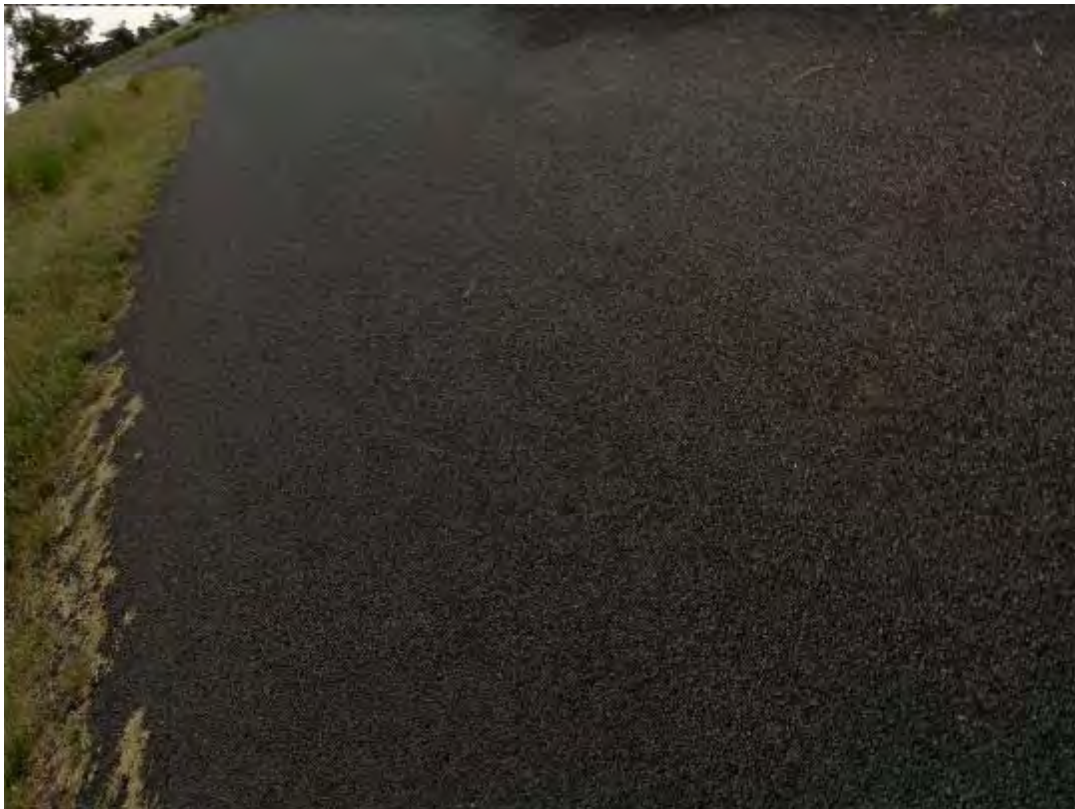
S083 - View to West

**S083 – Coolah Creek Rd - 1200m East of Cooks Dr Intersection**  
450mm Pipe Culvert  
Fair Condition and Serviceable

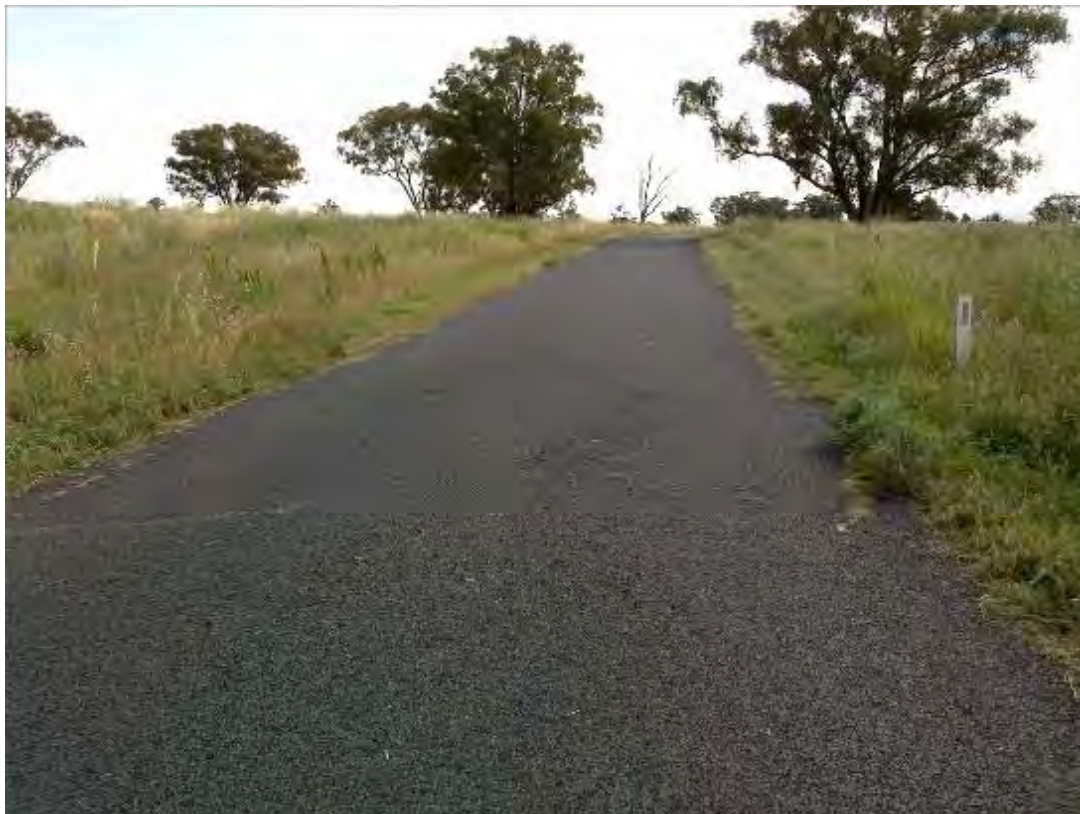
**S084 – Coolah Creek Rd - 1000m East of Cooks Dr Intersection**  
600mm Pipe Culvert  
Moderate Condition and Serviceable

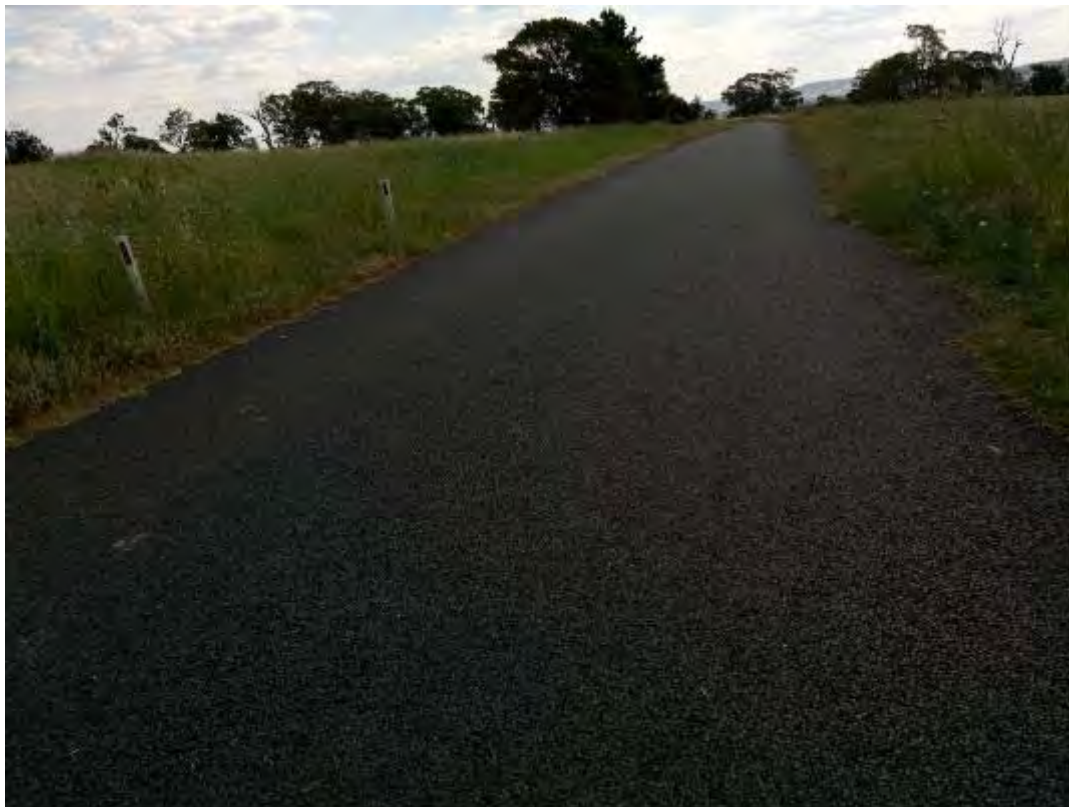
**S085 – View to West**

Pipe Culvert of Unknown Dimensions

Unknown Condition

Maintenance required

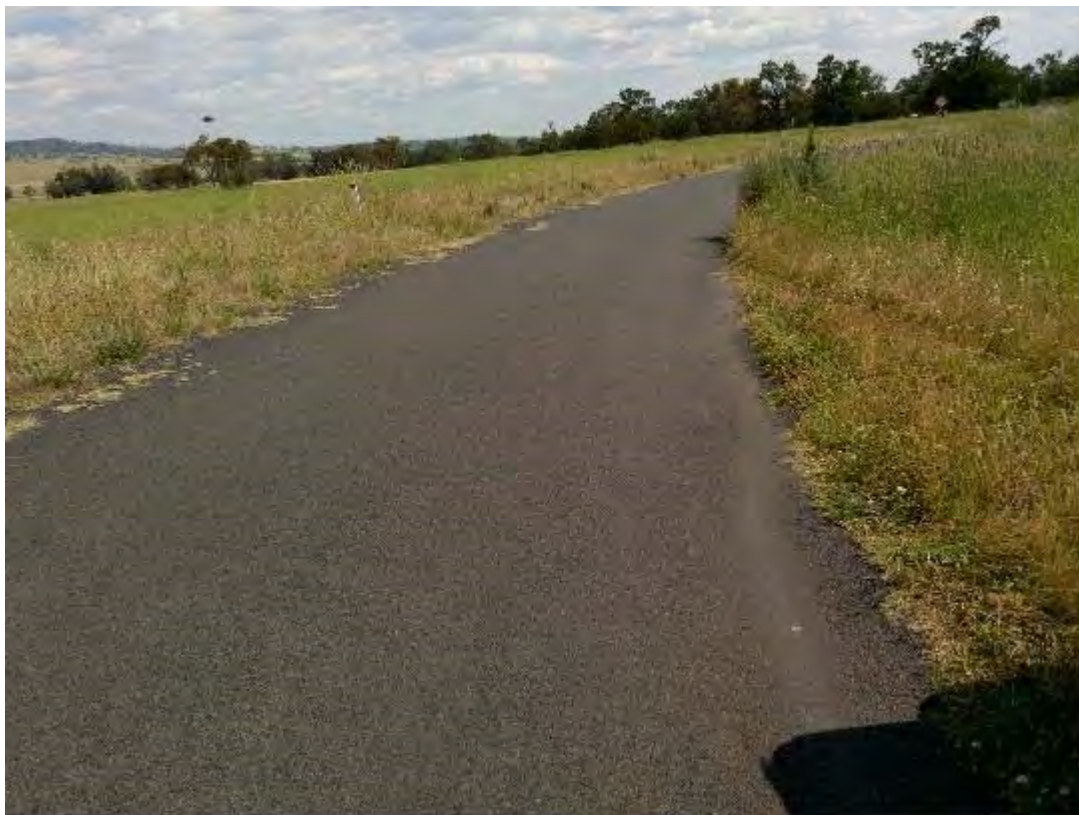
S087 - View to South

Pipe Culvert

Inaccessible at time of inspection

Maintenance required

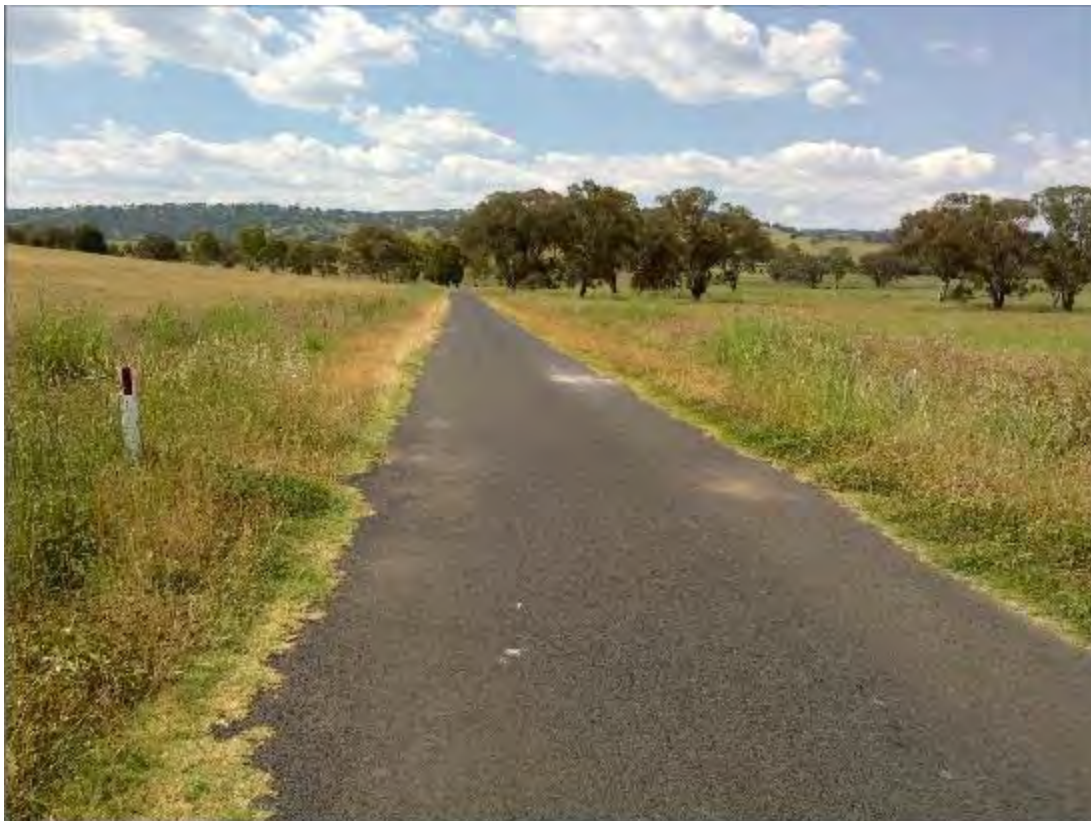
S088 – View to North

**S088 – Gundae Rd - 400m North of Cooks Dr Intersection**  
Dual 600mm Pipe Culvert  
Fair Condition and Serviceable, may require some maintenance

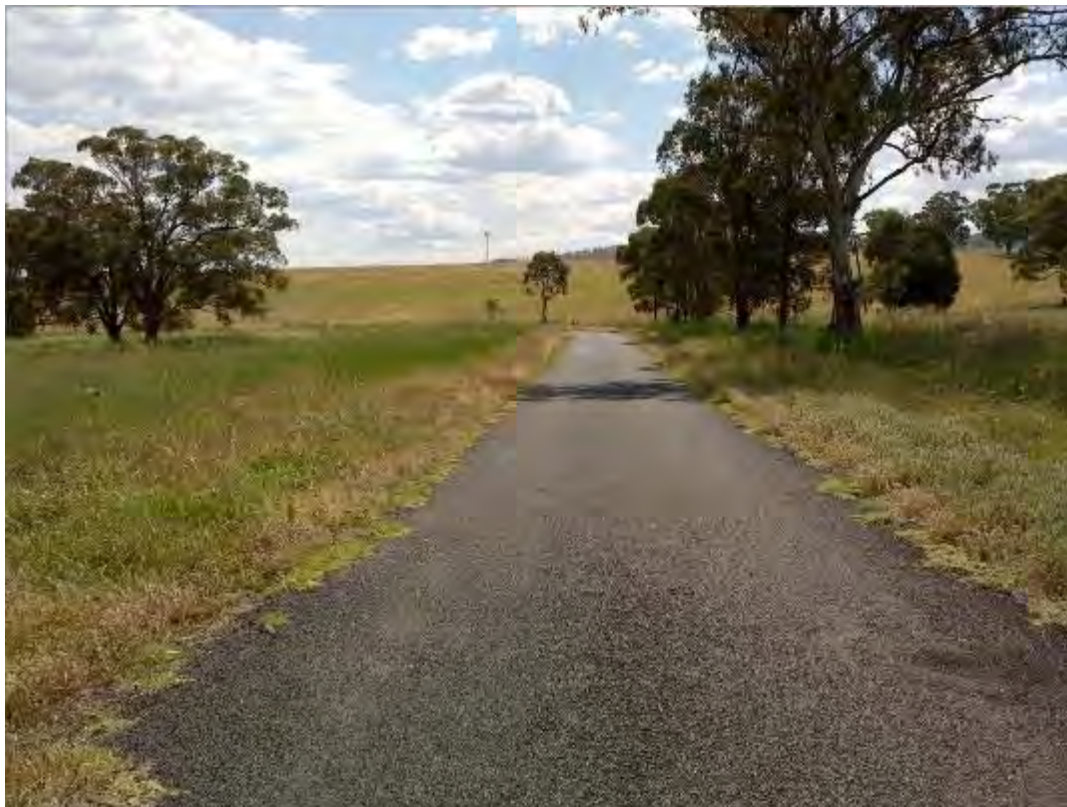
**S089 – View to West showing 3.5m Seal of Bitumen**

Dual 750mm-1200mm Reinforced Concrete Box Culvert with 3500mm bitumen seal  
Moderate Condition and Serviceable

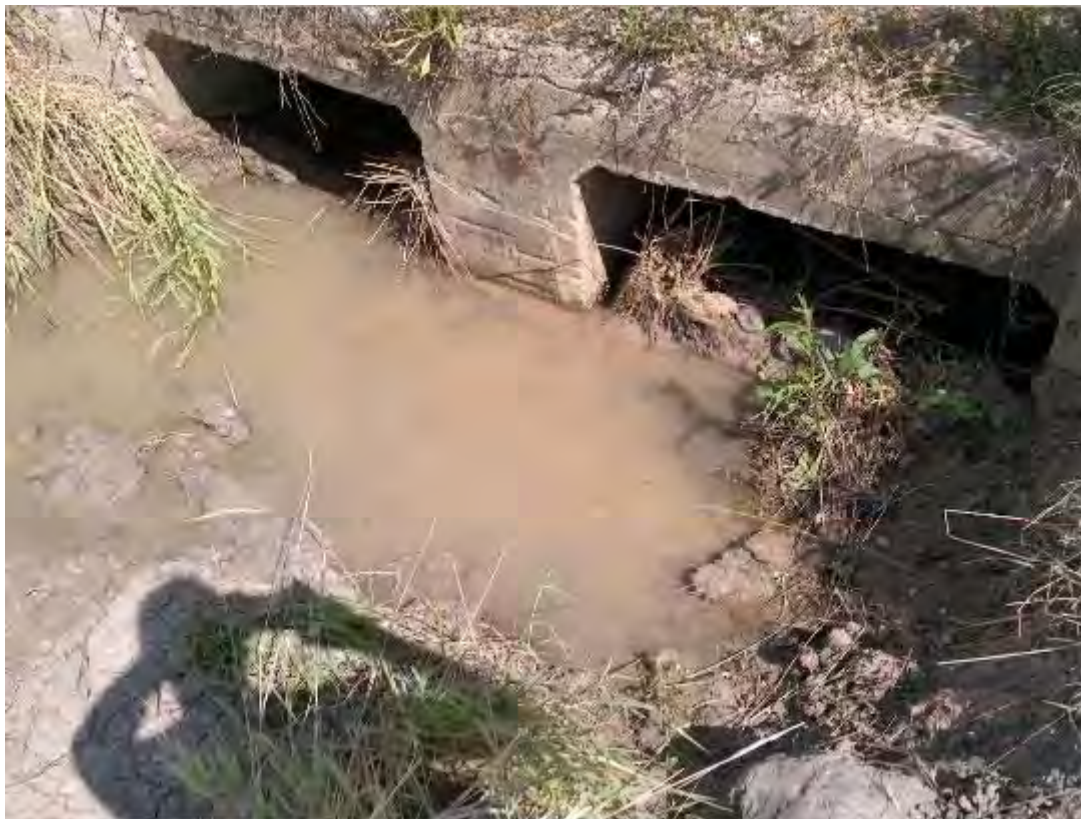
**S090 – Dual 750mm-1200mm Reinforced Concrete Box Culvert**

**S090 – Gundare Rd - 500m East of Cooks Dr Intersection**  
Dual 750mm-1200mm Reinforced Concrete Box Culvert  
Fair Condition and Serviceable

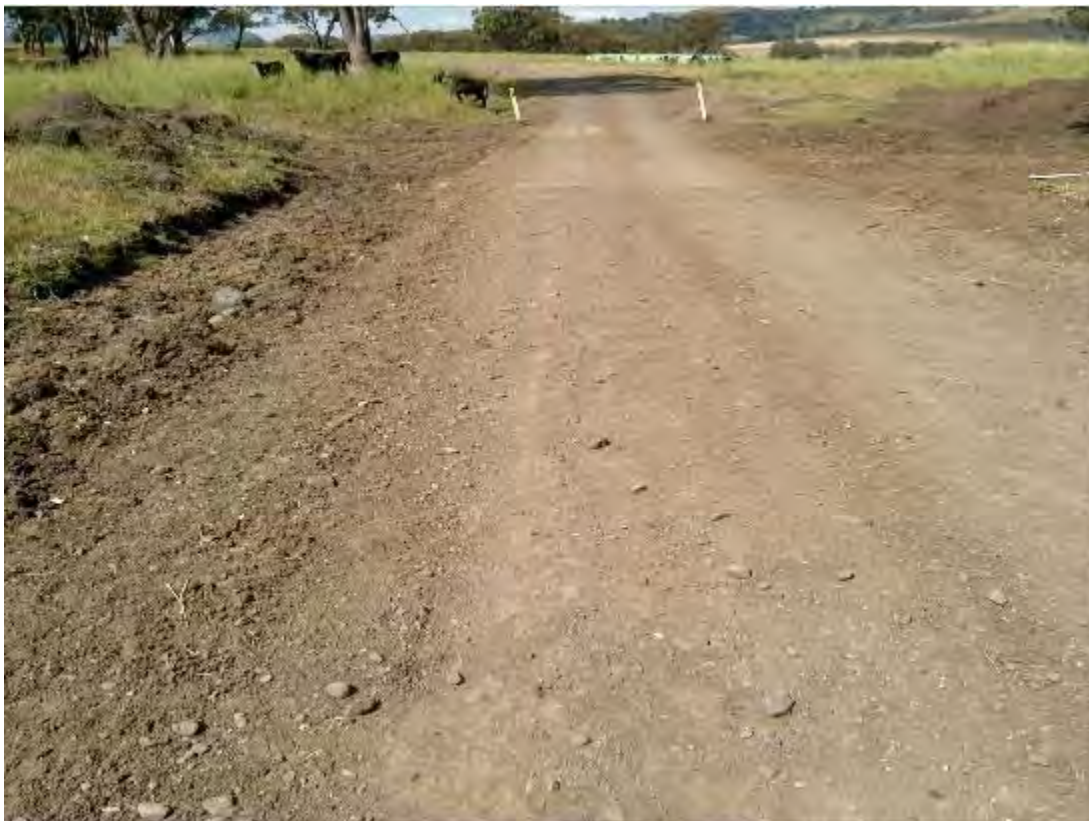
**S093 – View to East**

**S093 – Gundare Rd - 1850m East of Cooks Dr-Gundare Rd Intersection**  
Causeway  
Heavily silted at time of inspection, may require upgrade.

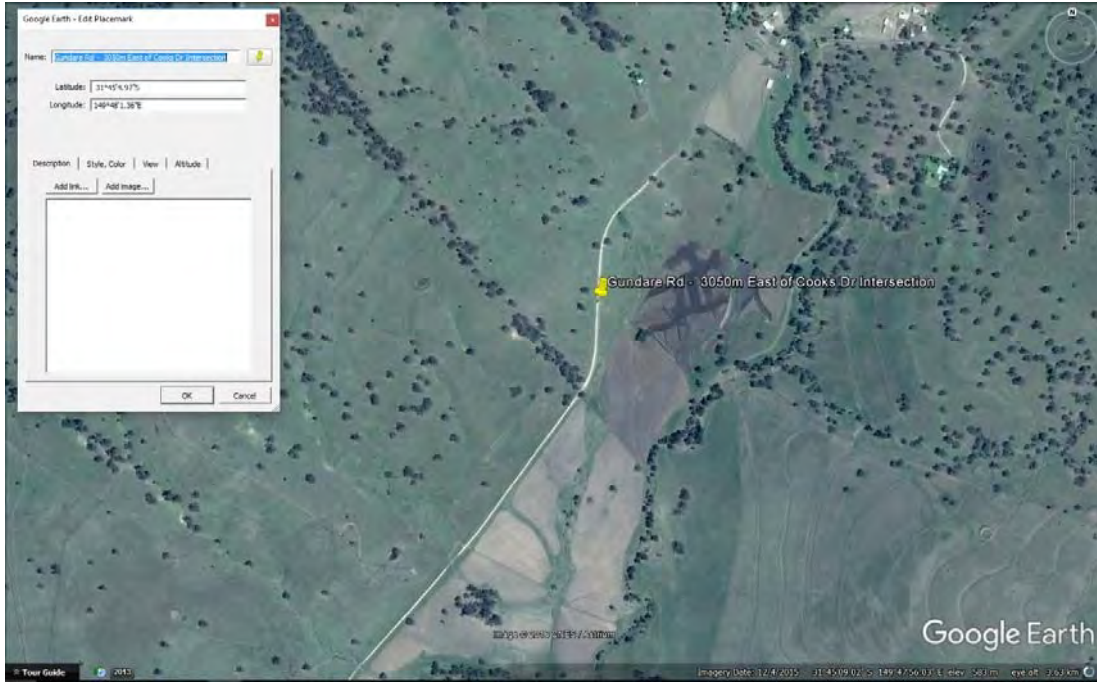
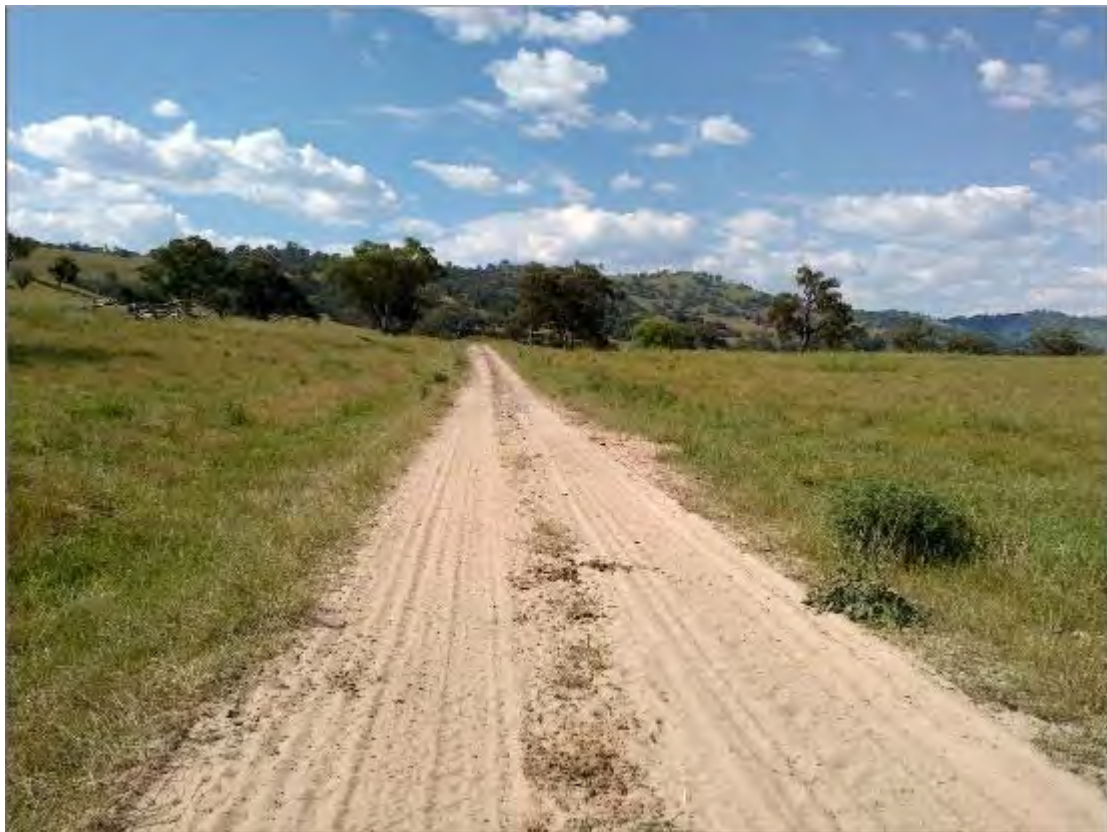
S096 – View to North

**S096 - Gundare Rd - 3050m East of Cooks Dr Intersection**  
New Pipe Culvert required

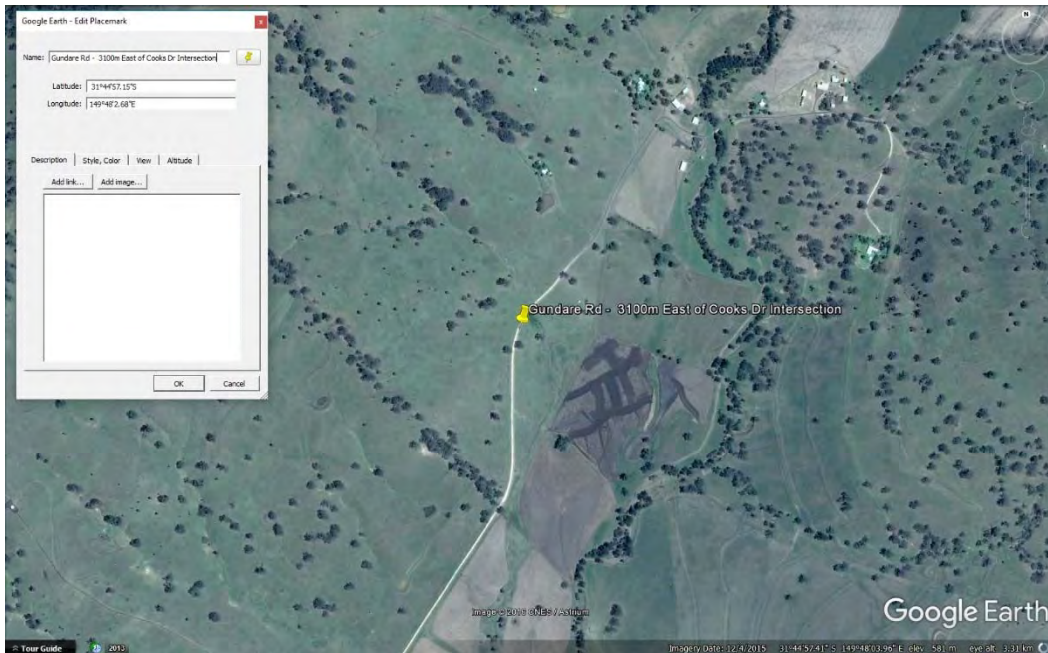
S097 – Location Plan

**S097- Gundare Rd - 3100m East of Cooks Dr Intersection**  
New Pipe Culvert Required

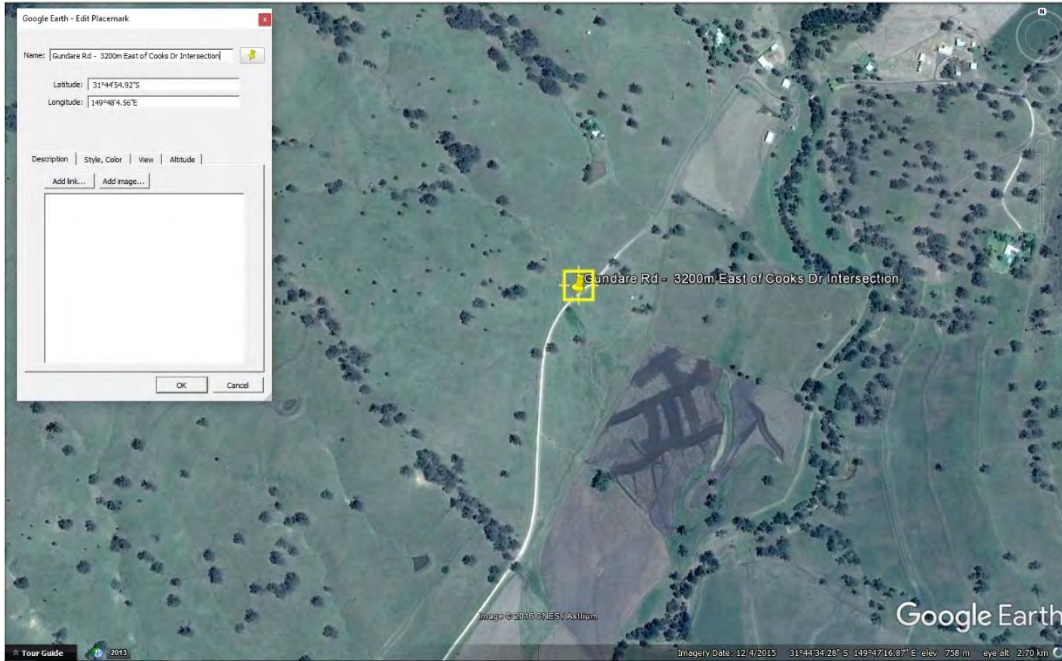
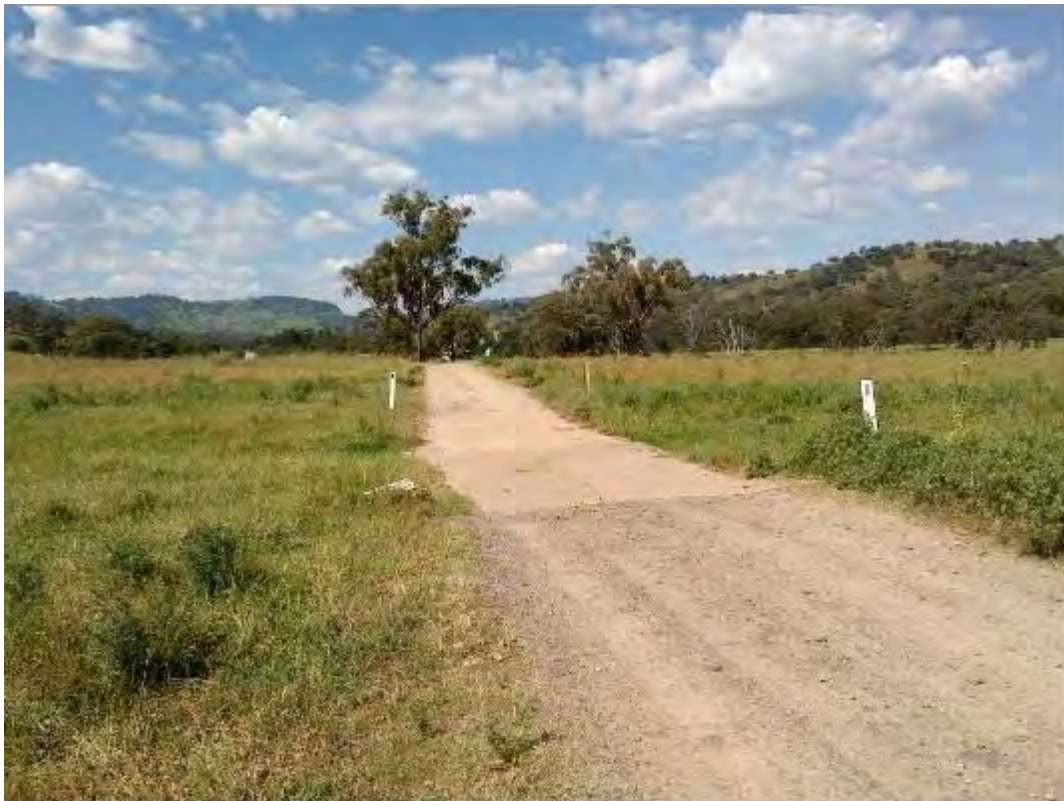
**S098 – View to North**

**S098 – Gundare Rd - 3200m East of Cooks Dr Intersection**  
Causeway  
Pipe culvert required for low flow.

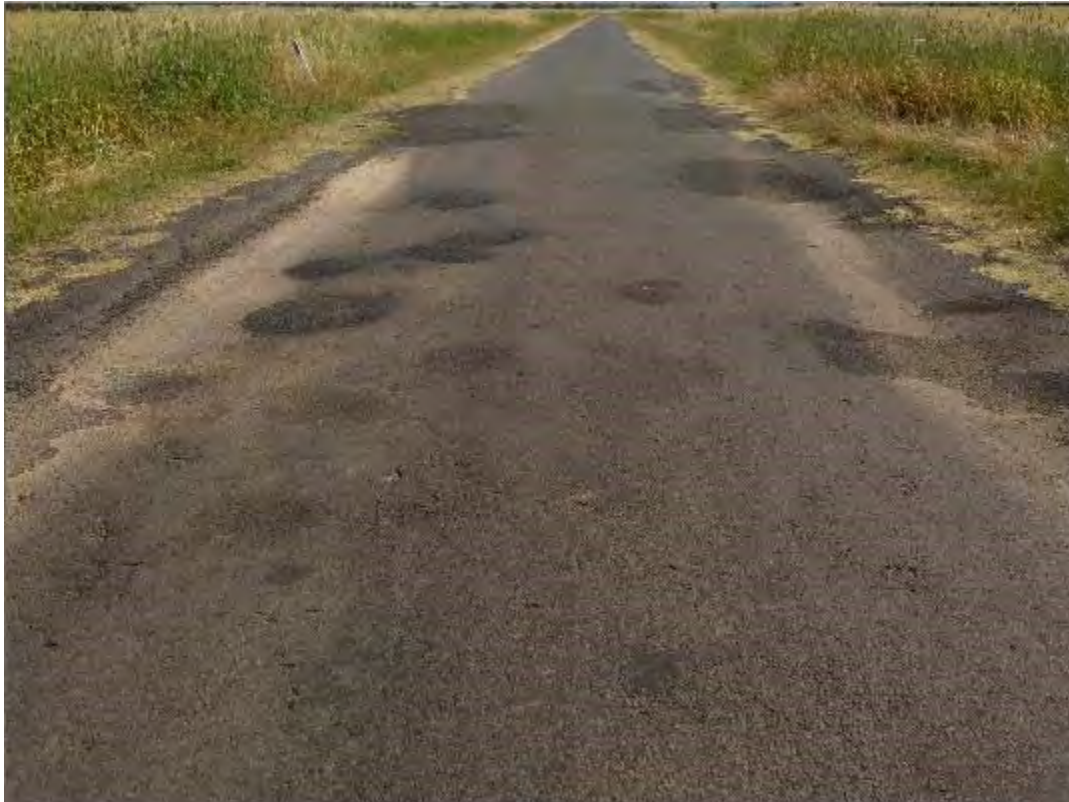
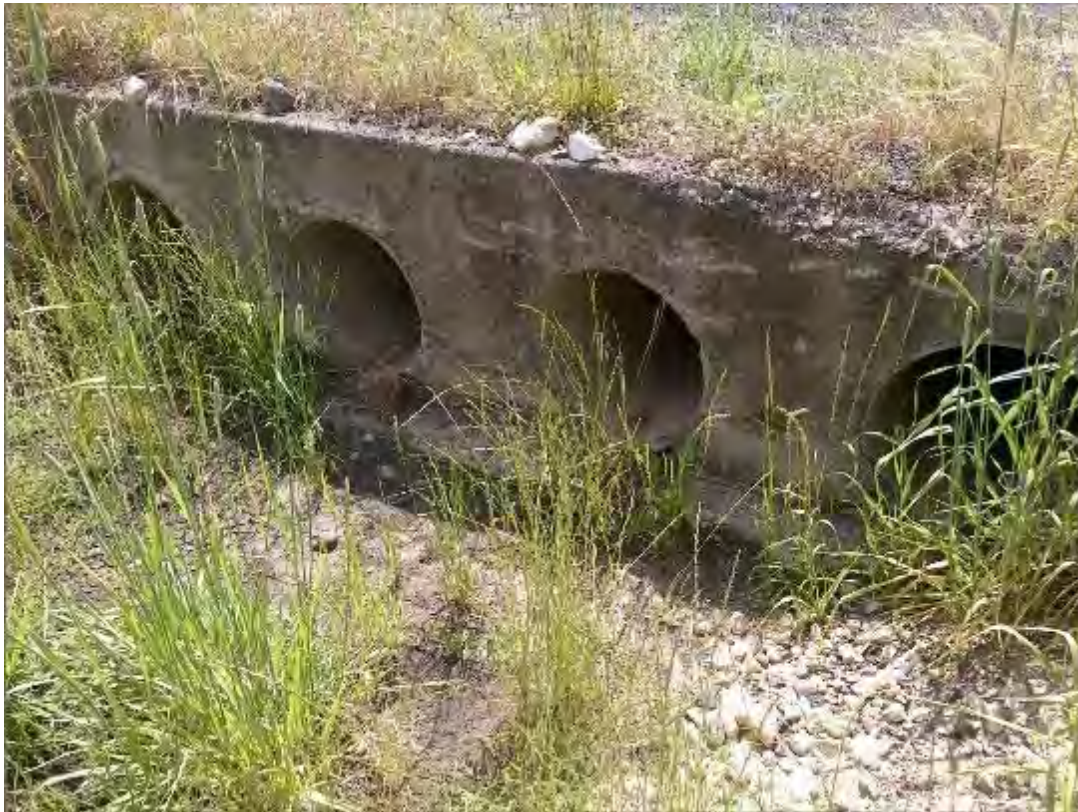
S099 - 4-450mm Pipe Culvert

Concrete causeway, 4 of 450mm Pipe Culvert headwall broken  
Poor Condition and Serviceable, upgrade may be required

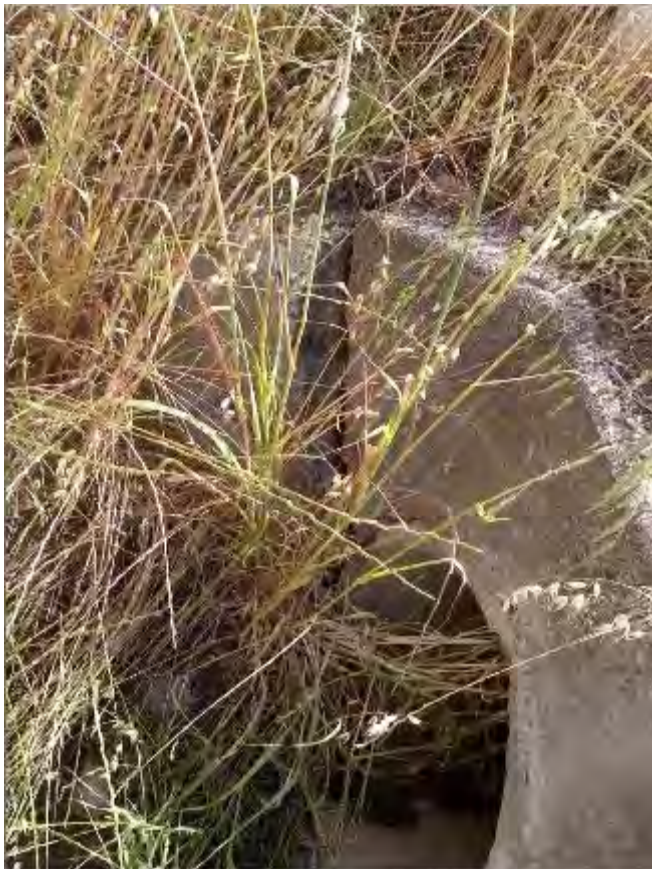
S099 – Broken Headwall

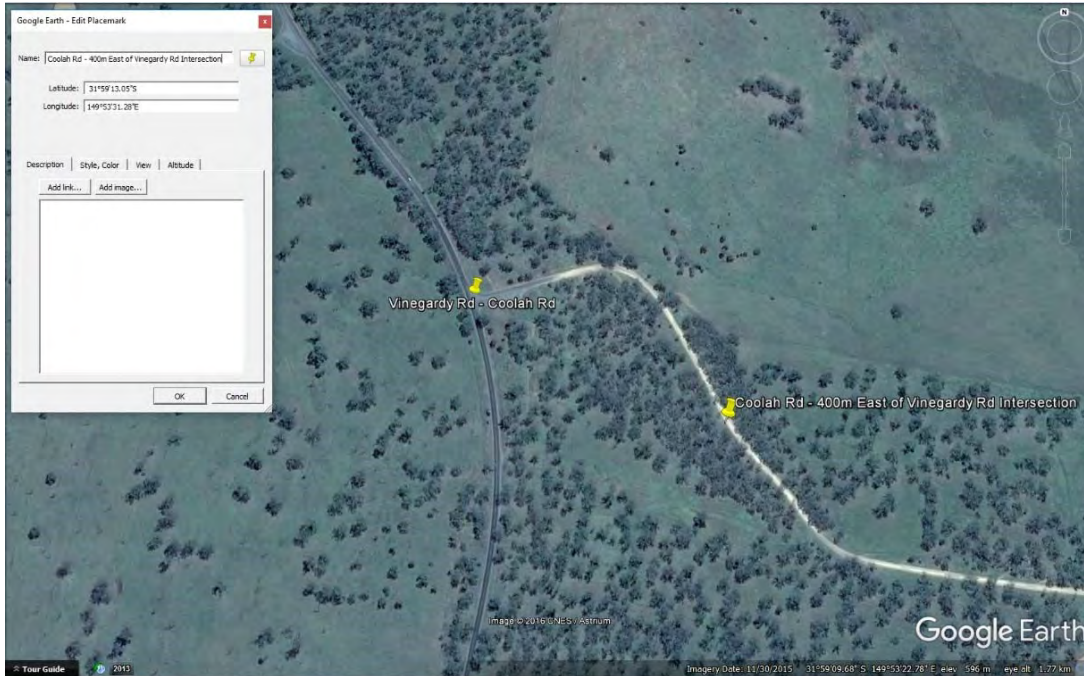
S100 – Location Plan

Inaccessible pipe culvert of unknown dimensions  
Condition unable to be assessed at time of inspection.

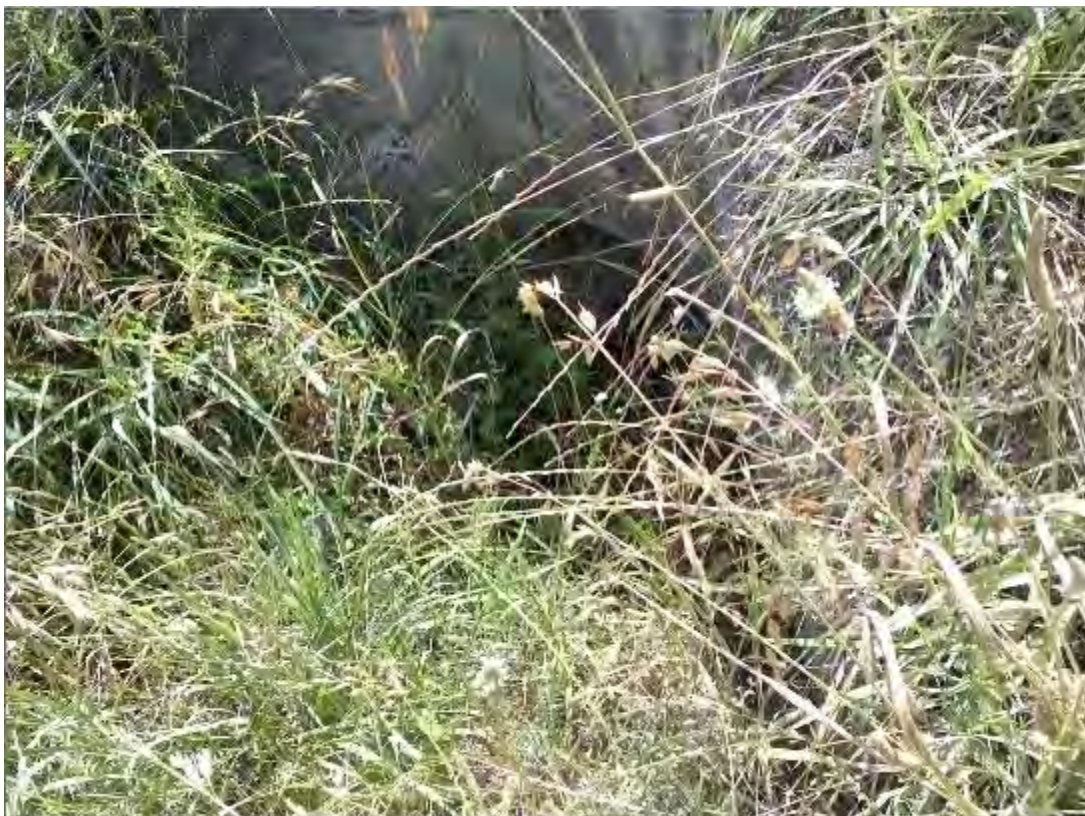
S101 - 450mm Pipe Culvert

**S101 – Coolah Creek Rd - 2800m North of Vinegaroy Road Intersection**  
450mm Pipe Culvert  
Fair Condition and Serviceable

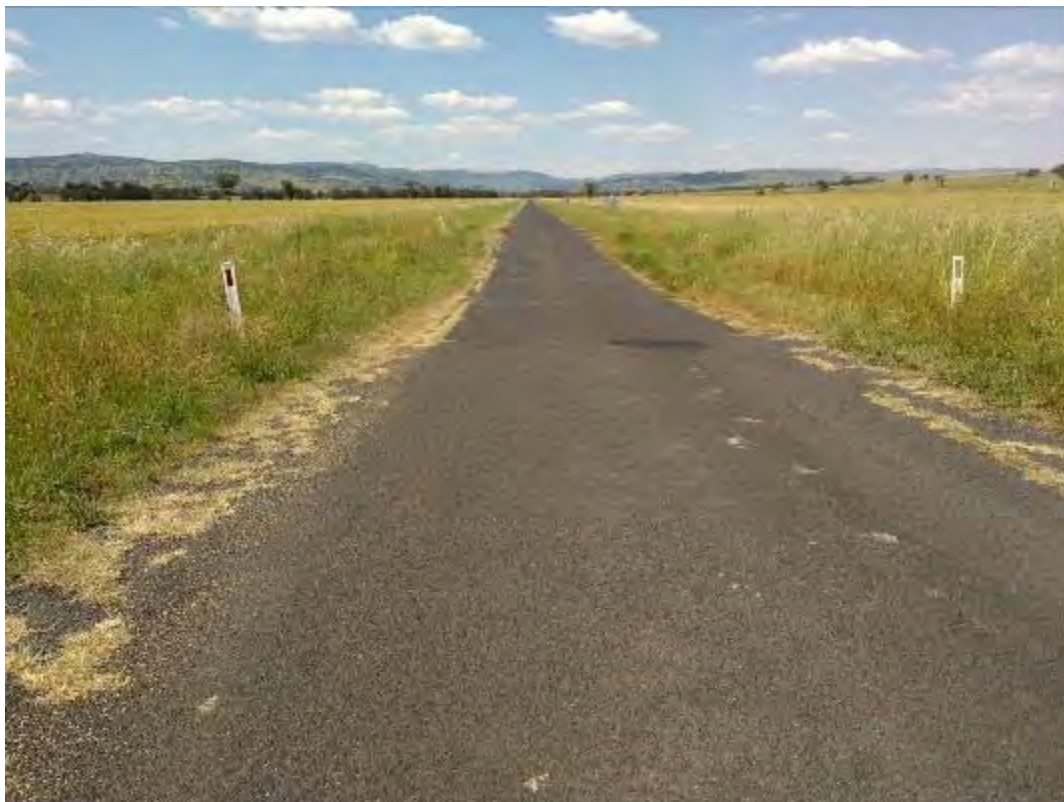
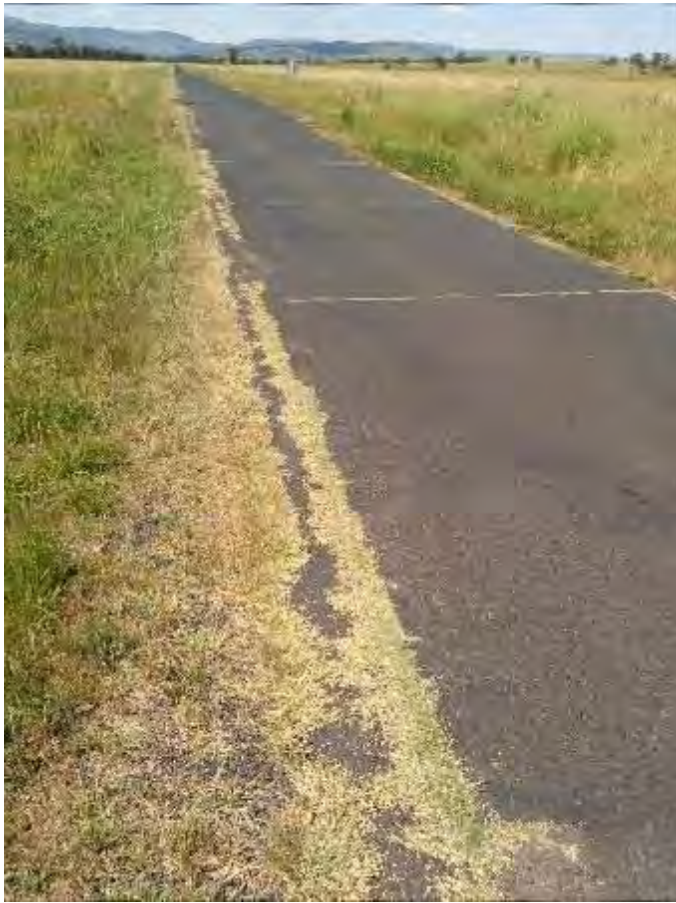
S102 – View to North

Causeway

May require upgrade

Vertical Geometry for HLP's to be verified by Survey
