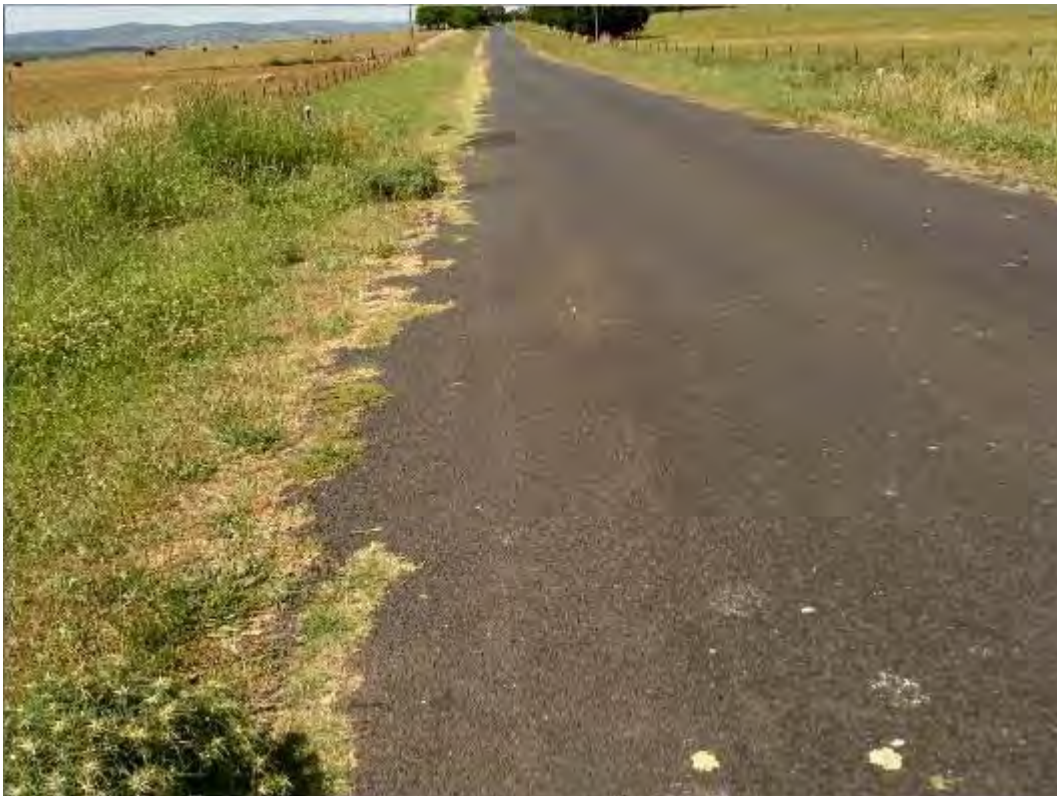
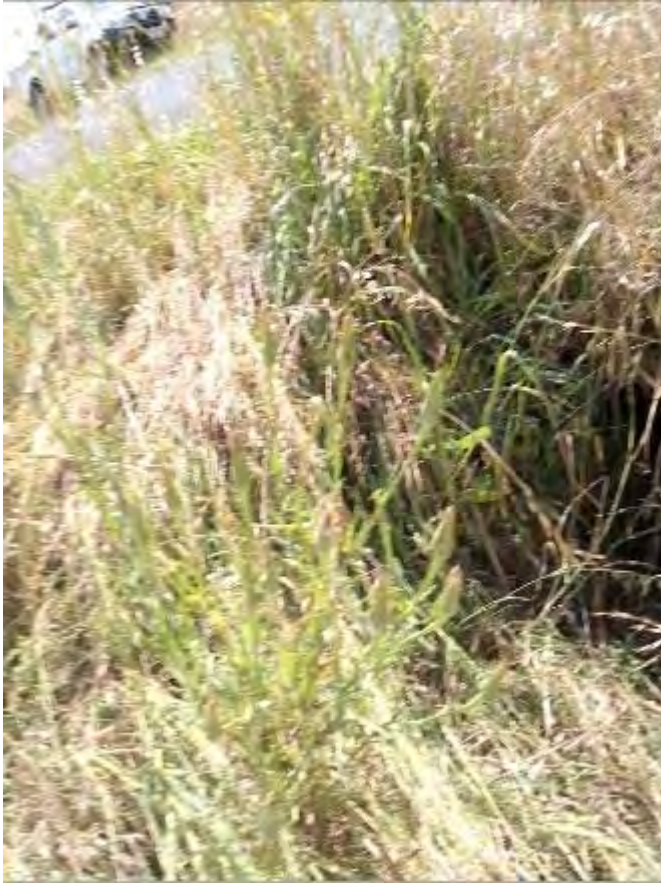
S104 – 525mm Pipe Culvert

**S104 – Coolah Creek Rd - 400m North of Vinegaroy Rd**  
Pipe Culvert of Approximately 525mm in diameter  
Moderate Condition and Serviceable

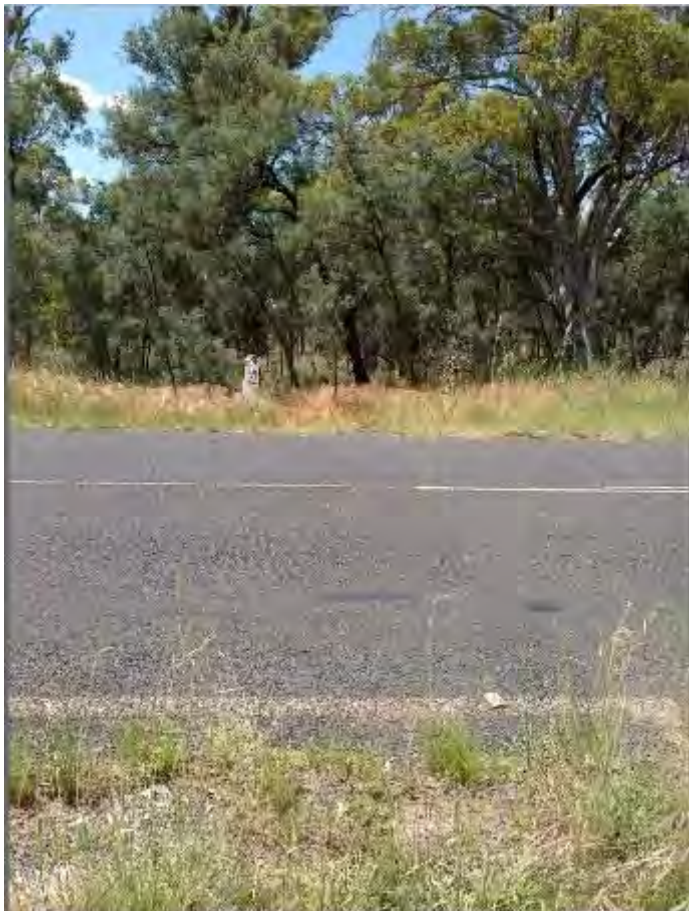
S107 – View to North perpendicular to Culvert

**S107 – Vinegaroy Rd - 900m South of Coolah Creek Rd Intersection**  
600mm Pipe Culvert  
Fair Condition and Serviceable,

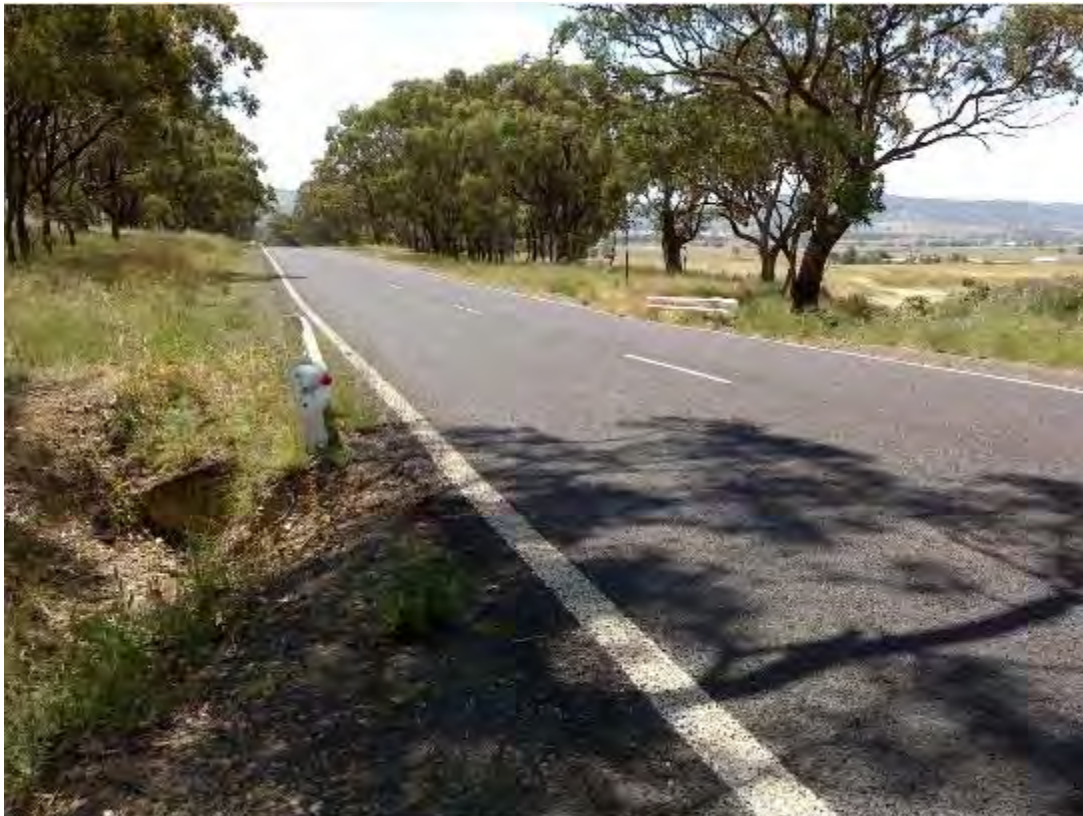
S108 – View to North

**S108 - Vinegaroy Rd - 2000m South of Coolah Creek Rd Intersection**  
1050mm Pipe Culvert. Skewed across road alignment.  
Fair Condition and Serviceable, Internal condition is also Fair

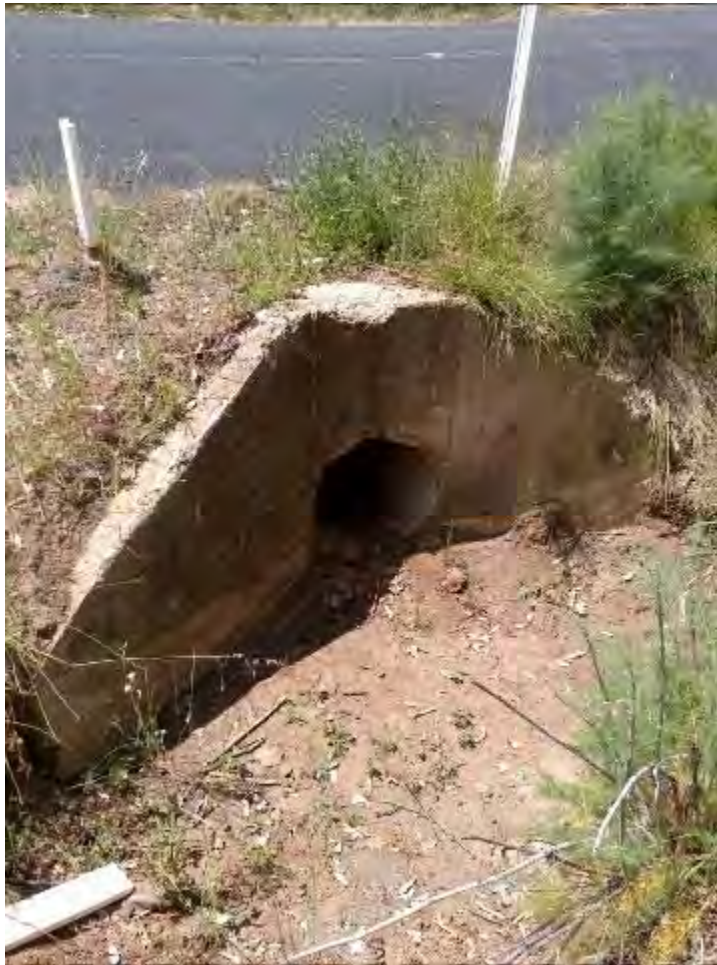
Blocked, further inspection required of internal condition after blockage has been removed

Moderate Condition and Serviceable

S109 – 600mm Blocked Pipe Culvert

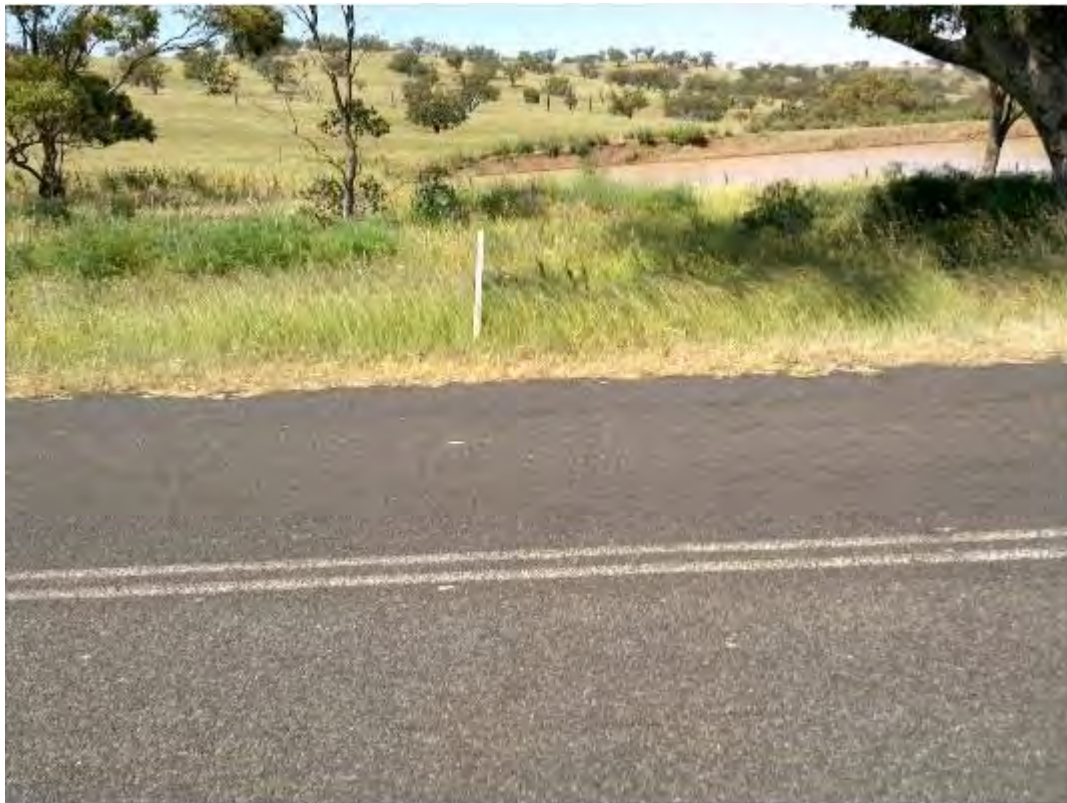
S110 – View to South

**S110 – Vinegaroy Rd - 3900m East of Coolah Creek Intersection**  
Pipe Culvert of Approximately 450mm  
Unknown Condition

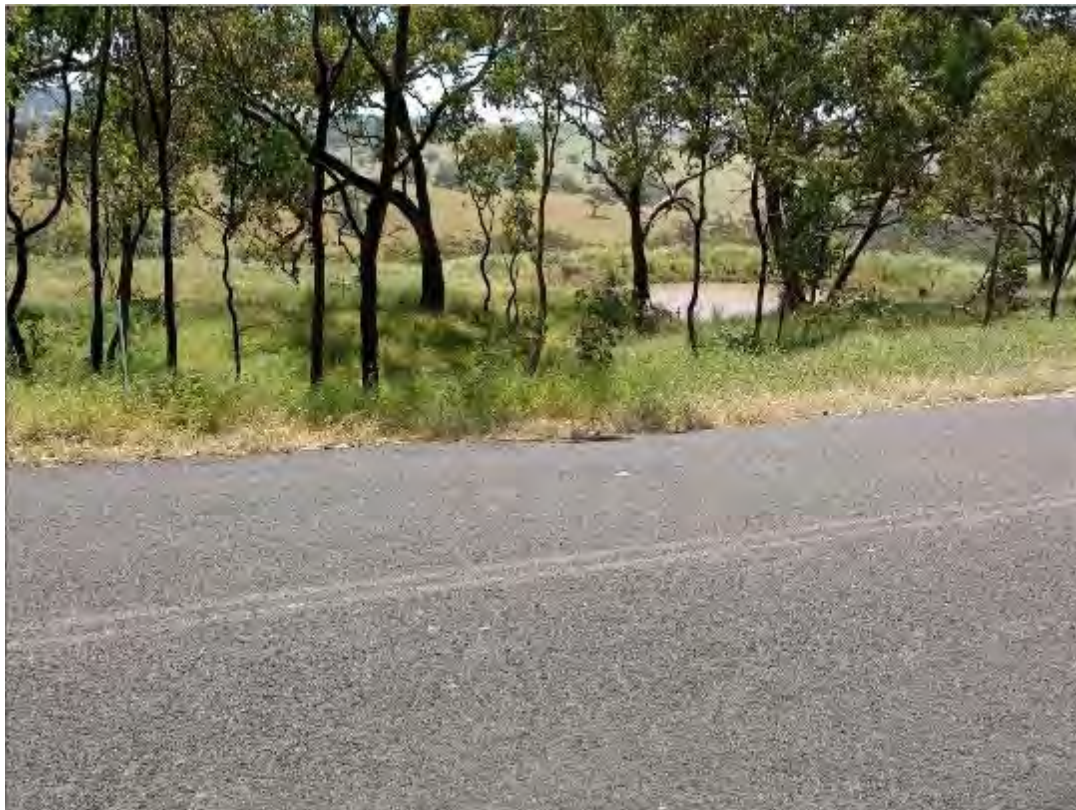
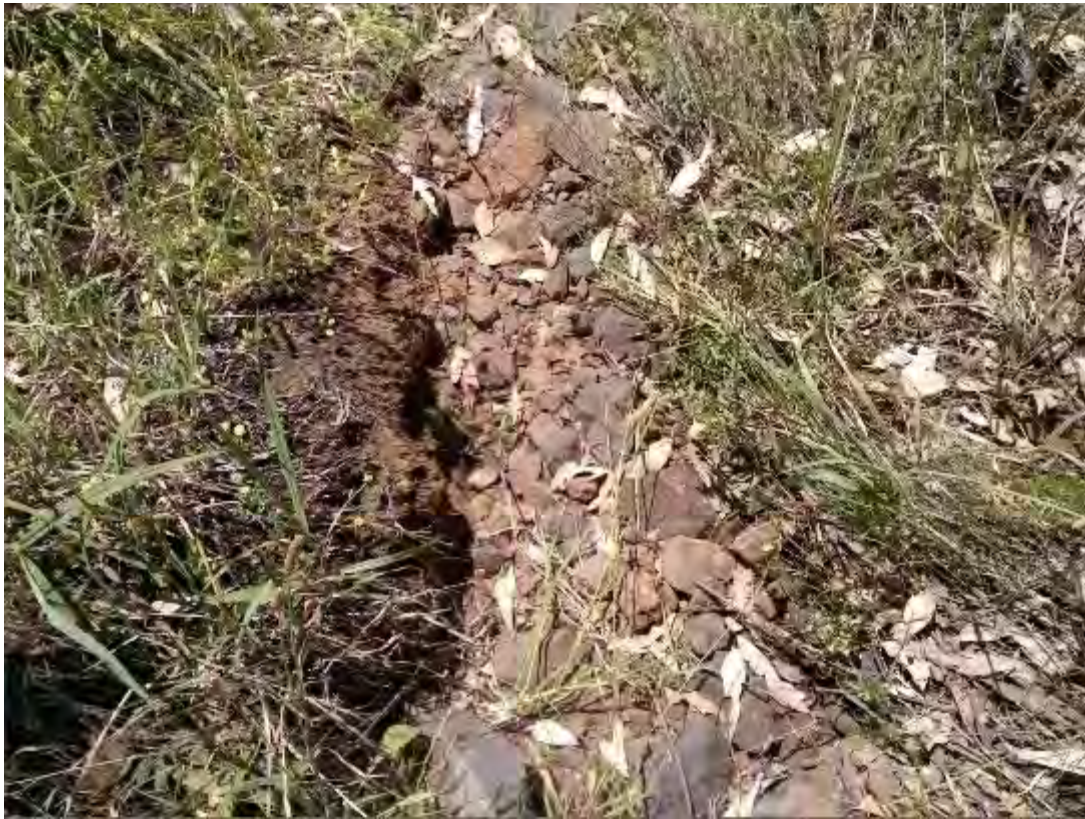
S111 –600mm Corrugated Metal Pipe

600mm Corrugated Metal Pipe

Inaccessible at time of inspection, condition unknown.

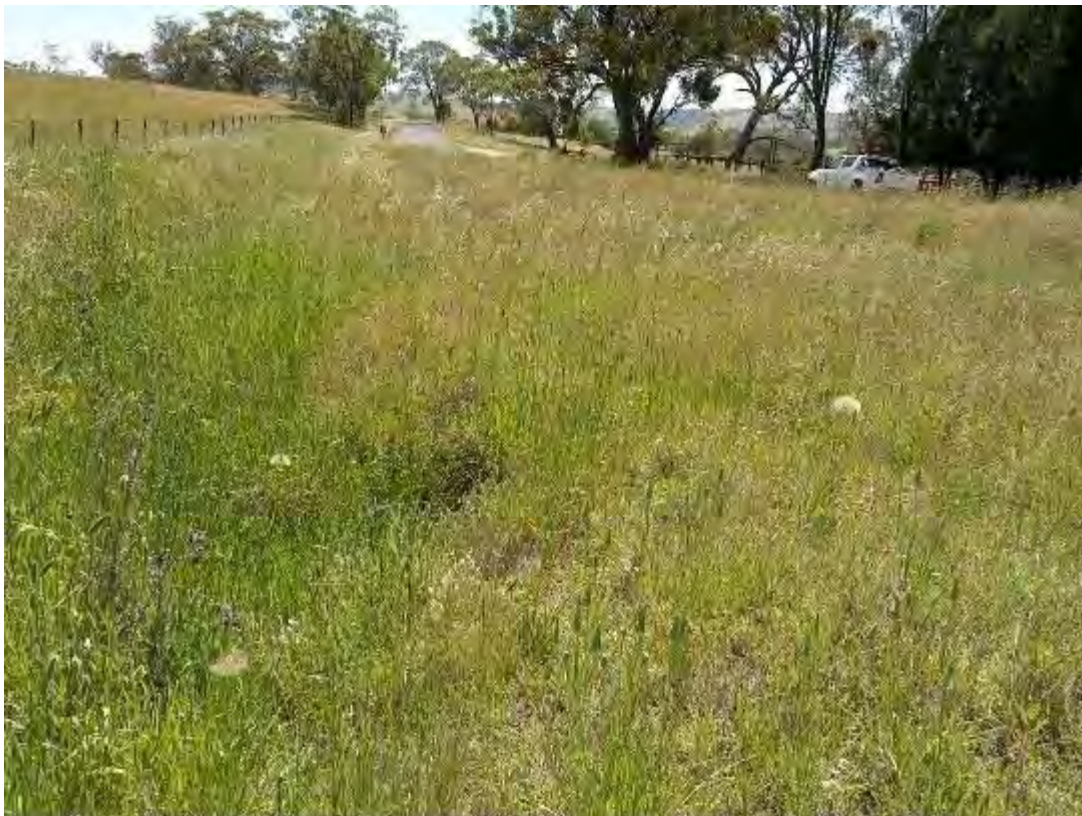
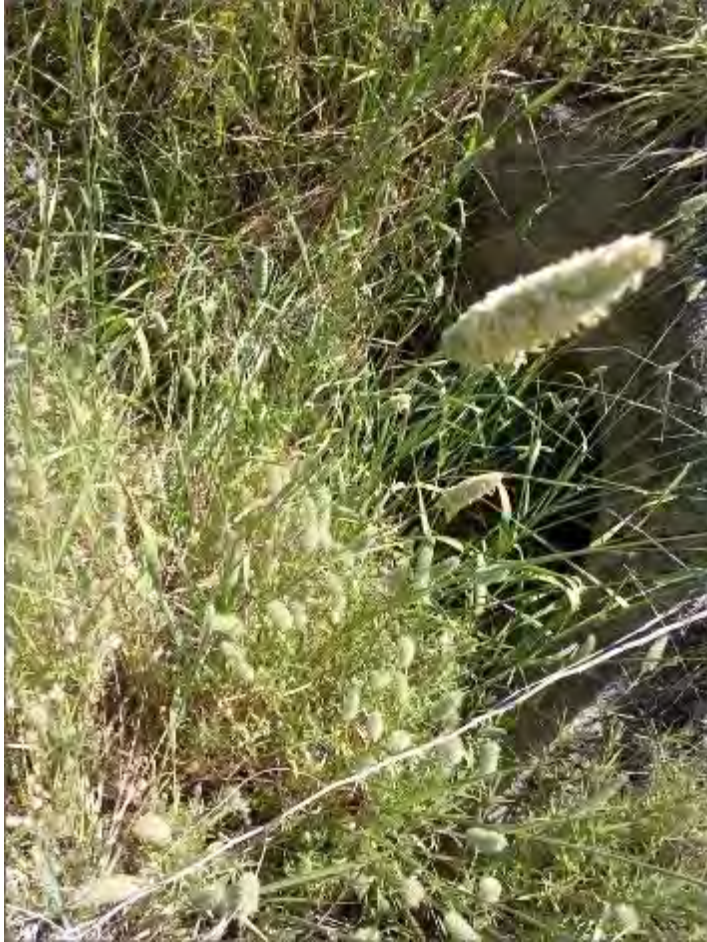
**S114 – Vinegaroy Rd - 5600m South from Coolah Town**  
600mm Pipe Culvert  
Unknown Condition

**S114 –View to North, 600mm Pipe Culvert**

S114 – 600mm Pipe Culvert

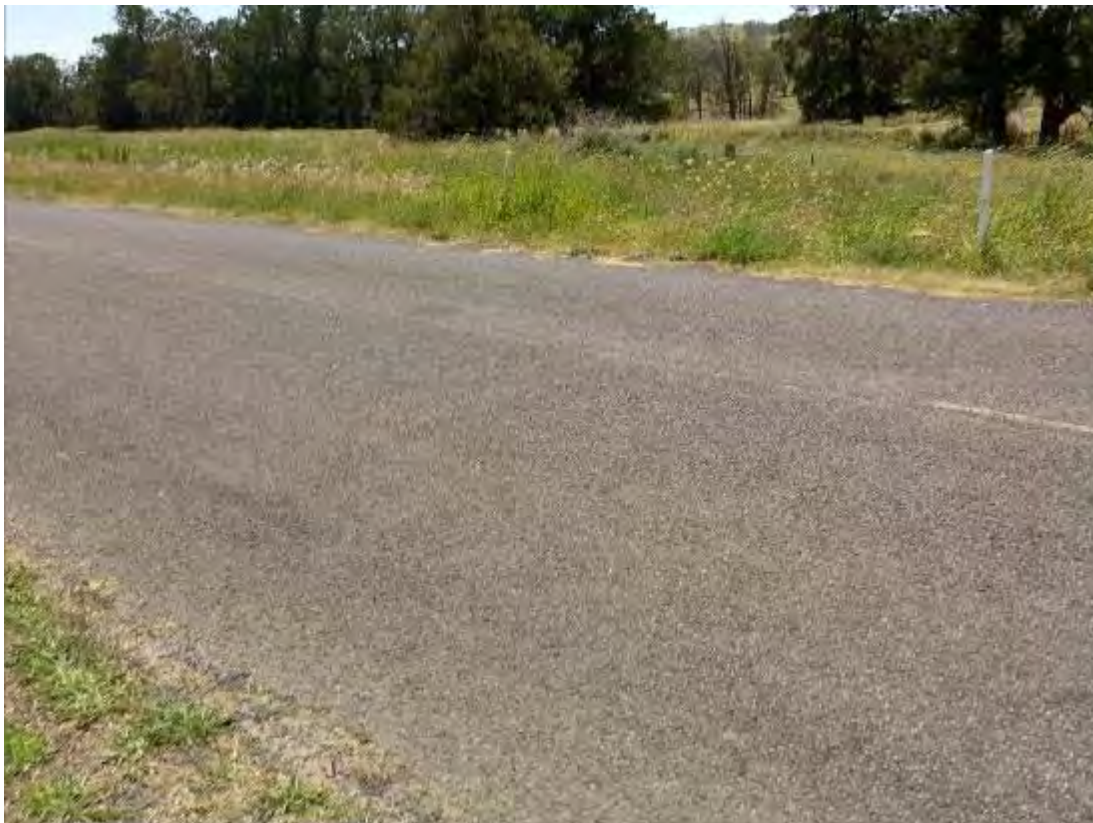
S116 – View to East

**S116 - Vinegaroy Rd - 3300m North of Rotherwood Rd Intersection**  
3-750mm Pipe Culvert  
Moderate Condition and Serviceable

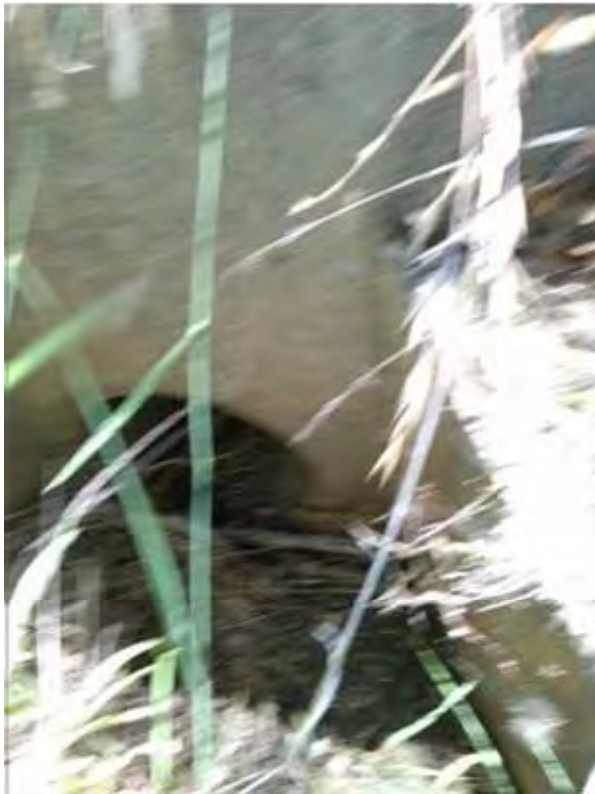
**S117 – Vinegaroy Rd - 3200m North of Rotherwood Rd Intersection**  
450mm Pipe Culvert  
Moderate Condition and Serviceable

S117 - 450mm Pipe Culvert

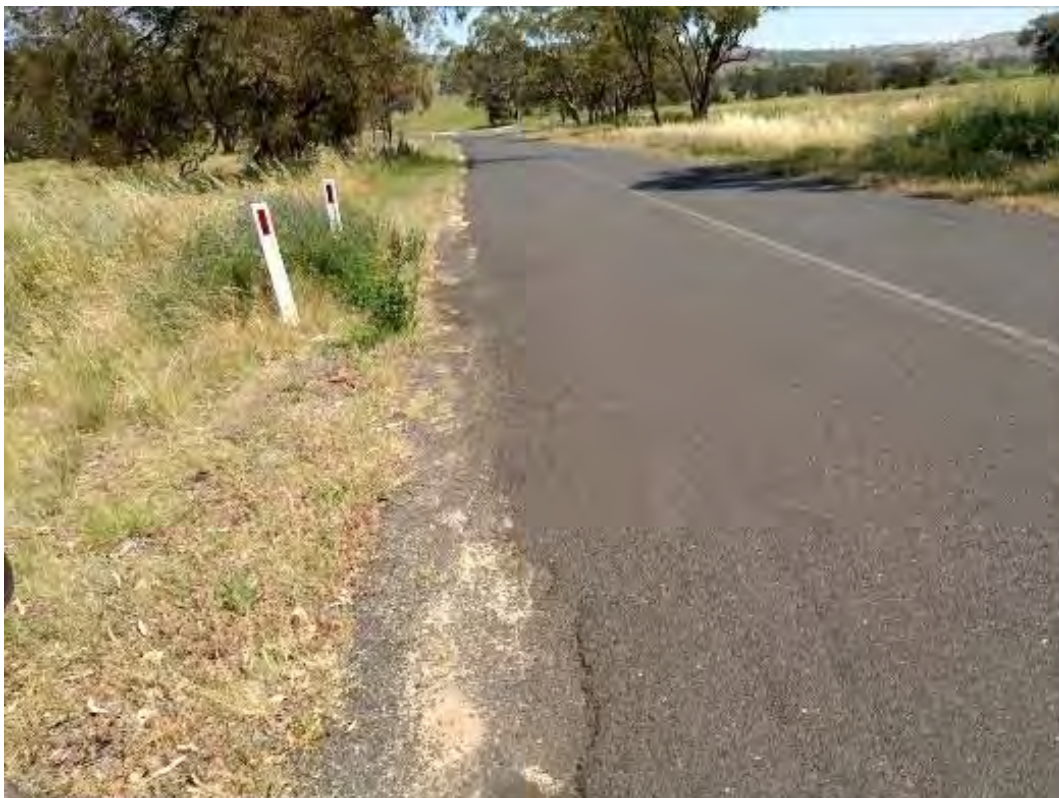
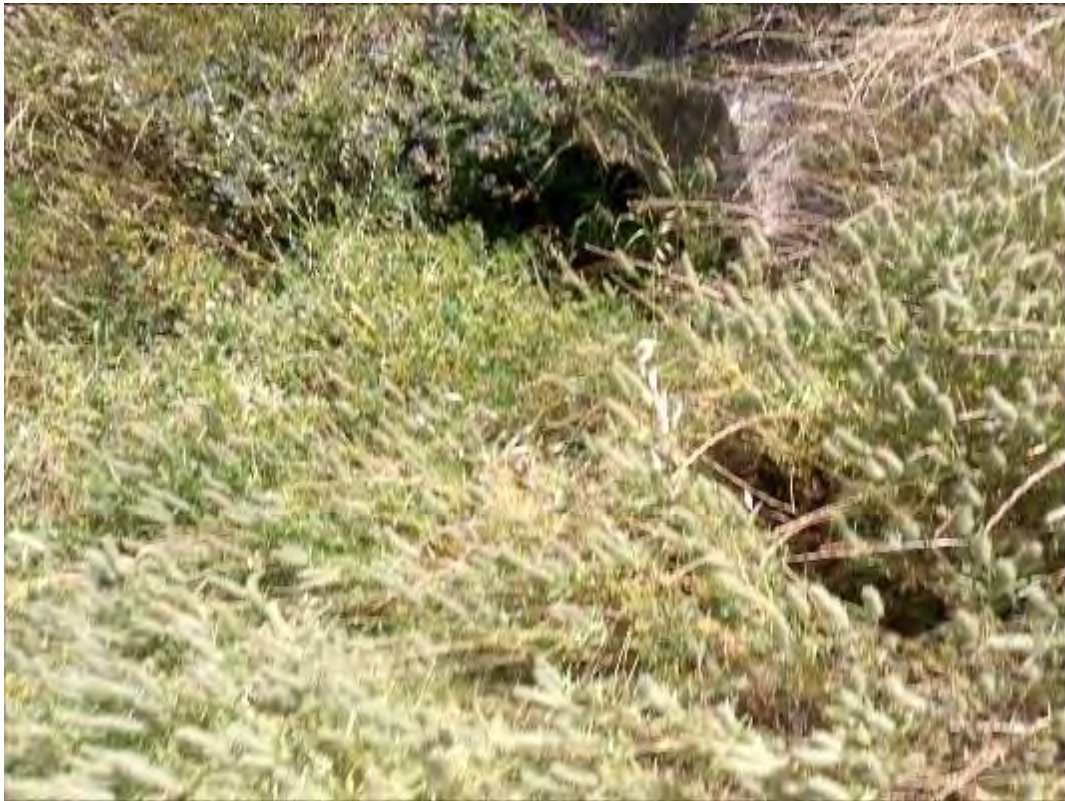
600mm Pipe Culvert

Moderate Condition and Serviceable

Fairly overgrown and requires maintenance. Further inspection of internal condition is required

S118 – 600mm Pipe Culvert

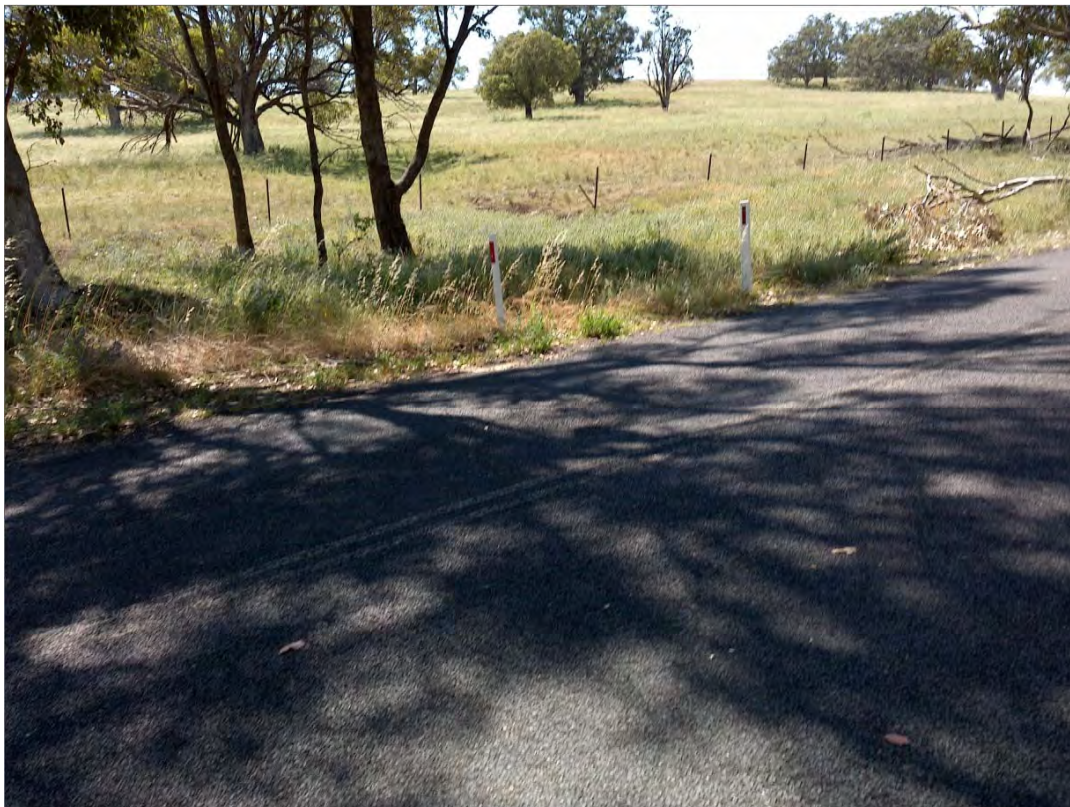
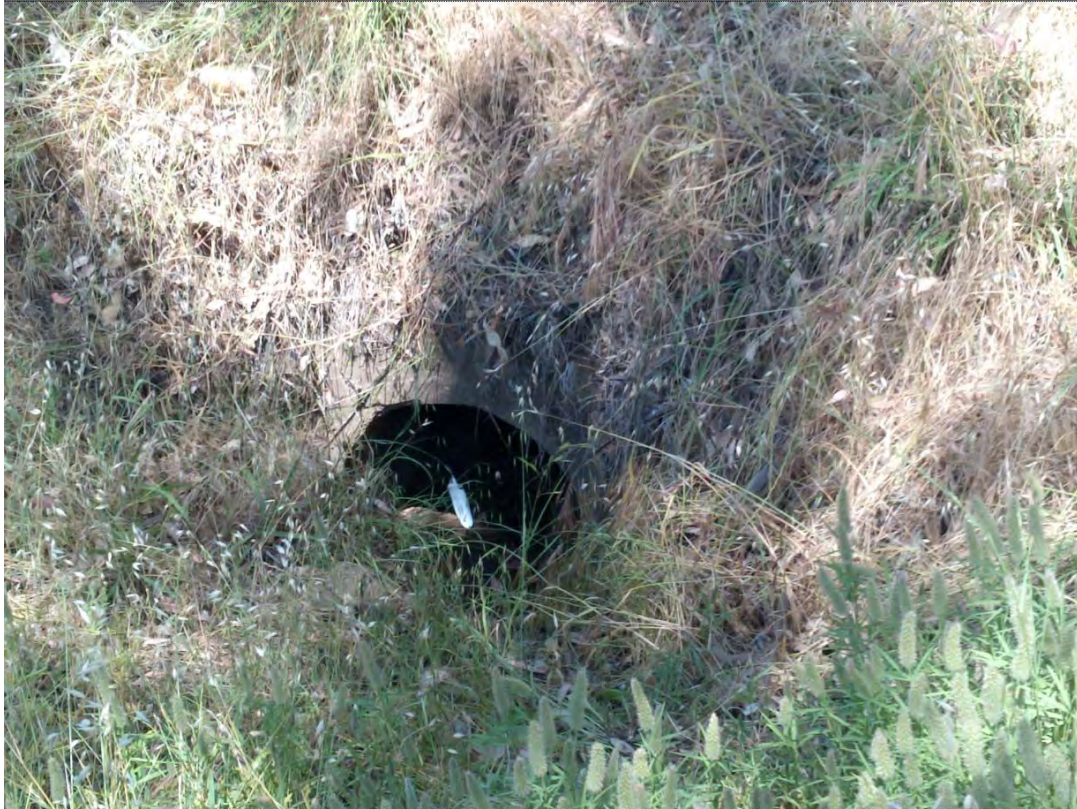
750mm Pipe Culvert

Moderate Condition and Serviceable, partially overgrown may require maintenance

S120 - 750mm Pipe Culvert

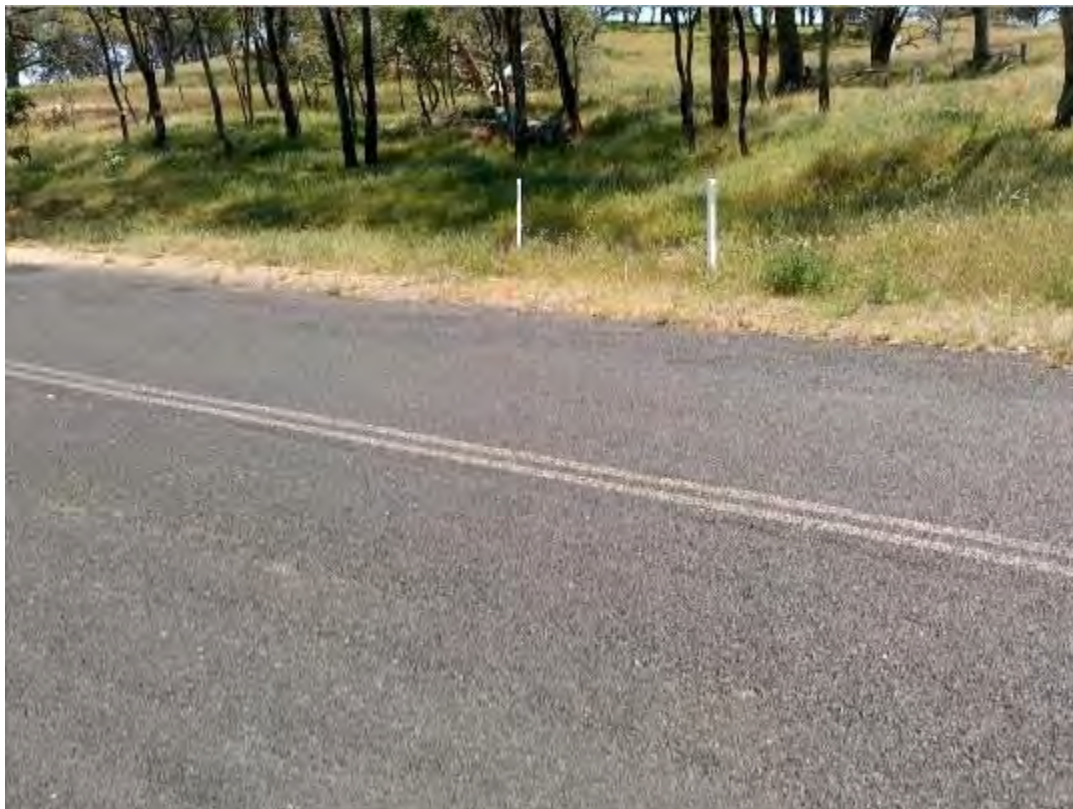
S122 – View to North

**S122 - Vinegaroy Rd - 1300m North of Rotherwood Intersection**  
Dual 450mm Pipe Culvert  
Fair Condition and Serviceable

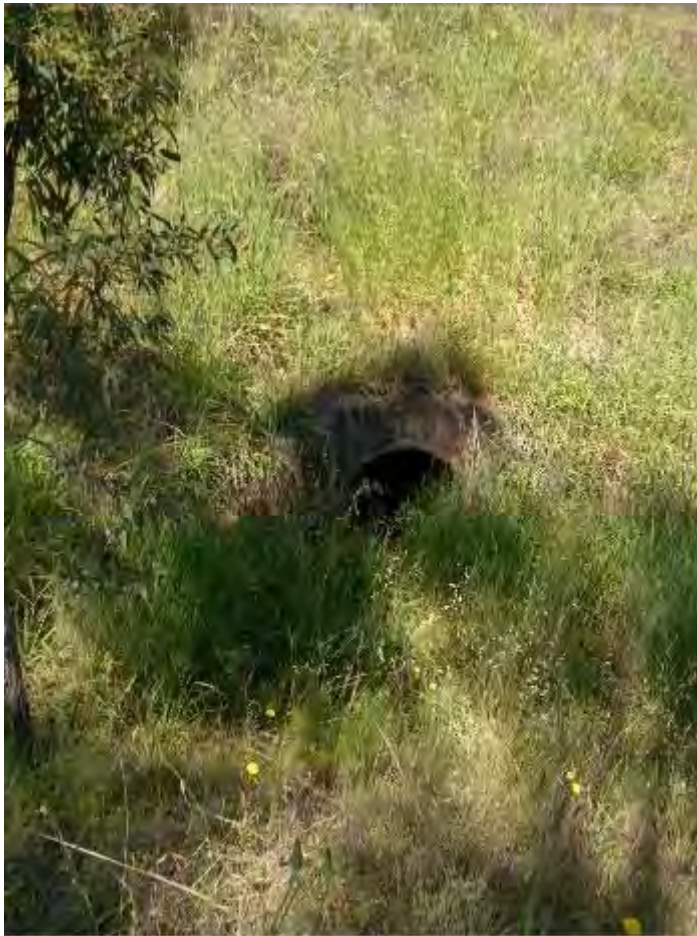
**S123 – Vinegaroy Rd - 1250m North of Rotherwood Intersection**  
1050mm Pipe Culvert  
Fair Condition and Serviceable

S123 – 1050mm Pipe Culvert

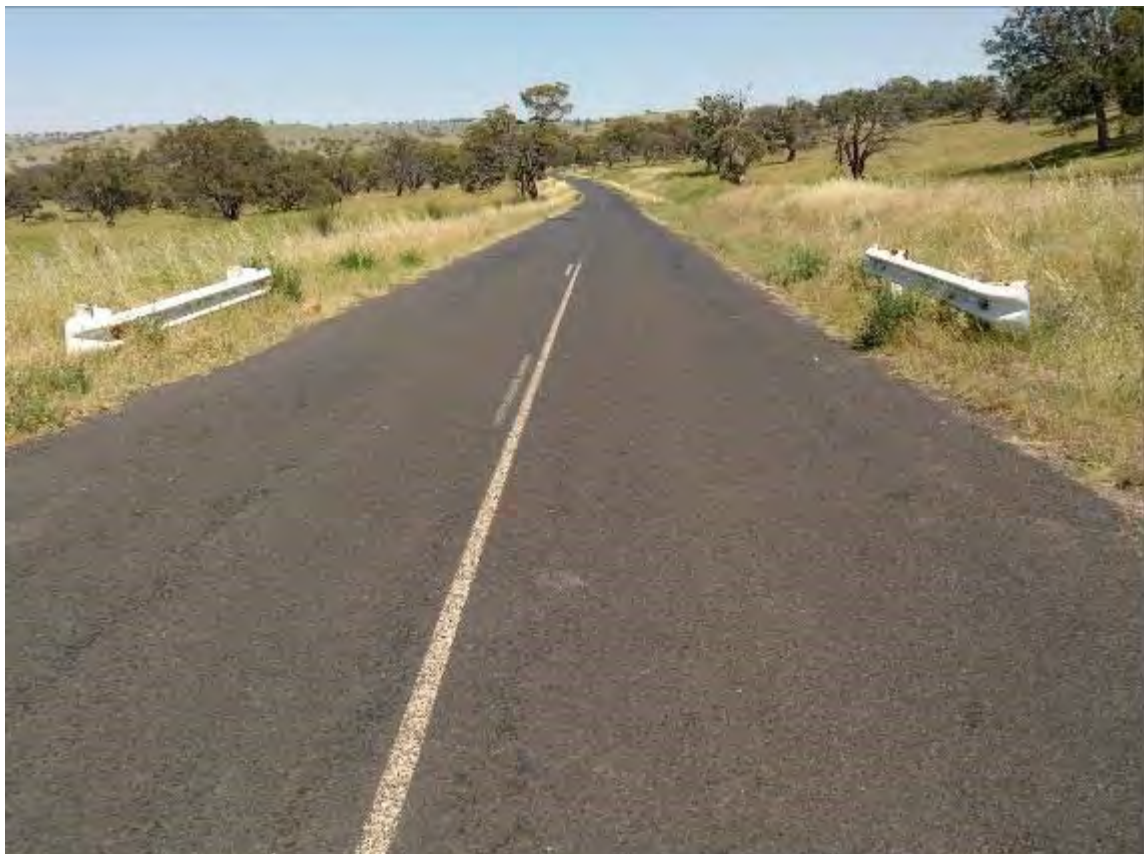
**S125 – View to West**

450mm Pipe Culvert

Blocked at time of inspection

Moderate Condition and Serviceable, maintenance required.

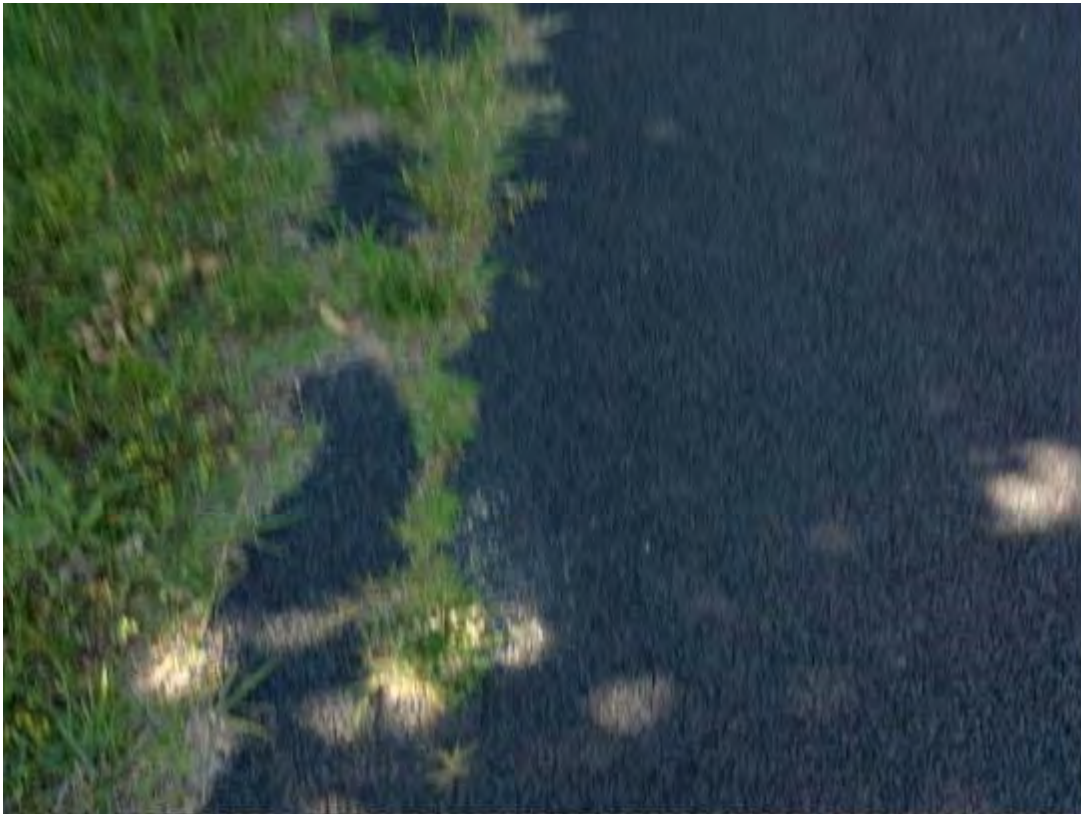
S126 – Moss growing into Road

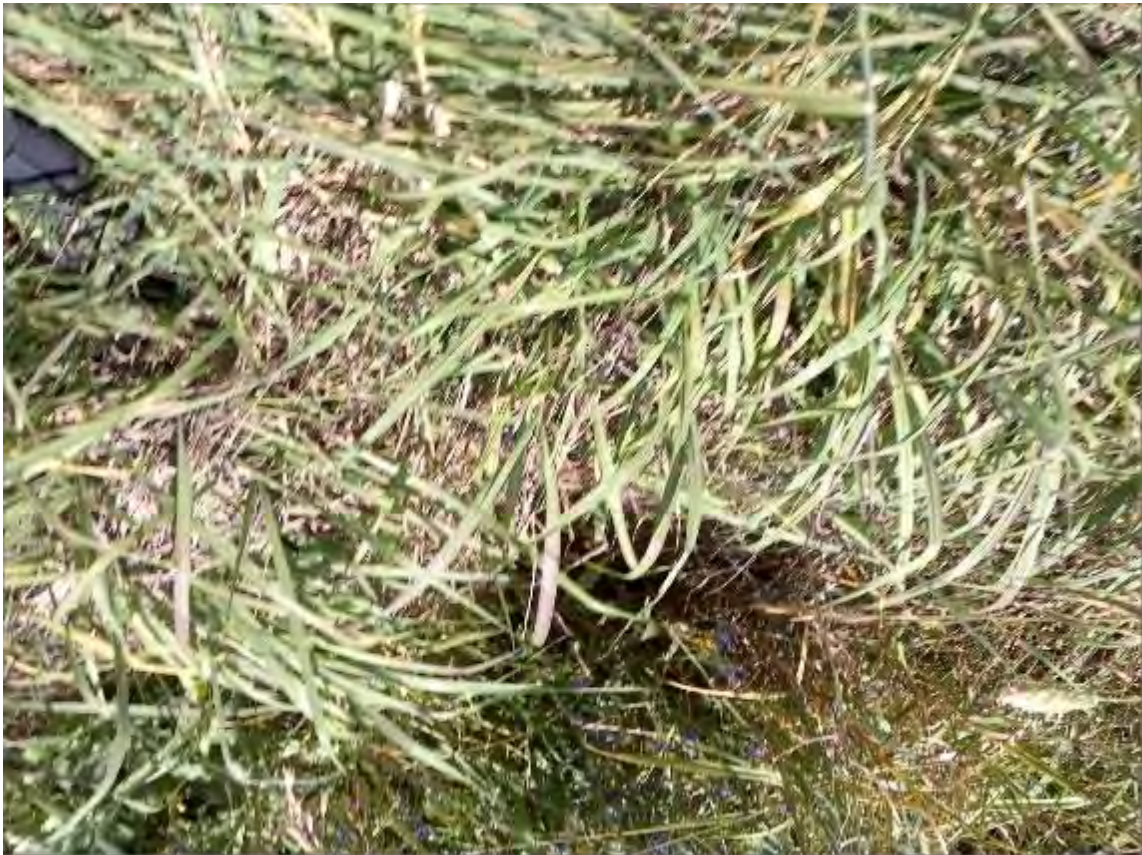
**S127 – Turee Vale Rd - 600m North of Vinegaroy Rd Intersection**  
Pipe Culvert of Unknown Dimensions  
Unknown Condition

S127 – View looking to Pipe Culvert

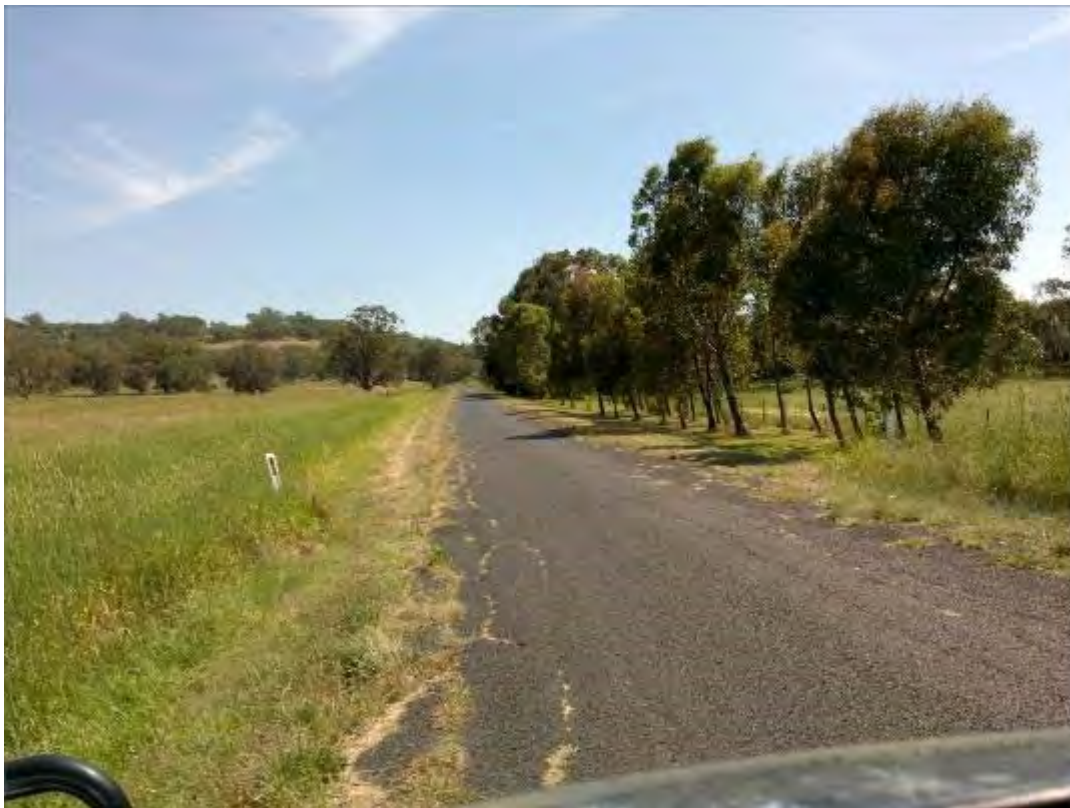
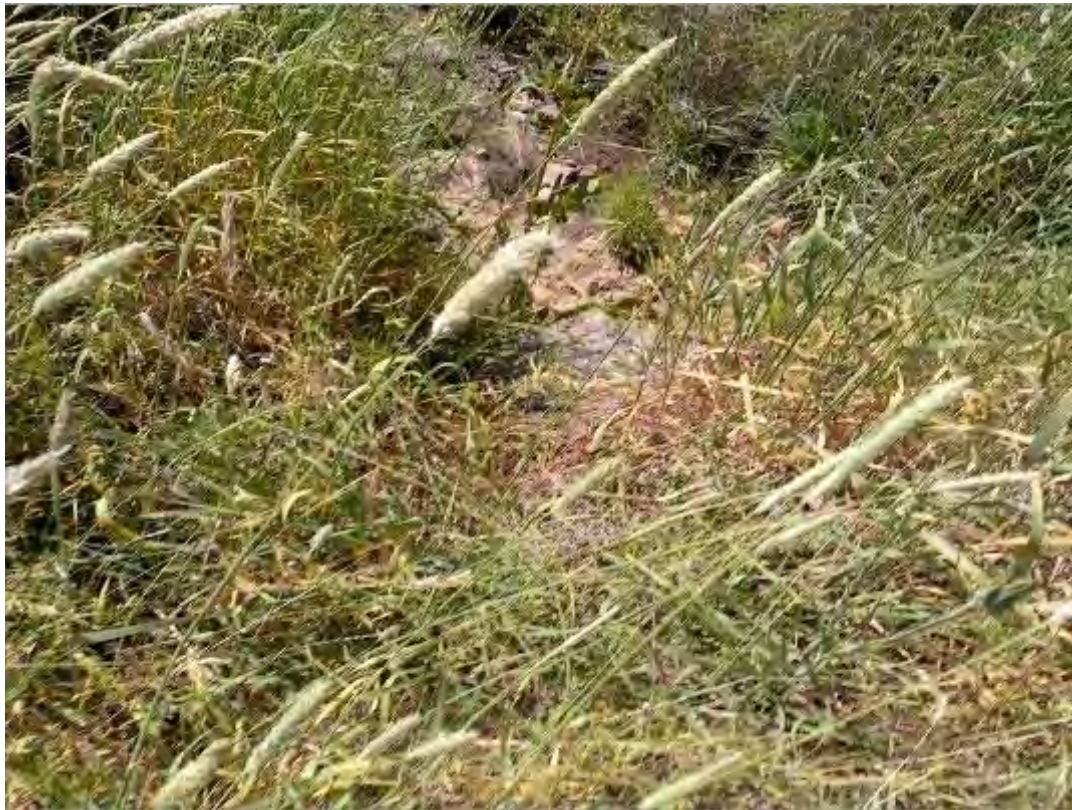
**S133 – Turee Vale Rd - 2400m North of Vinegaroy Intersection**  
600mm Pipe Culvert with no headwall.  
Moderate Condition and Serviceable

S133 – 600mm Pipe Culvert
