S136 – Turee Vale Rd - 3200m North of Vinegaroy Intersection
450mm Pipe Culvert
Fair Condition and Serviceable

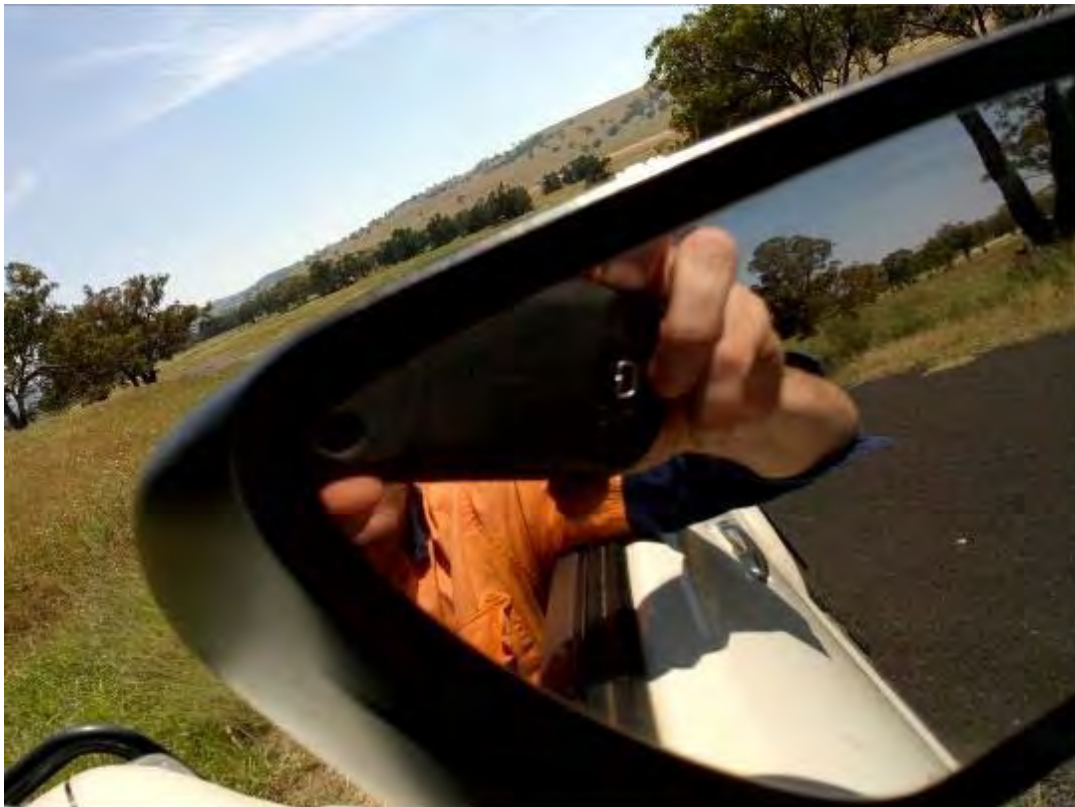
S137 – View to North

S137 - Turee Vale Rd - 3250m North of Vinegaroy Intersection
Pipe Culvert of Unknown Dimensions
Unknown Condition

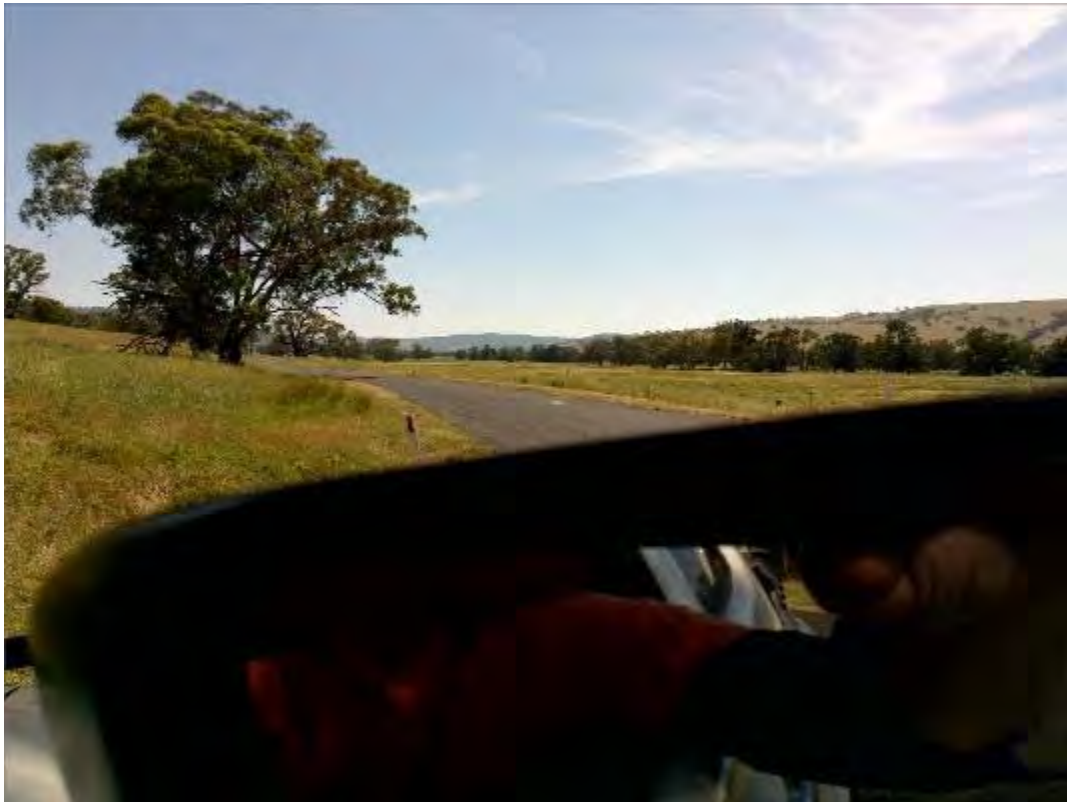
S138 – View to North

S138 - Turee Vale Rd - 3300m North of Vinegaroy Intersection
Pipe Culvert of Unknown Dimensions
Unknown Condition

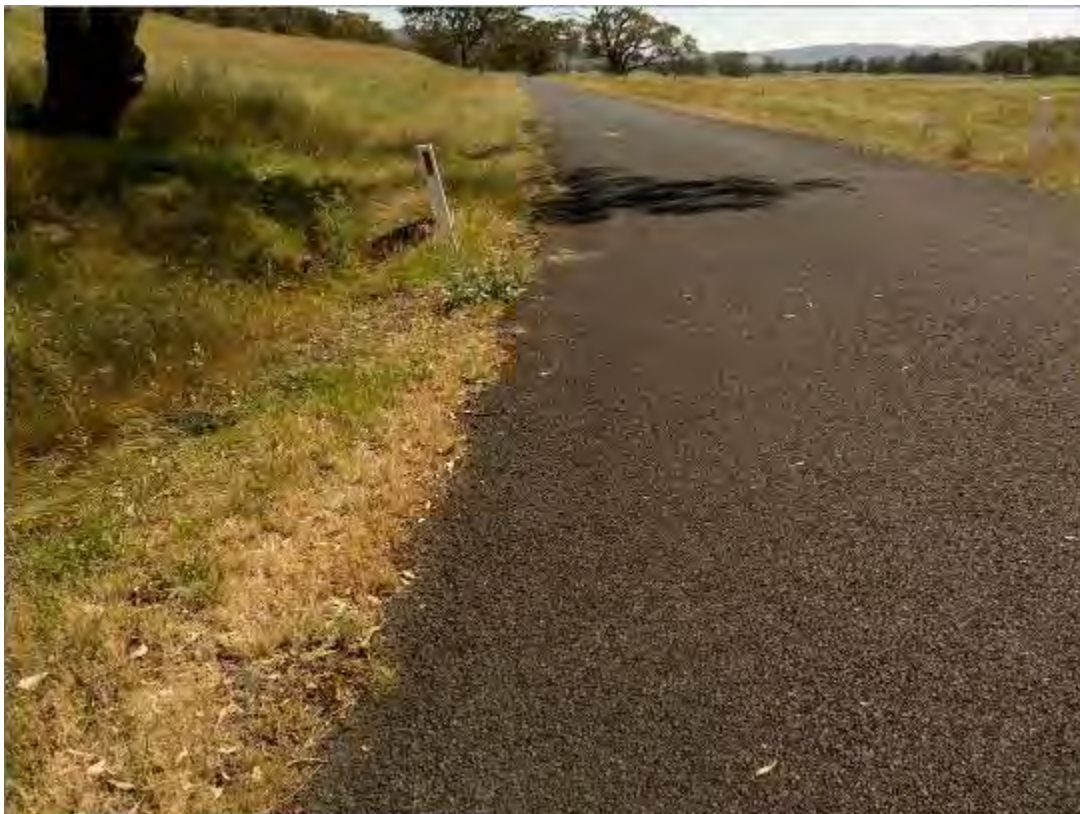
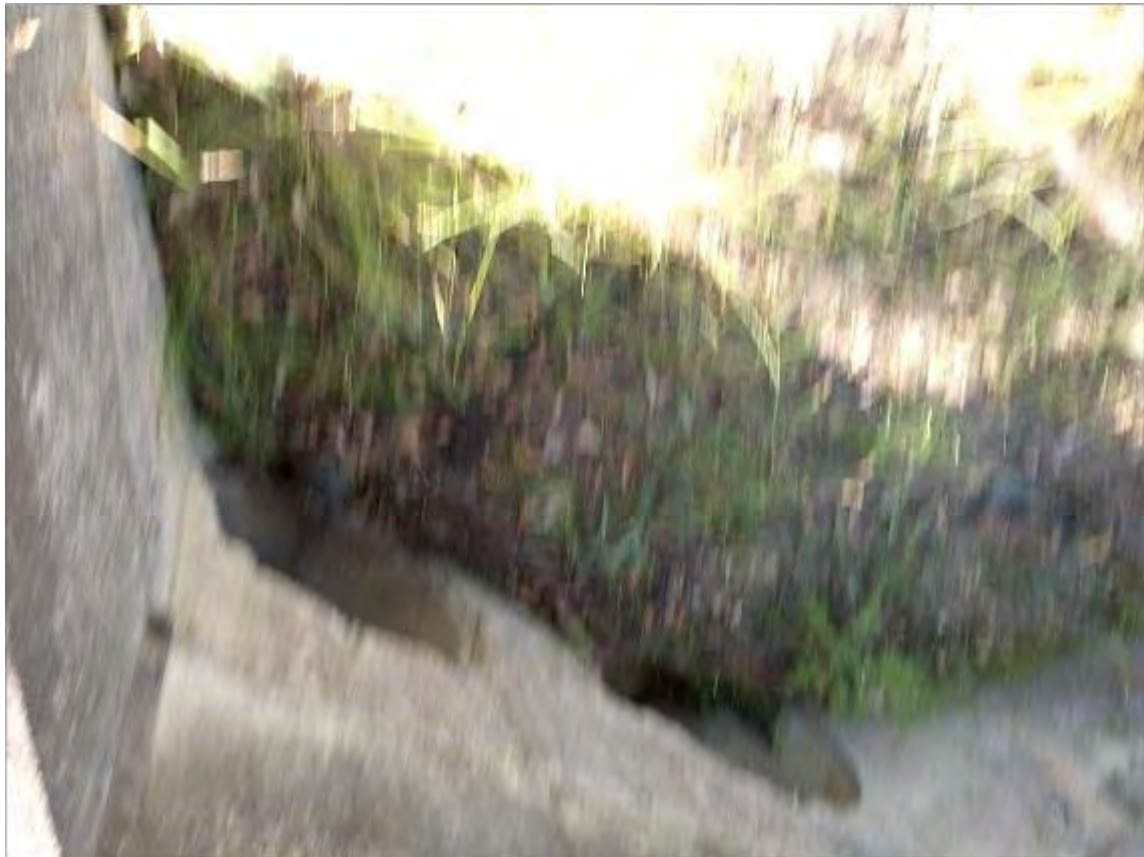
S139 – View to North

S139 - Turee Vale Rd - 3350m North of Vinegaroy Intersection

Dual 600mm Pipe Culvert

Good Condition and Serviceable

S139 – Dual 600mm Pipe Culvert

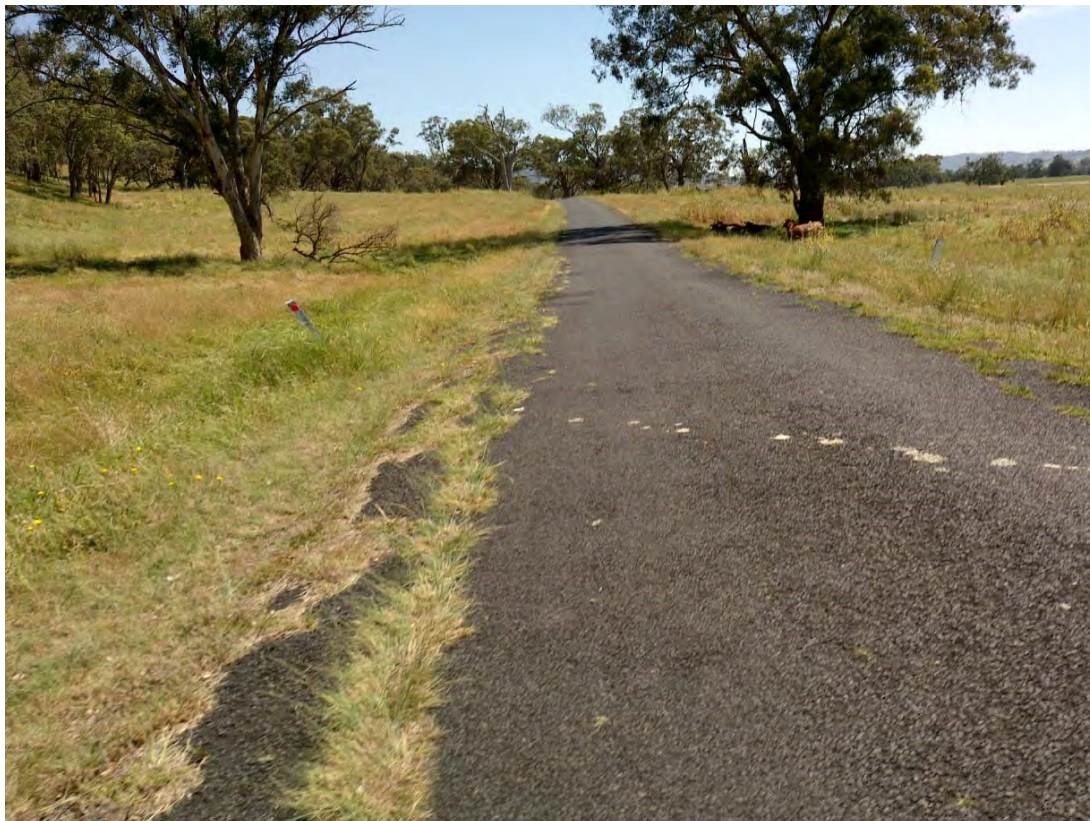
S140 – View to North

S140 – Turee Vale Rd - 3800m North of Vinegaroy Intersection

375mm Pipe Culvert,

Cracked headwall may not last through life of project

Poor Condition and serviceable

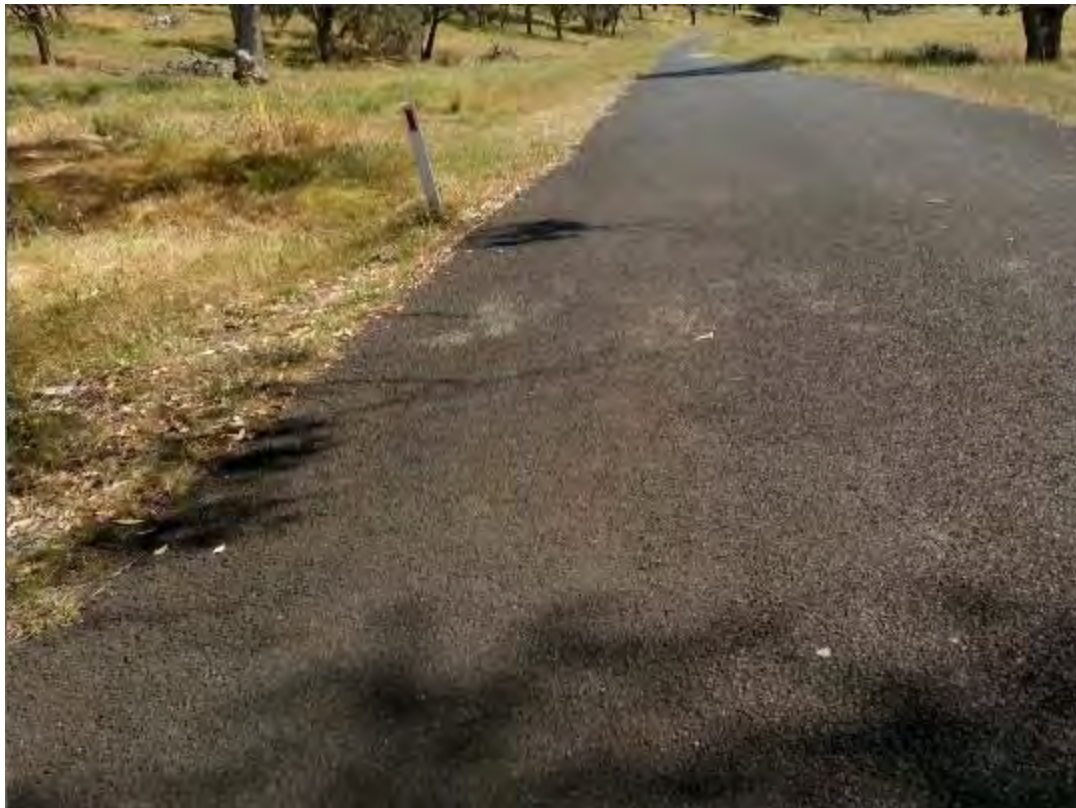
S141 – View to North

S141 – Turee Vale Rd - 3800m North of Vinegaroy Intersection
1200mm-450mm Reinforced Concrete Box Culvert
Moderate Condition and Serviceable

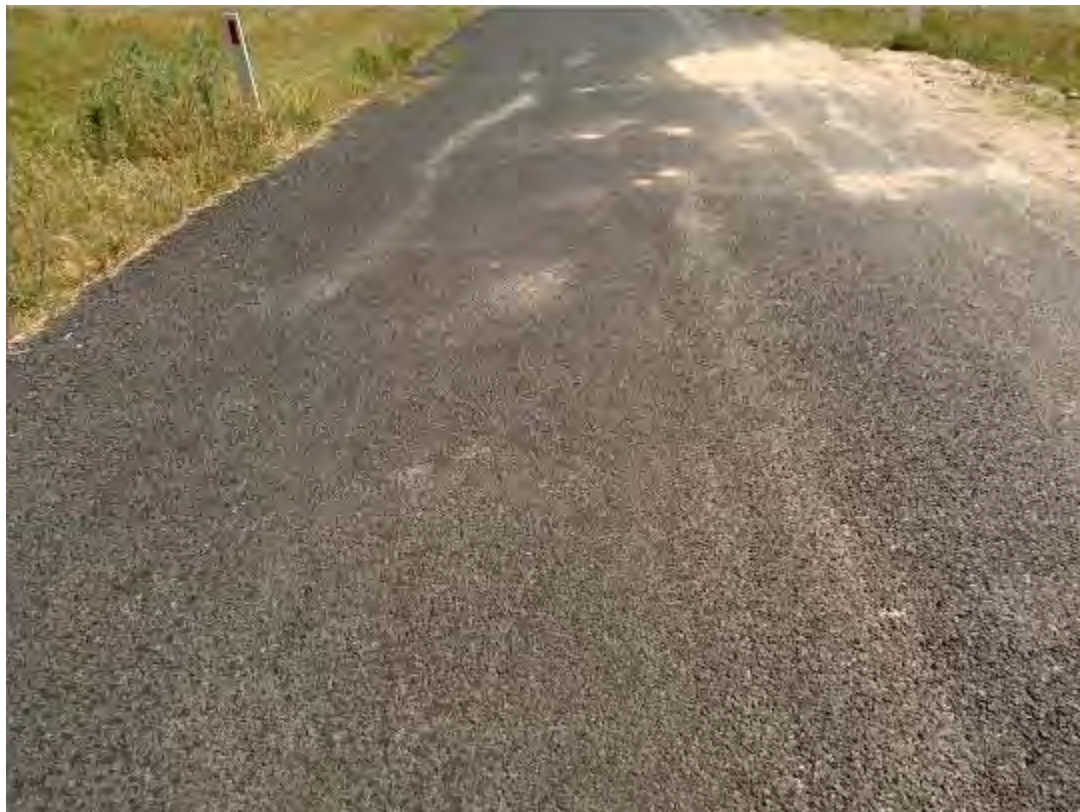
S142 – View to North

S142 – Turee Vale Rd - 4100m North of Vinegaroy Intersection
450mm Pipe Culvert
Fair Condition and Serviceable

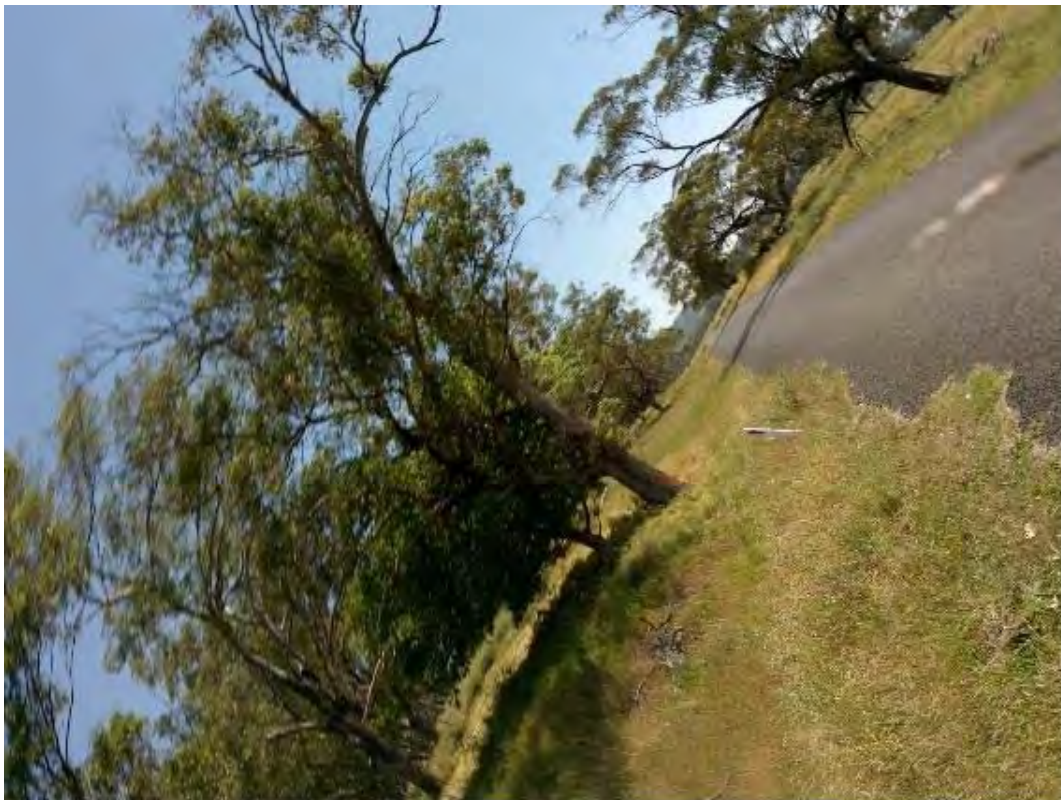
S143 - View to North

S143 – Turee Vale Rd - 4200m North of Vinegaroy Intersection
Pipe Culvert of Unknown Dimensions,
Inaccessible at time of inspection. Unknown Condition

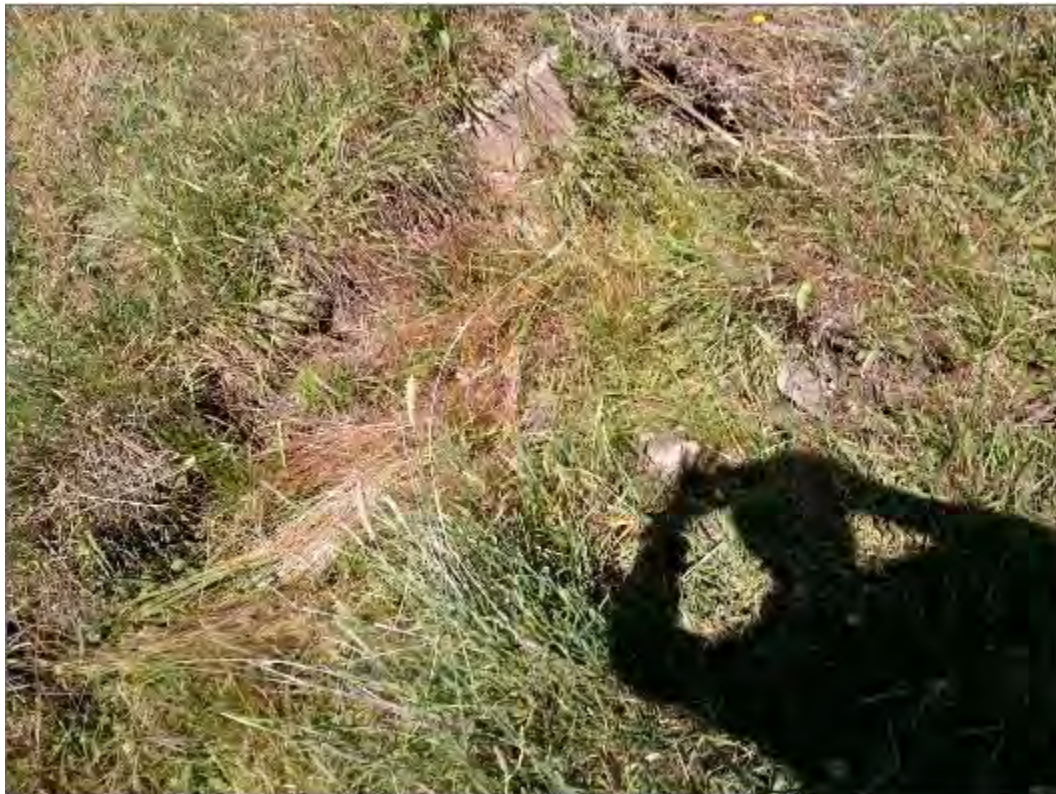
S145 – Turee Vale Rd - 4750m North of Vinegaroy Intersection
600mm Pipe Culvert, may require some Maintenance
Moderate Condition and Serviceable

S145 - 600mm Pipe Culvert at top of Image

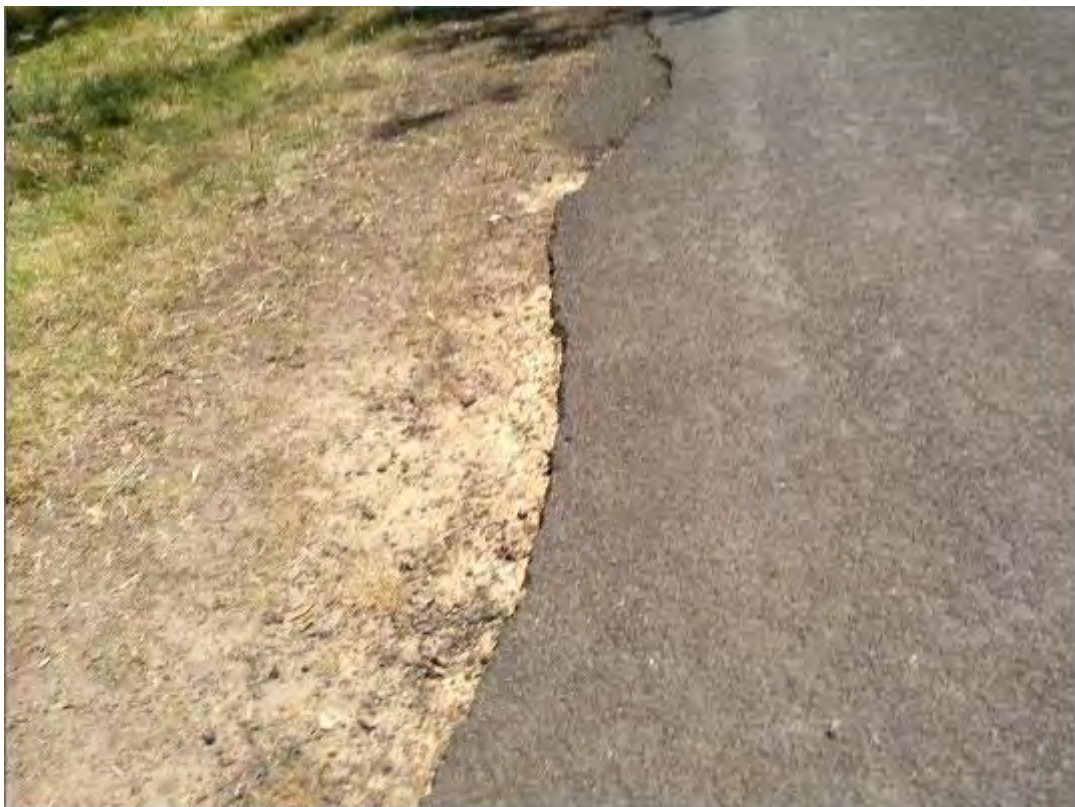
S145a - Turee Vale Rd - 5250m North from Vinegaroy Rd Intersection

525mm Pipe Culvert

Location is of Poor Condition, Will require upgrade otherwise it will further degrade over the course of the project

S145a – Road showing Edge Break

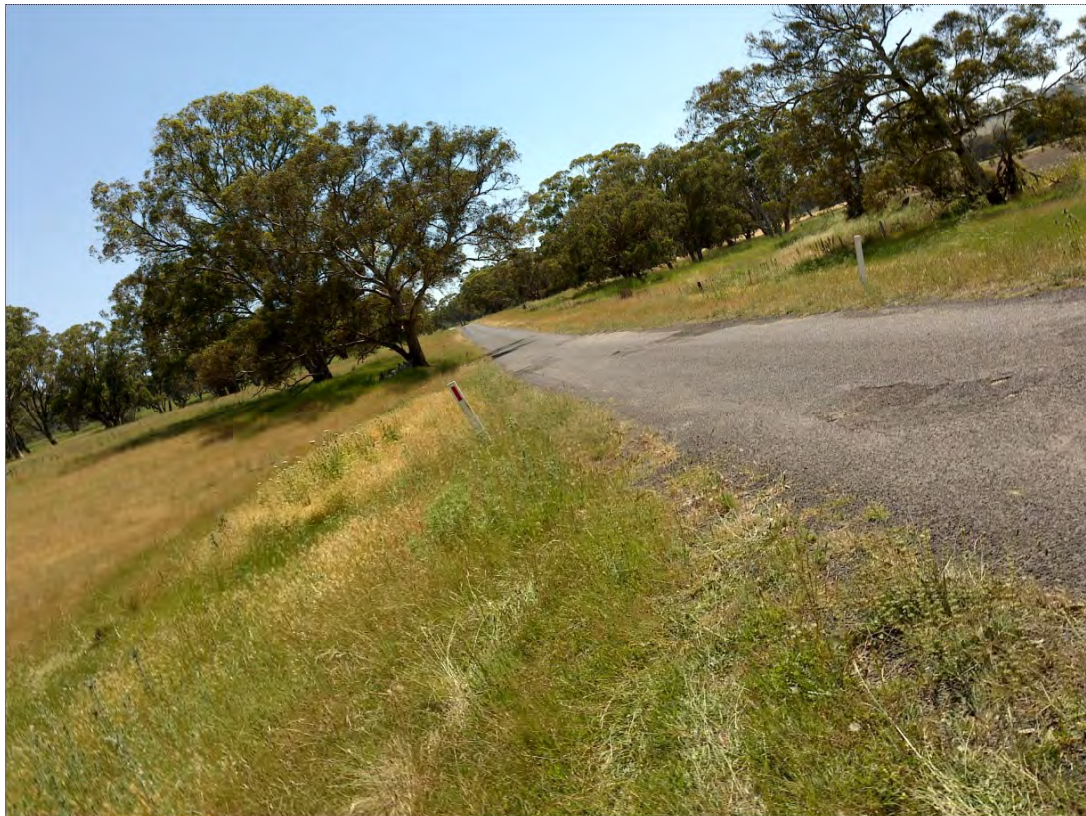
S146 – View to North

S146 – Turee Vale Rd - 5600m North from Vinegaroy Rd Intersection
Pipe Culvert of unknown Dimensions
Unknown Condition

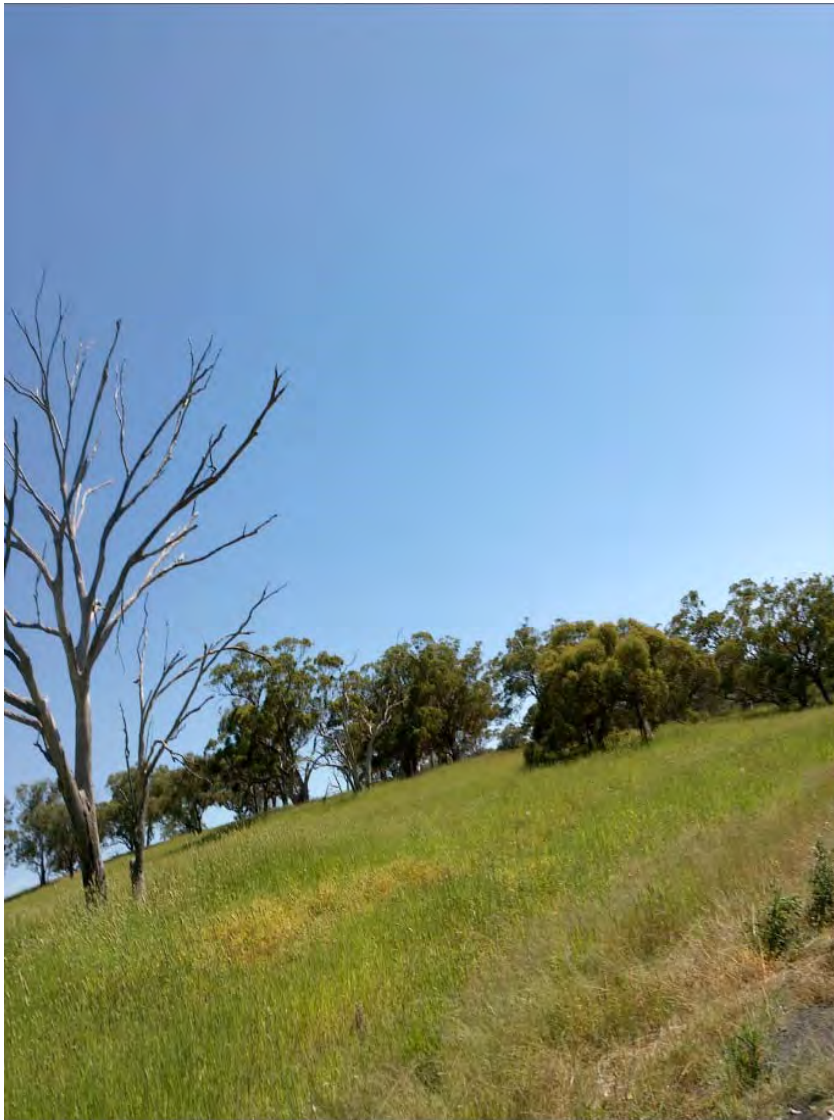
S147 – View to North

S147 – Turee Vale Rd - 6000m North from Vinegaroy Rd Intersection

Pipe culvert of unknown dimensions

Inaccessible at time of inspection

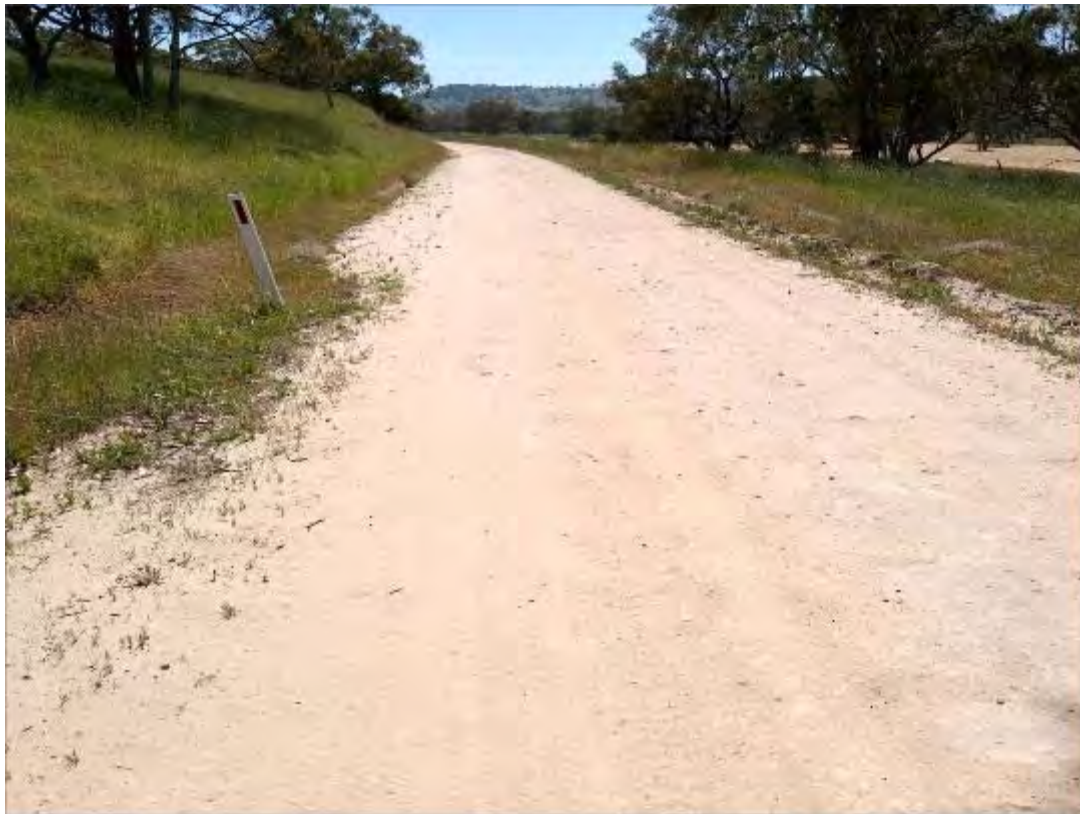
S148 – View to North

S148 – Turee Vale Rd - 6600m North from Vinegaroy Rd Intersection
375mm Pipe Culvert with no headwall
Moderate Condition and Serviceable

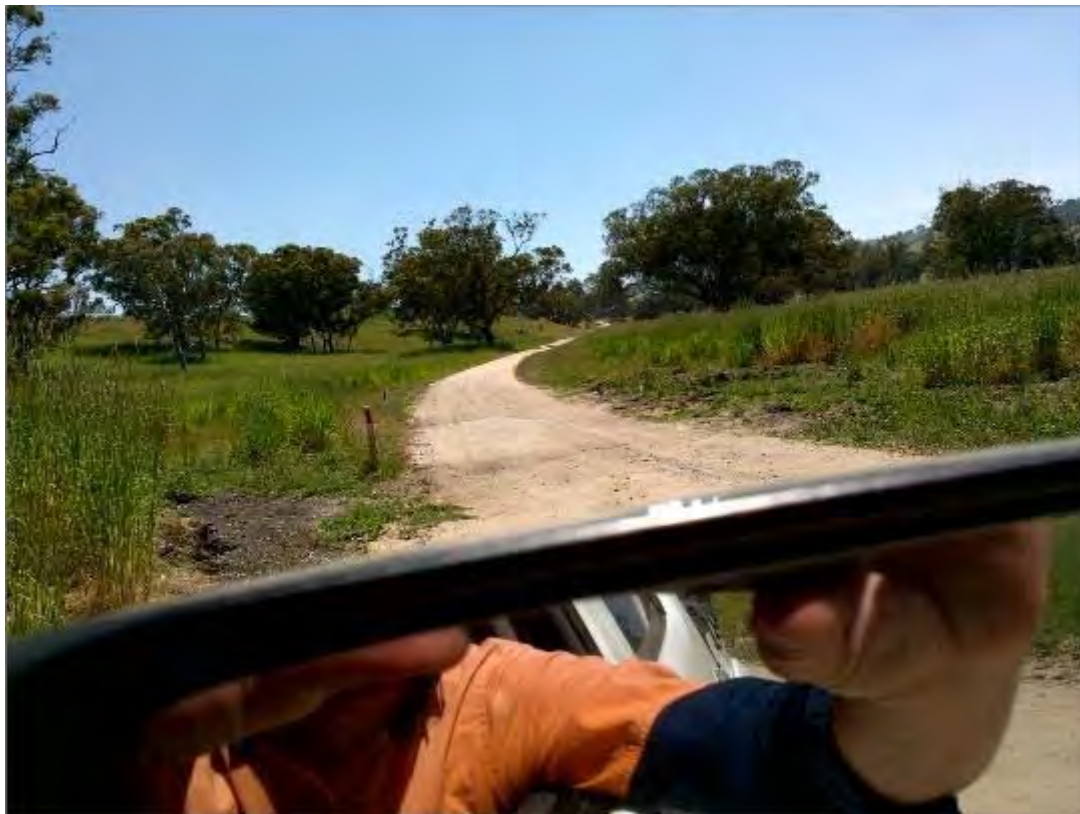
S149 – View to North

Causeway with no low flow pipe,
Upgrade may be required
Moderate Condition and Serviceable

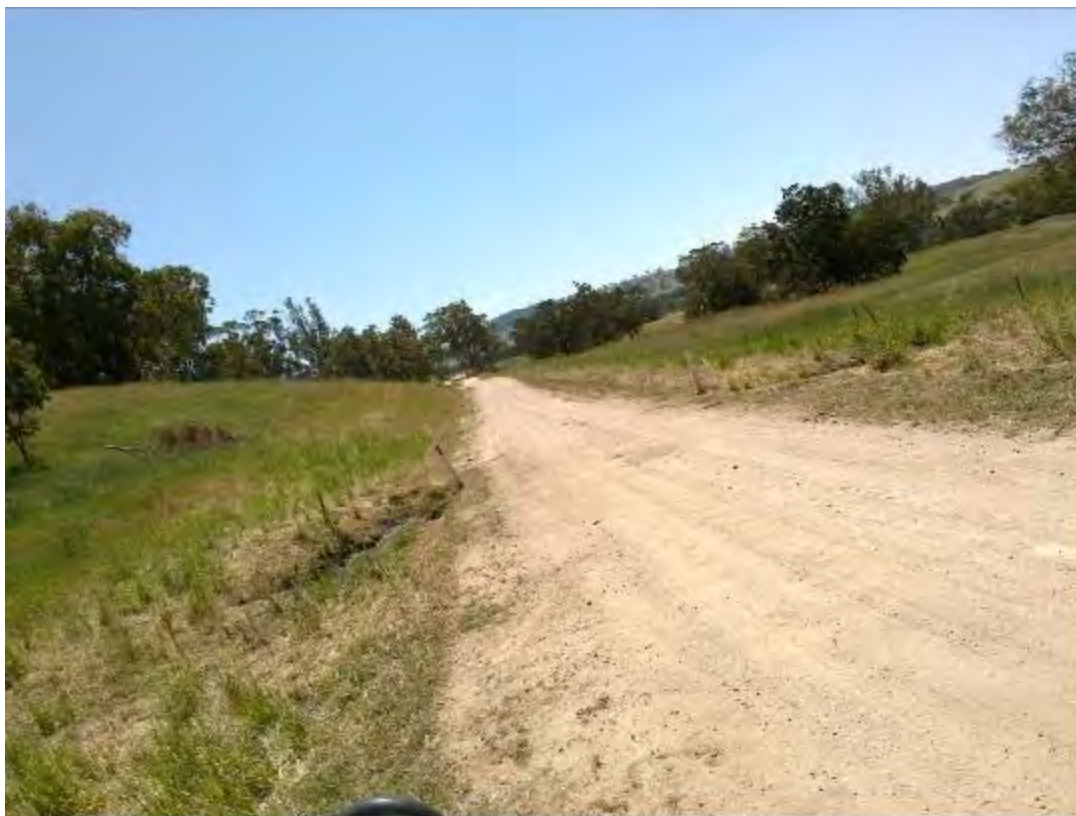
S150 – View to North

S150 – Turee Vale Rd - 7100m North from Vinegaroy Rd Intersection

Pipe Culvert

Damaged inlet and outlet

Moderate Condition and Serviceable

Upgrade likely to be required.

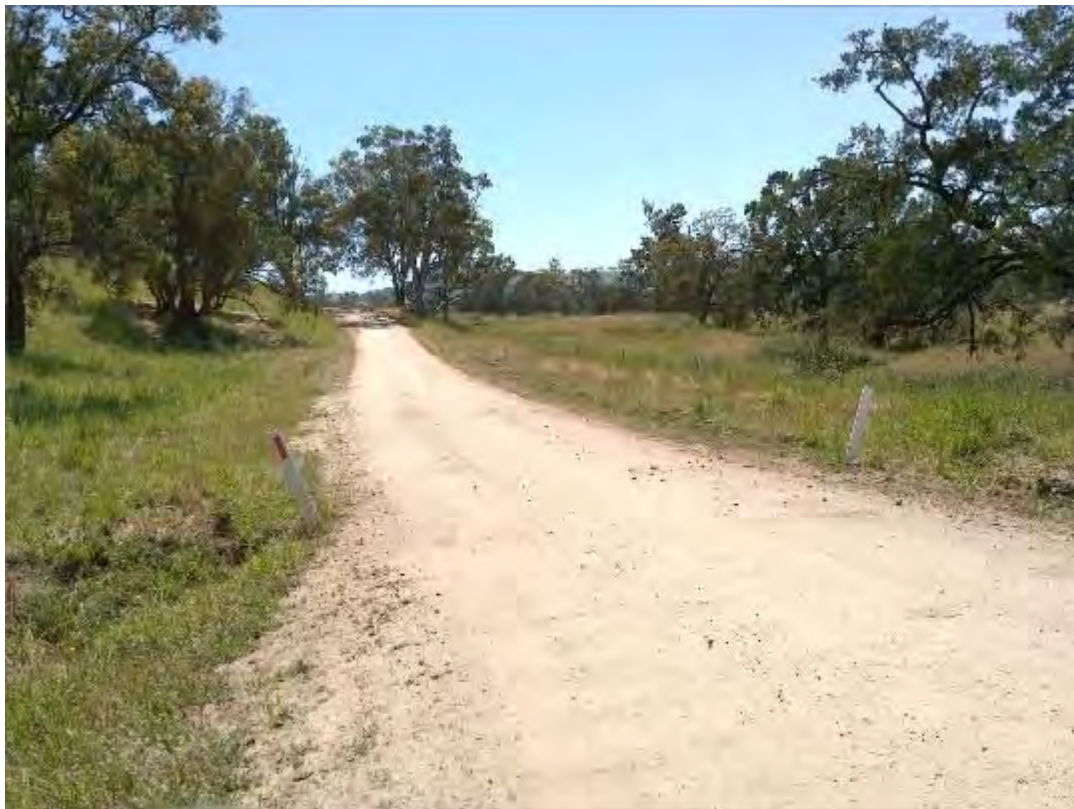
S151 – View to North

S151 – Turee Vale Rd - 7150m North from Vinegaroy Rd Intersection

Pipe Culvert

Blocked,

Will require Upgrade or maintenance

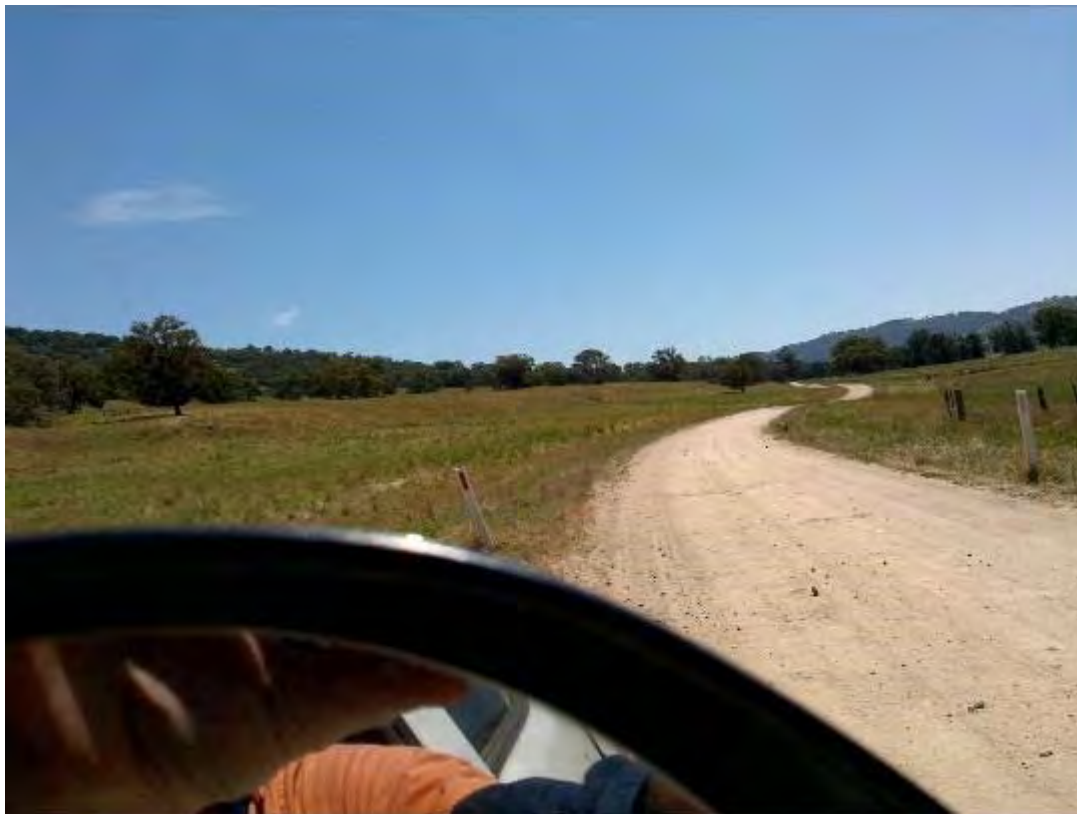
S152 - View to North

S152 – Turee Vale Rd - 7500m North from Vinegaroy Rd Intersection
525mm Pipe Culvert
Unknown Condition and Serviceable

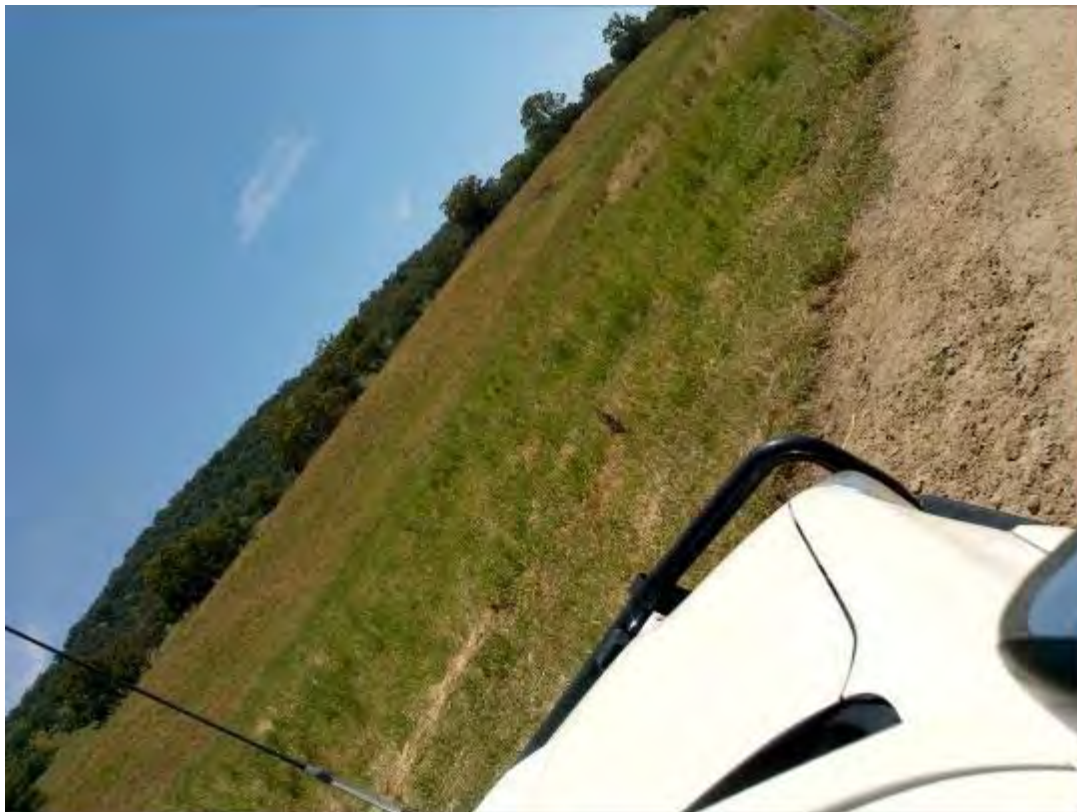
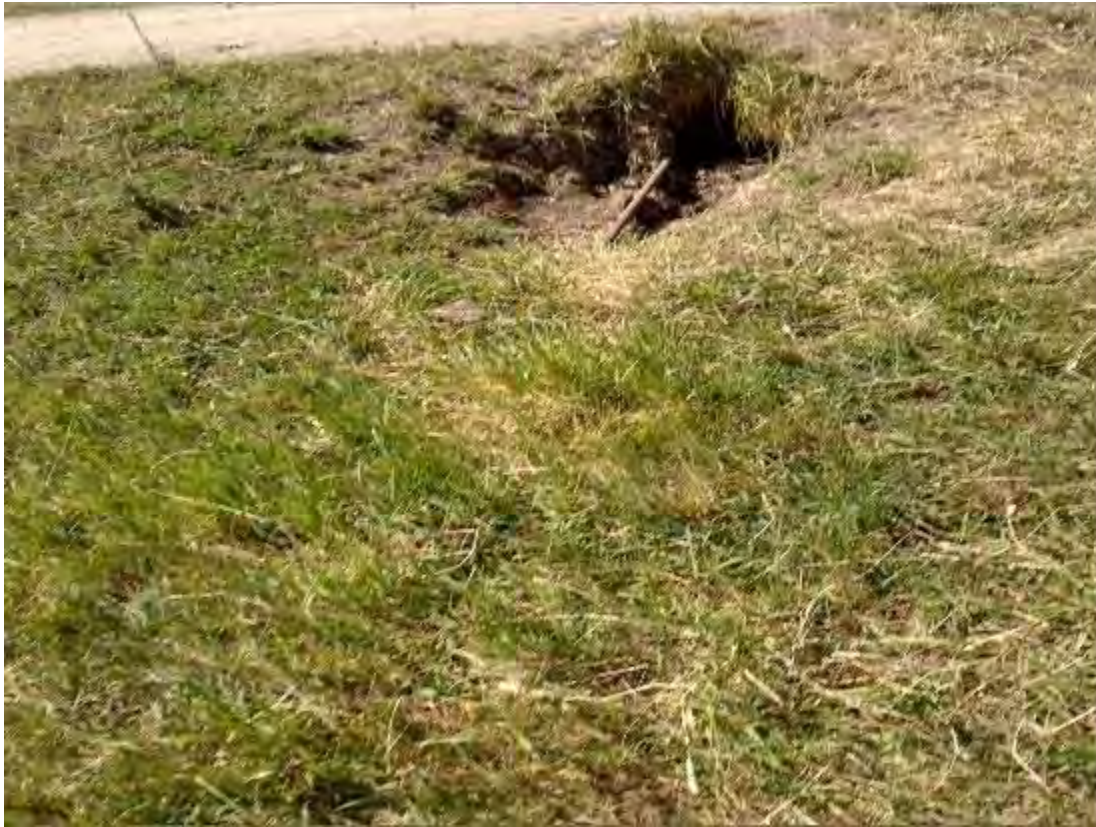
S153 – View to North

S153 – Turee Vale Rd - 7900m North from Vinegaroy Rd Intersection
Causeway, 600mm Pipe Culvert
Moderate Condition and Serviceable

S153 – 600mm Pipe Culvert

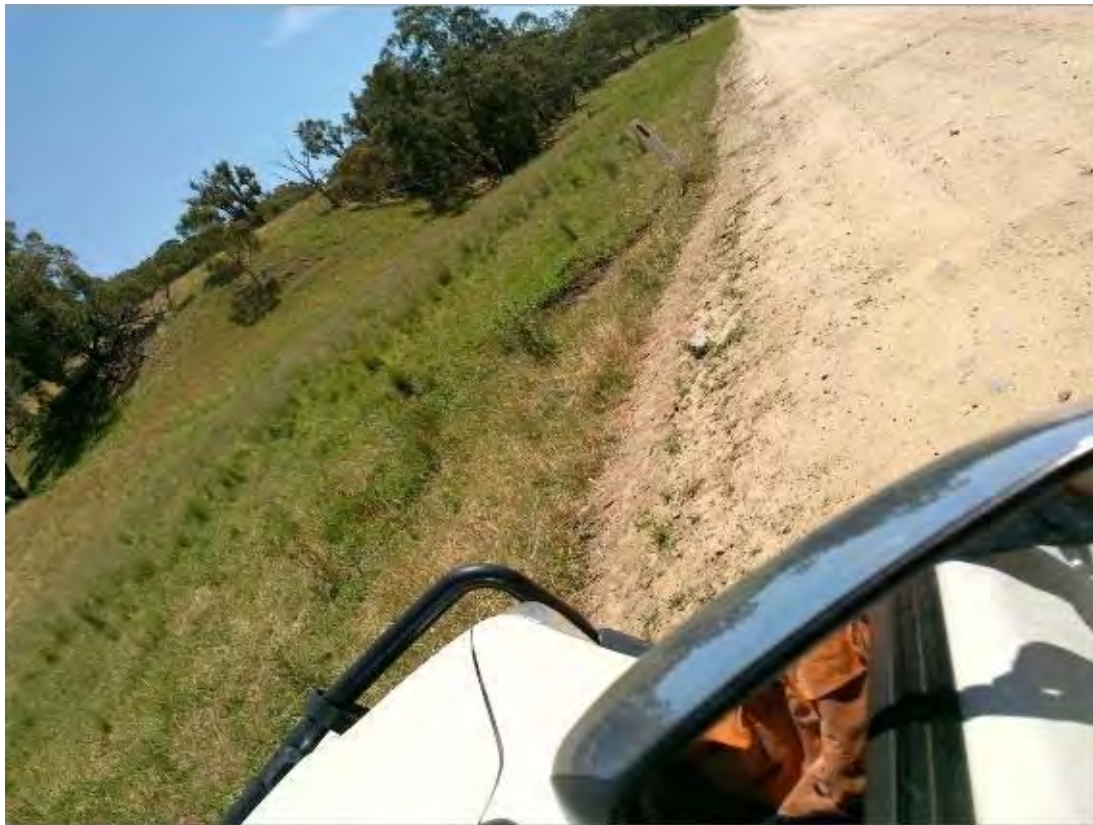
S155 – View to North

S155 – Turee Vale Rd - 8300m North from Vinegaroy Rd Intersection
450mm Pipe Culvert
Fair Condition and Serviceable

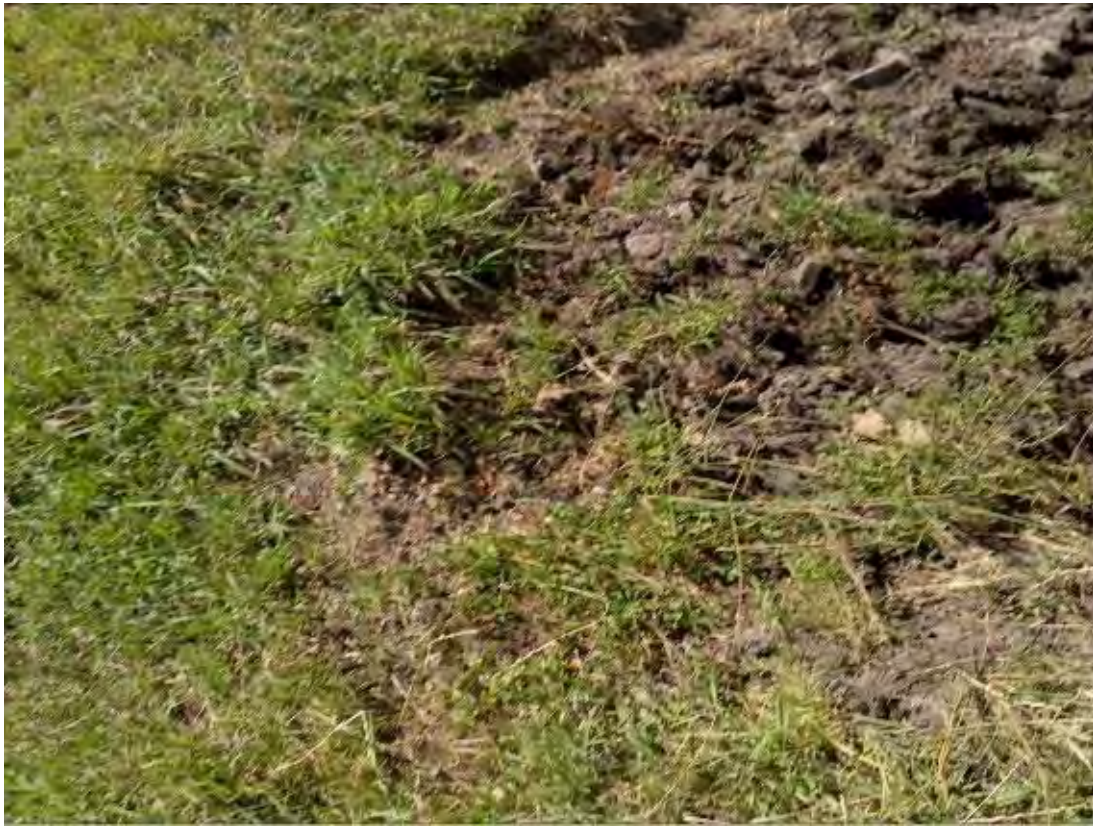
S155 – View over 450mm Pipe Culvert

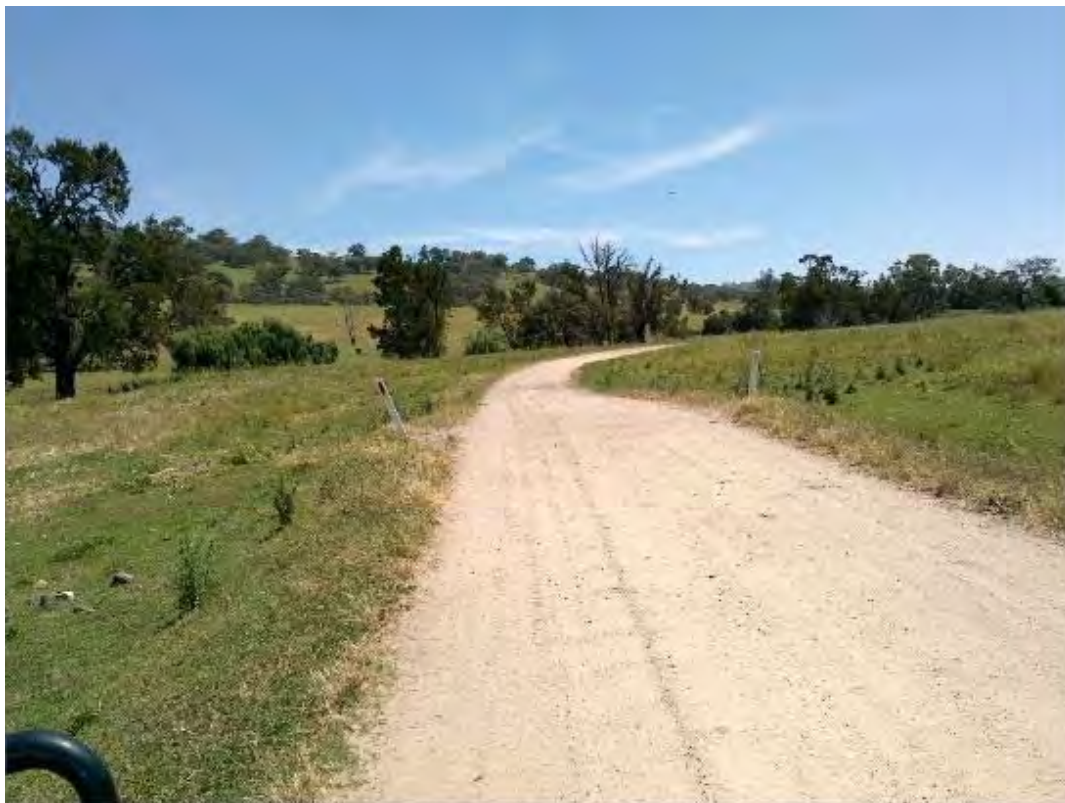
S156 - Turee Vale Rd - 9200m North from Vinegaray Rd Intersection
Causeway, 1500mm-600mm Reinforced Concrete Box Culvert
Good Condition and Serviceable

S156 – View to North

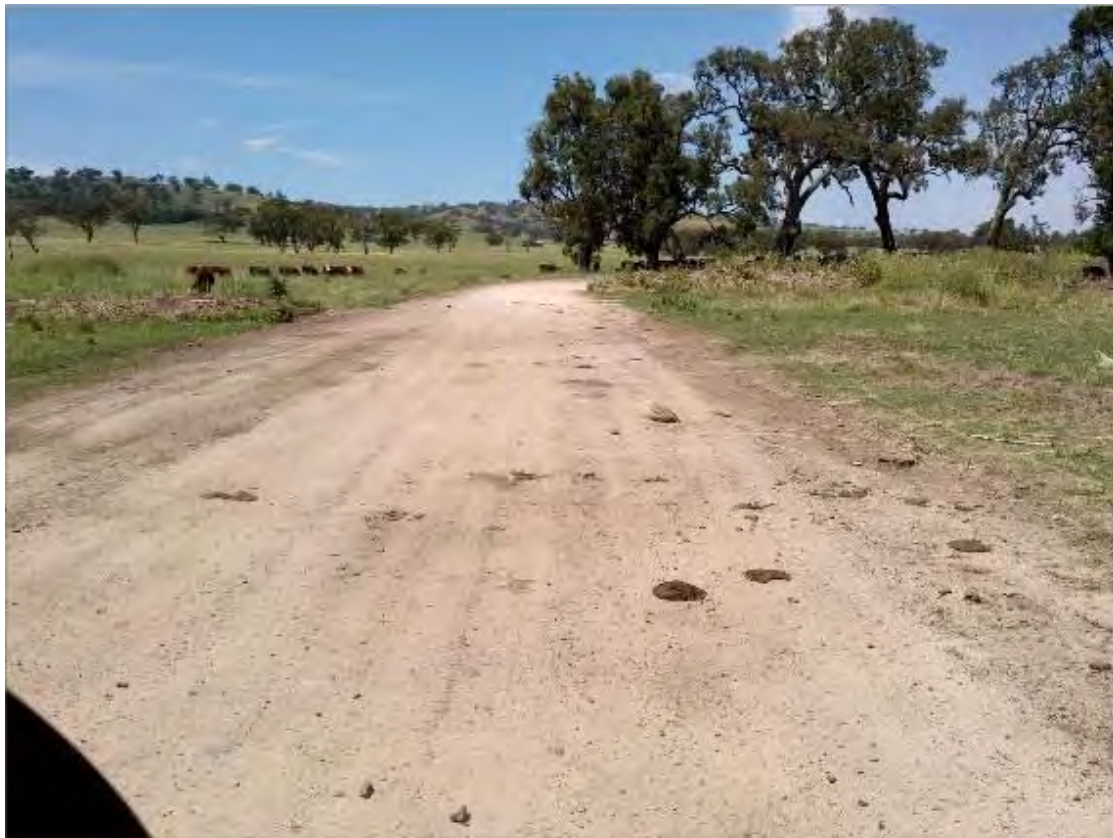
S157 – Turee Vale Rd - 9600m North from Vinegaroy Rd Intersection
Causeway, a culvert will be needed for this location
Poor Condition and Serviceable

S157 – View to South

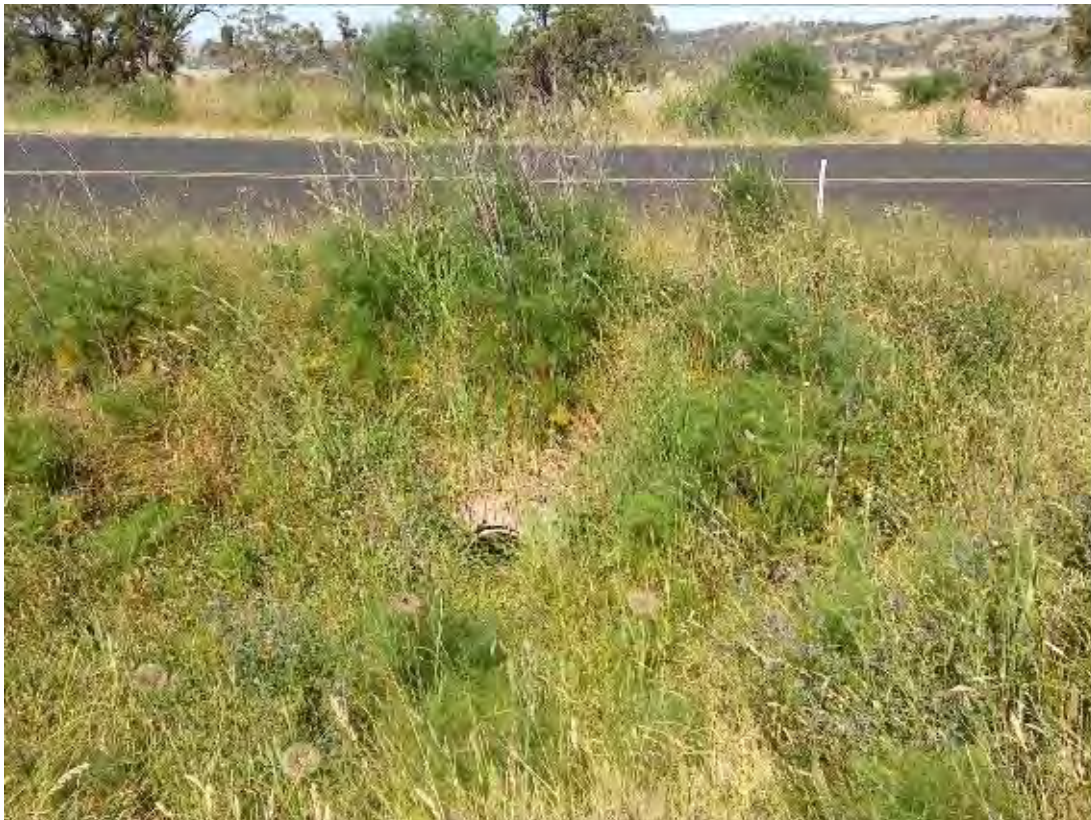
S160 – Vinegaroy Road - 400m South of Rotherwood Rd Intersection
450mm Pipe Culvert
Fair Condition and Serviceable, requires maintenance

S160 – 450mm Pipe Culvert
