S136 – Turee Vale Rd - 3200m North of Vinegaroy Intersection
450mm Pipe Culvert
Fair Condition and Serviceable

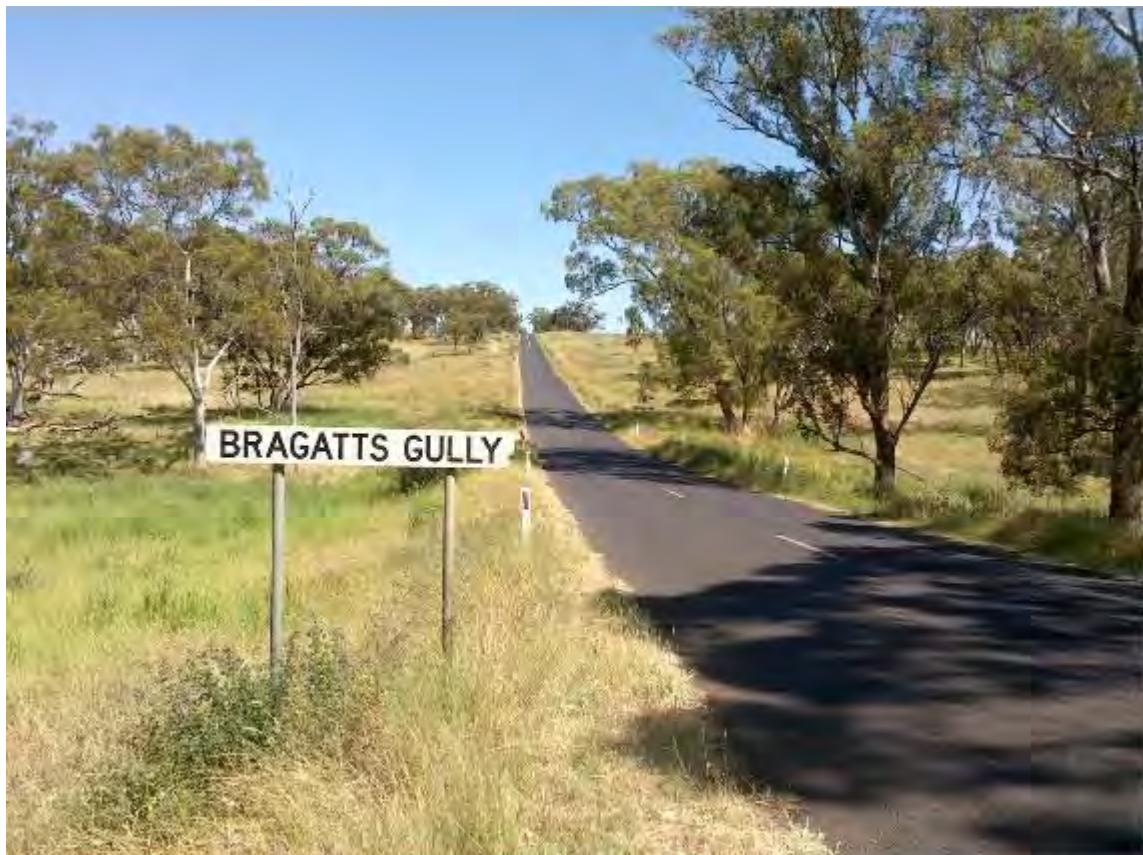
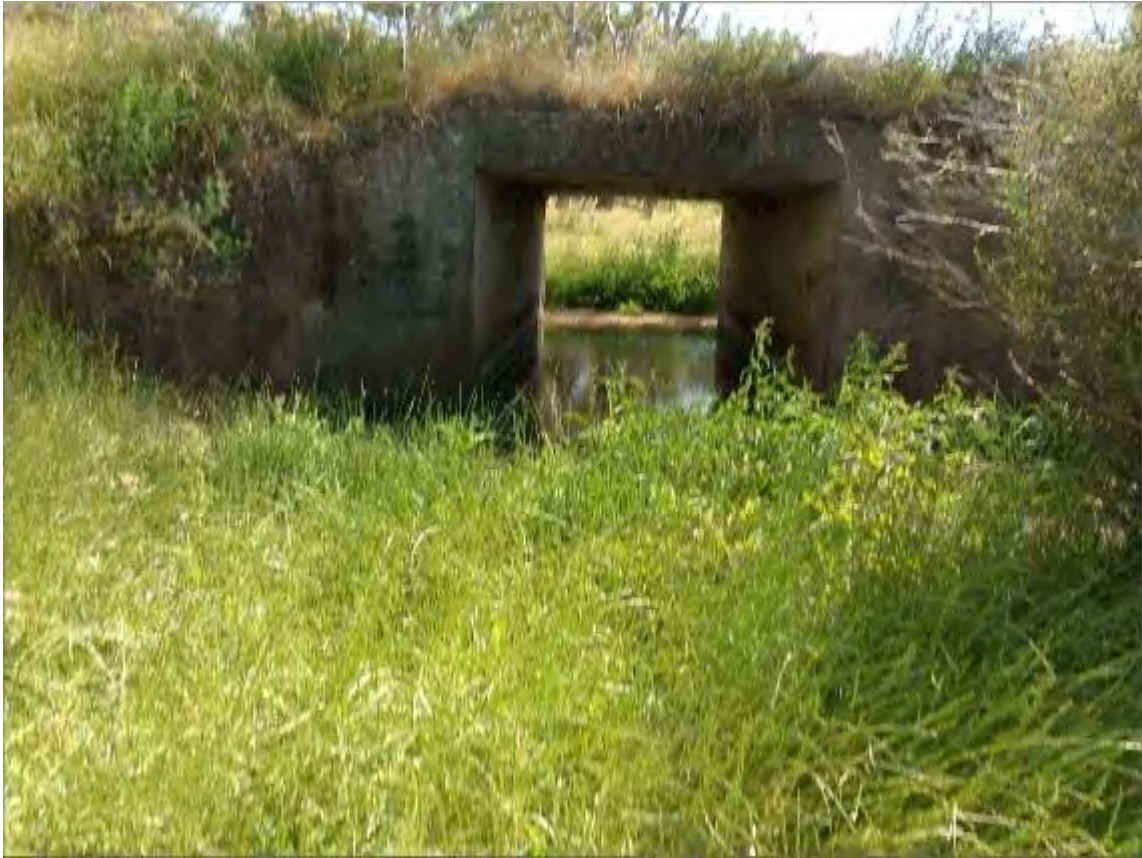
S161 – Vinegaroy Road - 1700m South of Rotherwood Rd Intersection

Concrete causeway with bitumen seal

Single Span 1500mm Square Reinforced Concrete Box Culvert

Good Condition and Serviceable

S161 - View to North

S161 - 1500mm Square Reinforced Concrete Box Culvert

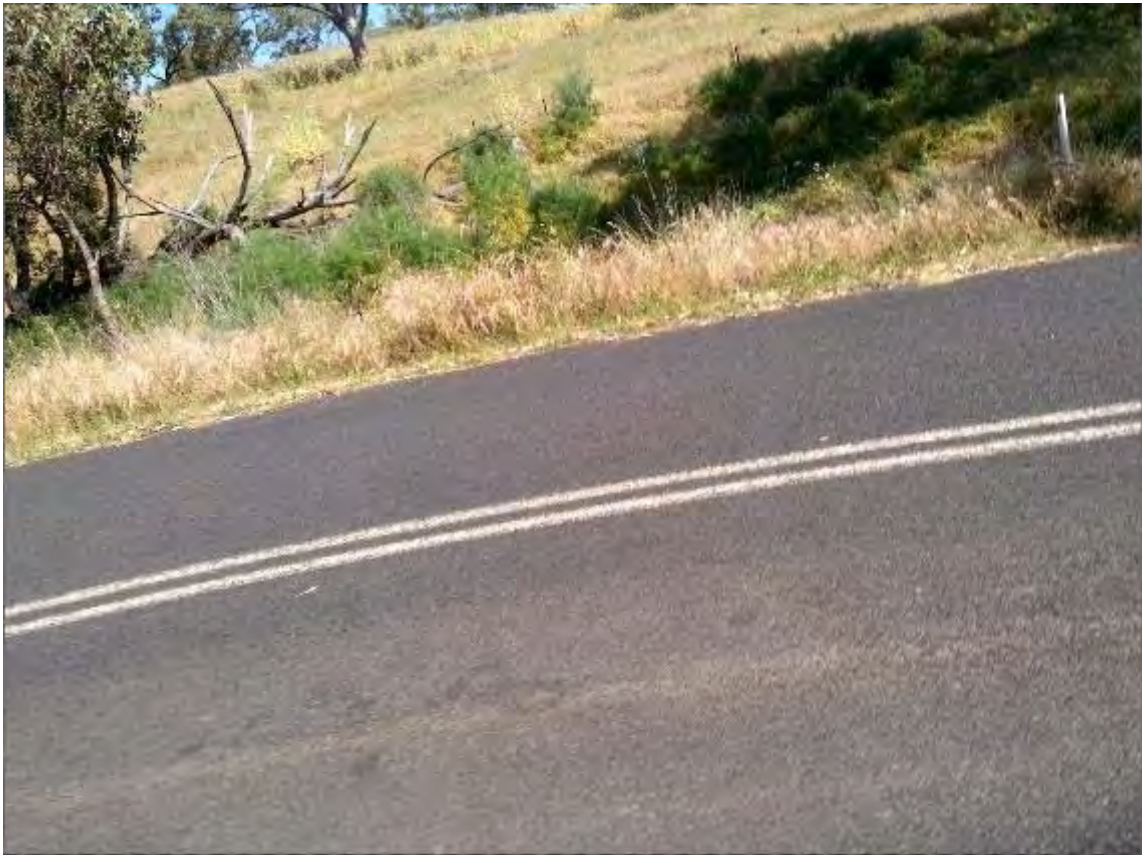
S162 – Vinegaroy Road - 1800m South of Rotherwood Rd Intersection

Concrete culvert

Culvert inaccessible at time of inspection,

Dimensions unknown

Condition unknown

S162- View to West

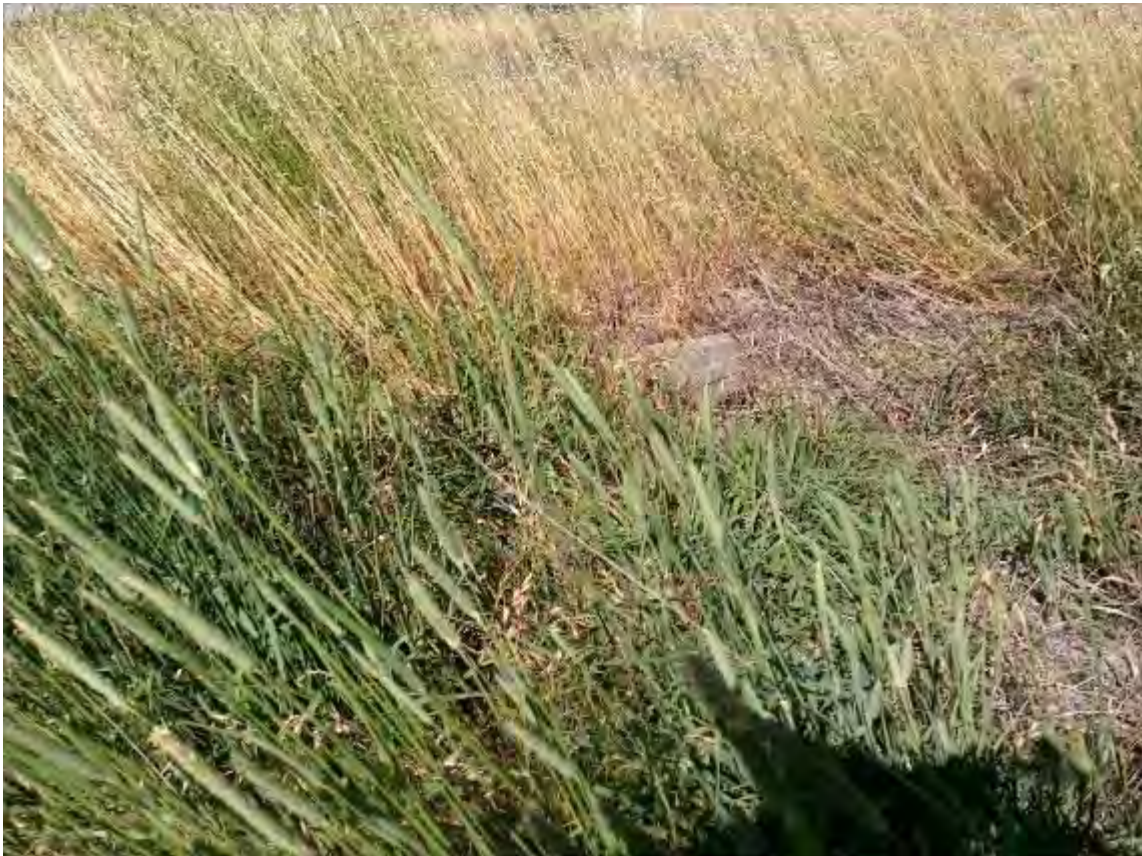
S163 – Vinegaroy Rd - 4350m North of Coolah Rd Intersection
600mm Pipe Culvert
Fair Condition and Serviceable

S163 – 600mm Pipe Culvert
Level 2, 39 Sherwood Road
Toowong QLD 4066

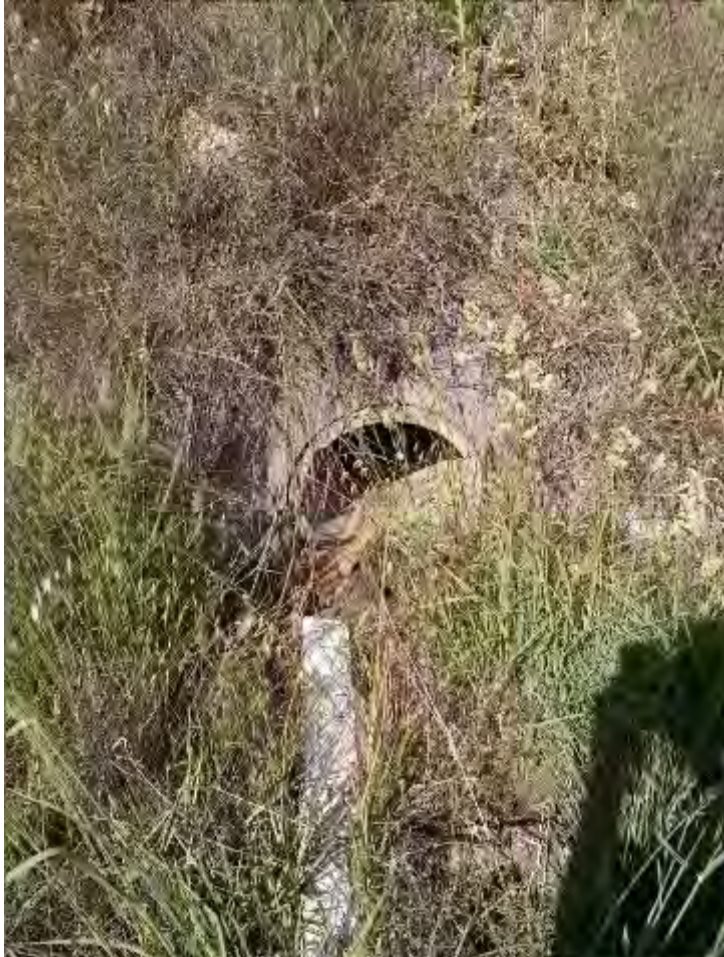
S168 – Vinegaroy Rd - 1350m North of Coolah Rd Intersection
450mm Pipe Culvert
Fair Condition and Serviceable

S168 - 450mm Pipe Culvert

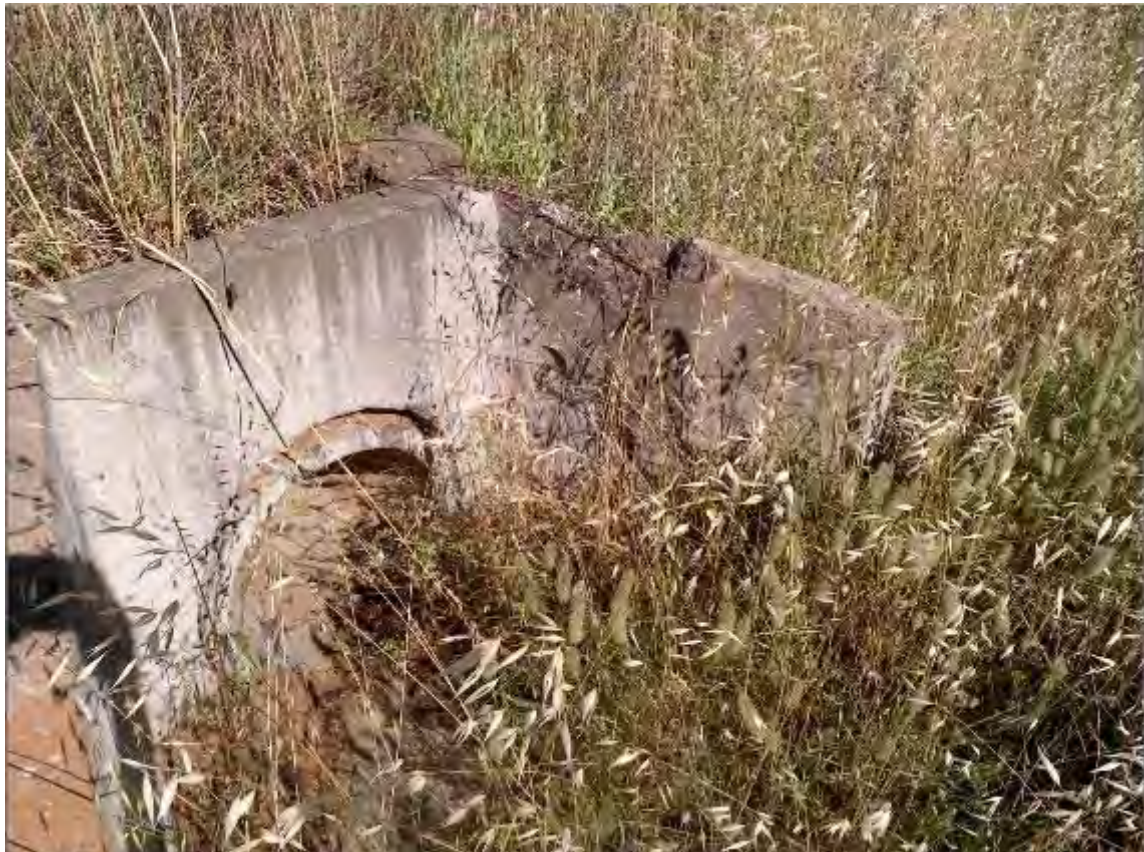
S169 – Vinegaroy Rd - 1200m North of Coolah Rd Intersection
450mm Pipe Culvert
Moderate Condition and Serviceable

S169 - 450mm Pipe Culvert
Level 2, 39 Sherwood Road
Toowong QLD 4066

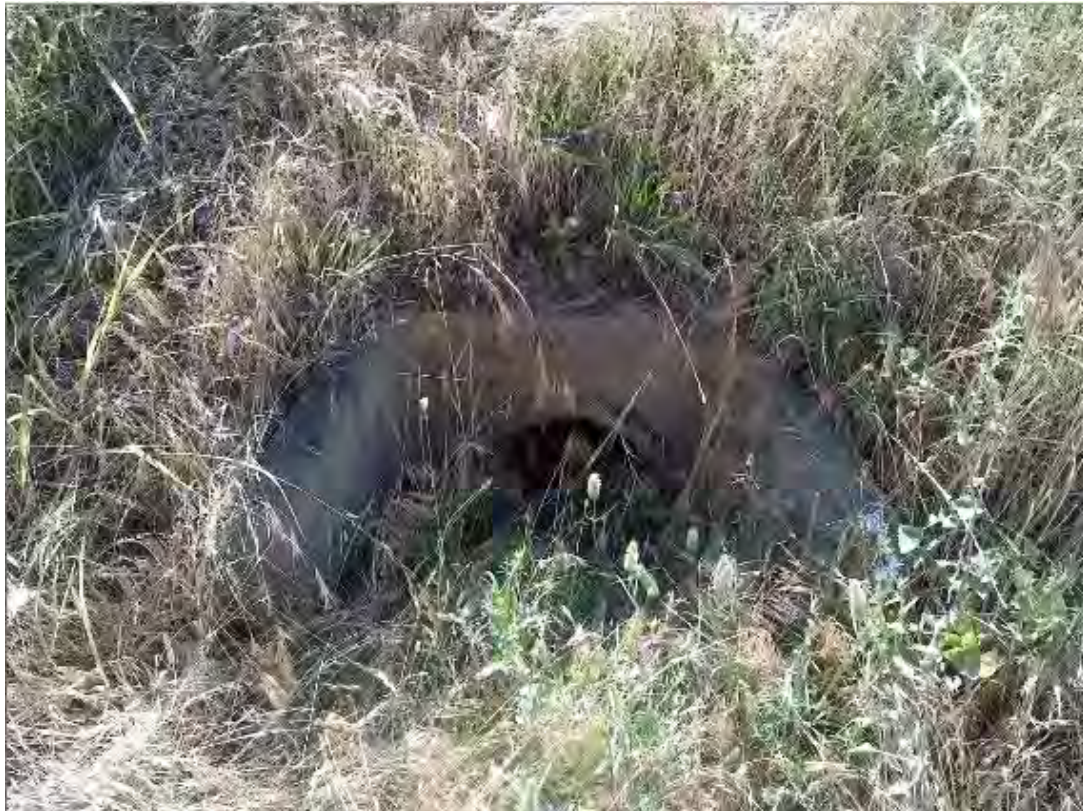
S173 – Vinegaroy Rd - 400m South of Coolah Rd Intersection
300mm Pipe Culvert
Fair Condition and Serviceable

S173 – 300mm Pipe Culvert

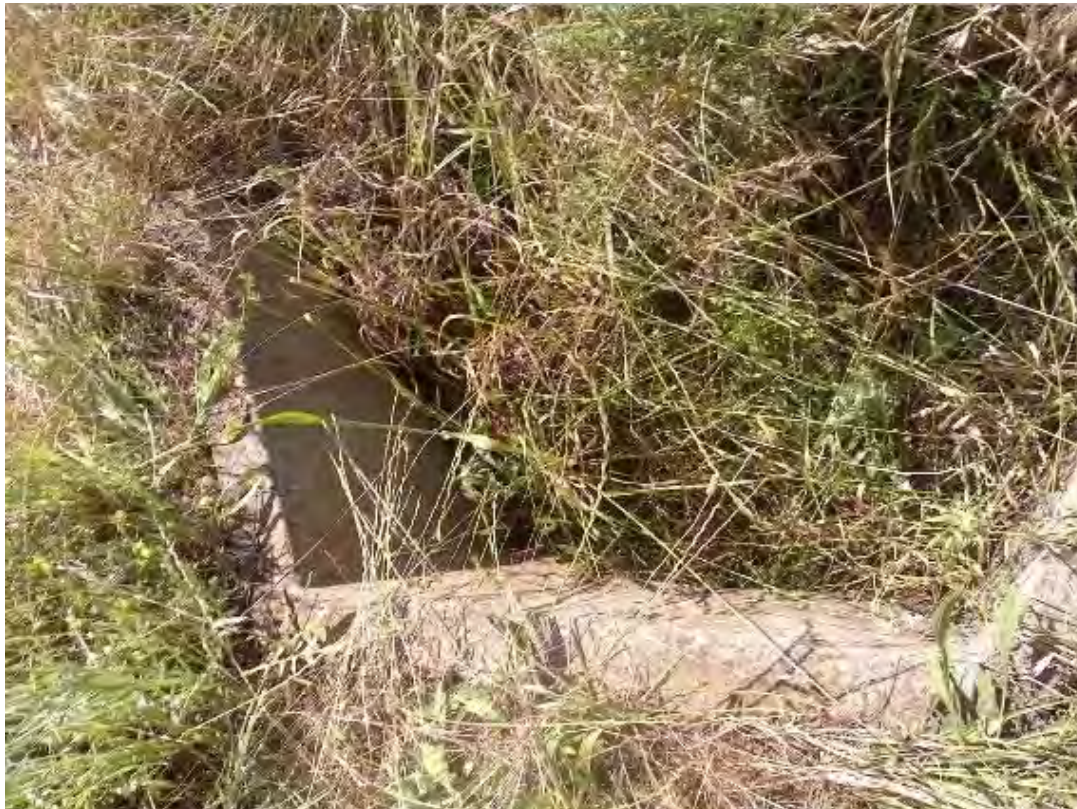
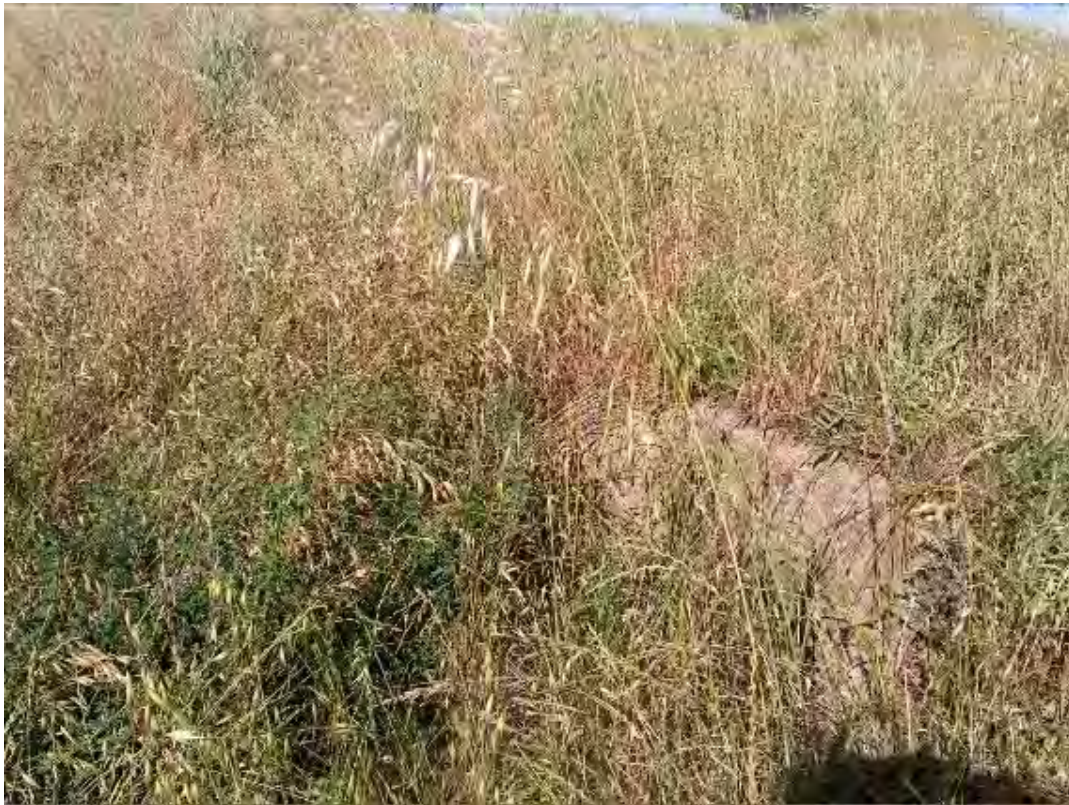
S174 – Vinegaroy Rd - 1300m South of Coolah Rd Intersection
450mm Pipe Culvert
Moderate Condition and Serviceable,
Inaccessible at time of inspection, requires maintenance

S174 – Top View of Culvert 450mm Pipe Culvert

S174 – 450mm Pipe Culvert

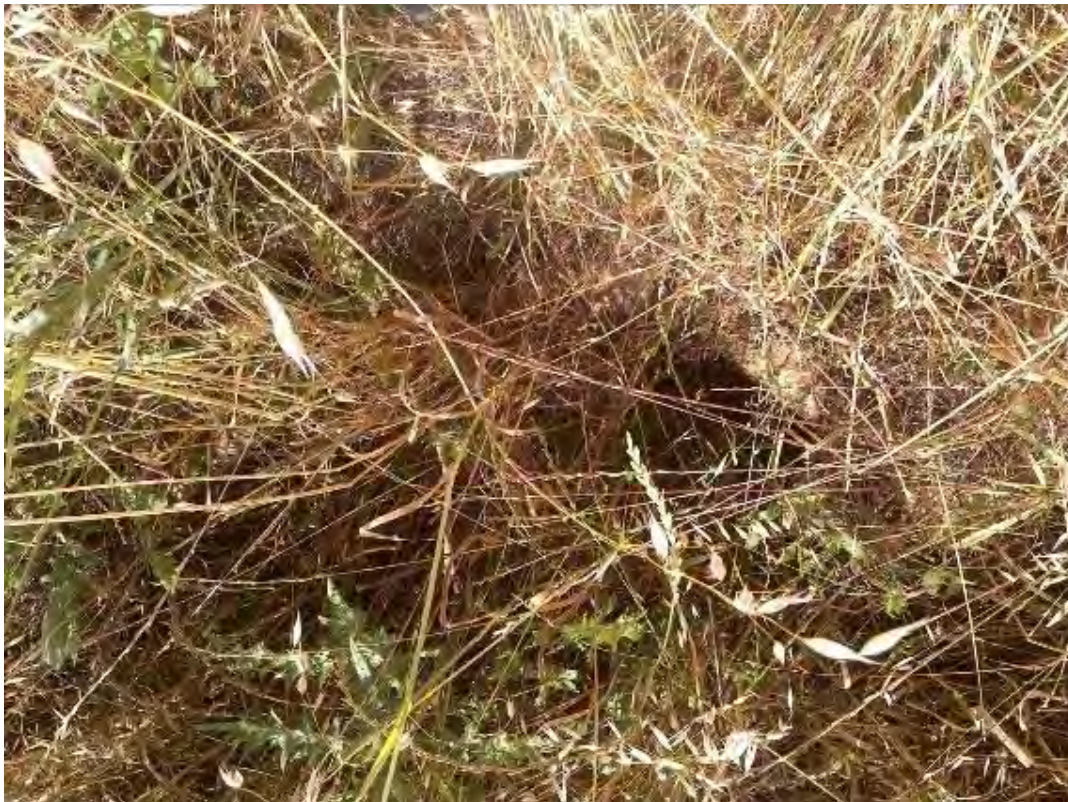
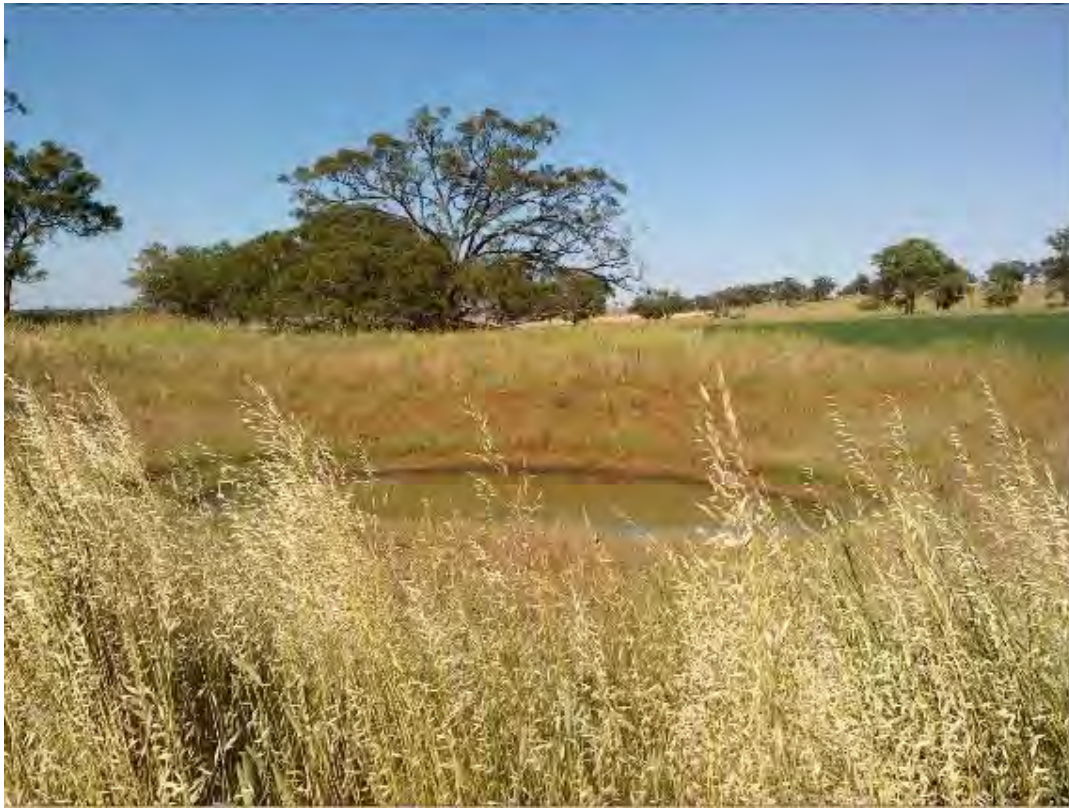
S175 – Vinegaroy Rd - 2200m North of Golden Highway Intersection

450mm Pipe Culvert

Moderate Condition and Serviceable,
Maintenance may be required

S175 – 450mm Pipe Culvert

S175 – Retention Pond

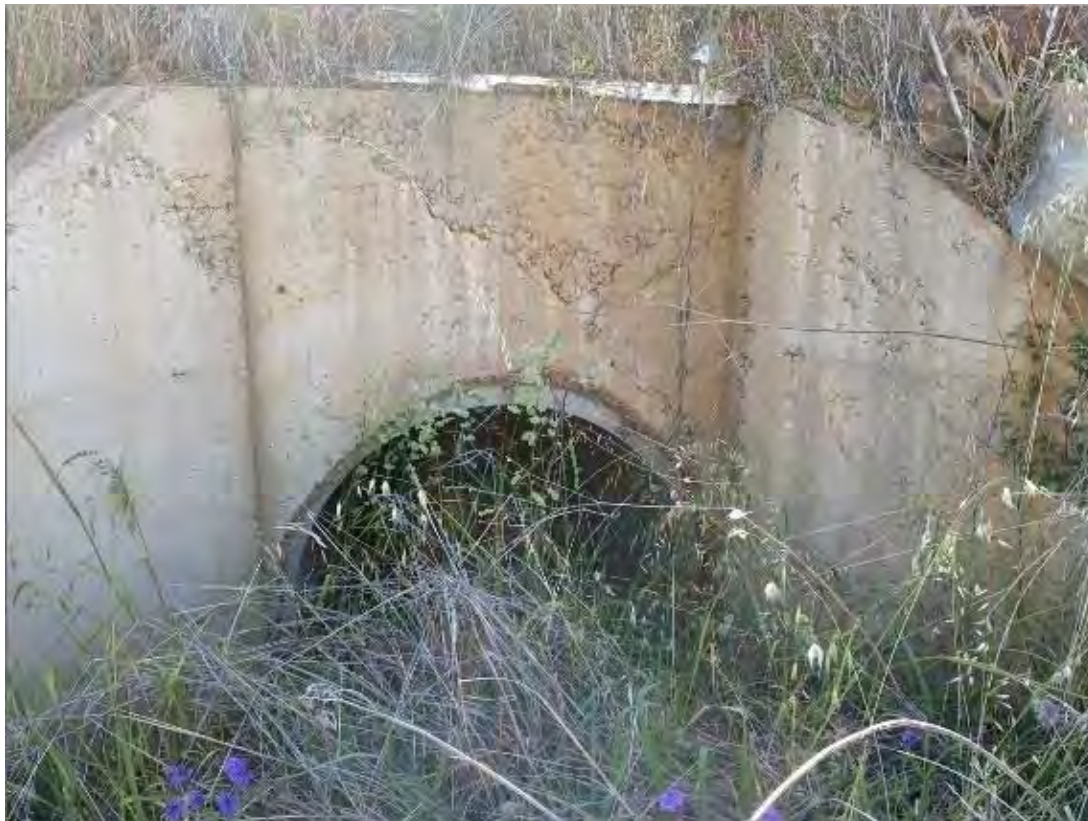
S176 – Vinegaroy Rd- 50m North of Golden Highway Intersection
1050mm Pipe Culvert
Good Condition and Serviceable

S176 - 1050mm Pipe Culvert

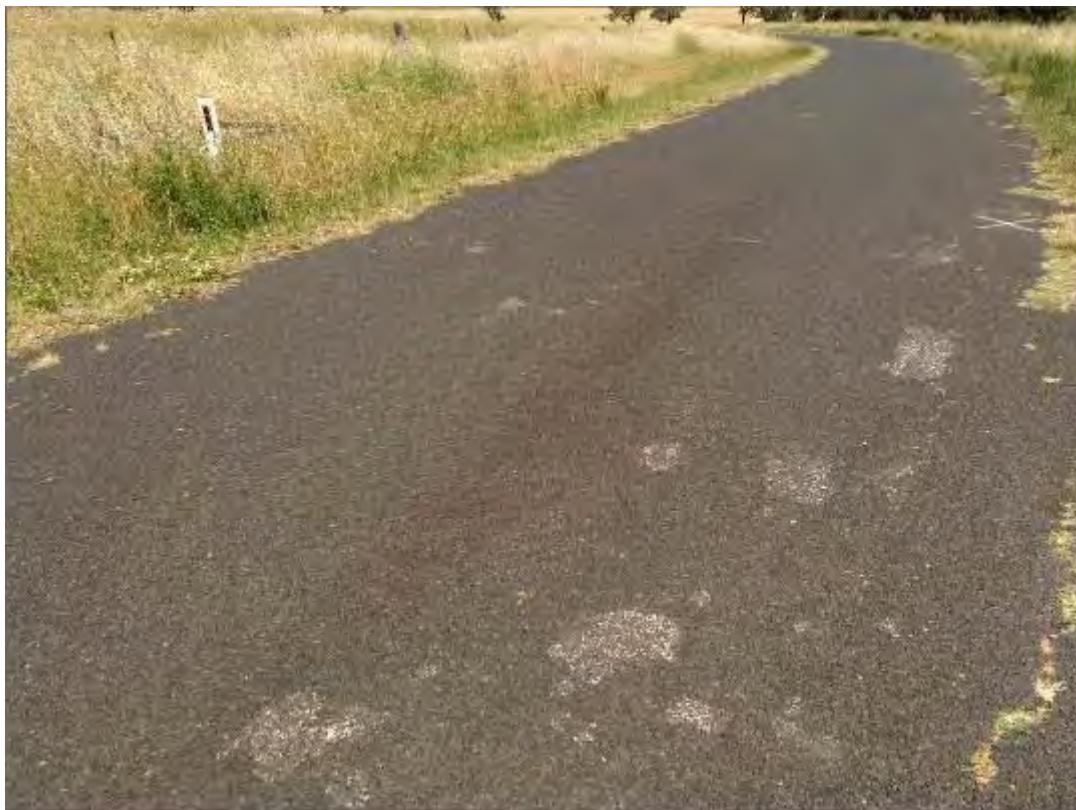
S177 – Rotherwood Rd - 300m East of Vinegaroy Rd Intersection

Pipe Culvert of Unknown Dimensions

Inaccessible at time of inspection

Condition Unknown

S177 – View to West

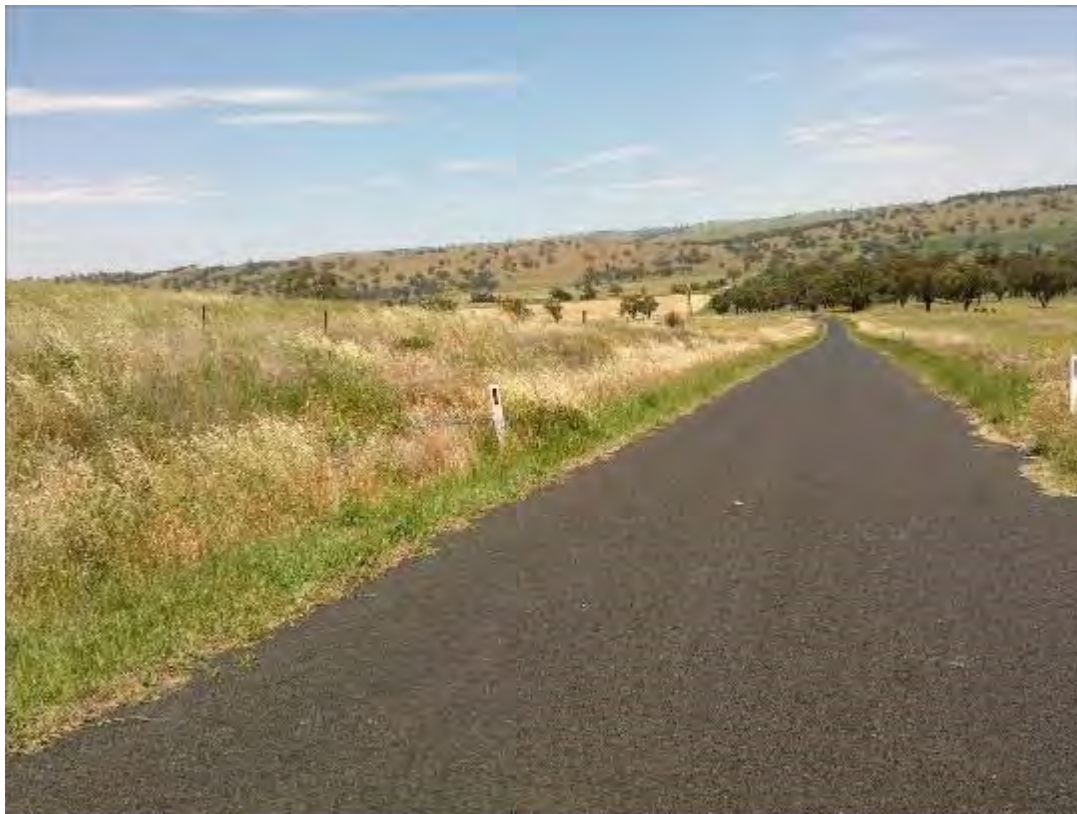
S179 – View to West

S179 – Rotherwood Rd - 500m East of Vinegaroy Rd Intersection
Pipe Culvert of unknown Dimensions
Condition Unknown

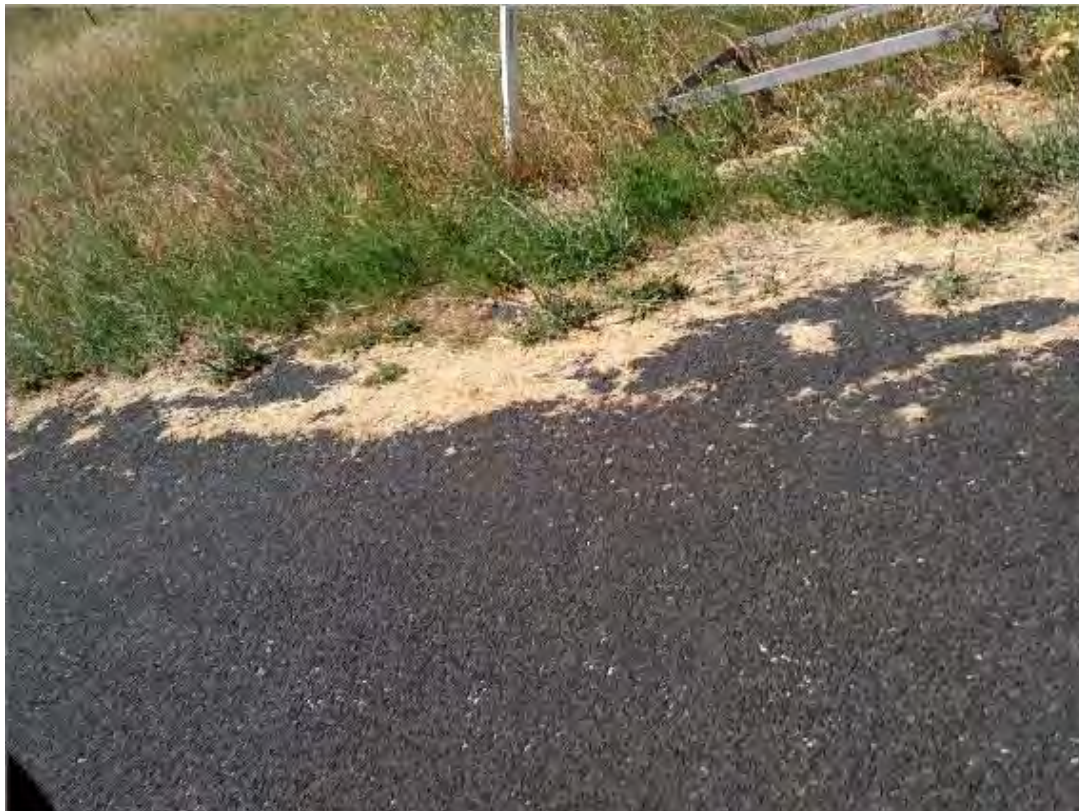
S180 – View of Culvert

S180 – Rotherwood Rd - 600m East of Vinegaroy Rd Intersection
Pipe Culvert of unknown Dimensions
Condition Unknown

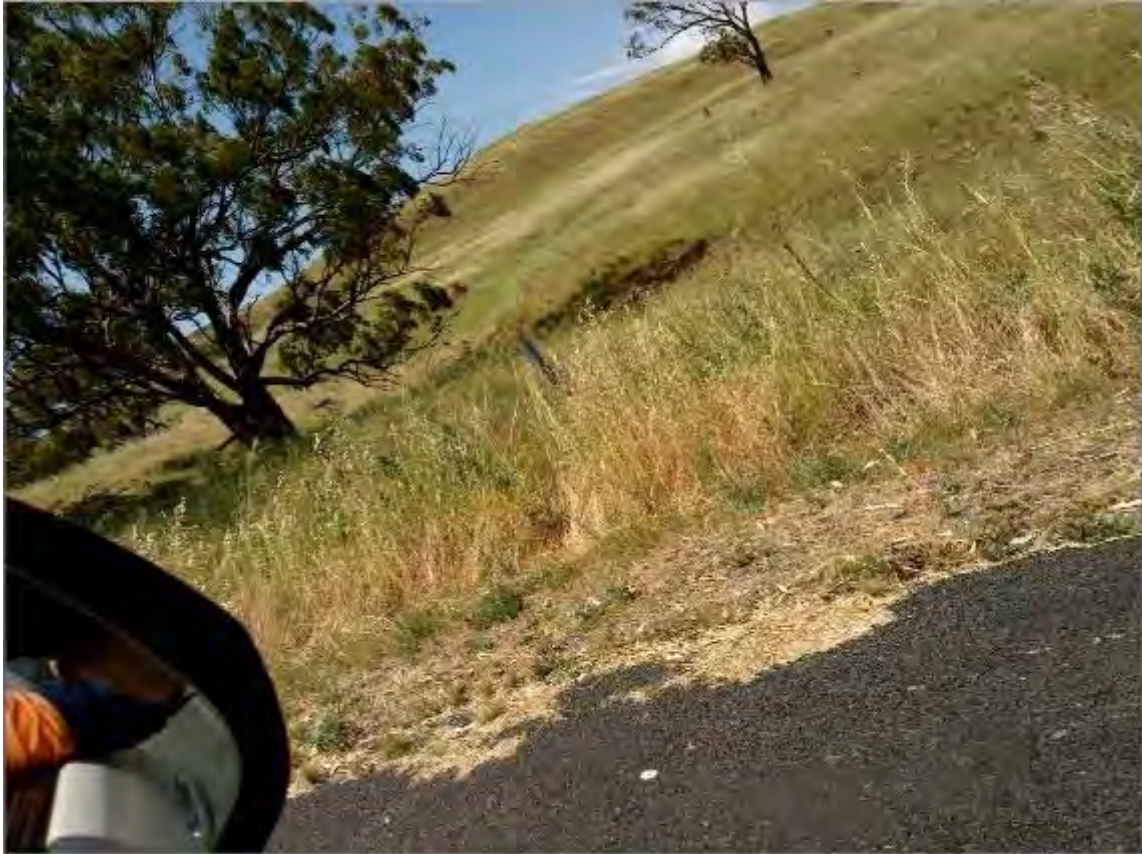
S181 – View towards Culvert

S181 – Rotherwood Rd - 700m East of Vinegaroy Rd Intersection
Pipe Culvert of Unknown Dimensions
Unknown Condition

S181 – Water damage on Road

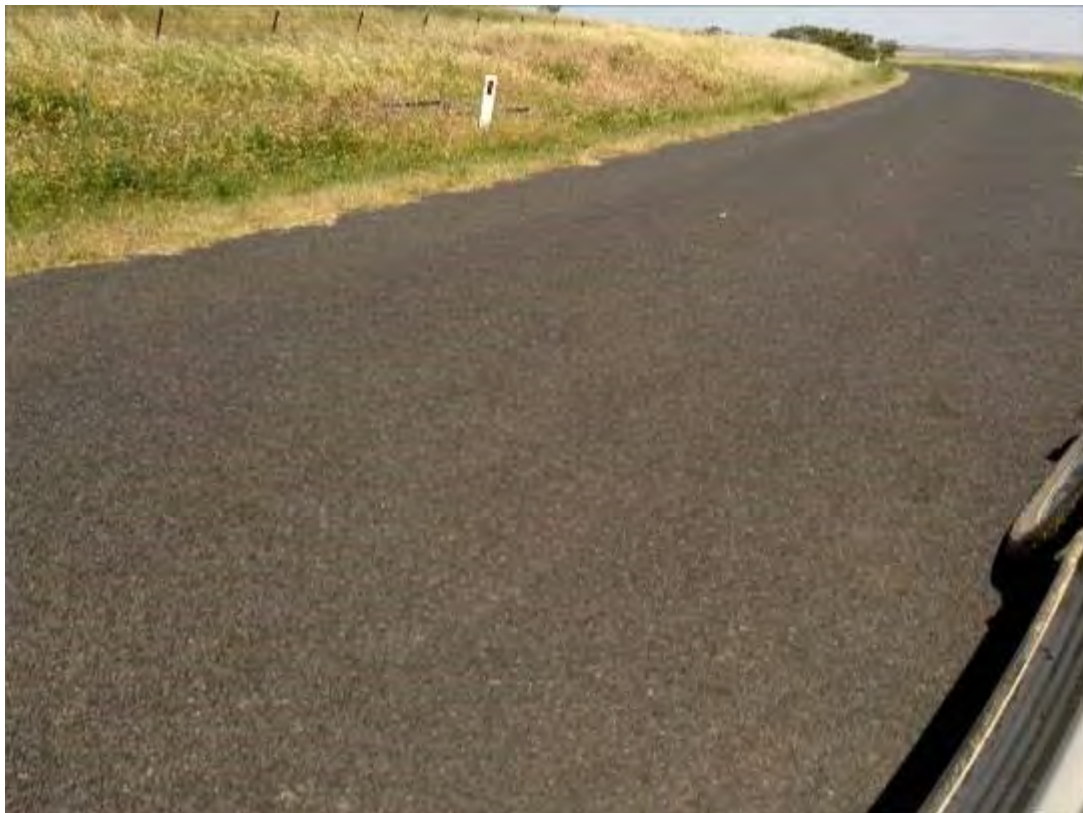
S182 – View to West

S182 – Rotherwood Rd - 700m East of Vinegaroy Rd Intersection
Pipe Culvert of Unknown Dimensions
Condition Unknown

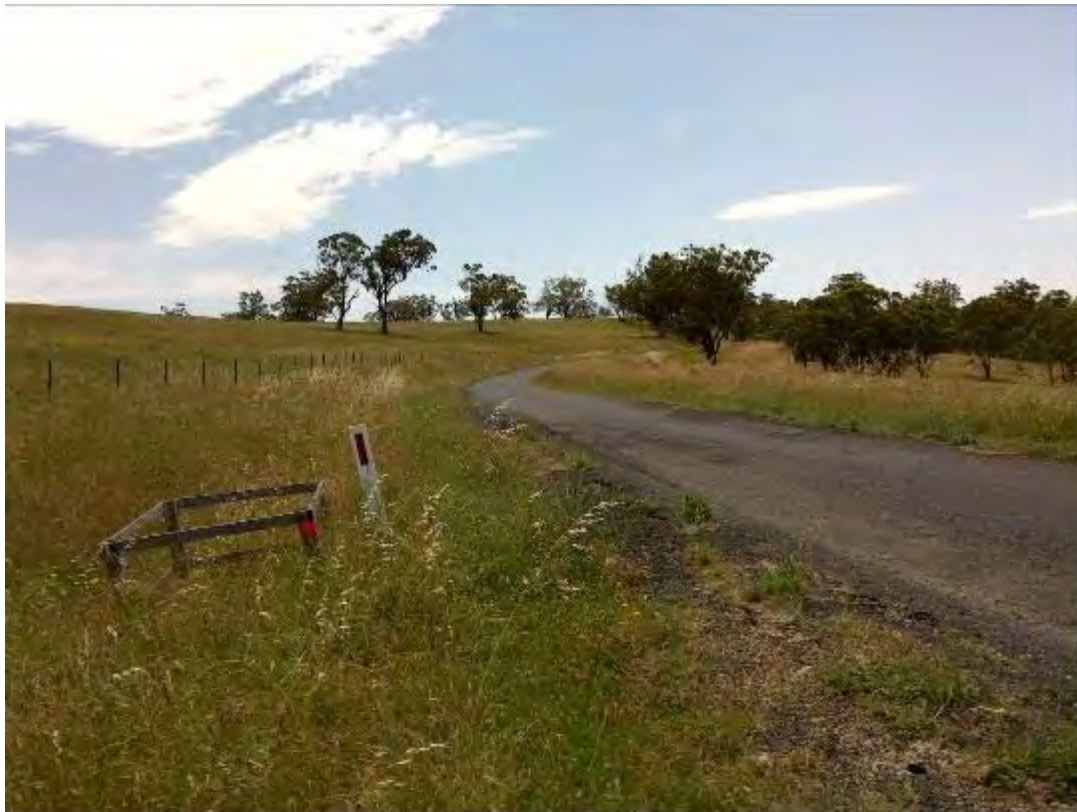
S184 – Rotherwood Rd - 2250m East of Vinegaroy Rd Intersection
750mm Pipe Culvert
Fair Condition and Serviceable

S184 - 750mm Pipe Culvert

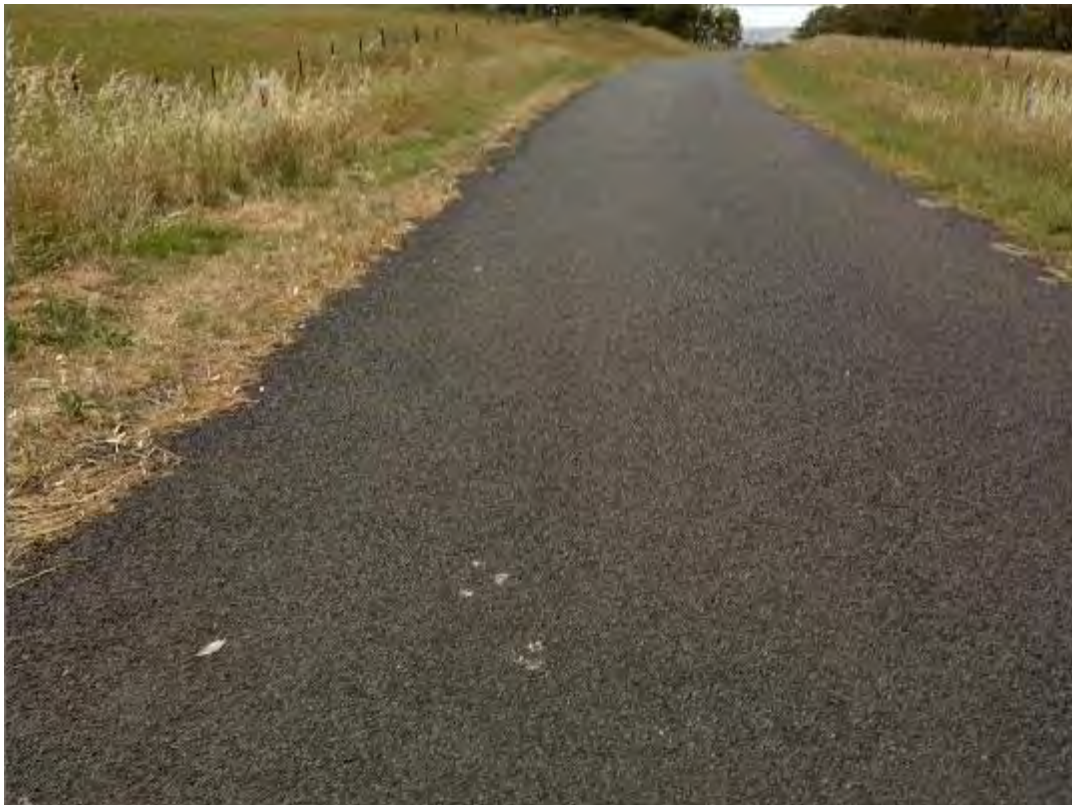
S185 – View to East

S185 – Rotherwood Rd - 2400m East of Vinegaroy Intersection
Pipe Culvert of Unknown Dimensions
Unknown Condition

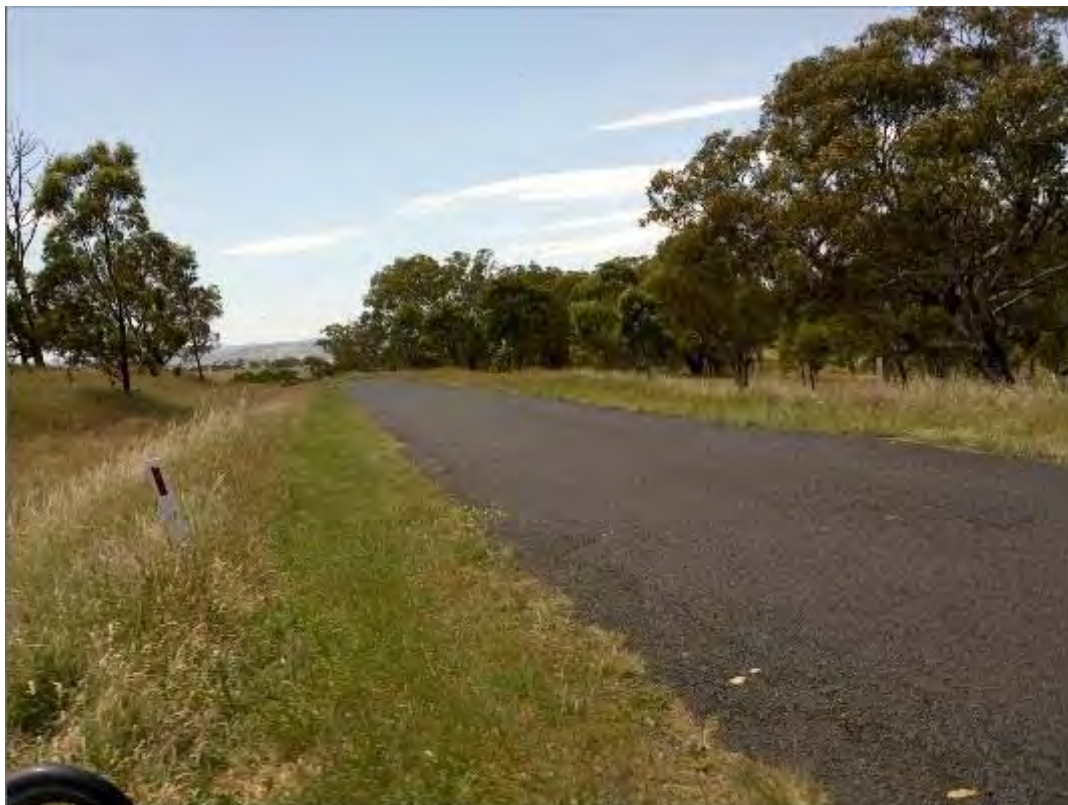
S186 – View to East

S186 – Rotherwood Rd - 2400m East of Vinegaroy Intersection
750mm Pipe Culvert with cracked headwall
Moderate Condition and Serviceable

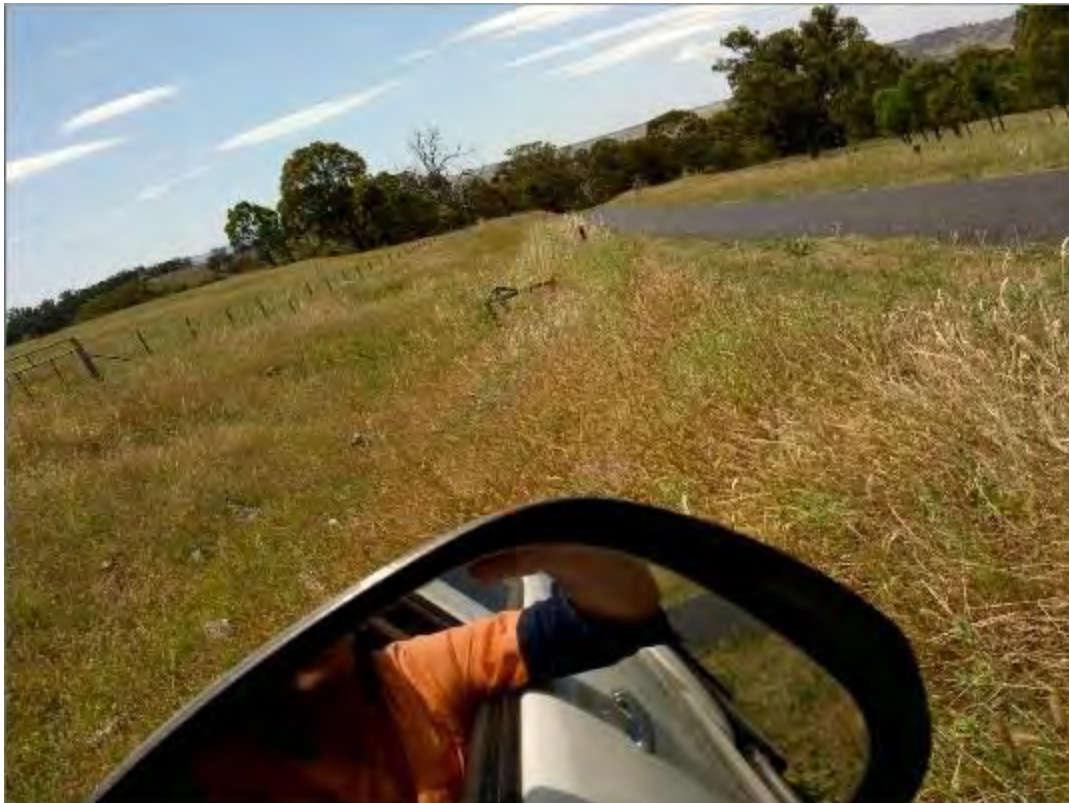
S188 – View to East

S188 – Rotherwood Rd - 3000m East of Vinegaroy Intersection
Pipe Culvert of Unknown Dimensions
Unknown Condition

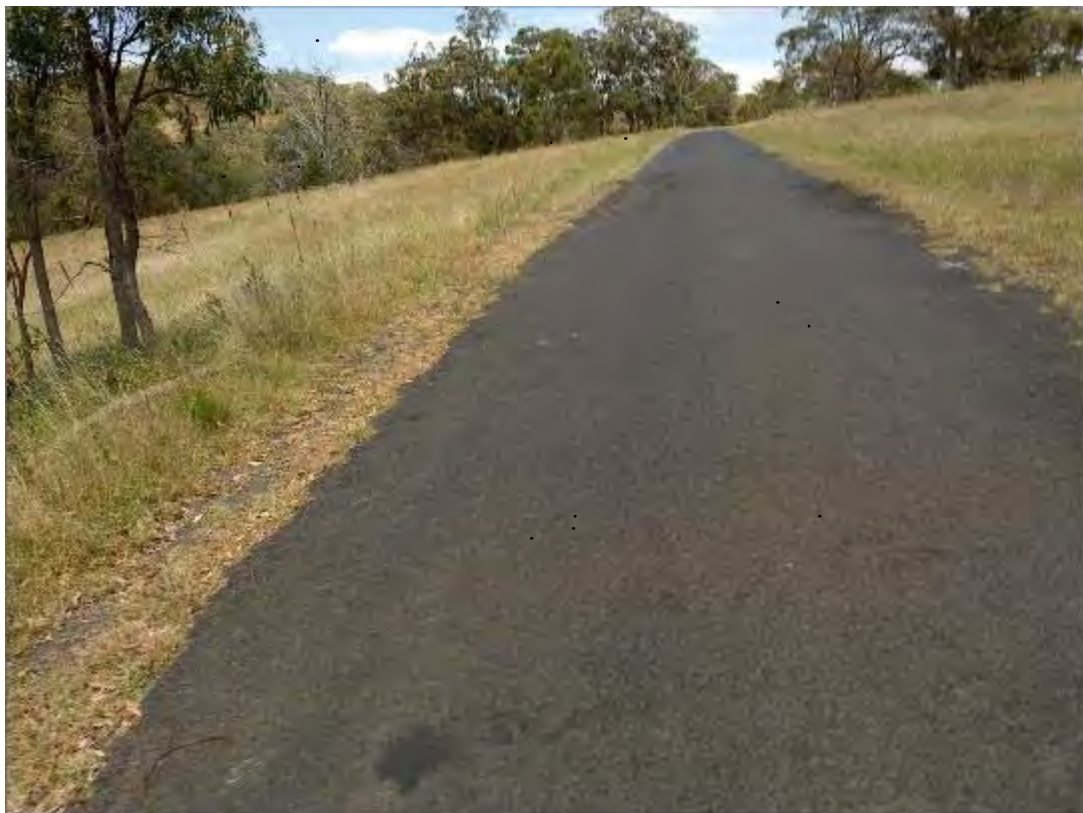
S189 – View to West

S189 – Rotherwood Rd - 3000m East of Vinegaroy Intersection
Dual 375mm Pipe Culvert
Fair Condition and Serviceable

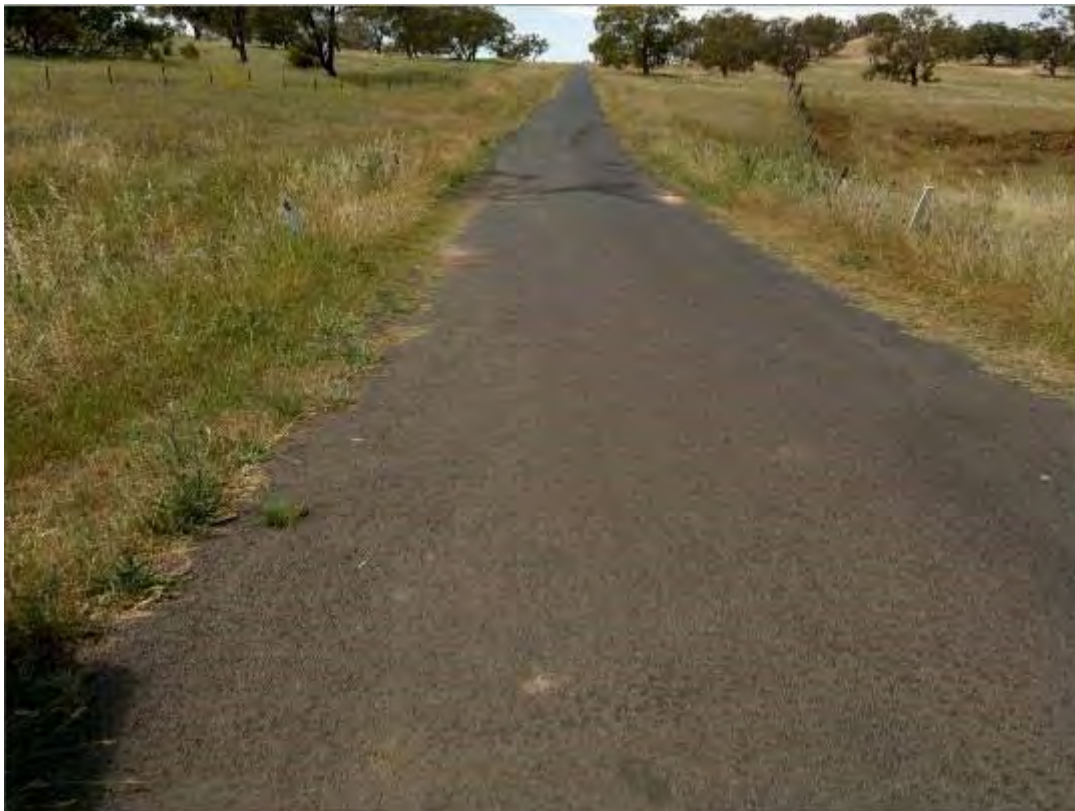
S190 – View to East

S190 – Rotherwood Rd - 3700m East of Vinegaroy Intersection
4-1200mm-900mm Reinforced Concrete Box Culvert

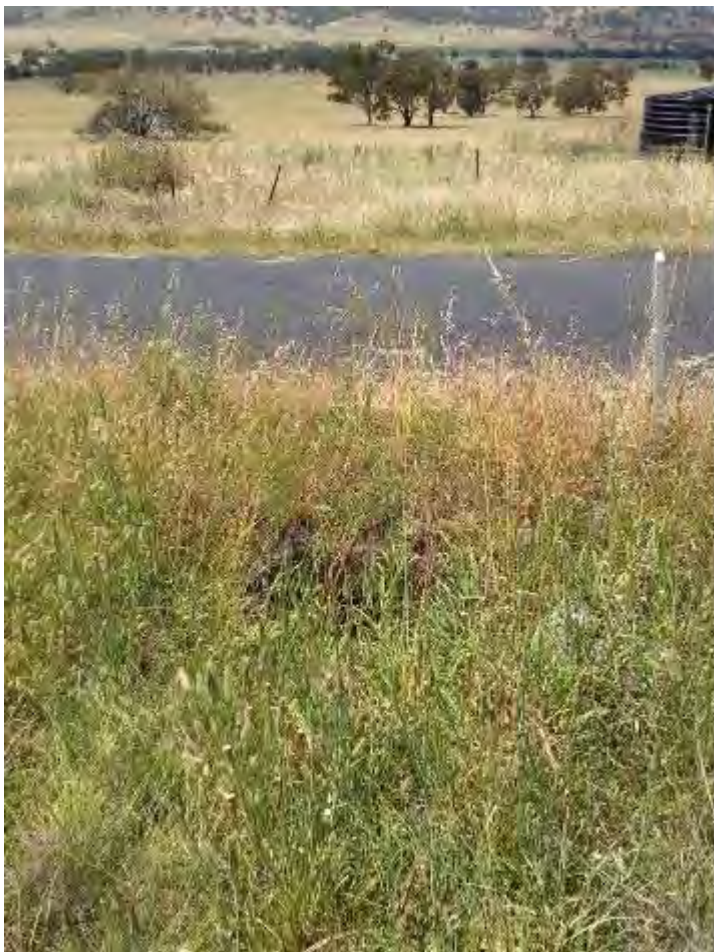
S193 – Rotherwood Rd - 4400m East of Vinegaroy Intersection
450mm Pipe Culvert
Fair Condition and Serviceable

S193 – 450mm pipe culvert

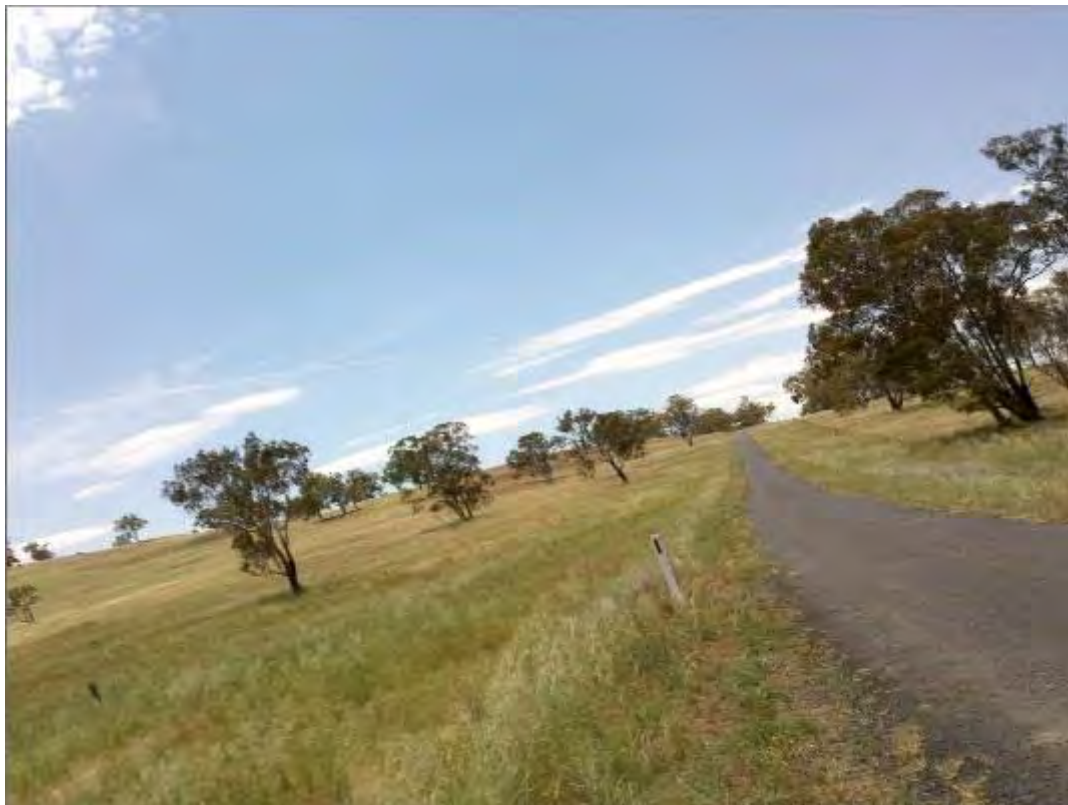
S193a – View to East

S193a – Rotherwood Rd - 3400m West of Yarrowonga Rd
675mm Pipe Culvert
Good Condition and Serviceable
