S136 – Turee Vale Rd - 3200m North of Vinegaroy Intersection
450mm Pipe Culvert
Fair Condition and Serviceable

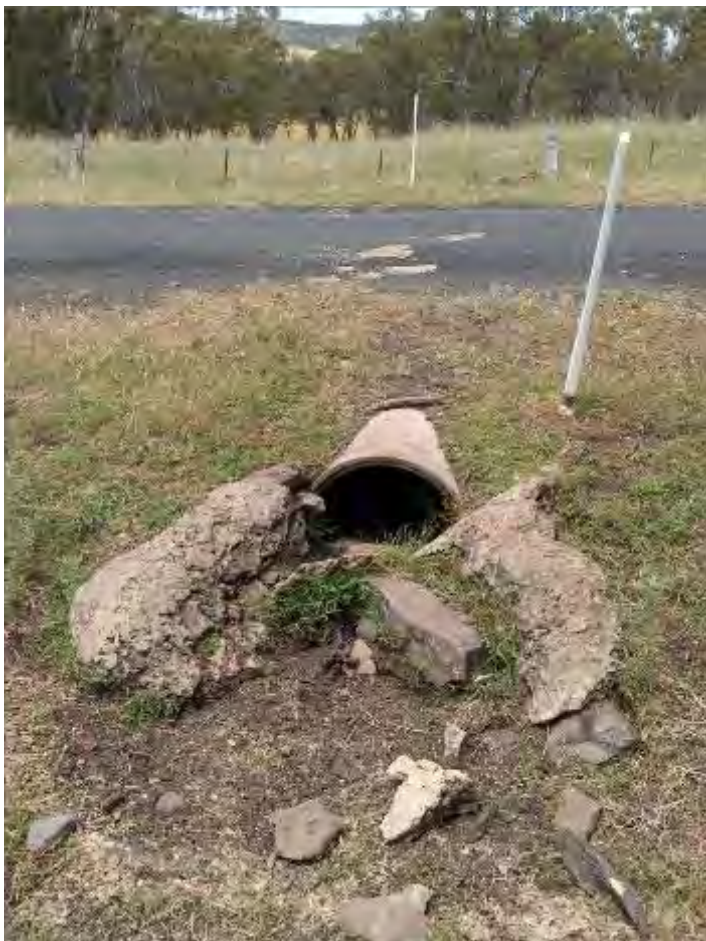
S194 – Rotherwood Rd - 3100m West of Yarrawonga Rd
600mm Pipe Culvert
Moderate Condition and Serviceable

S194 – 600mm Pipe Culvert

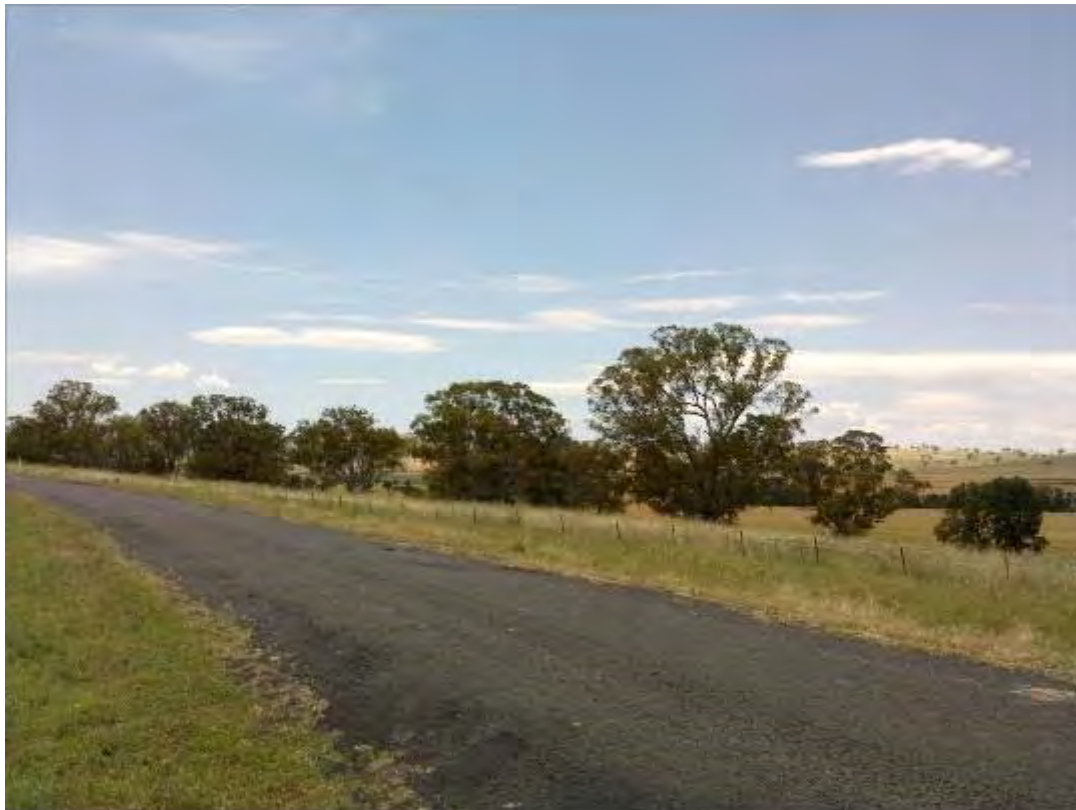
S195 – View to East

S195 – Rotherwood Rd - 2200m West of Yarrawonga Rd
600mm Pipe Culvert
Fair Condition and Serviceable

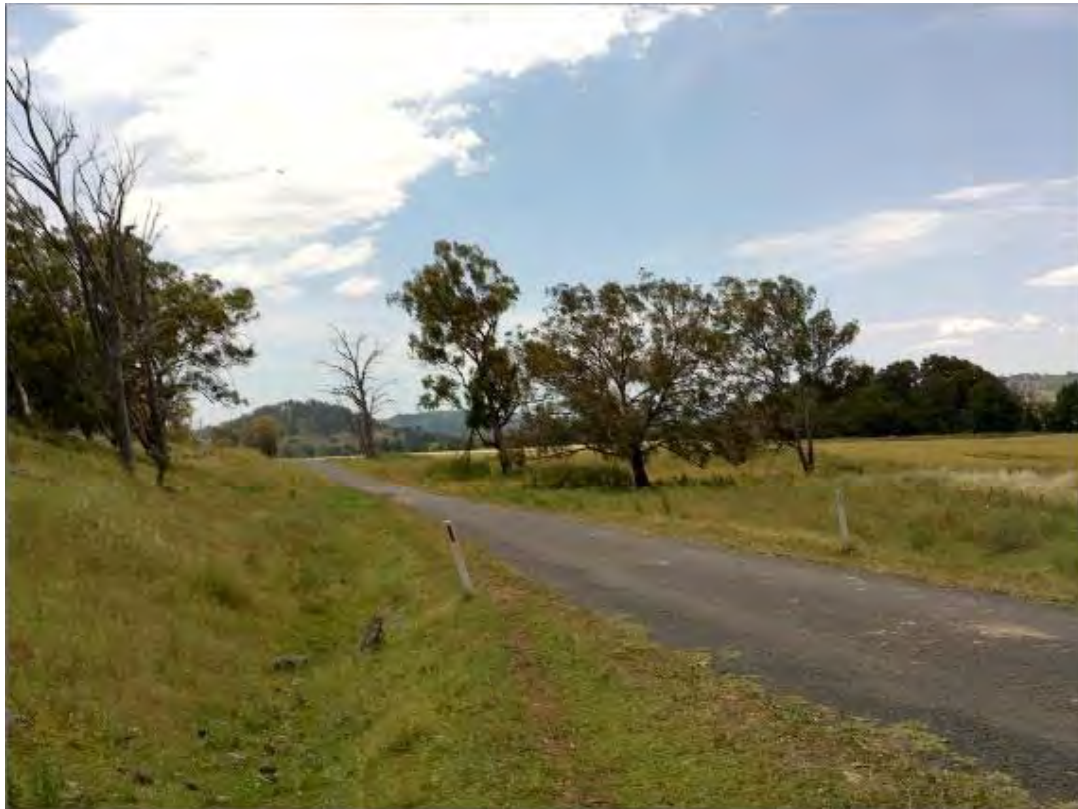
S196 – View to North

S196 – Rotherwood Rd - 1900m West of Yarrawonga Rd
Dual -525mm Pipe Culvert
Fair Condition and Serviceable

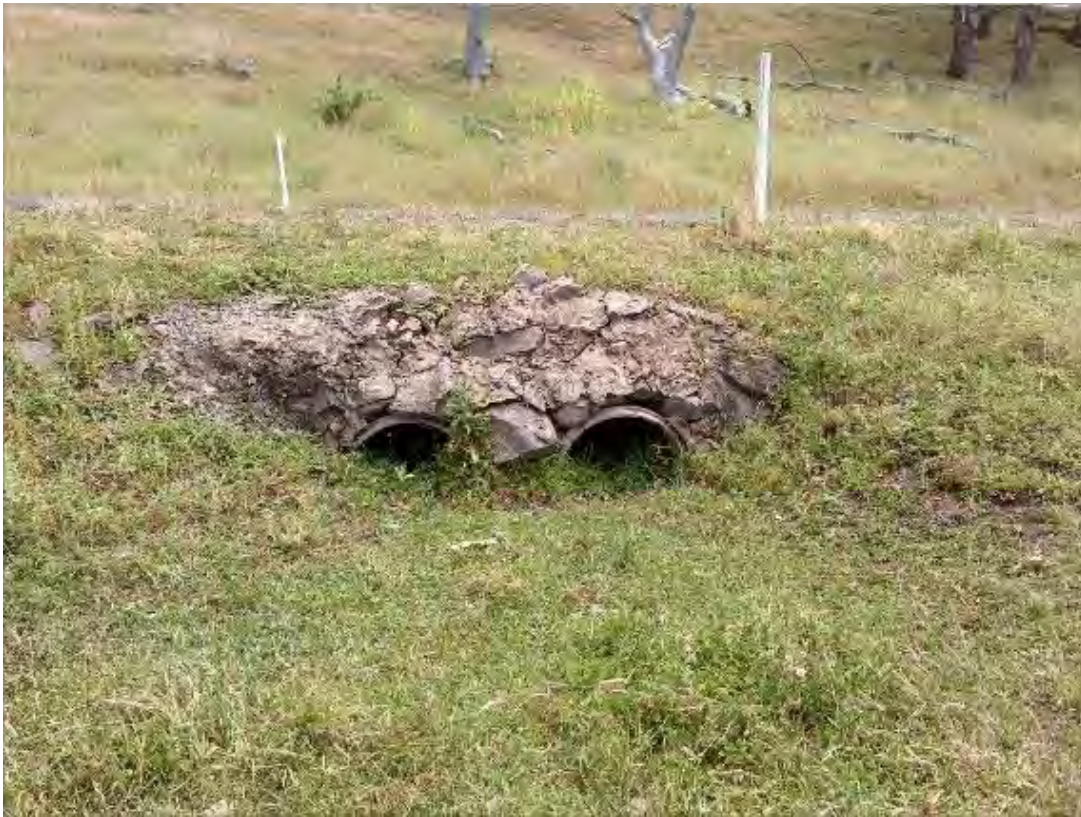
S196 – Dual -525mm Pipe Culvert
