3 November, 2015

Our Reference: 0295776 PROJECT MODIFICATION HERITAGE SURVEY\_FINAL.DOCX

RE: HERITAGE SURVEY FOR MODIFICATION AREAS - WHITE  
ROCK WIND FARM

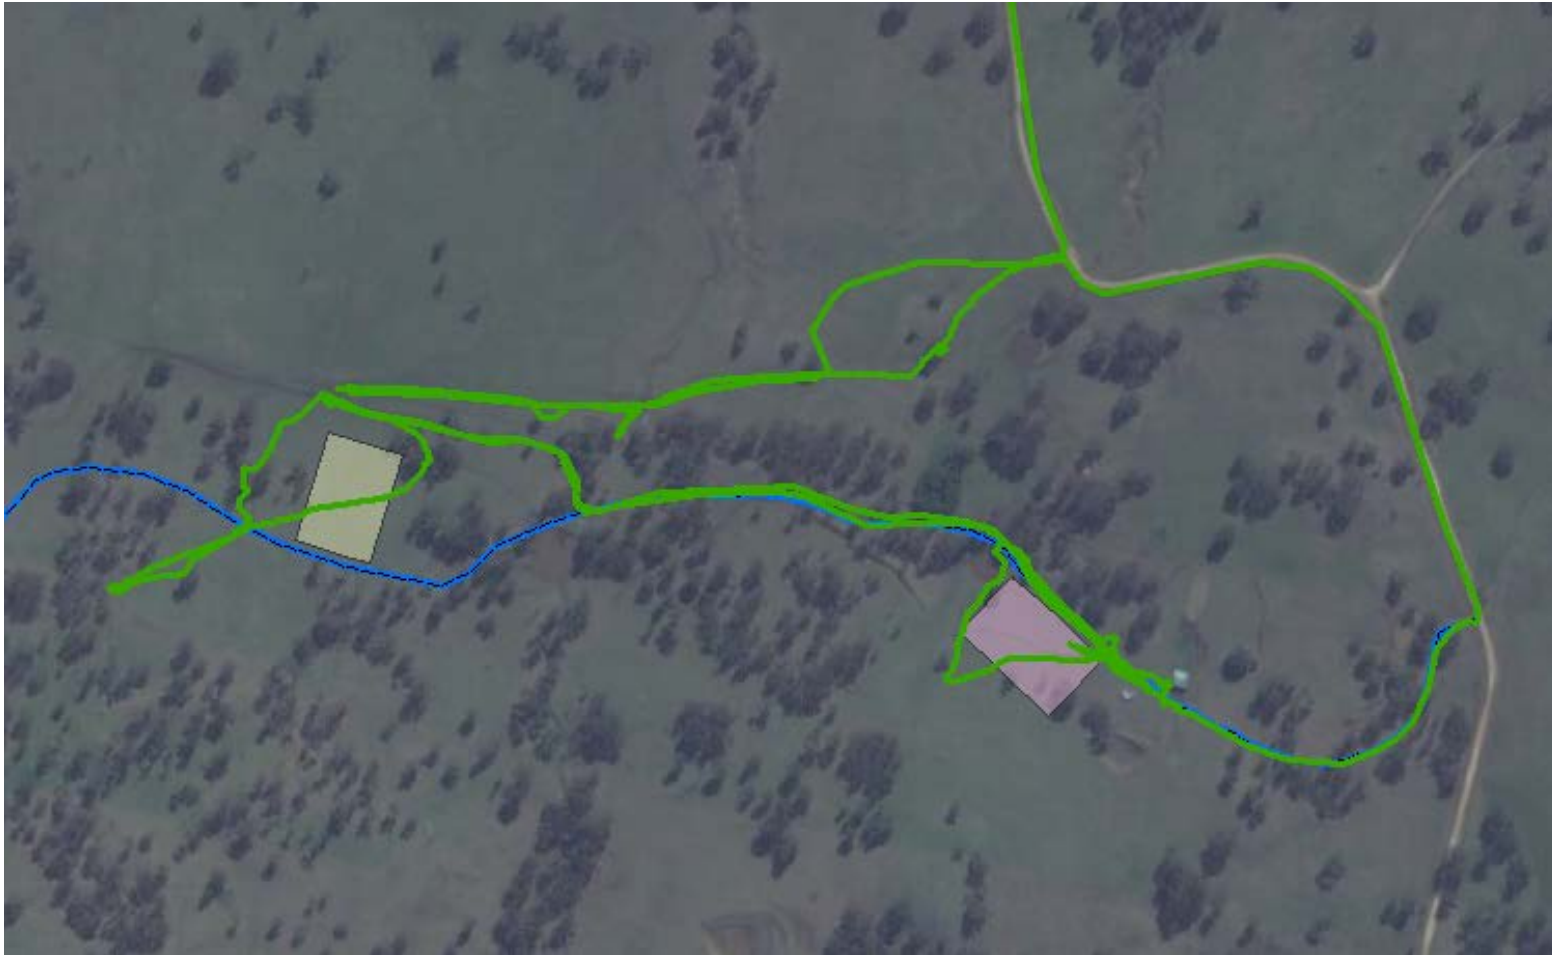
*Figure 1 Detail of assessed areas at Survey Unit 4 showing previously approved tracks (blue), current survey transects (green) and proposed ancillary facilities (yellow and pink).*

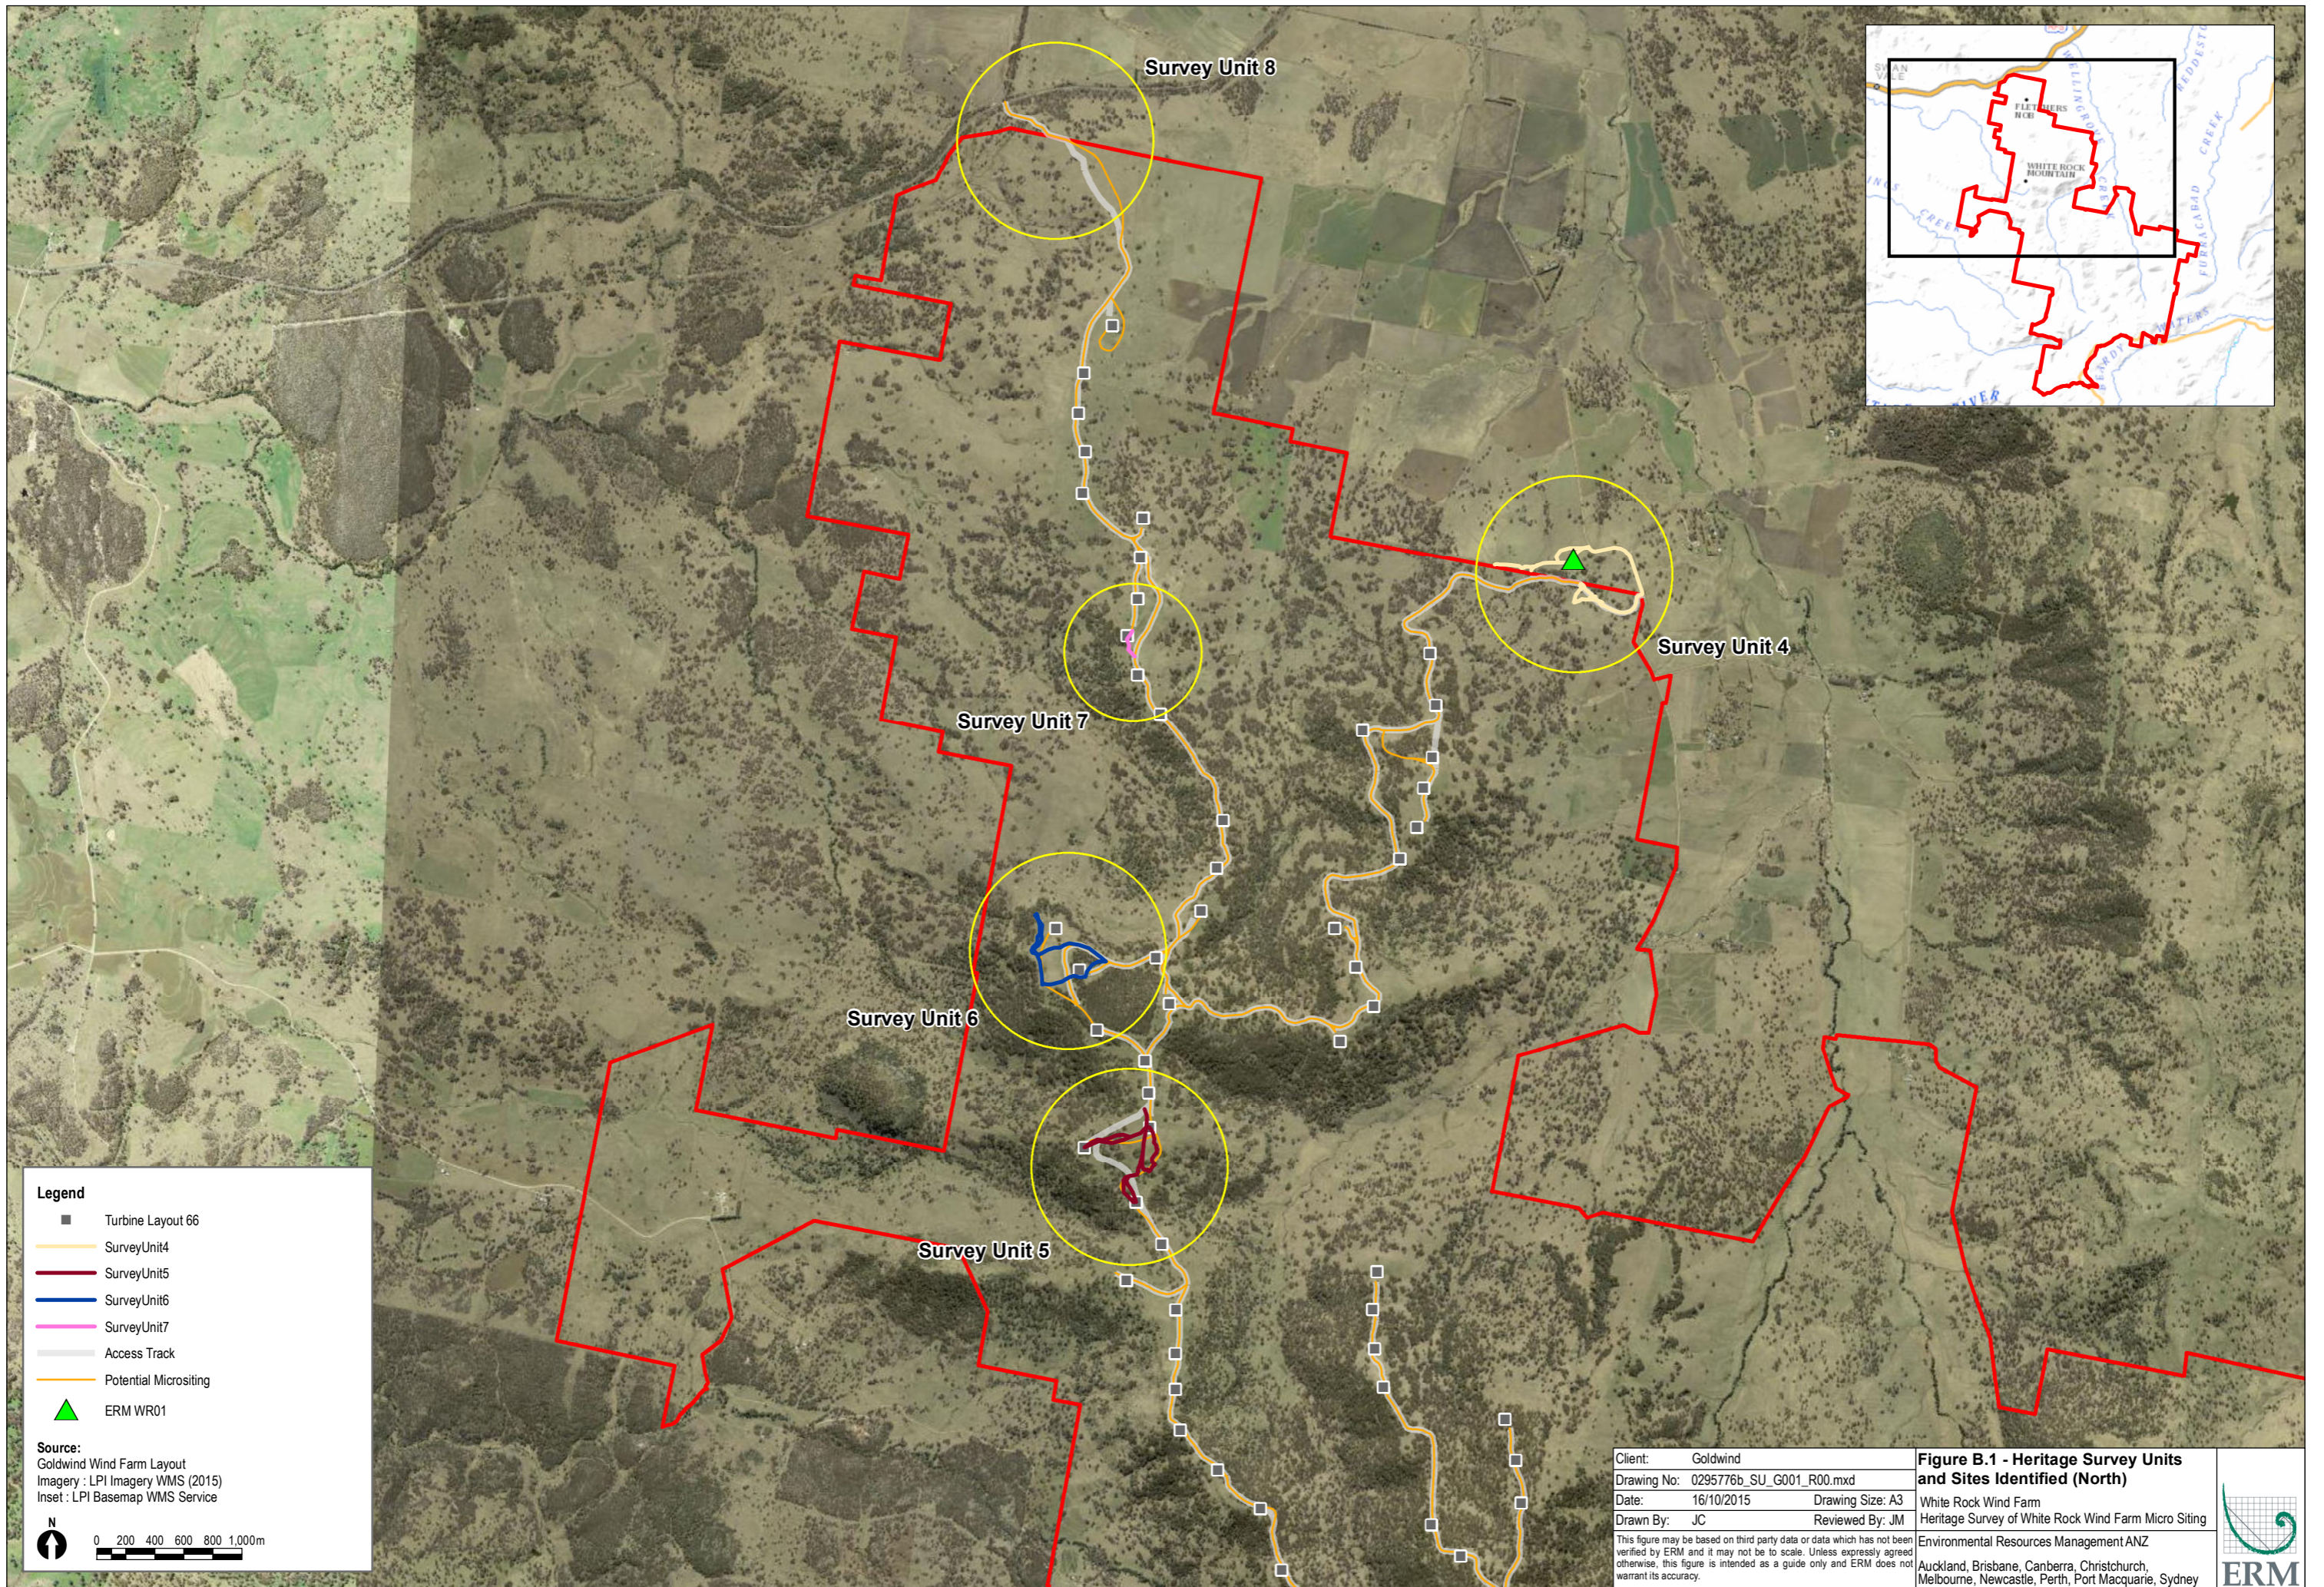
# SURVEY UNITS AND HERITAGE SITES IDENTIFIED

The field survey identified one new Aboriginal heritage site (refer to *Photograph 1* and *Annex B*). No historic heritage sites or areas of archaeological sensitivity were identified. The new site, ERM WR01 is described below with completed site card attached in *Annex C*:

Location (GDA94 MGA Zone 56): Easting 362631 Northing: 6704300

ERM WR01 consists of one grey silcrete core artefact. Three flake scars and overhang removal were present on the artefact. The artefact was identified adjacent to a vehicle access track within an area of soil erosion under a tree. The surrounding area comprises a paddock with dense grass coverage. No other artefacts were found within the area. Soils at this location comprise highly disturbed (ploughed) medium brown loose silt. The area has been disturbed by land clearance and farming activities.
